**TEST REPORT**

**NGONG PING SEWAGE TREATMENT PLANT,  
TRUNK SEWERS AND EFFLUENT EXPORT  
PIPELINE  
OPERATION PHASE**

**MONTHLY EM&A REPORT  
FOR  
GROUND WATER MONITORING  
(JULY 2007)**

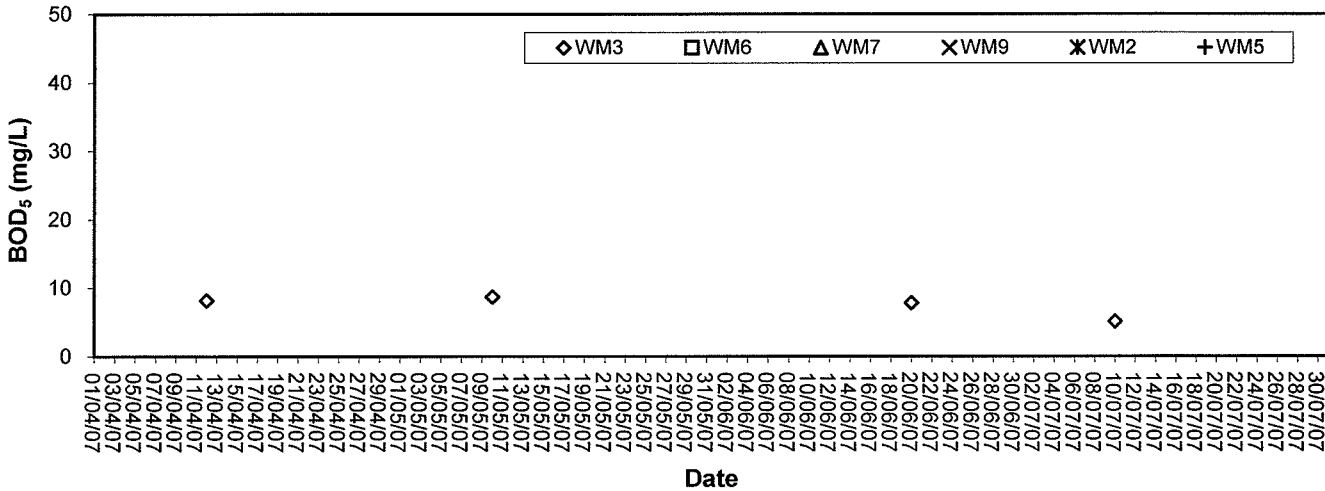
**5-day Biochemical Oxygen Demand (BOD<sub>5</sub>)**

In this reporting month, groundwater monitoring was carried out on 10 July 2007. During this monitoring, groundwater was found in Borehole No WM3 and the other boreholes were dry. The groundwater quality measurement results are detailed in Appendix B. Graphical presentation of the monitoring parameters for this reporting month is shown in Appendix C.

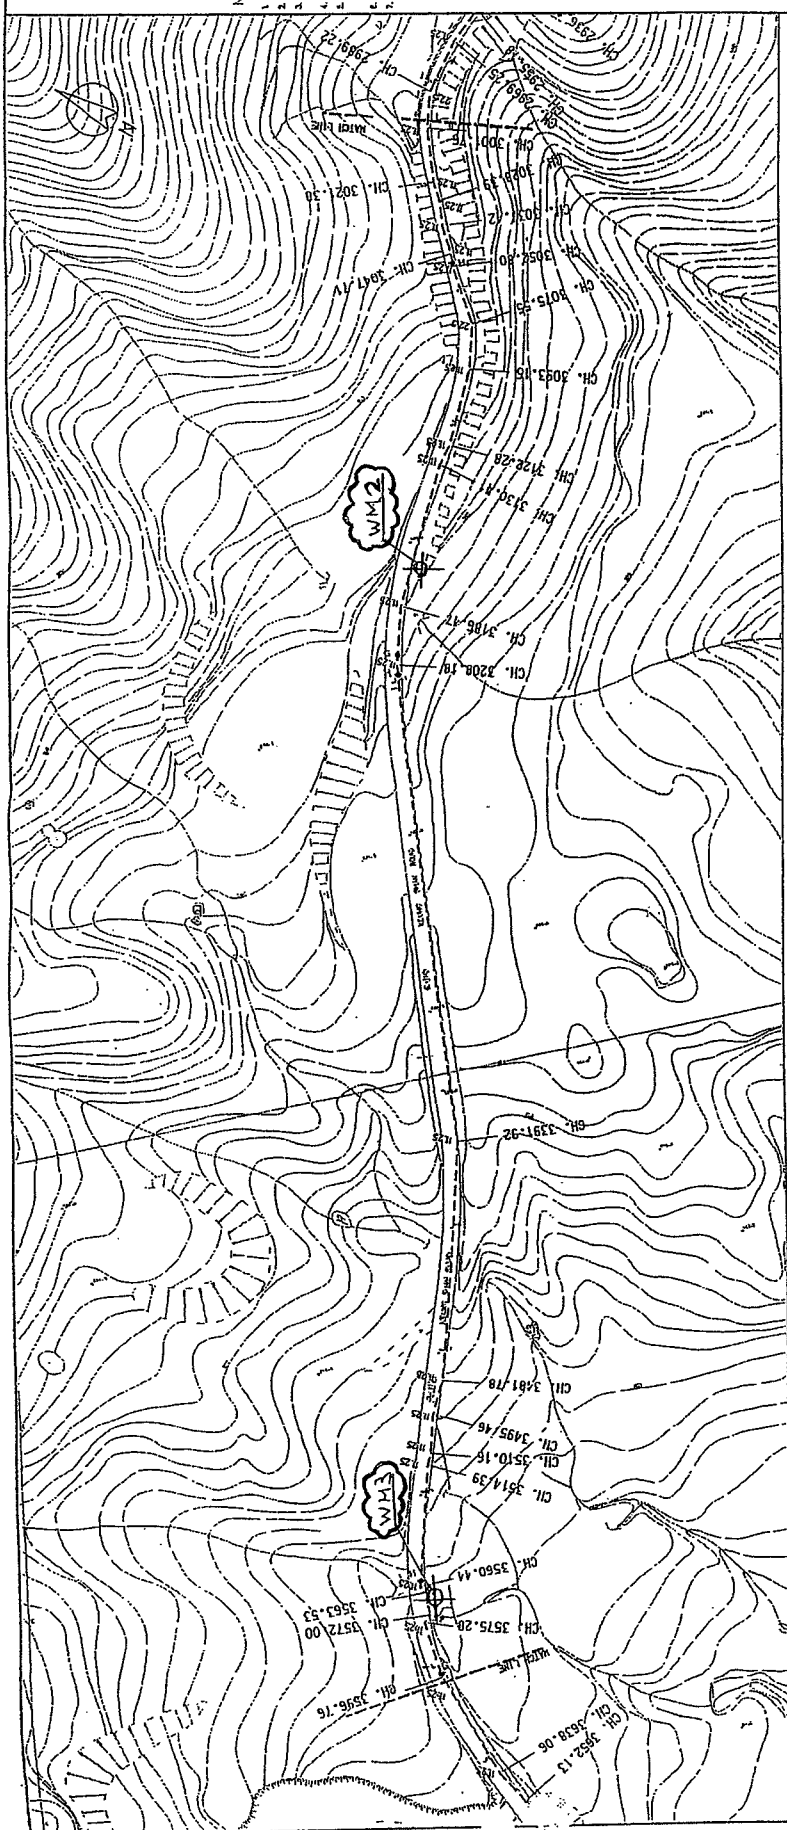
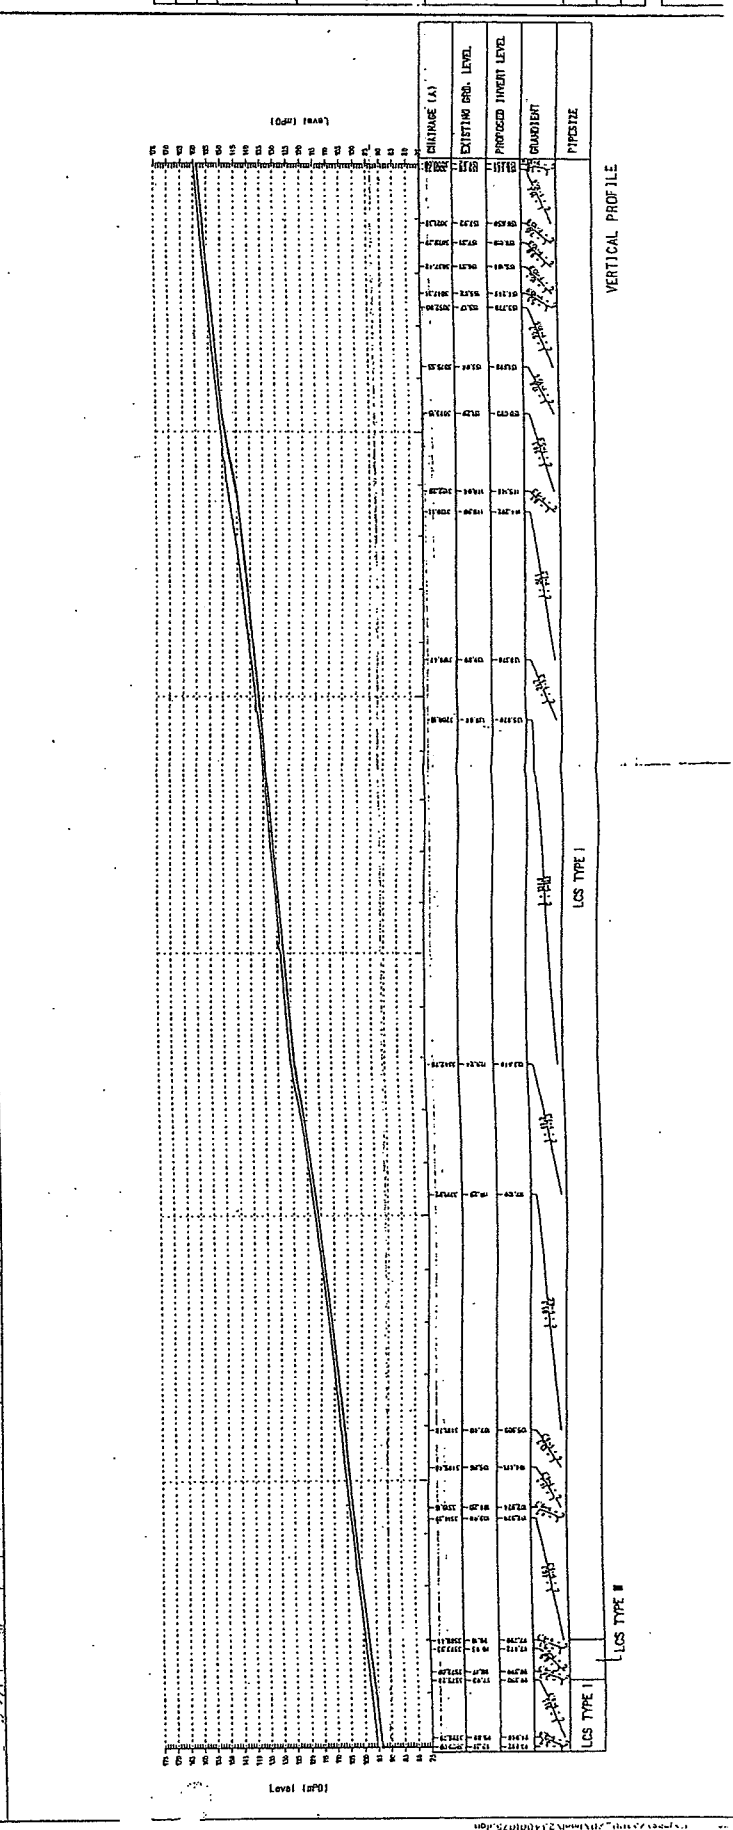
DRAWING TITLE:  
EFFLUENT EXPORT PIPELINE;  
ALIGNMENT AND PROFILE  
(SHEET 6 OF 10)

The general layout plan of the project is shown in Appendix D. The groundwater monitoring locations are also shown in the Drawing No. 23400/T/202, 23400/T/074, 23400/T/075 and 23400/T/076.
