**CONTRACT NO. DC/2006/15 BUILDING AND  
CIVIL MAINTENANCE AND MINOR WORKS OF  
DSD PLANTS AND FACILITIES (2007-2009)**

**GROUNDWATER MONITORING AT  
NGONG PING STW AND EFFLUENT EXPORT  
PIPE**

**MONTHLY EM&A REPORT**

**(DECEMBER 2007)**

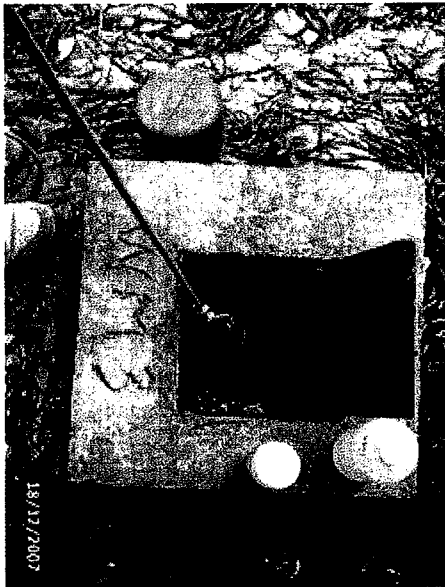
**WM3**

Remark (if any) : The tests marked with "\*" indicated the tests were sub-contract to ALS Technichem (HK) Pty Ltd and HOKLAS accredited. Ground water monitoring was only carried out at WM3, WM3a, WM7a, WM10, WM11 and WM12 only since other sampling points were observed to be dry during the monitoring.

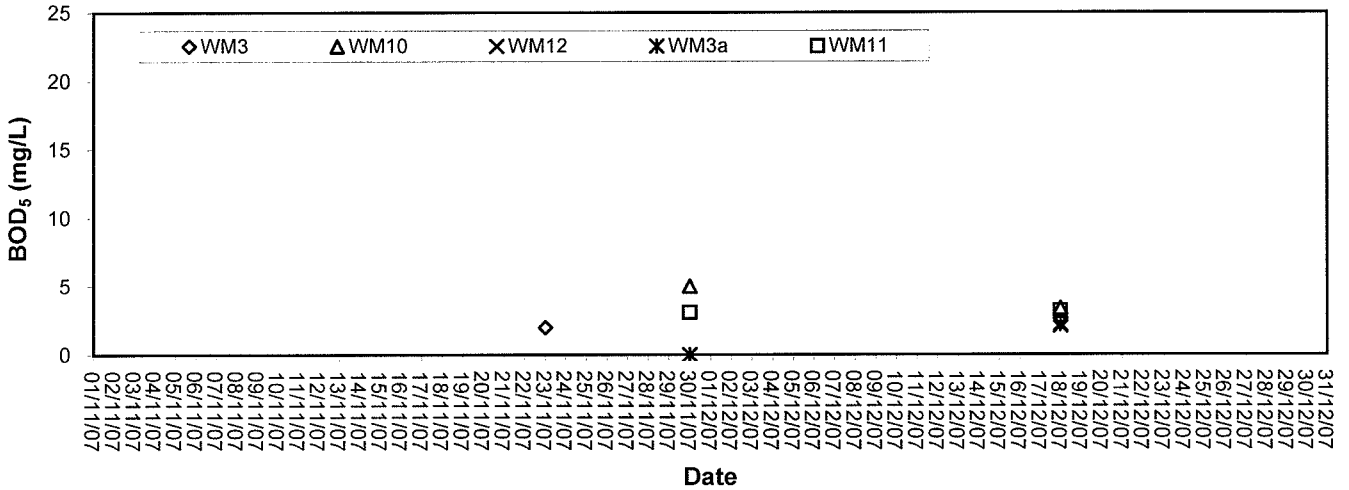
### 5-day Biochemical Oxygen Demand (BOD<sub>5</sub>)

In this reporting month, groundwater monitoring was carried out on 18 December 2007. During this monitoring, groundwater was found in Borehole No WM3, WM3a, WM7a, WM10, WM11 and WM12 and the other boreholes were dry. The groundwater quality measurement results are detailed in Appendix B. Graphical presentation of the monitoring parameters for this reporting month is shown in Appendix C.
