**CONTRACT NO. DC/2006/15 BUILDING AND
CIVIL MAINTENANCE AND MINOR WORKS OF
DSD PLANTS AND FACILITIES (2007-2009)**

**GROUNDWATER MONITORING AT
NGONG PING STW AND EFFLUENT EXPORT
PIPE**

MONTHLY EM&A REPORT

(MARCH 2008)

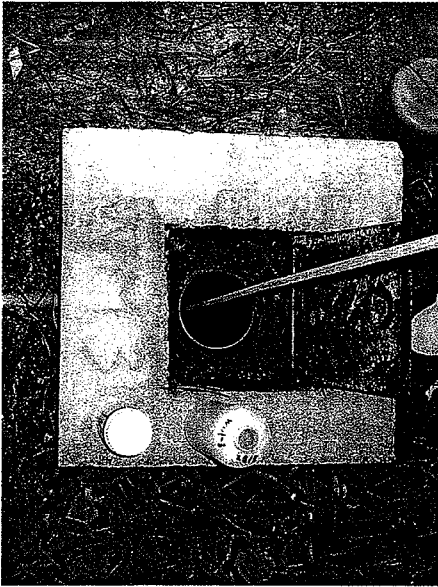
WM3

Remark (if any) : The tests marked with "*" indicated the tests were sub-contract to ALS Technichem (HK) Pty Ltd and HOKLAS accredited. Ground water monitoring was only carried out at WM3, WM3a, WM 6, WM7, WM7a, WM10 and WM12 only since other sampling points were observed to be dry during the monitoring.

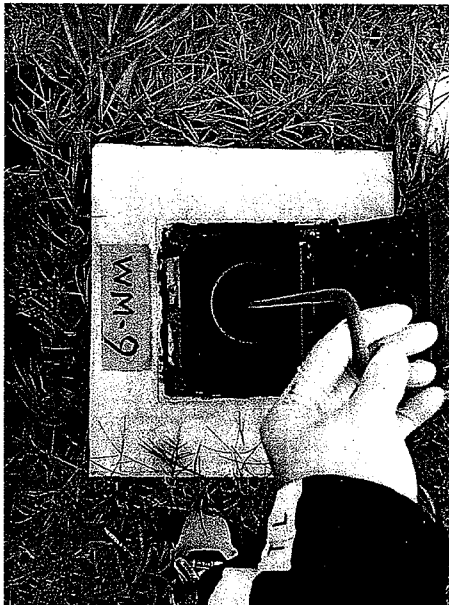
In this reporting month, groundwater monitoring was carried out on 28 March 2008. During this monitoring, groundwater was found in Borehole No WM3, WM3a, WM6, WM7, WM7a, WM10 and WM12 but no groundwater was observed in WM9 and WM11. The groundwater quality measurement results are detailed in Appendix B. Graphical presentation of the monitoring parameters for this reporting month is shown in Appendix C.

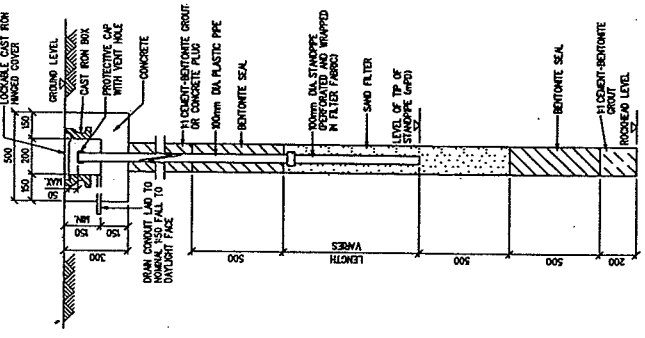
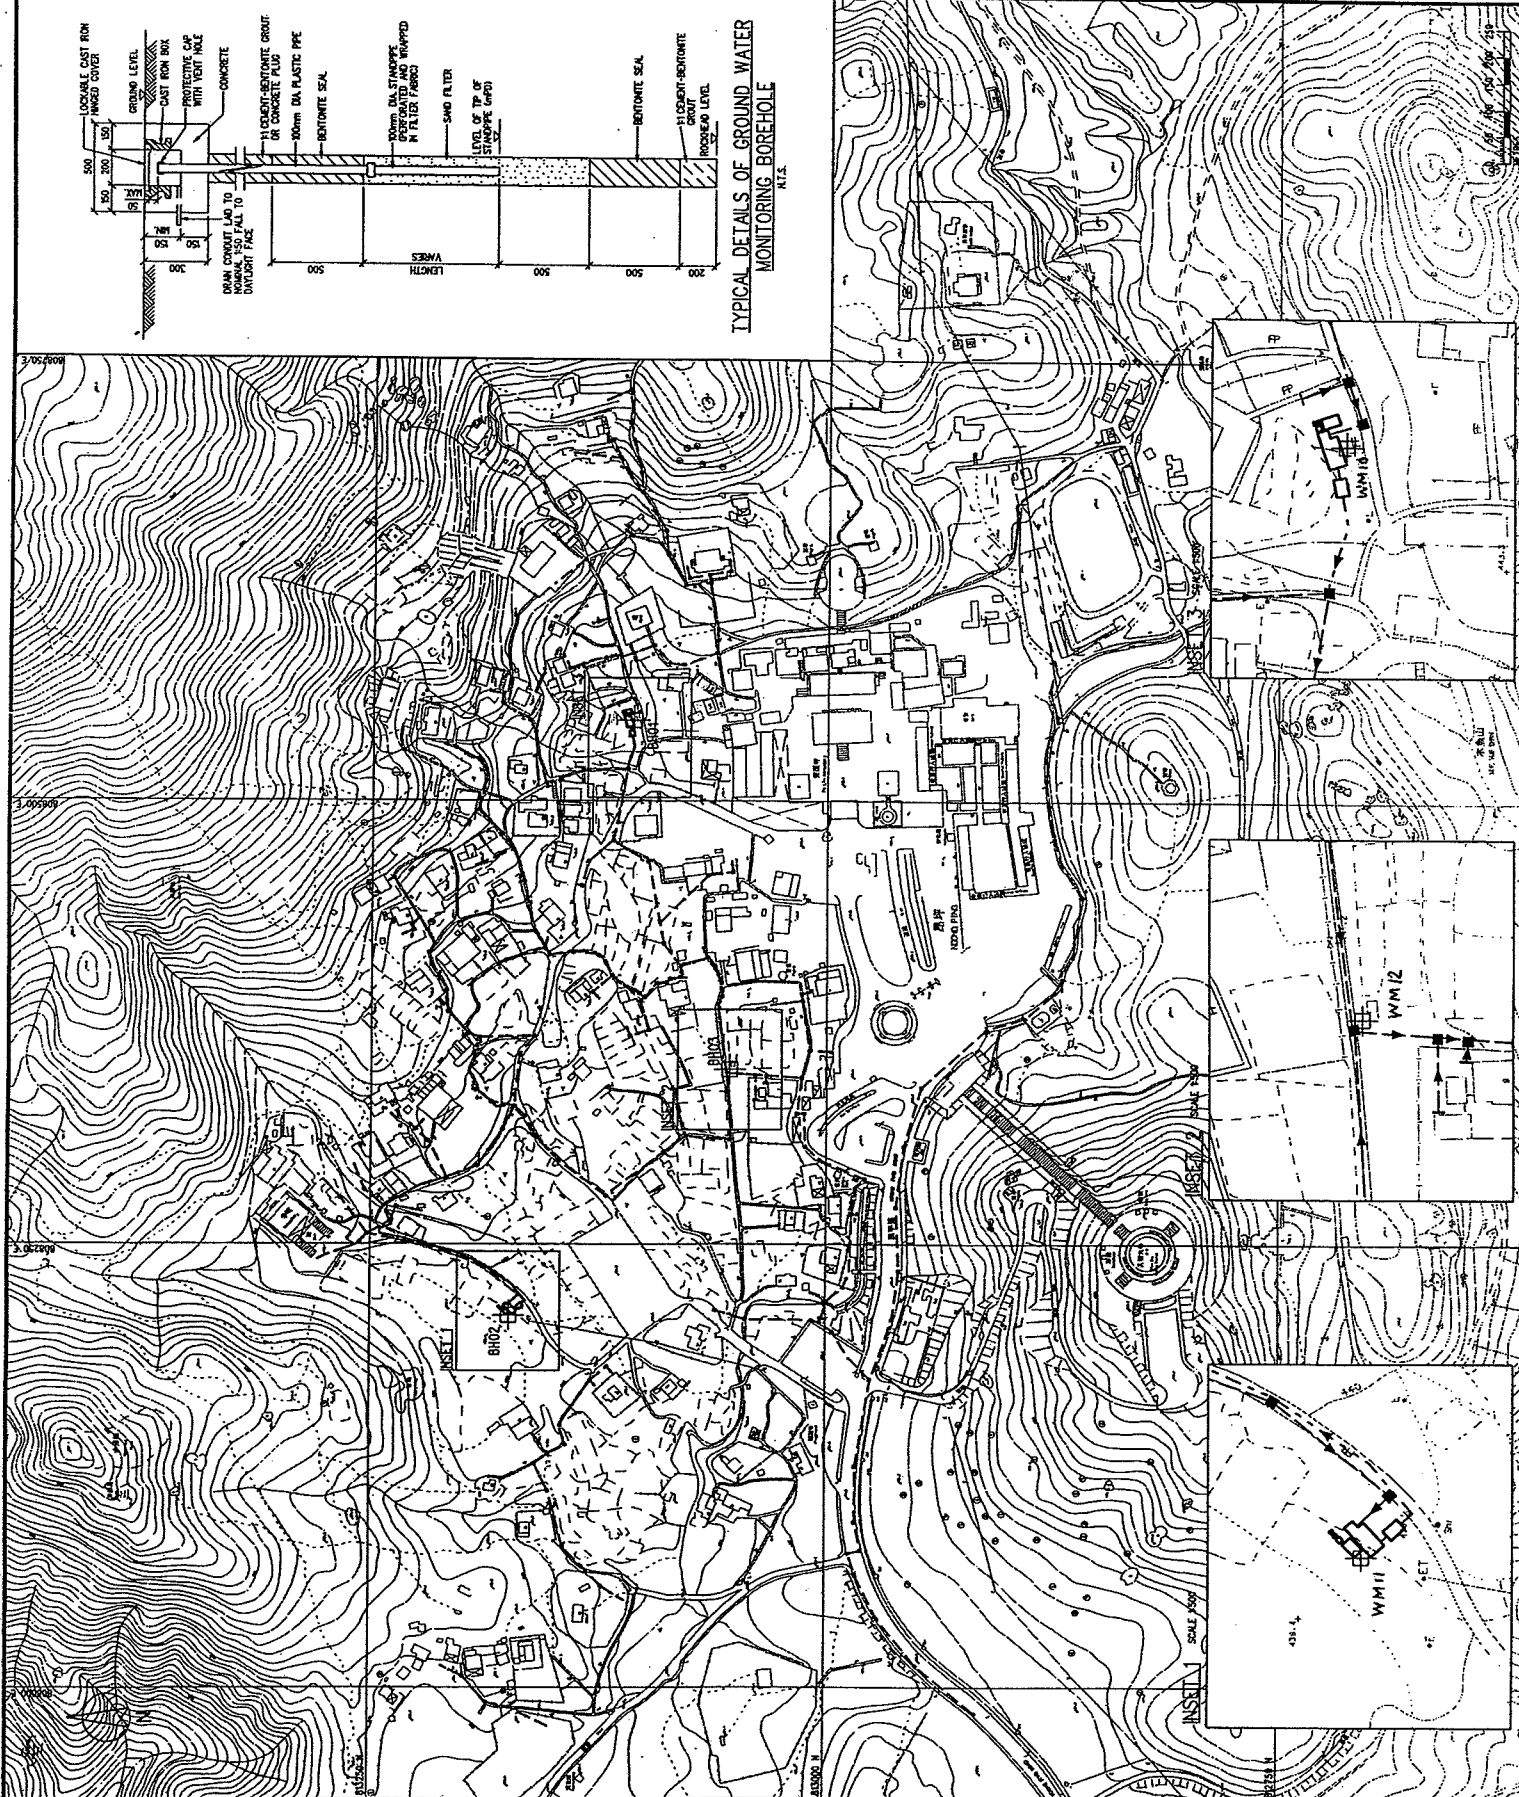
TYPICAL DETAILS OF GROUND WATER MONITORING BOREHOLE
N.T.S.

**LOCATION & TYPICAL DETAILS OF
GROUND WATER MONITORING BOREHOLE**
