**CONTRACT NO. DC/2006/15 BUILDING AND
CIVIL MAINTENANCE AND MINOR WORKS OF
DSD PLANTS AND FACILITIES (2007-2009)**

**GROUNDWATER MONITORING AT
NGONG PING STW AND EFFLUENT EXPORT
PIPE**

MONTHLY EM&A REPORT

(APRIL 2008)

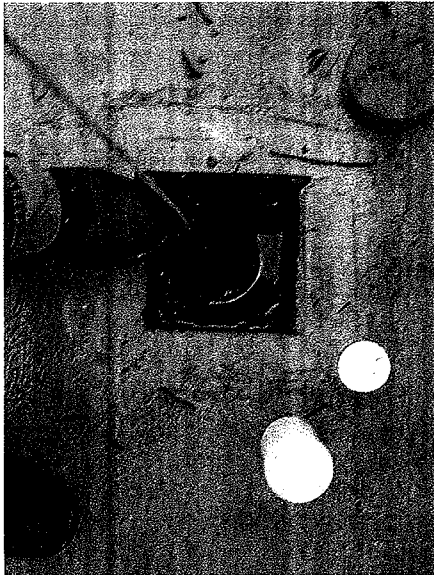
WM10

Date of sampling and photo taking : 28 April 2008

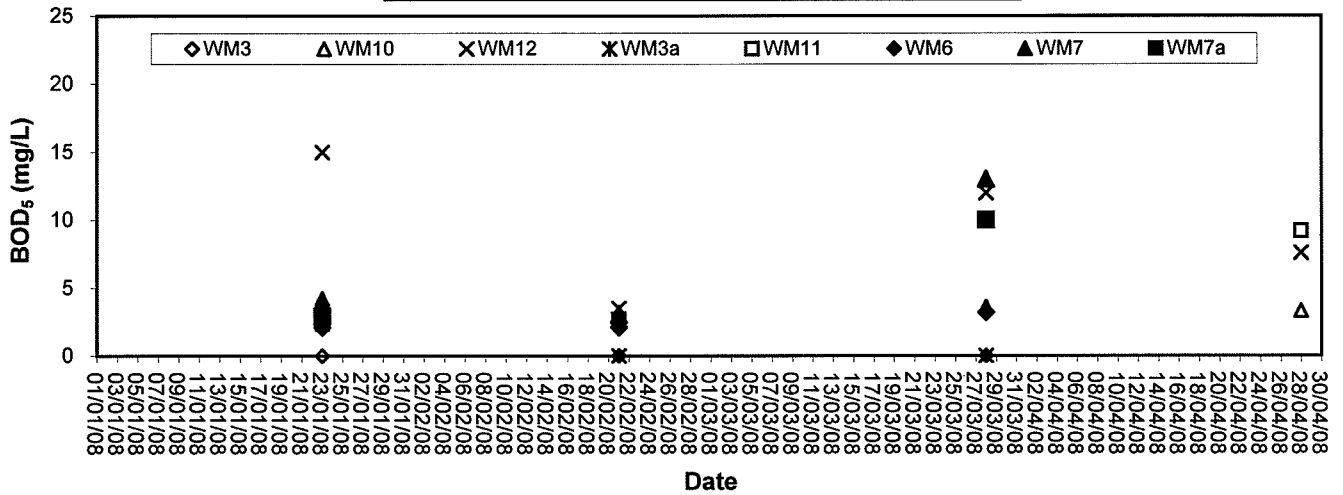
5-day Biochemical Oxygen Demand (BOD₅)

In this reporting month, groundwater monitoring was carried out at WM10, WM11 and WM12 on 28 April 2008. The groundwater quality measurement results are detailed in Appendix B. Graphical presentation of the monitoring parameters for this reporting month is shown in Appendix C.

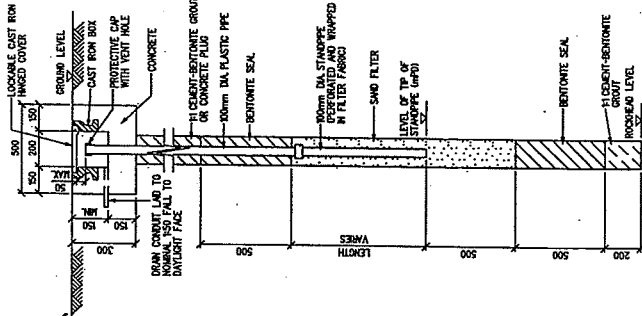
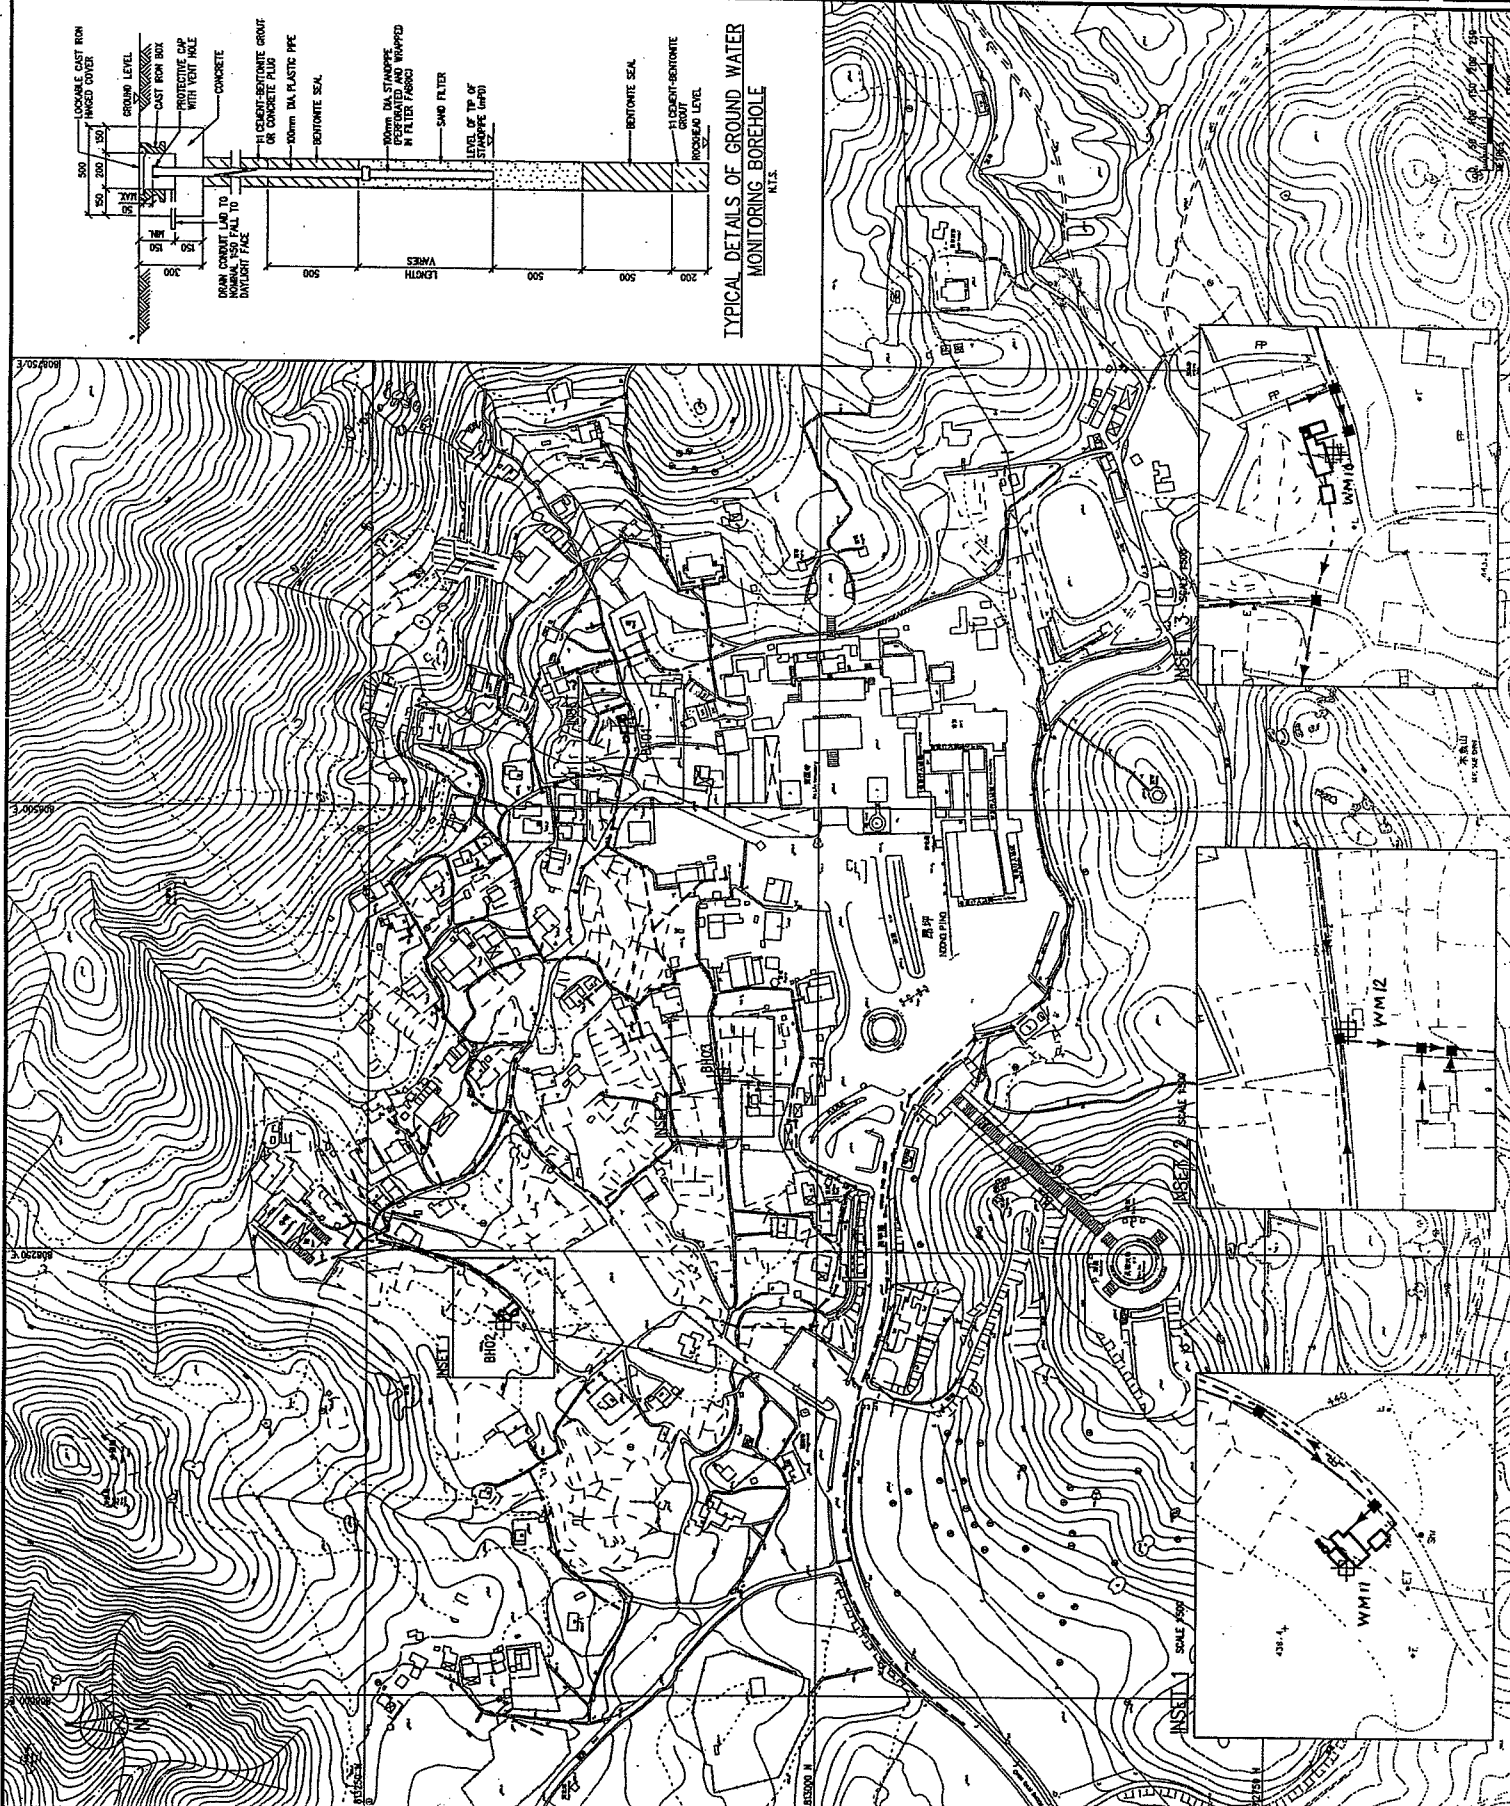
TYPICAL DETAILS OF GROUND WATER MONITORING BOREHOLE
N.S.S.

1. EXACT LOCATIONS OF GROUND WATER MONITORING BOREHOLES ARE SUBJECT TO CONFIRMATION ON SITE.

LOCATION & TYPICAL DETAILS OF GROUND WATER MONITORING BOREHOLE

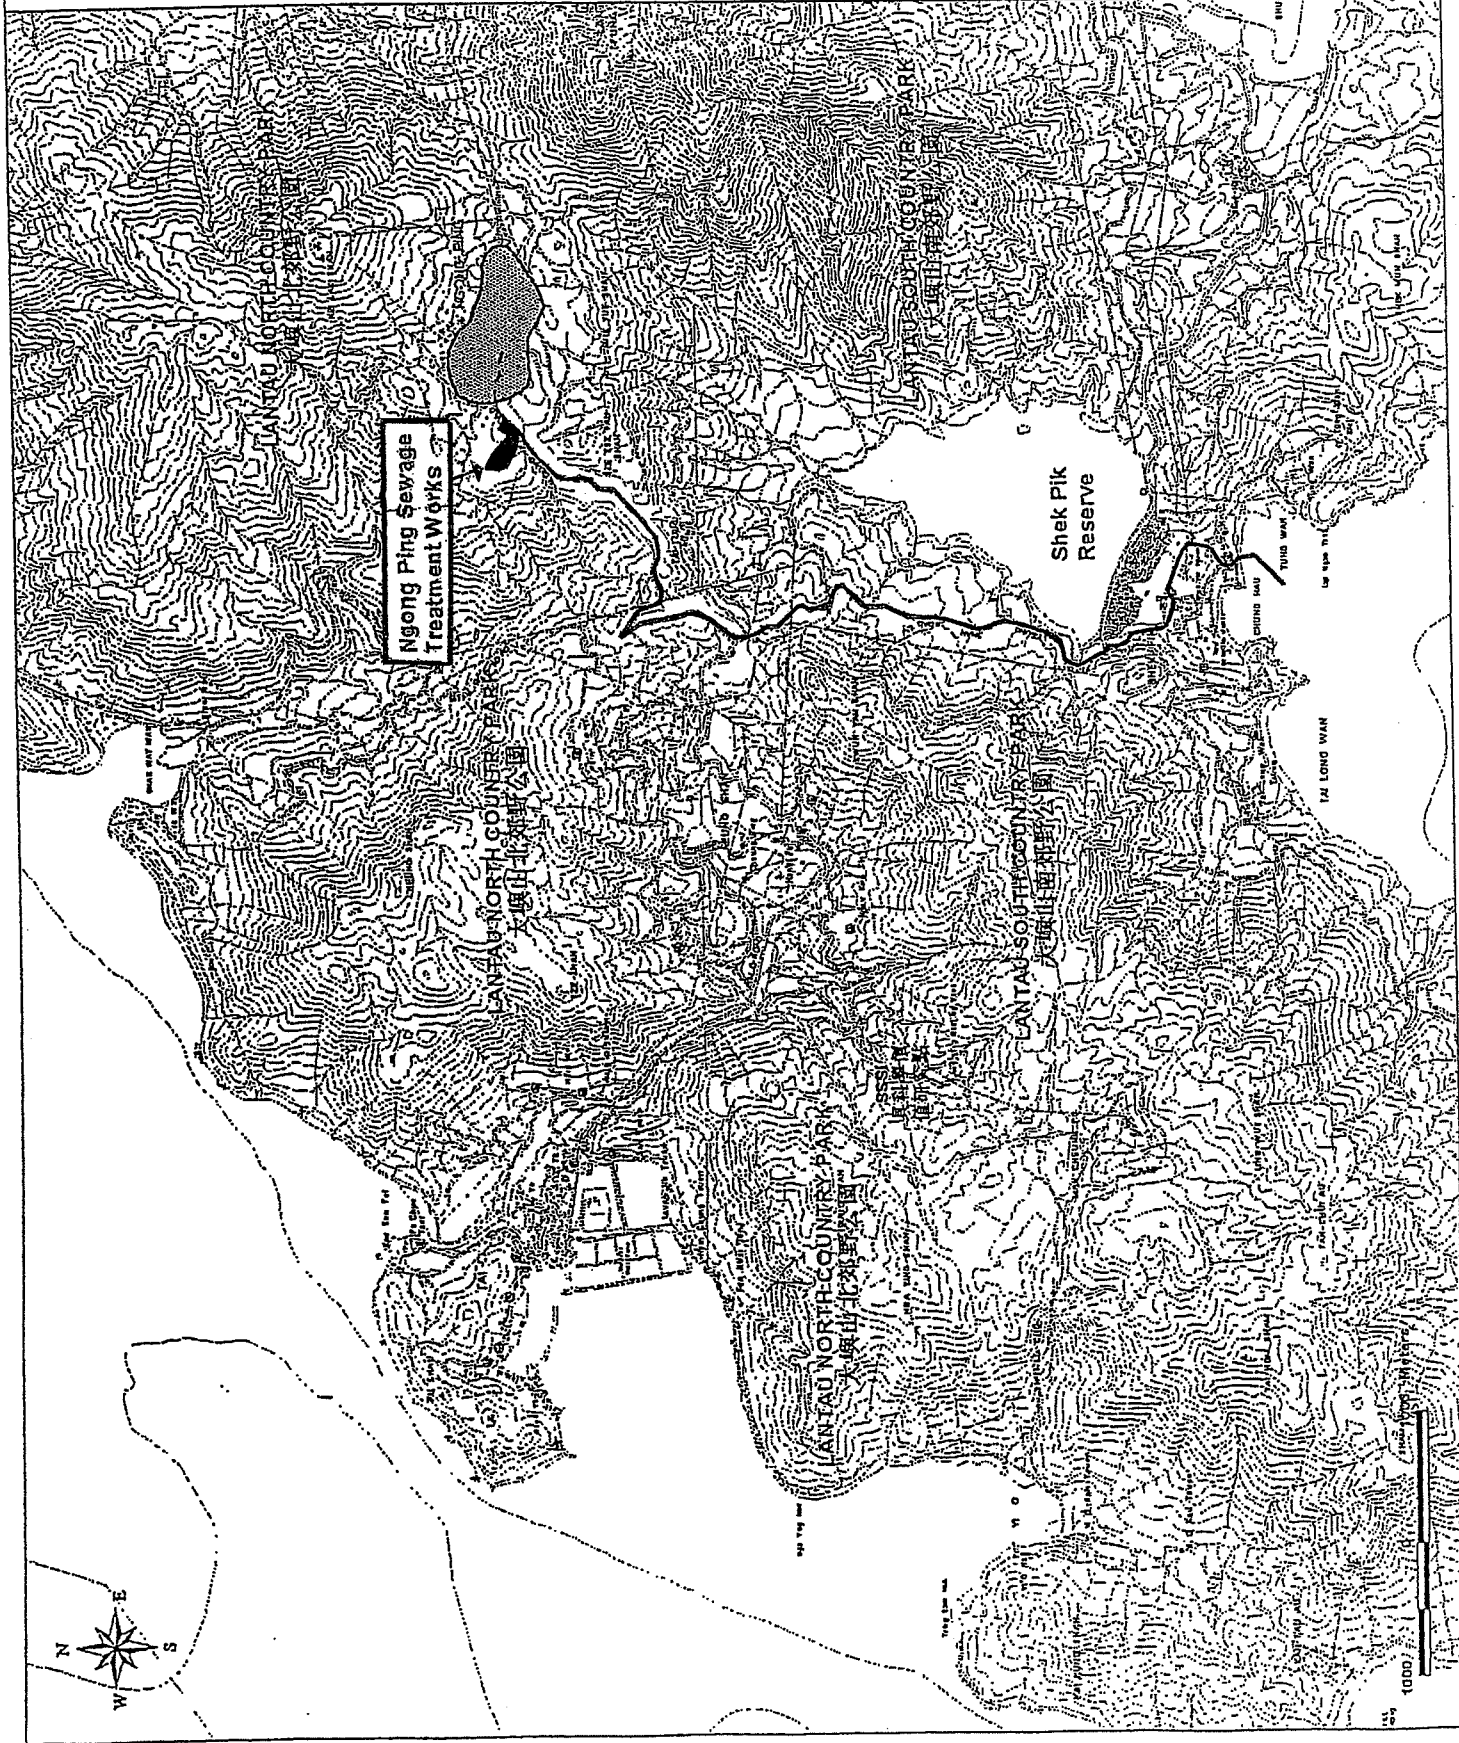
Ngong Ping Sewerage Project
 Scheme - General Layout

This Project only covers the operation phase of Package 1 and Package 2. The general layout plan of the project is shown in Appendix D (Drawing No. 23400/EN/098).

The general layout plan of the project is shown in Appendix D. The groundwater monitoring locations are also shown in the Drawing No. 23400/T/202, 23400/T/074, 23400/T/075 and 23400/T/076.
