**CONTRACT NO. DC/2006/15 BUILDING AND  
CIVIL MAINTENANCE AND MINOR WORKS OF  
DSD PLANTS AND FACILITIES (2007-2009)**

**GROUNDWATER MONITORING AT  
NGONG PING STW AND EFFLUENT EXPORT  
PIPE**

**MONTHLY EM&A REPORT**

**(MAY 2008)**

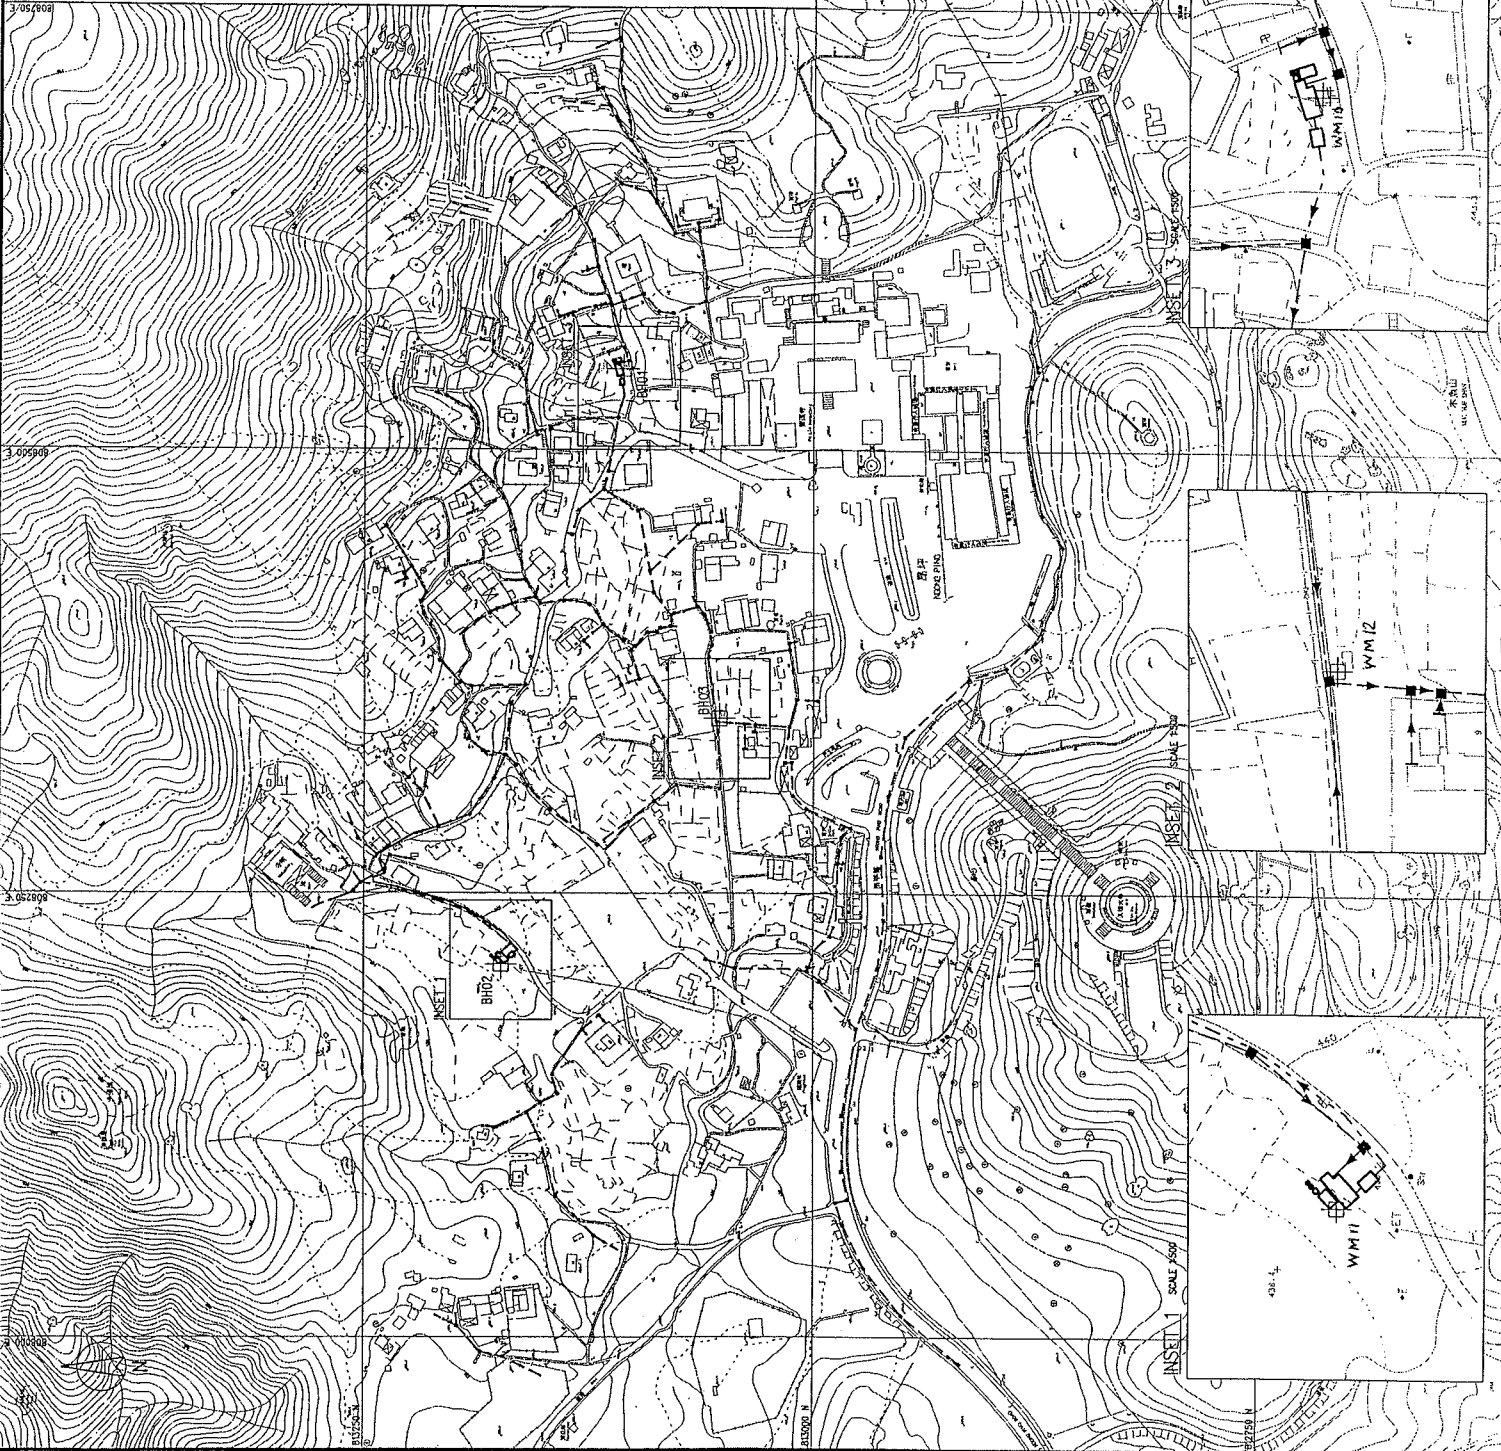
TYPICAL DETAILS OF GROUND WATER MONITORING BOREHOLE

The general layout plan of the project is shown in Appendix D. The groundwater monitoring locations are also shown in the Drawing No. 23400/R/VS/406.

NOTE:  
 1. EXACT LOCATIONS OF GROUND WATER MONITORING BOREHOLES ARE SUBJECT TO CORRECTION ON SITE.

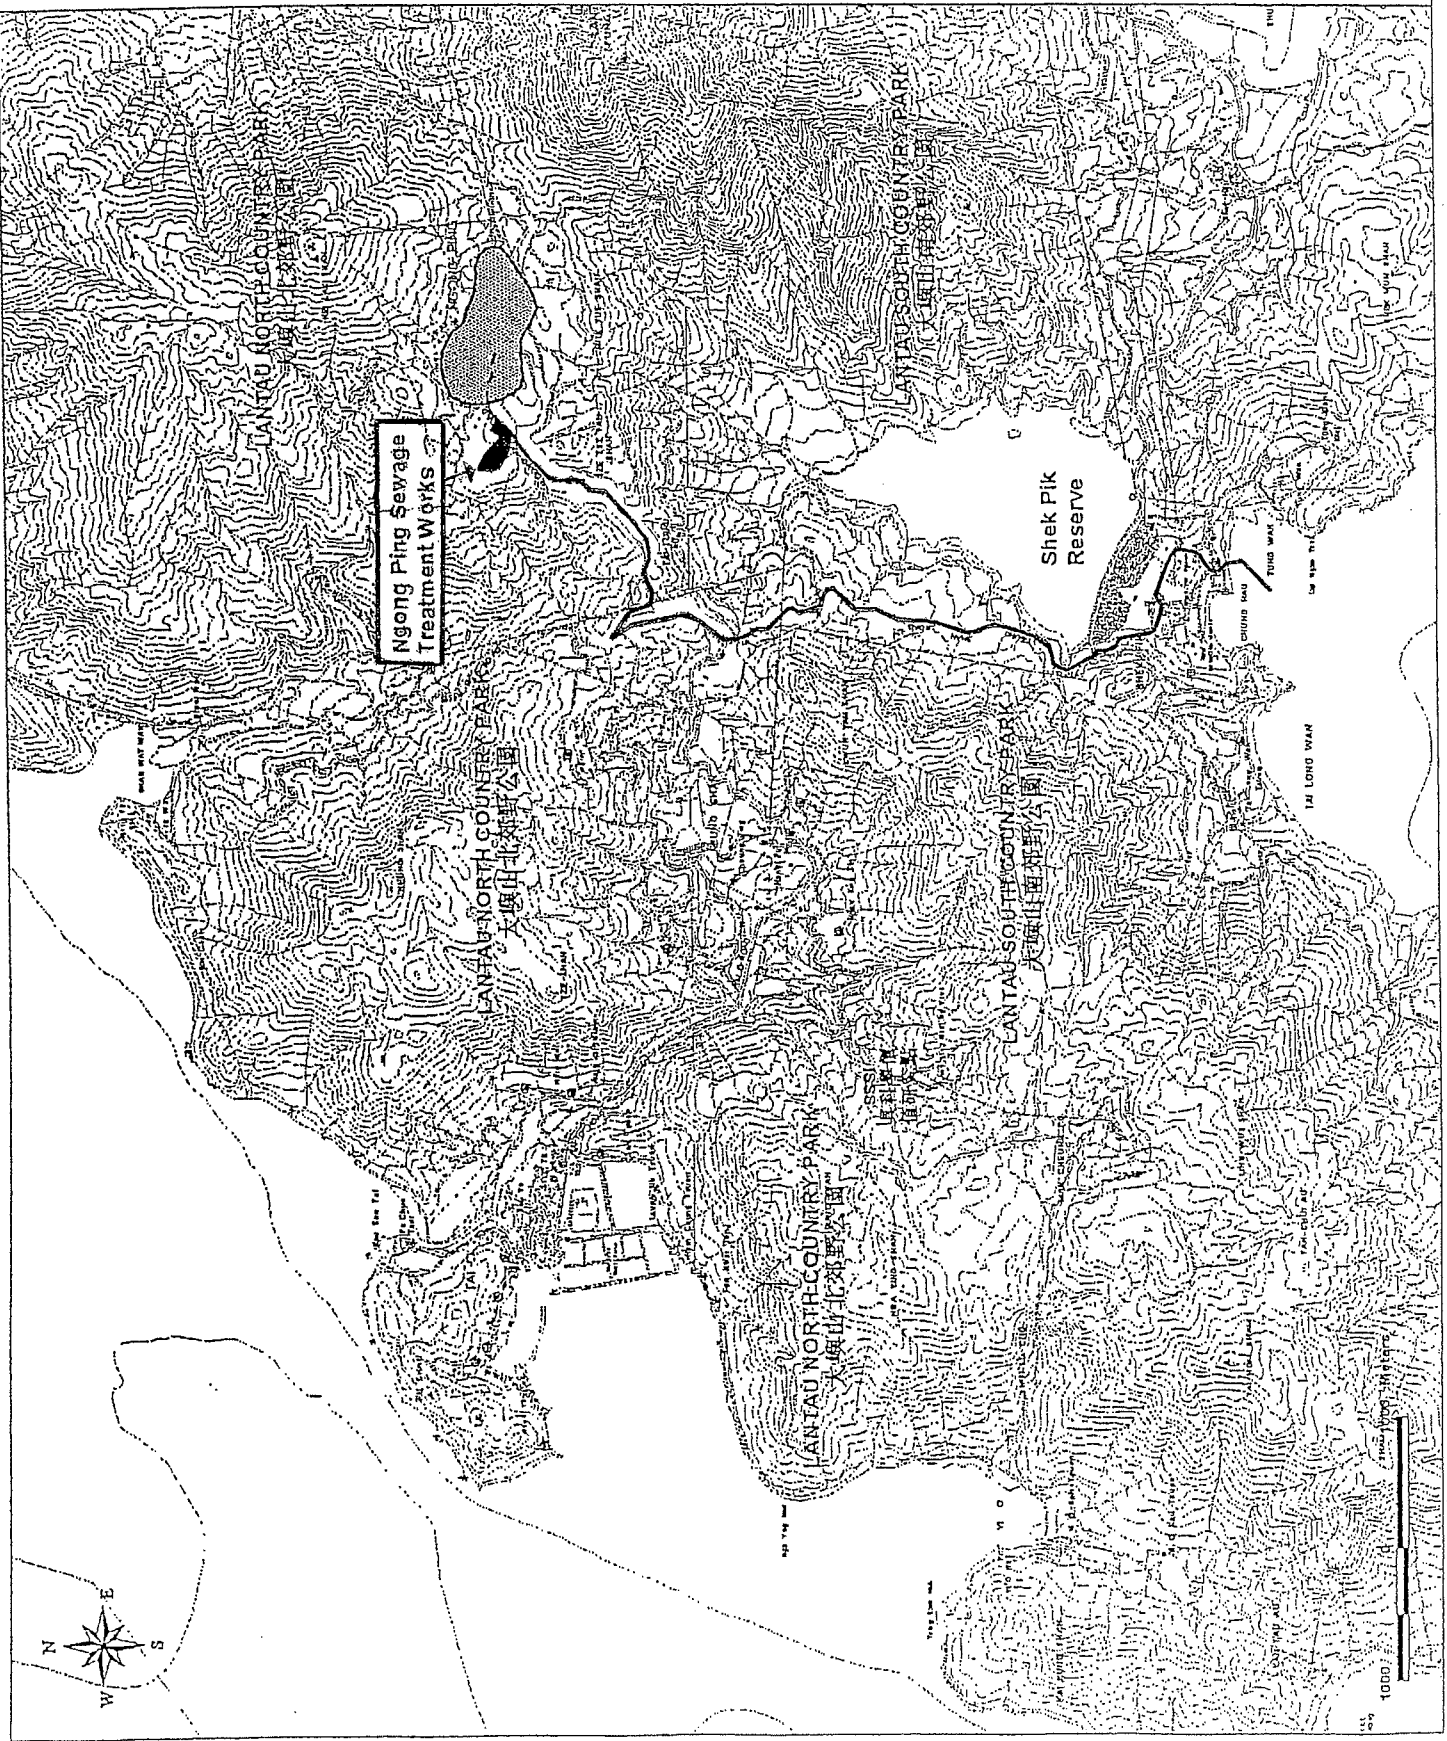
Ngong Ping Sewerage Project  
 Scheme - General Layout

This Project only covers the operation phase of Package 1 and Package 2. The general layout plan of the project is shown in Appendix D (Drawing No. 23400/EN/098).
