**CONTRACT NO. DC/2006/15 BUILDING AND
CIVIL MAINTENANCE AND MINOR WORKS OF
DSD PLANTS AND FACILITIES (2007-2009)**

**GROUNDWATER MONITORING AT
NGONG PING STW AND EFFLUENT EXPORT
PIPE**

MONTHLY EM&A REPORT

(JUNE 2008)

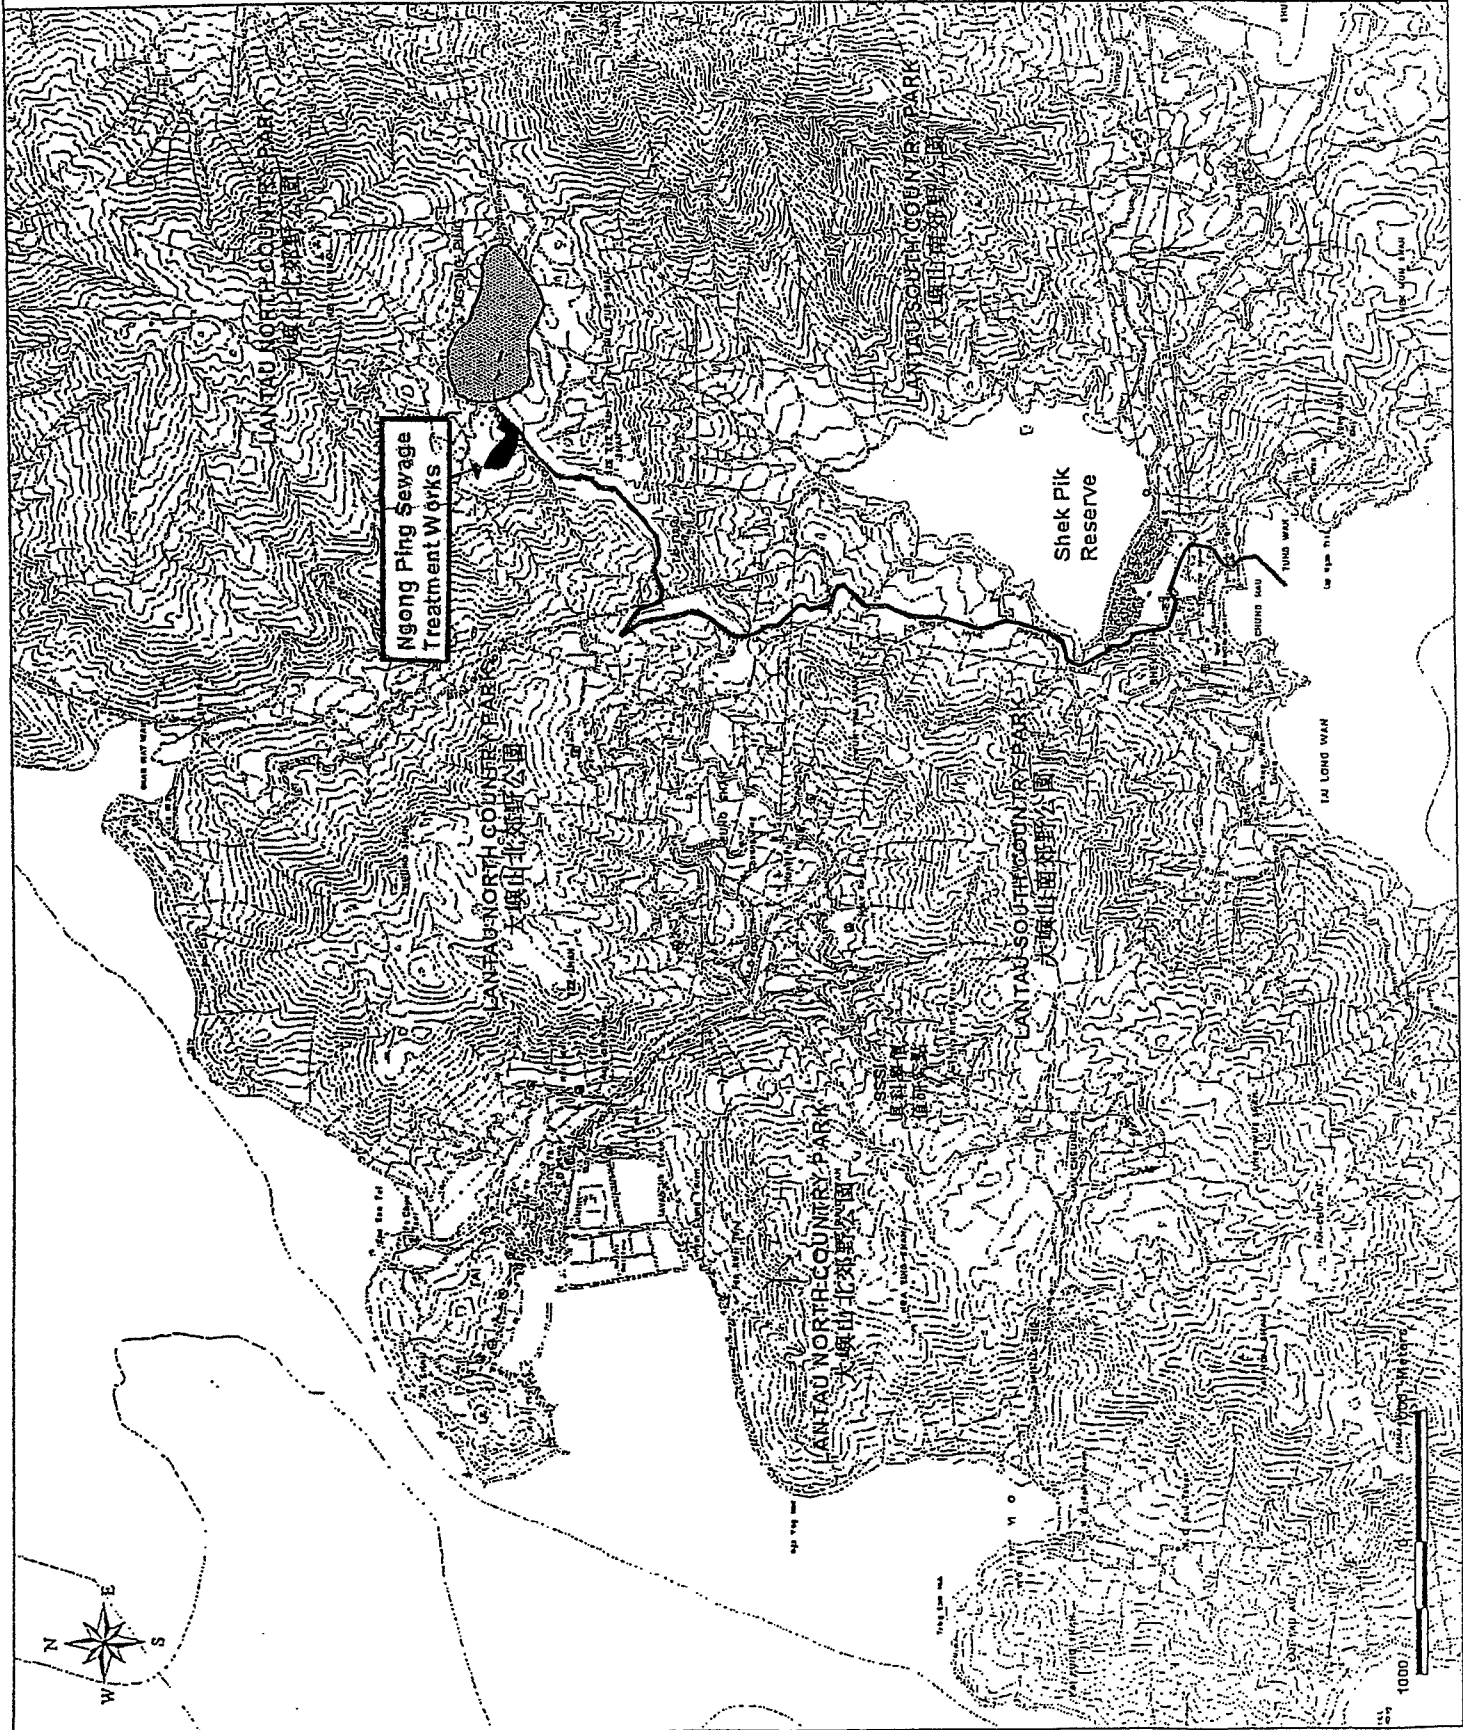
Ngong Ping Sewerage Project
 Scheme - General Layout

This Project only covers the operation phase of Package 1 and Package 2. The general layout plan of the project is shown in Appendix D (Drawing No. 23400/EN/098).

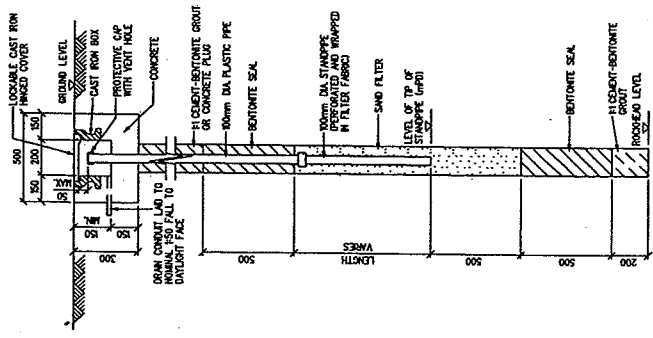
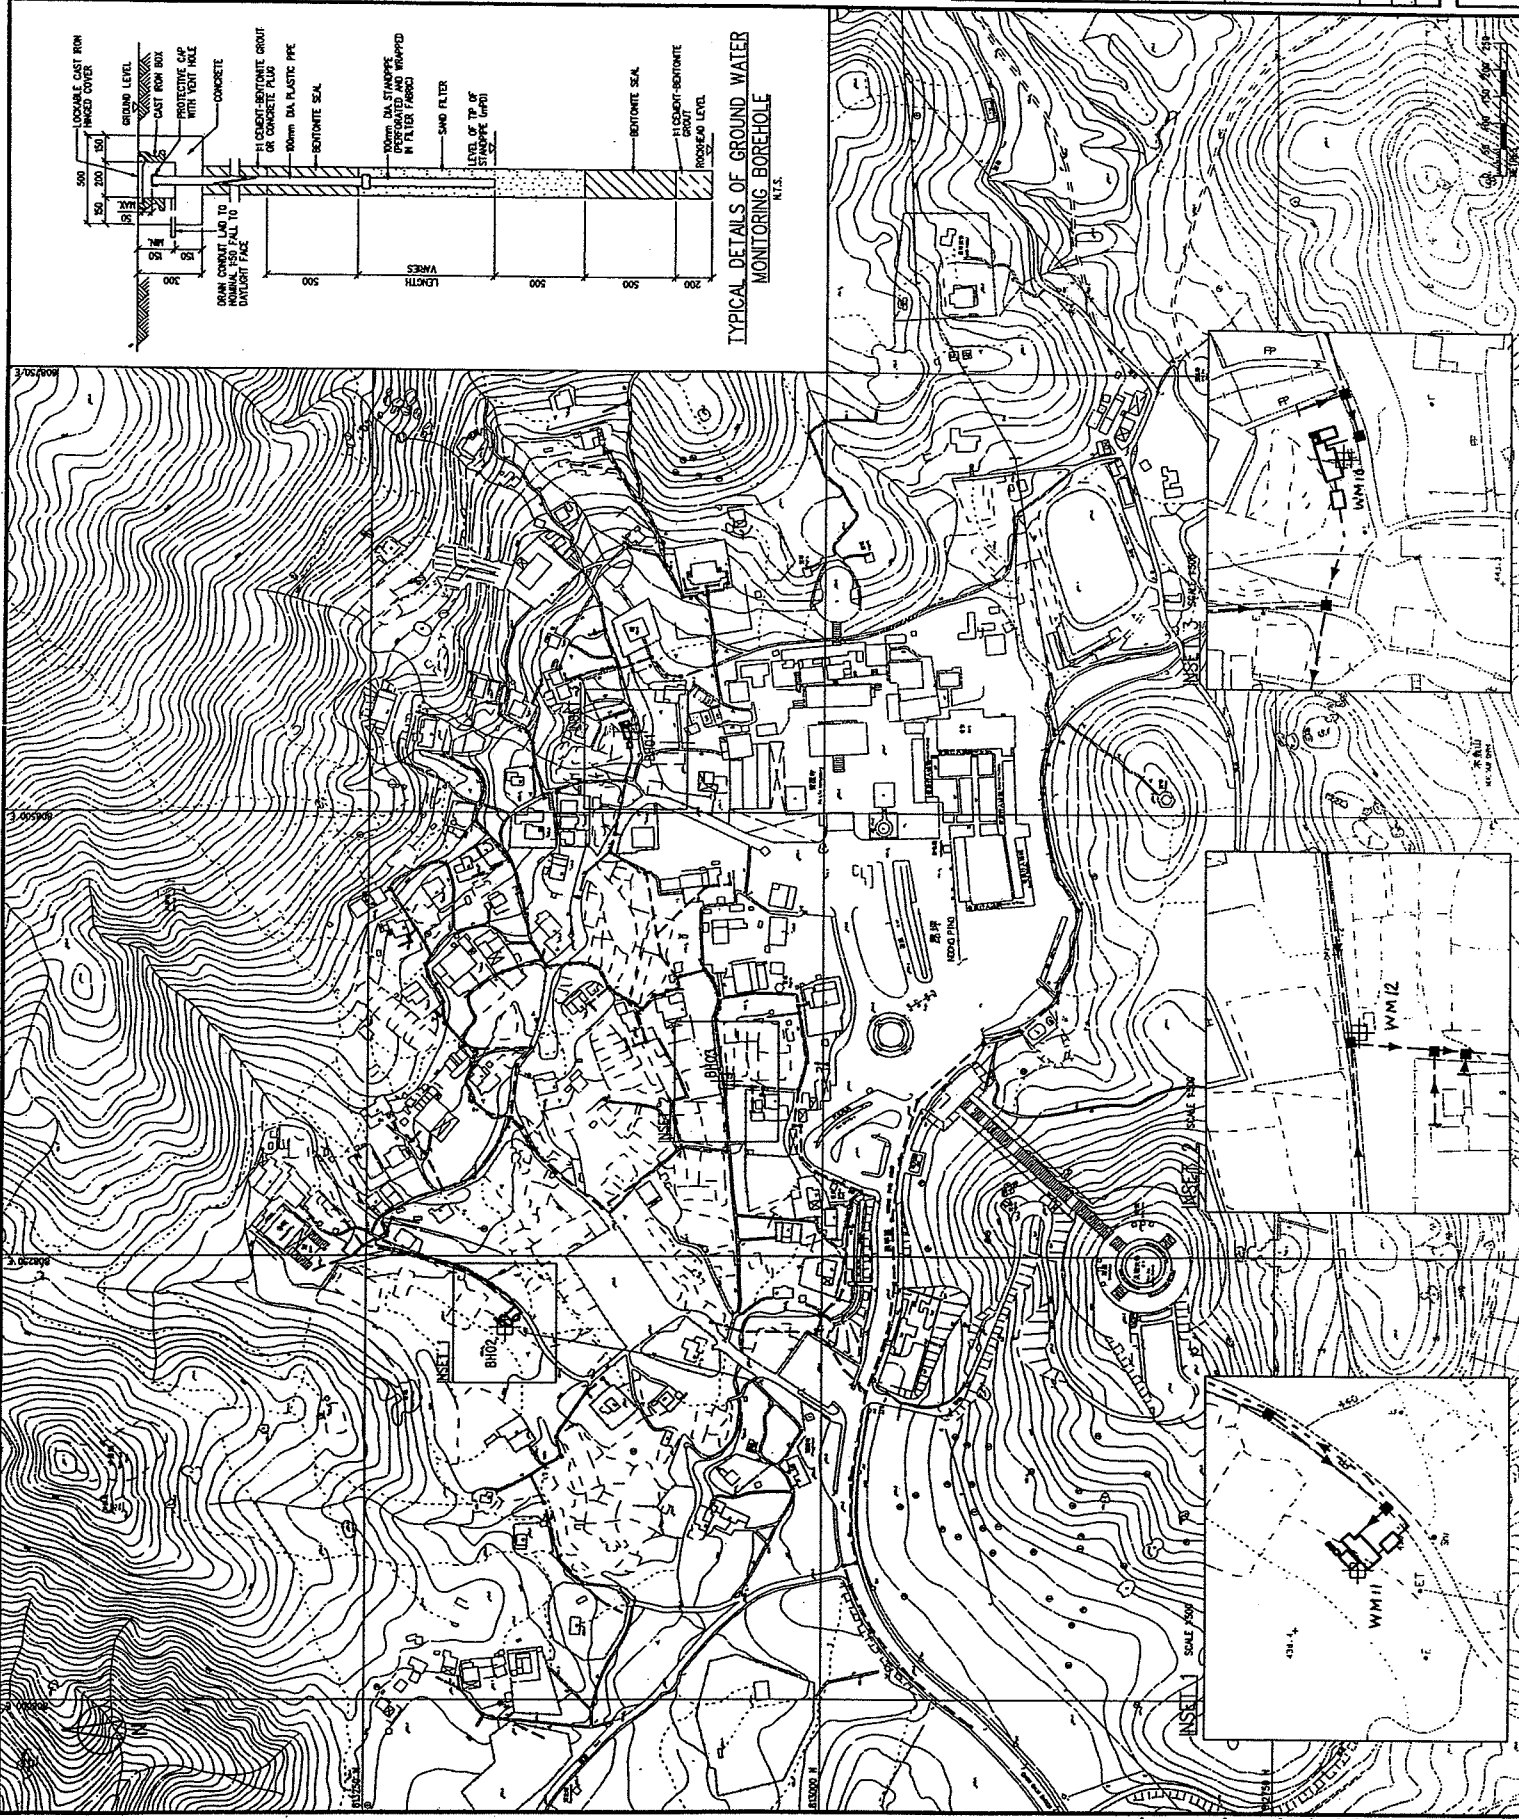
LOCATION & TYPICAL DETAILS OF GROUND WATER MONITORING BOREHOLE

1. EXACT LOCATIONS OF GROUND WATER MONITORING BOREHOLES ARE SUBJECT TO CONFIRMATION ON SITE.

TYPICAL DETAILS OF GROUND WATER MONITORING BOREHOLE
M.S.L.

The general layout plan of the project is shown in Appendix D. The groundwater monitoring locations are also shown in the Drawing No. 23400/R/VS/406.
