**CONTRACT NO. DC/2006/15 BUILDING AND
CIVIL MAINTENANCE AND MINOR WORKS OF
DSD PLANTS AND FACILITIES (2007-2009)**

**GROUNDWATER MONITORING AT
NGONG PING STW AND EFFLUENT EXPORT
PIPE**

MONTHLY EM&A REPORT

(AUGUST 2008)

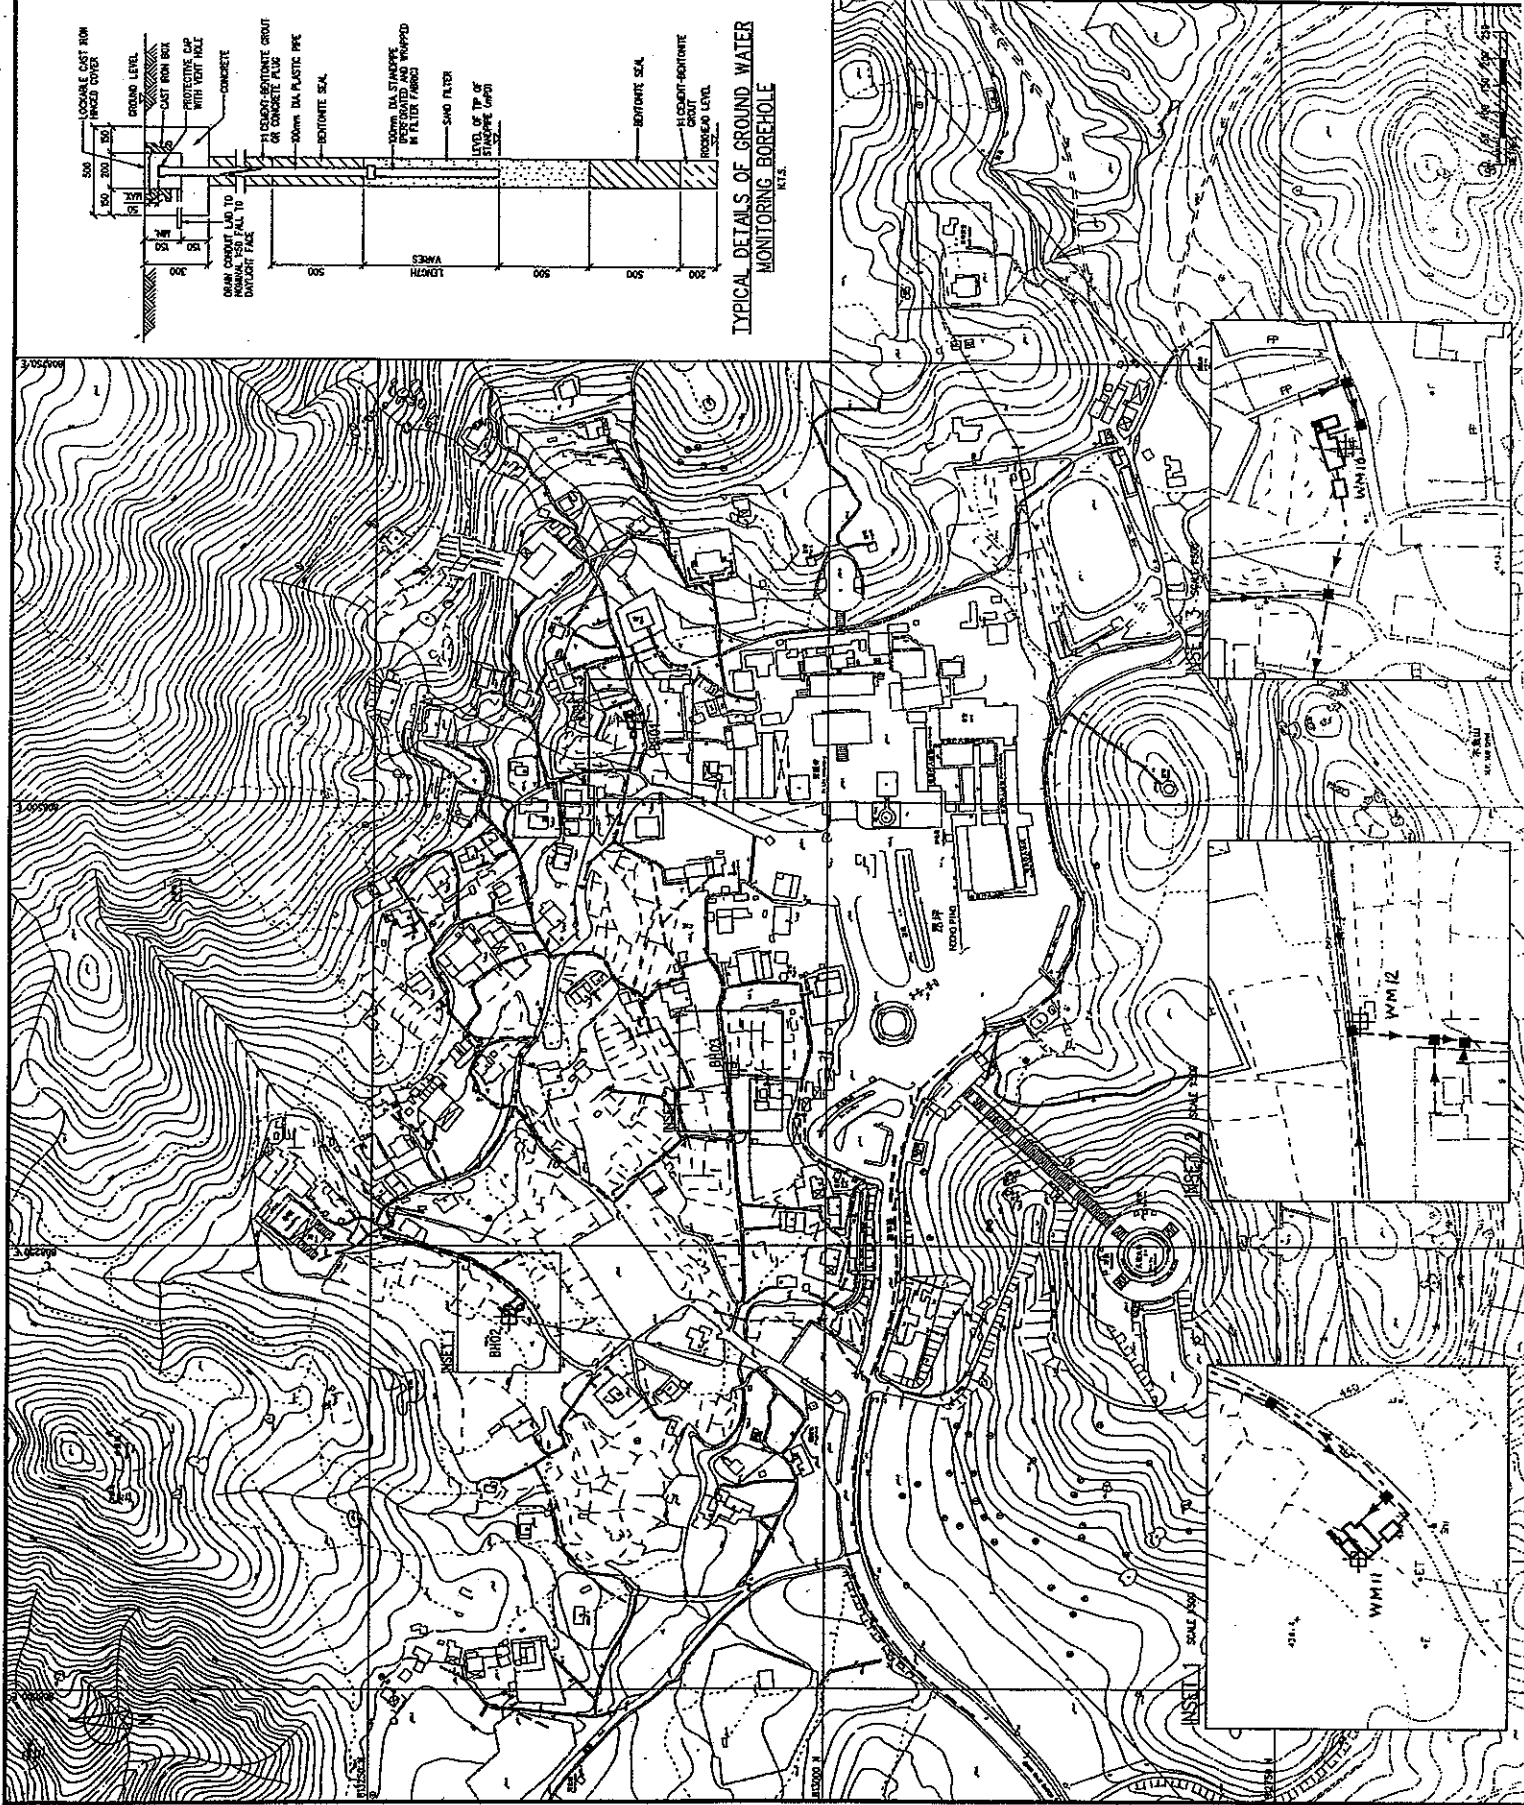
LOCATION & TYPICAL DETAILS OF GROUND WATER MONITORING BOREHOLE

The general layout plan of the project is shown in Appendix D. The groundwater monitoring locations are also shown in the Drawing No. 23400/R/VS/406.

NOTE:
 1. EXACT LOCATIONS OF GROUND WATER MONITORING BOREHOLES ARE SUBJECT TO CONFIRMATION ON SITE.

TYPICAL DETAILS OF GROUND WATER MONITORING BOREHOLE
 K.T.S.
