**CONTRACT NO. DC/2006/15 BUILDING AND
CIVIL MAINTENANCE AND MINOR WORKS OF
DSD PLANTS AND FACILITIES (2007-2009)**

**GROUNDWATER MONITORING AT
NGONG PING STW AND EFFLUENT EXPORT
PIPE**

MONTHLY EM&A REPORT

(OCTOBER 2008)

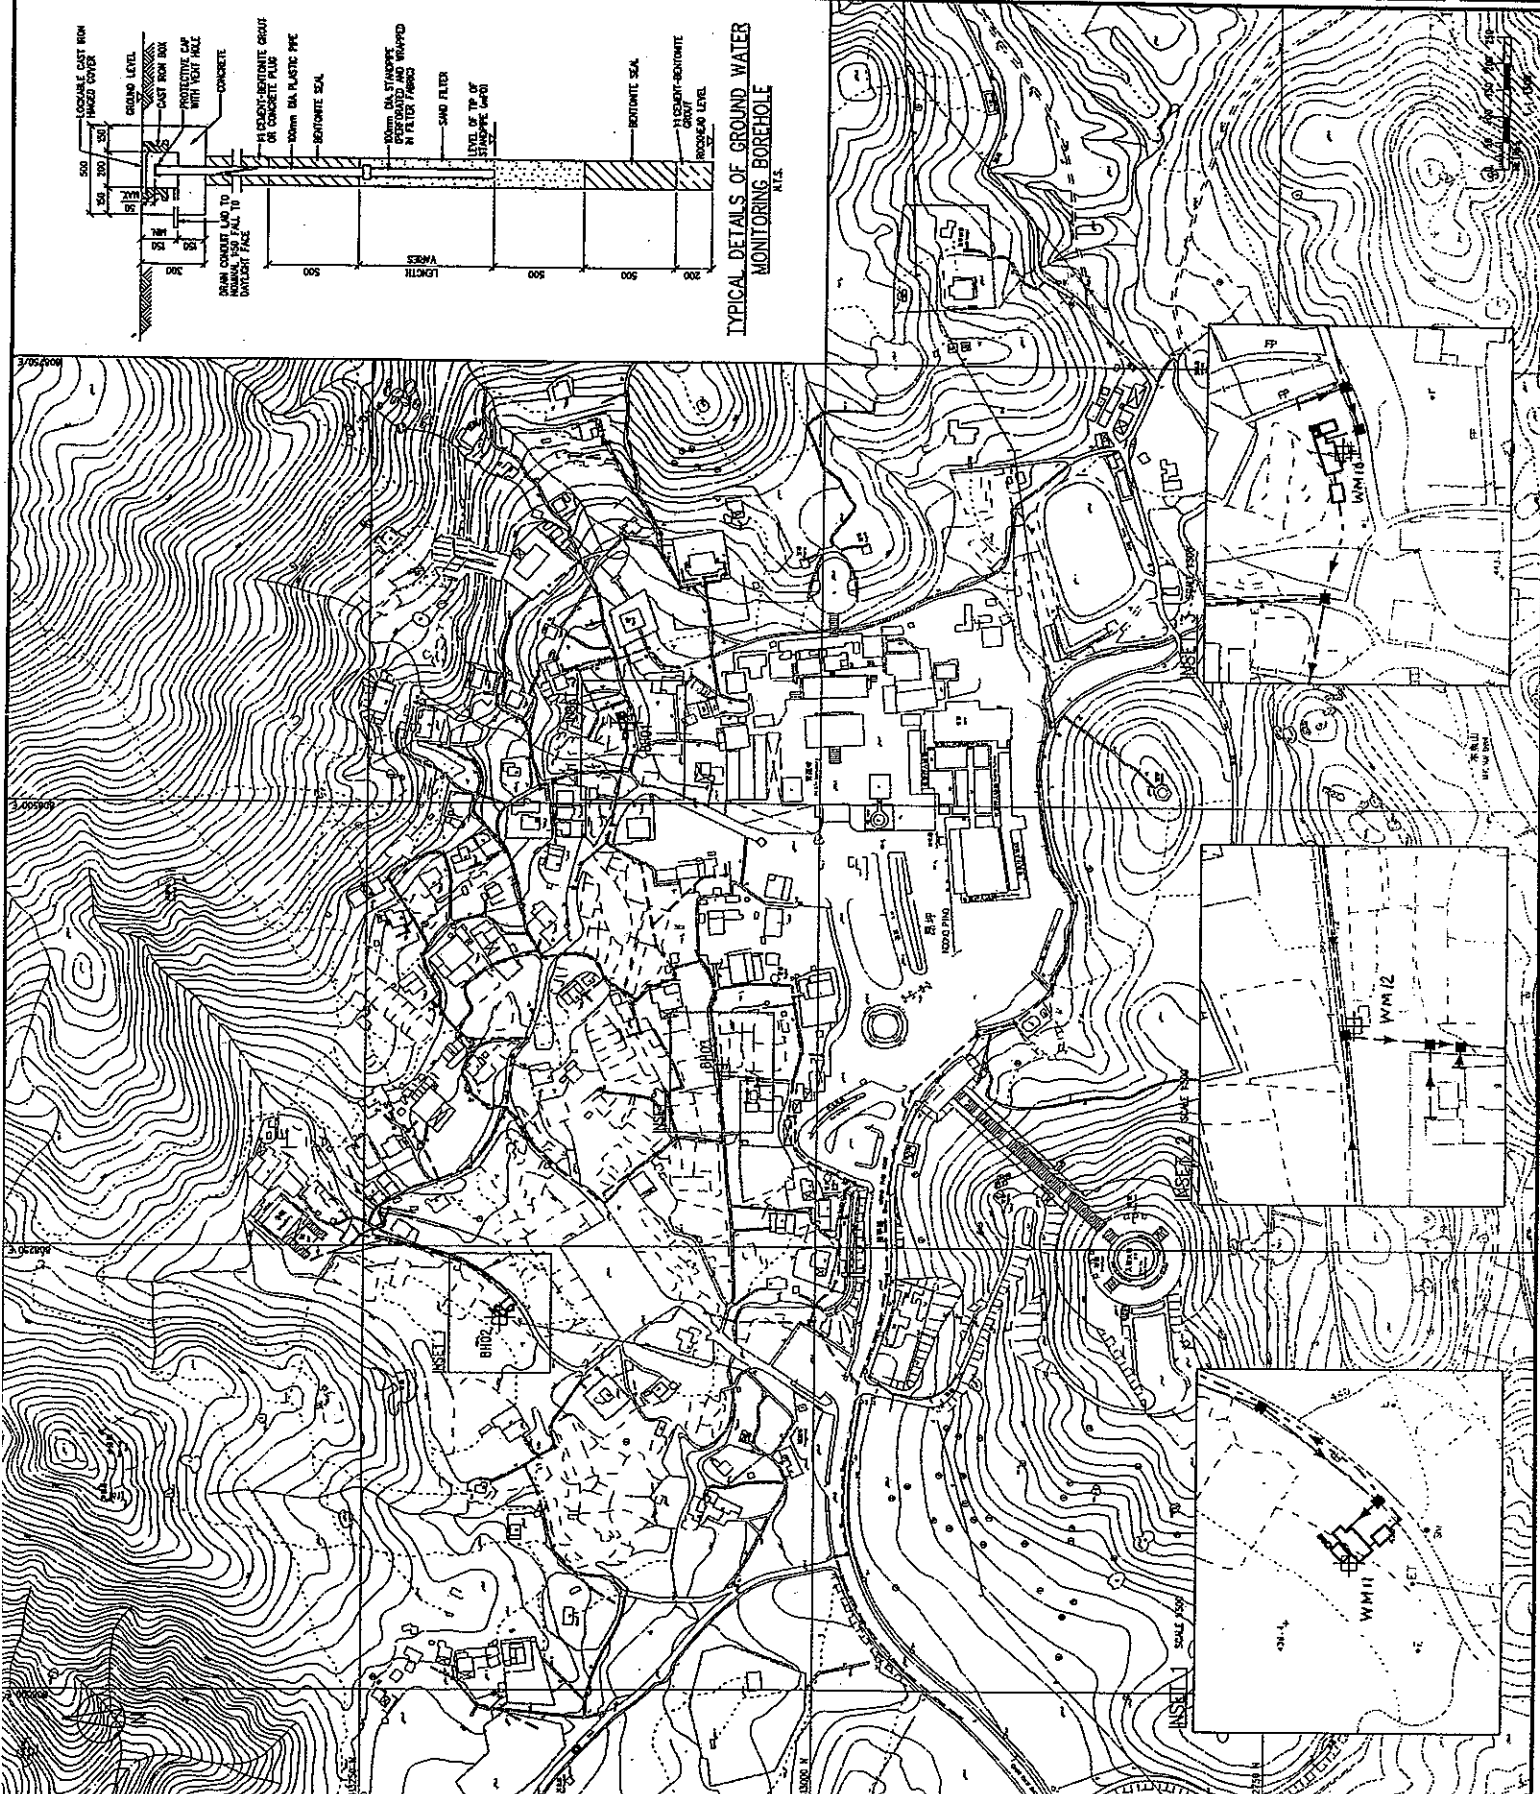
LOCATION & TYPICAL DETAILS OF
 GROUND WATER MONITORING BOREHOLE

The general layout plan of the project is shown in Appendix D. The groundwater monitoring locations are also shown in the Drawing No. 23400/R/VS/406.

TYPICAL DETAILS OF GROUND WATER MONITORING BOREHOLE
 M.T.S.
