**CONTRACT NO. DC/2006/15 BUILDING AND
CIVIL MAINTENANCE AND MINOR WORKS OF
DSD PLANTS AND FACILITIES (2007-2009)**

**GROUNDWATER MONITORING AT
NGONG PING STW AND EFFLUENT EXPORT
PIPE**

MONTHLY EM&A REPORT

(JANUARY 2009)

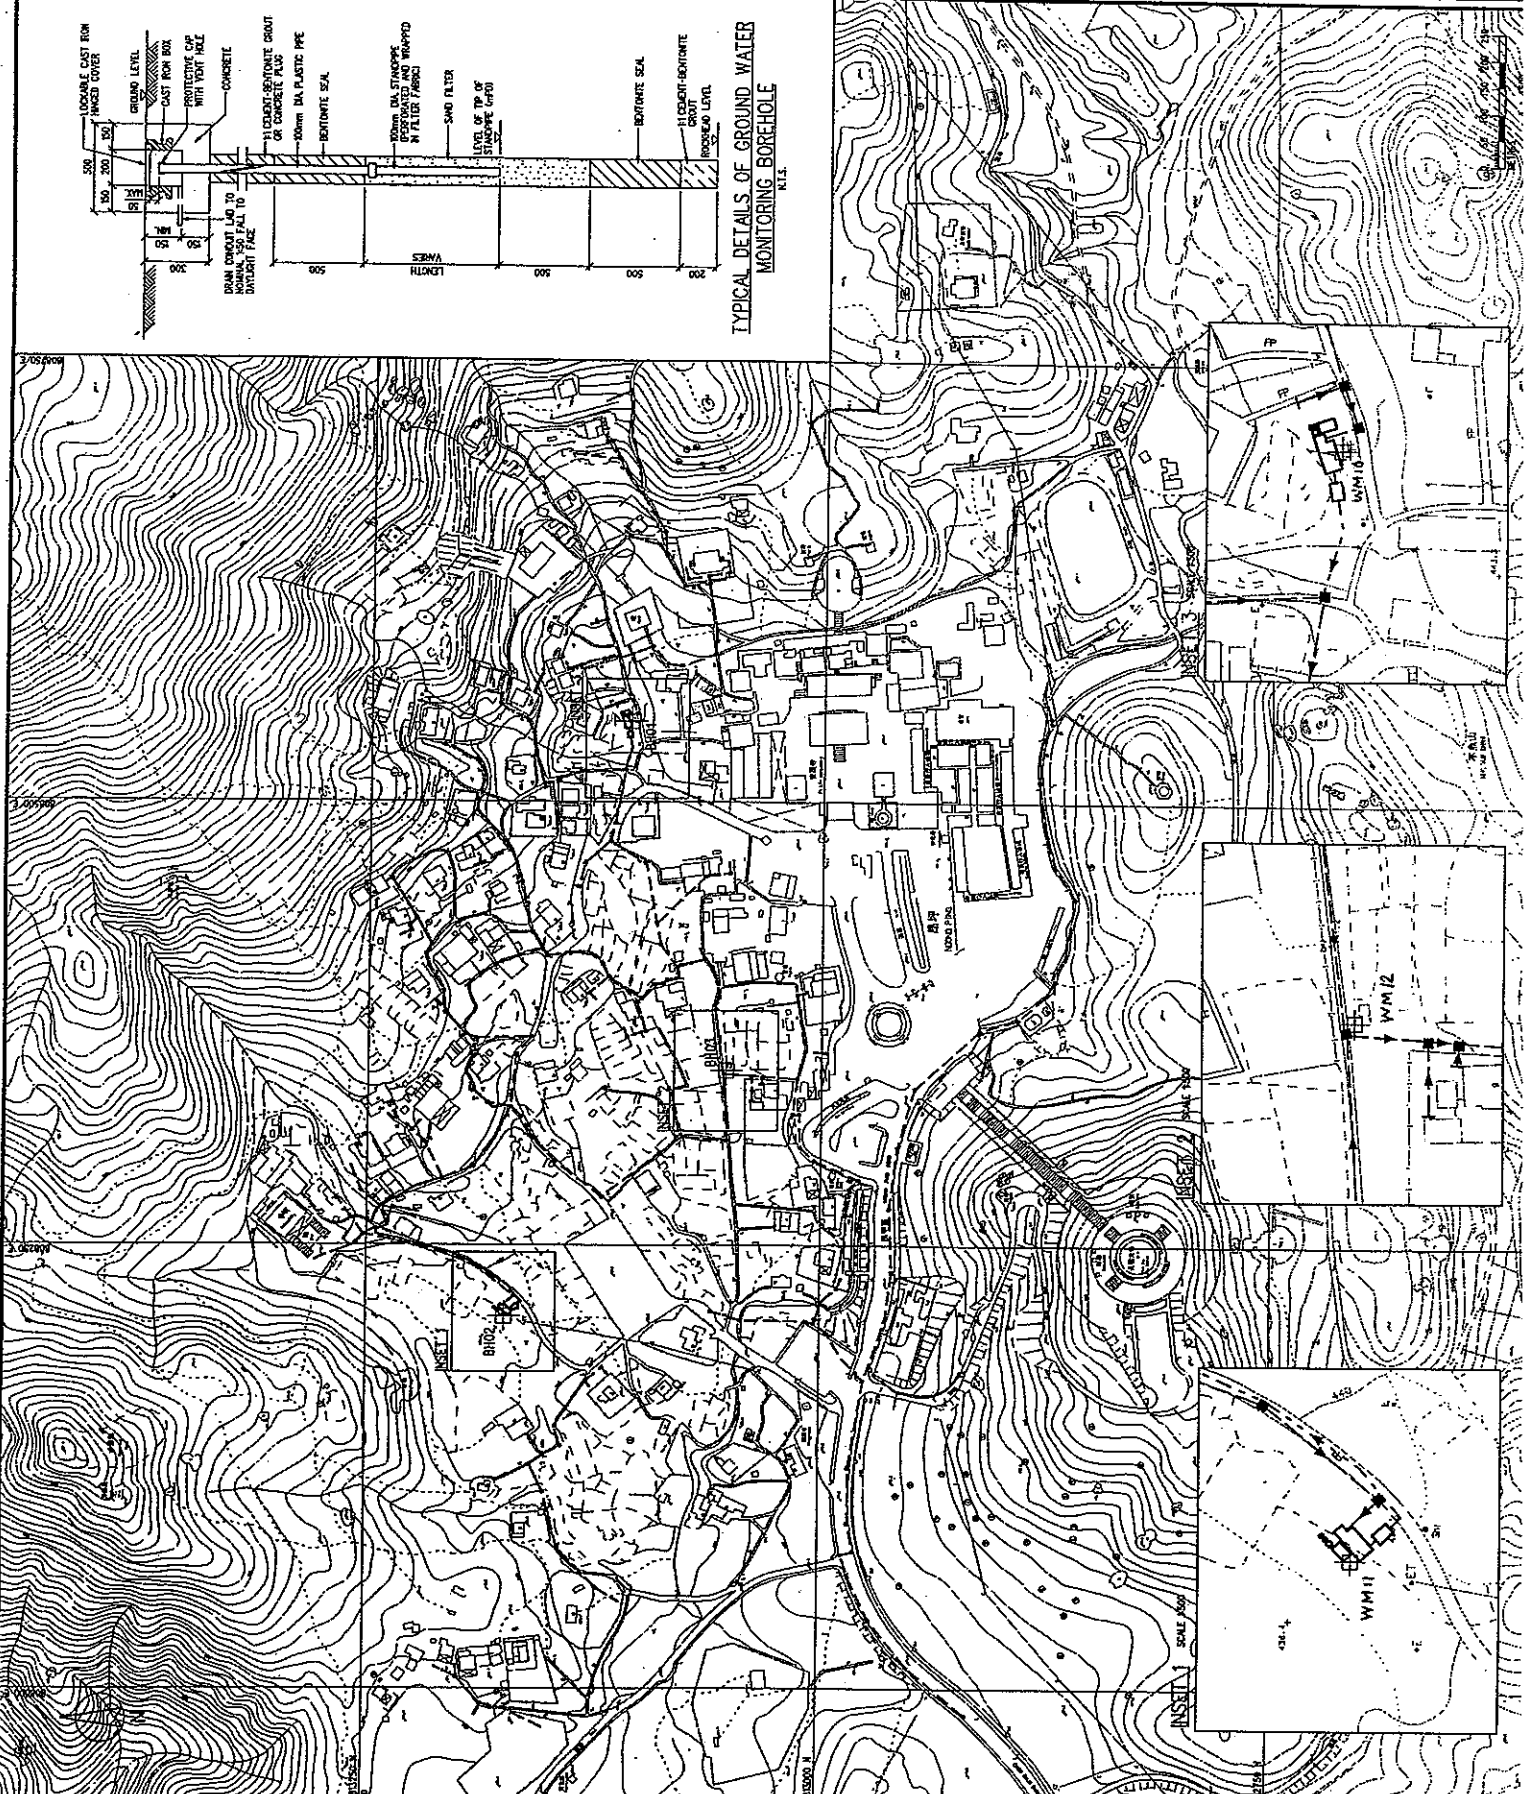
**LOCATION & TYPICAL DETAILS OF
GROUND WATER MONITORING BOREHOLE**

1. EXACT LOCATIONS OF GROUND WATER MONITORING BOREHOLES ARE SUBJECT TO CONFIRMATION ON SITE.

TYPICAL DETAILS OF GROUND WATER MONITORING BOREHOLE

The general layout plan of the project is shown in Appendix D. The groundwater monitoring locations are also shown in the Drawing No. 23400/R/VS/406.
