**CONTRACT NO. DC/2006/15 BUILDING AND
CIVIL MAINTENANCE AND MINOR WORKS OF
DSD PLANTS AND FACILITIES (2007-2009)**

**GROUNDWATER MONITORING AT
NGONG PING STW AND EFFLUENT EXPORT
PIPE**

MONTHLY EM&A REPORT

(FEBRUARY 2009)

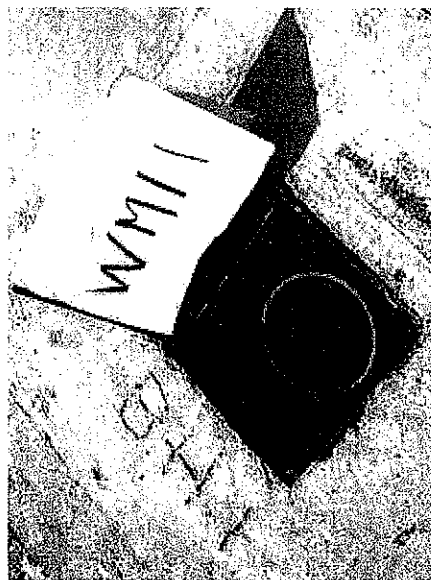
WM11

In this reporting month, groundwater monitoring was carried out on 25 February 2009 at WM10 and WM12 only since no groundwater was noted at WM11.
