**CONTRACT NO. DC/2006/15 BUILDING AND  
CIVIL MAINTENANCE AND MINOR WORKS OF  
DSD PLANTS AND FACILITIES (2007-2009)**

**GROUNDWATER MONITORING AT  
NGONG PING STW AND EFFLUENT EXPORT  
PIPE**

**MONTHLY EM&A REPORT**

**(APRIL 2009)**

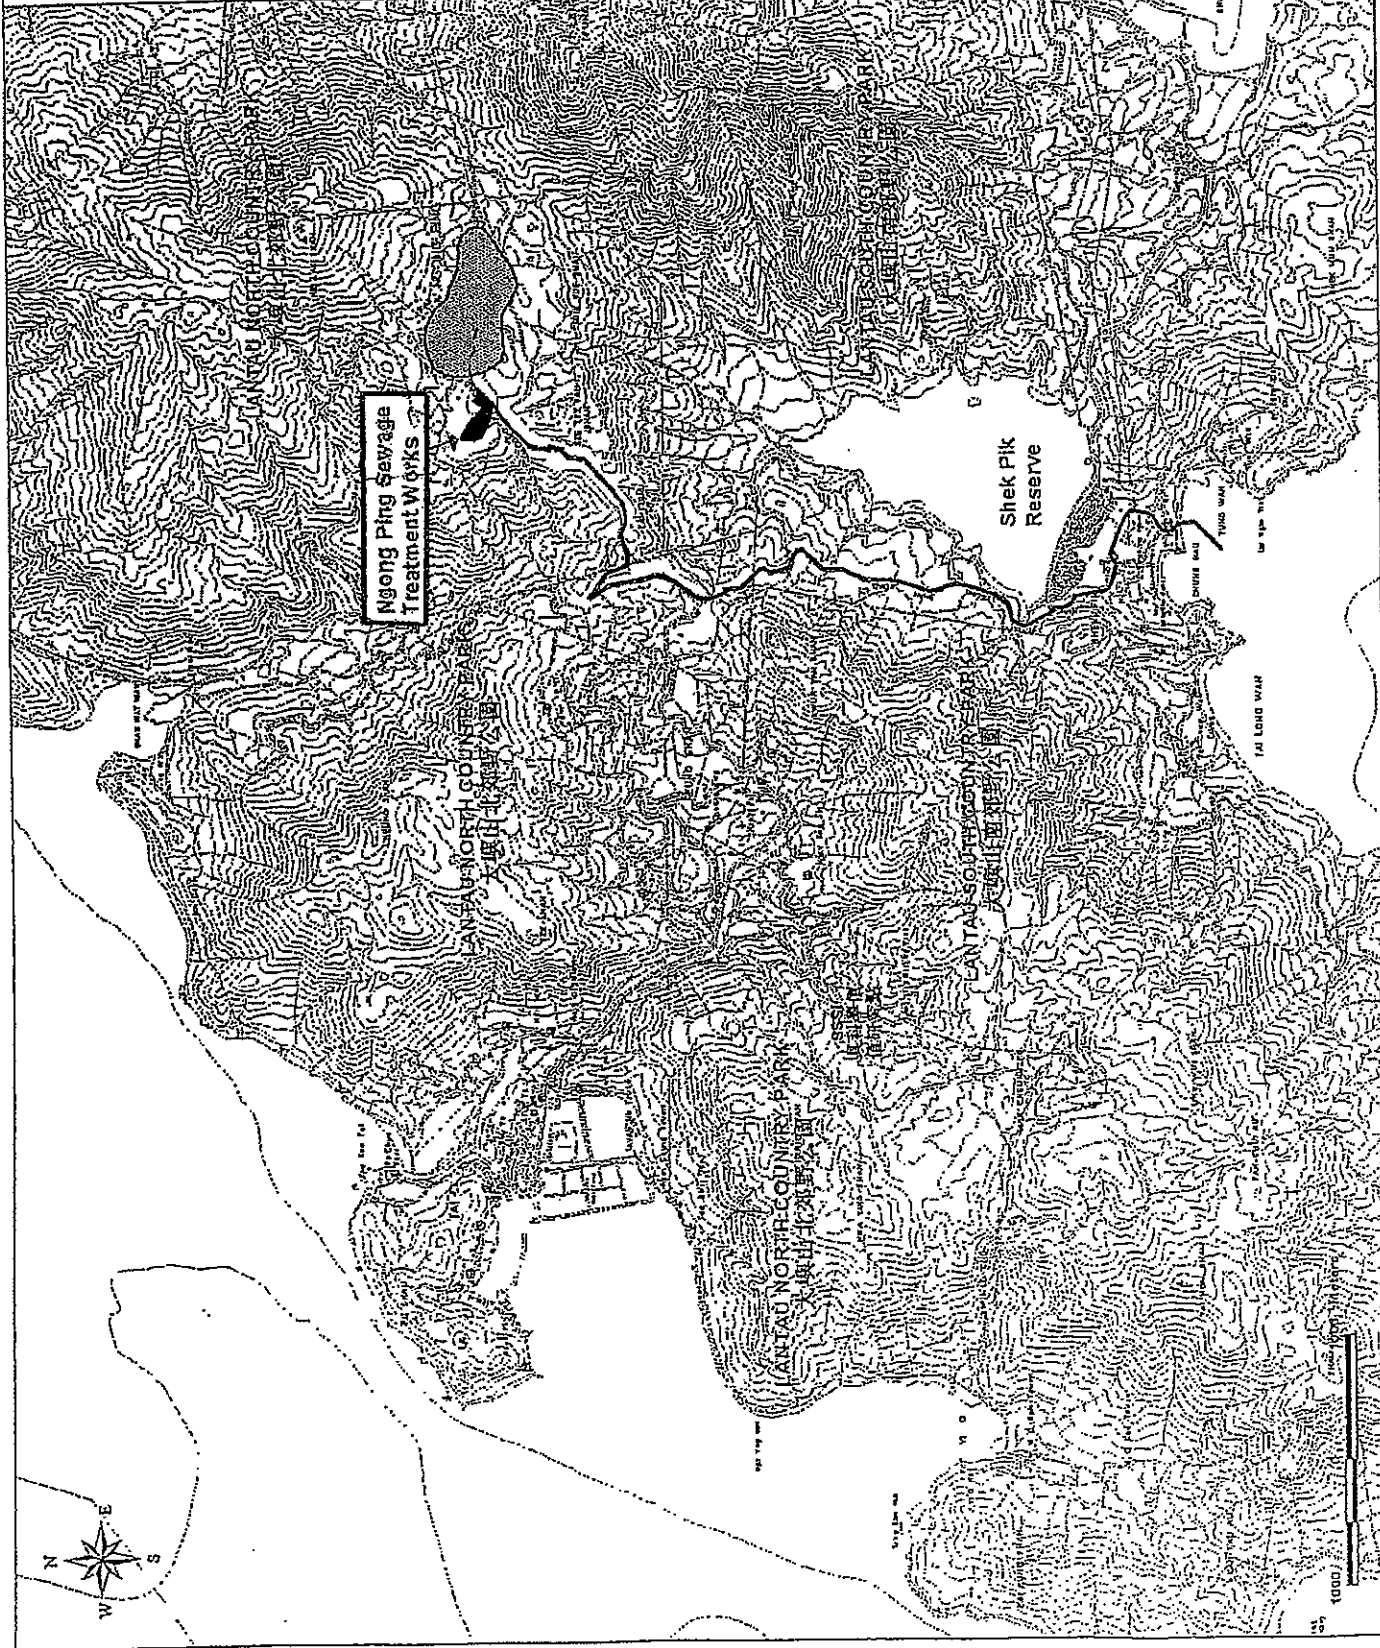
Ngong Ping Sewerage Project  
Scheme - General Layout

This Project only covers the operation phase of Package 1 and Package 2. The general layout plan of the project is shown in Appendix D (Drawing No. 23400/EN/098).

The general layout plan of the project is shown in Appendix D. The groundwater monitoring locations are also shown in the Drawing No. 23400/R/VS/406.
