**TEST REPORT**

**NGONG PING SEWAGE TREATMENT  
PLANT, TRUNK SEWERS AND EFFLUENT  
EXPORT PIPELINE  
OPERATION PHASE**

**FINAL REPORT**

**GROUND WATER MONITORING  
(FROM APRIL 2008 TO NOVEMBER 2009)**

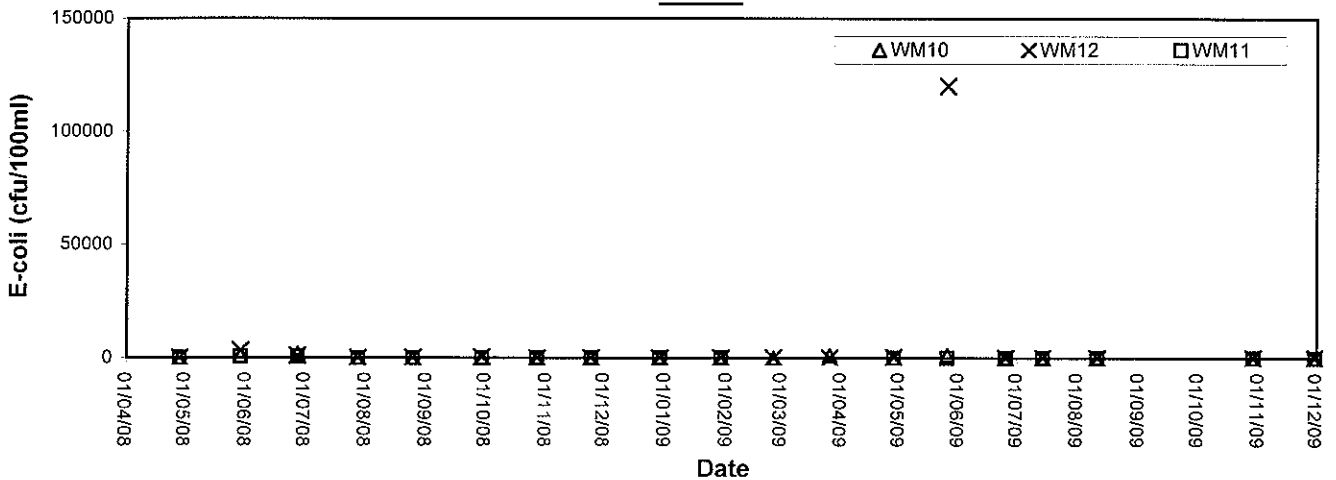
### E-coli

Refer to the ground water monitoring on 26 May 2009, the test results of groundwater at WM10 and WM11 were at low level in E-coli except at WM12. Refer to the testing results of other test parameters, no significant difference is found between WM10, WM11 and WM12 and hence there is no evidence of any leakage of treated effluent from effluent export pipeline. The high level of E-coli at WM12 is considered to be due to the contamination from wild-life.

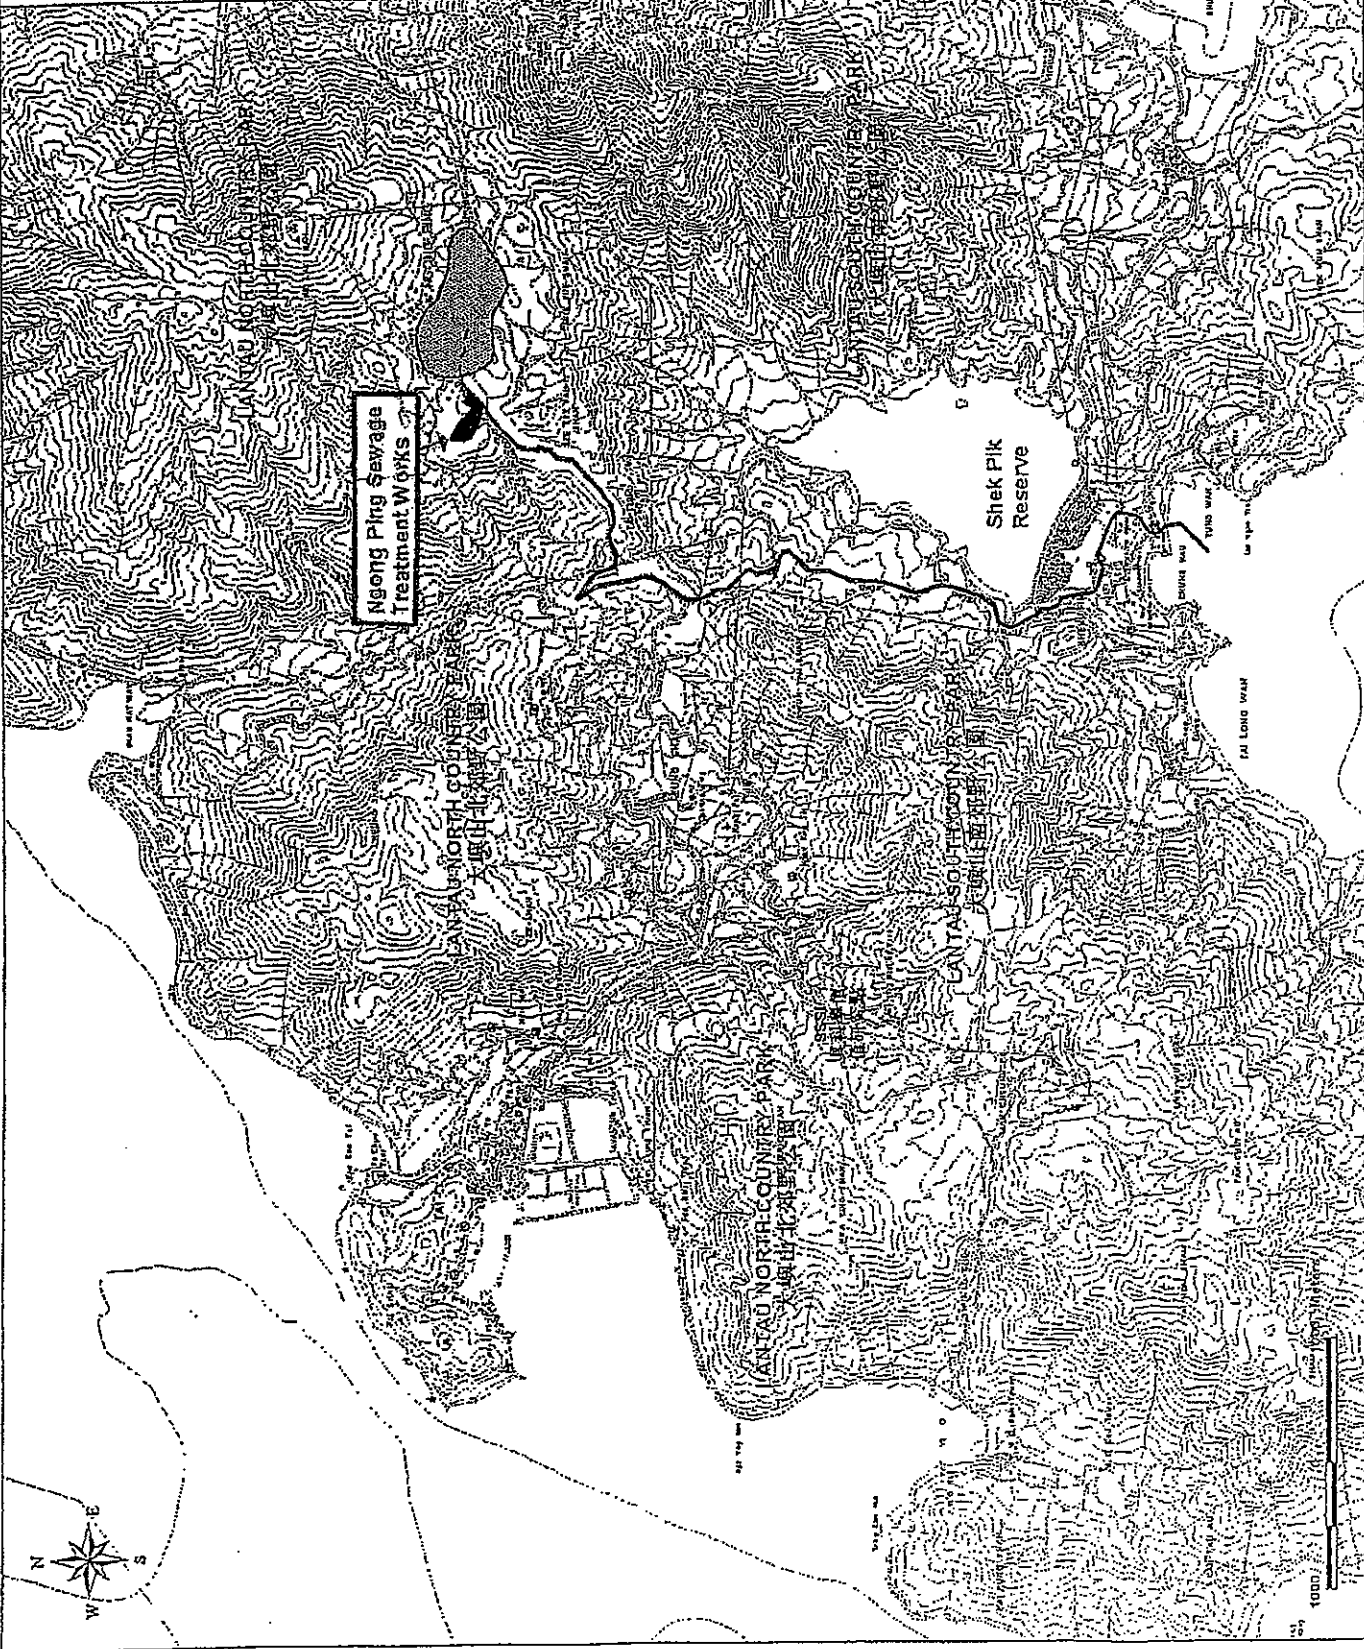
### General Layout Plan

This Project only covers the operation phase of Package 1 and Package 2. The general layout plan of the project is shown in Appendix D (Drawing No. 23400/EN/098).

The general layout plan of the project is shown in Appendix D. The groundwater monitoring locations are also shown in the Drawing No. 23400/R/VS/406.

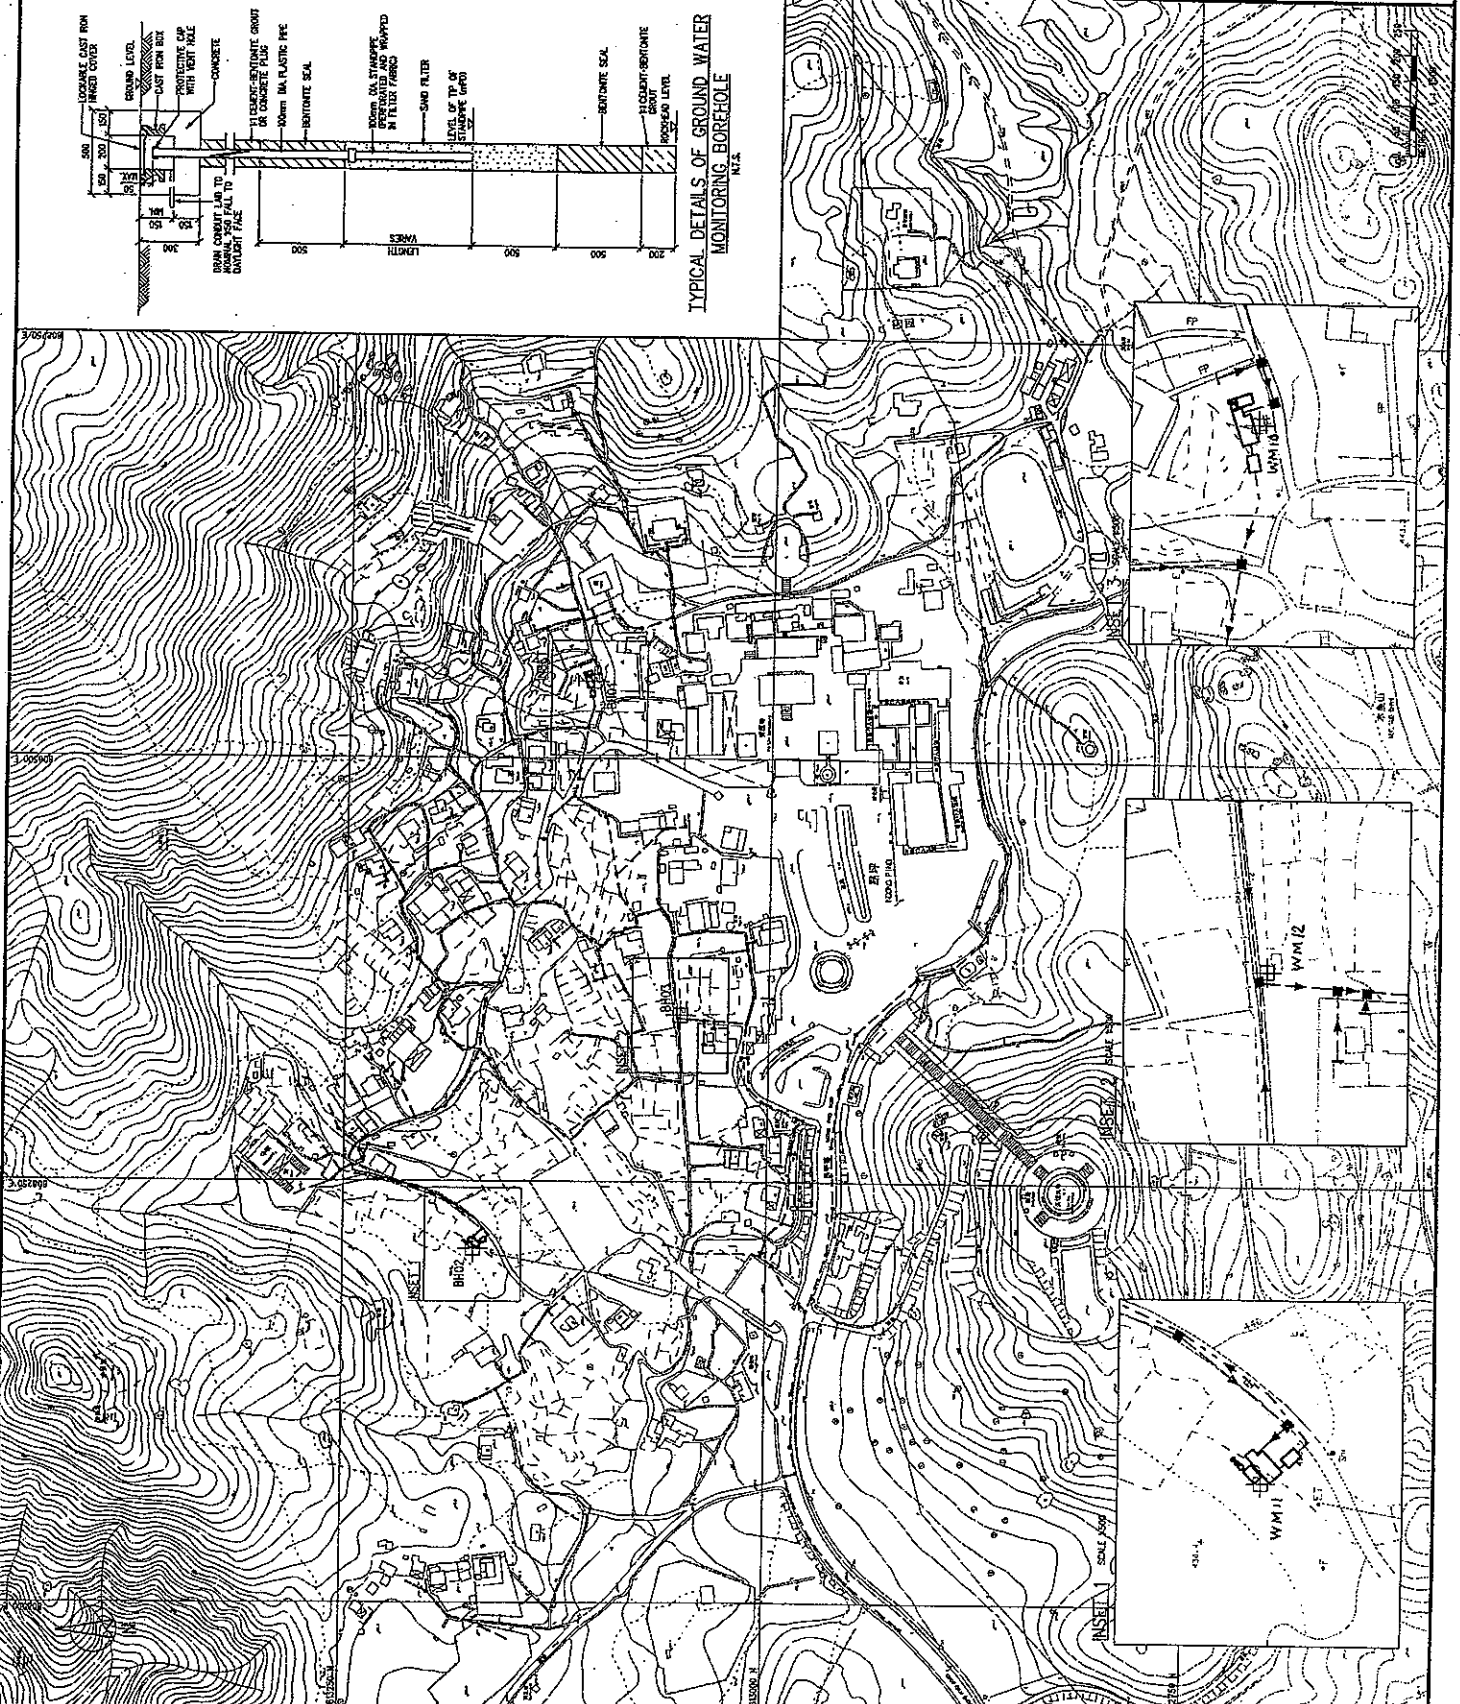
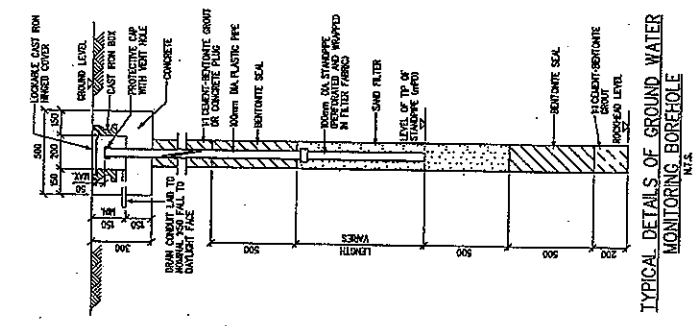
Drawing No. **23400/RS/406**

- Drawing No. 23400/R/VS/406      Location & Typical Details of Ground Water Monitoring Borehole

The working principle of the ground water monitoring borehole is that if there is leakage, the effluent will find its way from the Ngong Ping Sewage Treatment Works or its effluent export pipeline into the nearest borehole. If underground water table is above the effluent export pipeline, ground water inside the borehole will be contaminated by the treated effluent. If underground water table is below the effluent export pipeline, the borehole will be partially filled with the treated effluent. Laboratory tests on the water samples taken from the boreholes will be able to reveal if there is any leakage of treated effluent.
