**CONTRACT NO. DC/2006/15 BUILDING AND
CIVIL MAINTENANCE AND MINOR WORKS OF
DSD PLANTS AND FACILITIES (2007-2009)**

**GROUNDWATER MONITORING AT
NGONG PING STW AND EFFLUENT EXPORT
PIPE**

MONTHLY EM&A REPORT

(MAY 2009)

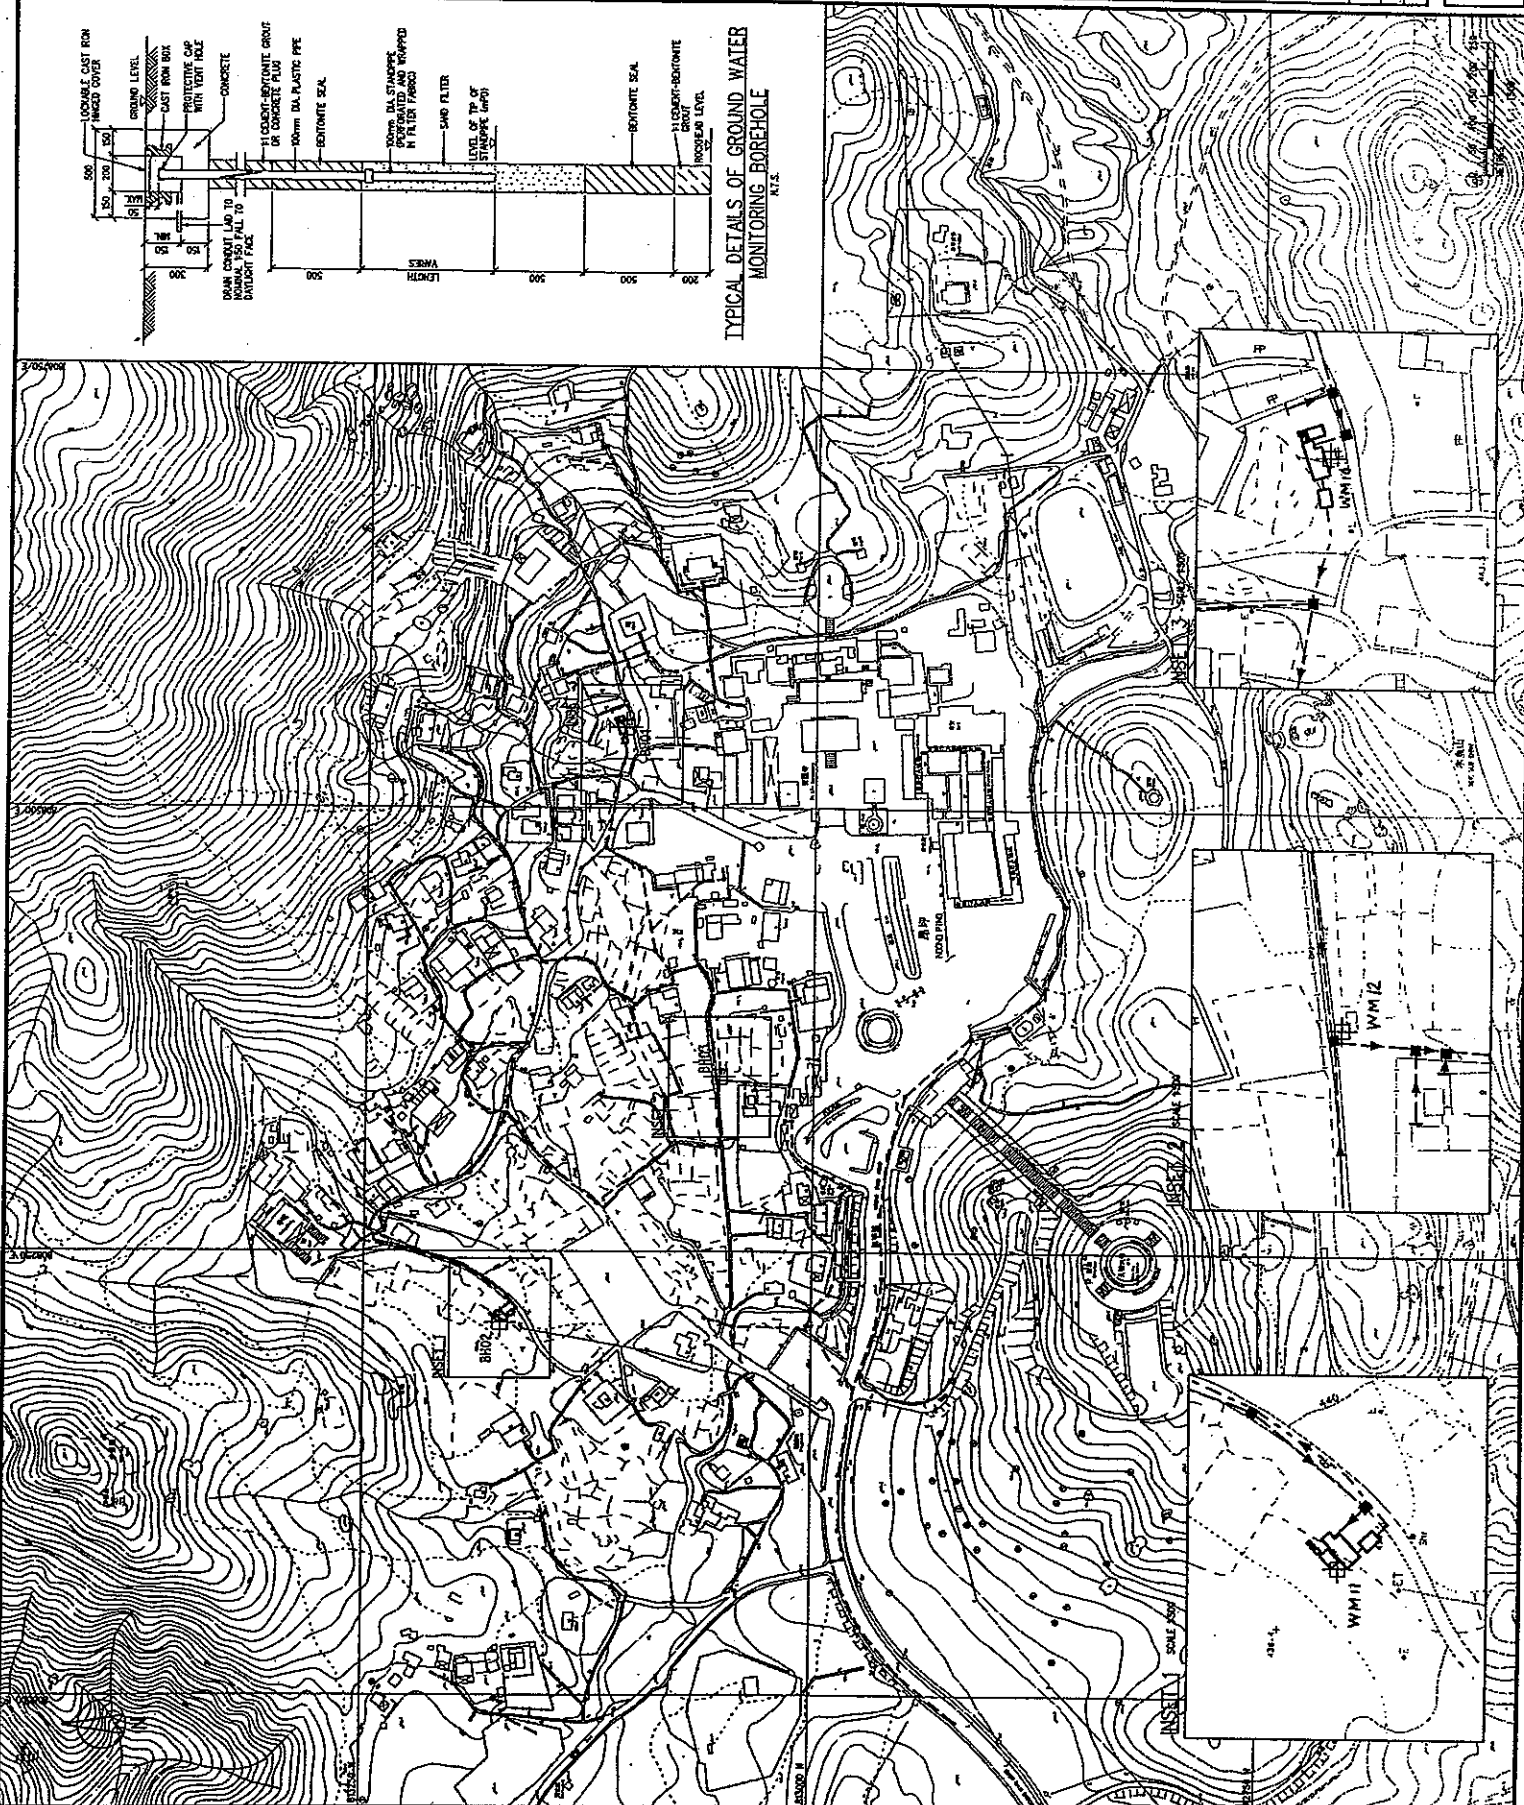
LOCATION & TYPICAL DETAILS OF GROUND WATER MONITORING BOREHOLE

The general layout plan of the project is shown in Appendix D. The groundwater monitoring locations are also shown in the Drawing No. 23400/R/VS/406.

TYPICAL DETAILS OF GROUND WATER MONITORING BOREHOLE
M.T.S.
