**CONTRACT NO. DC/2006/15 BUILDING AND  
CIVIL MAINTENANCE AND MINOR WORKS OF  
DSD PLANTS AND FACILITIES (2007-2009)**

**GROUNDWATER MONITORING AT  
NGONG PING STW AND EFFLUENT EXPORT  
PIPE**

**MONTHLY EM&A REPORT**

**(JUNE 2009)**

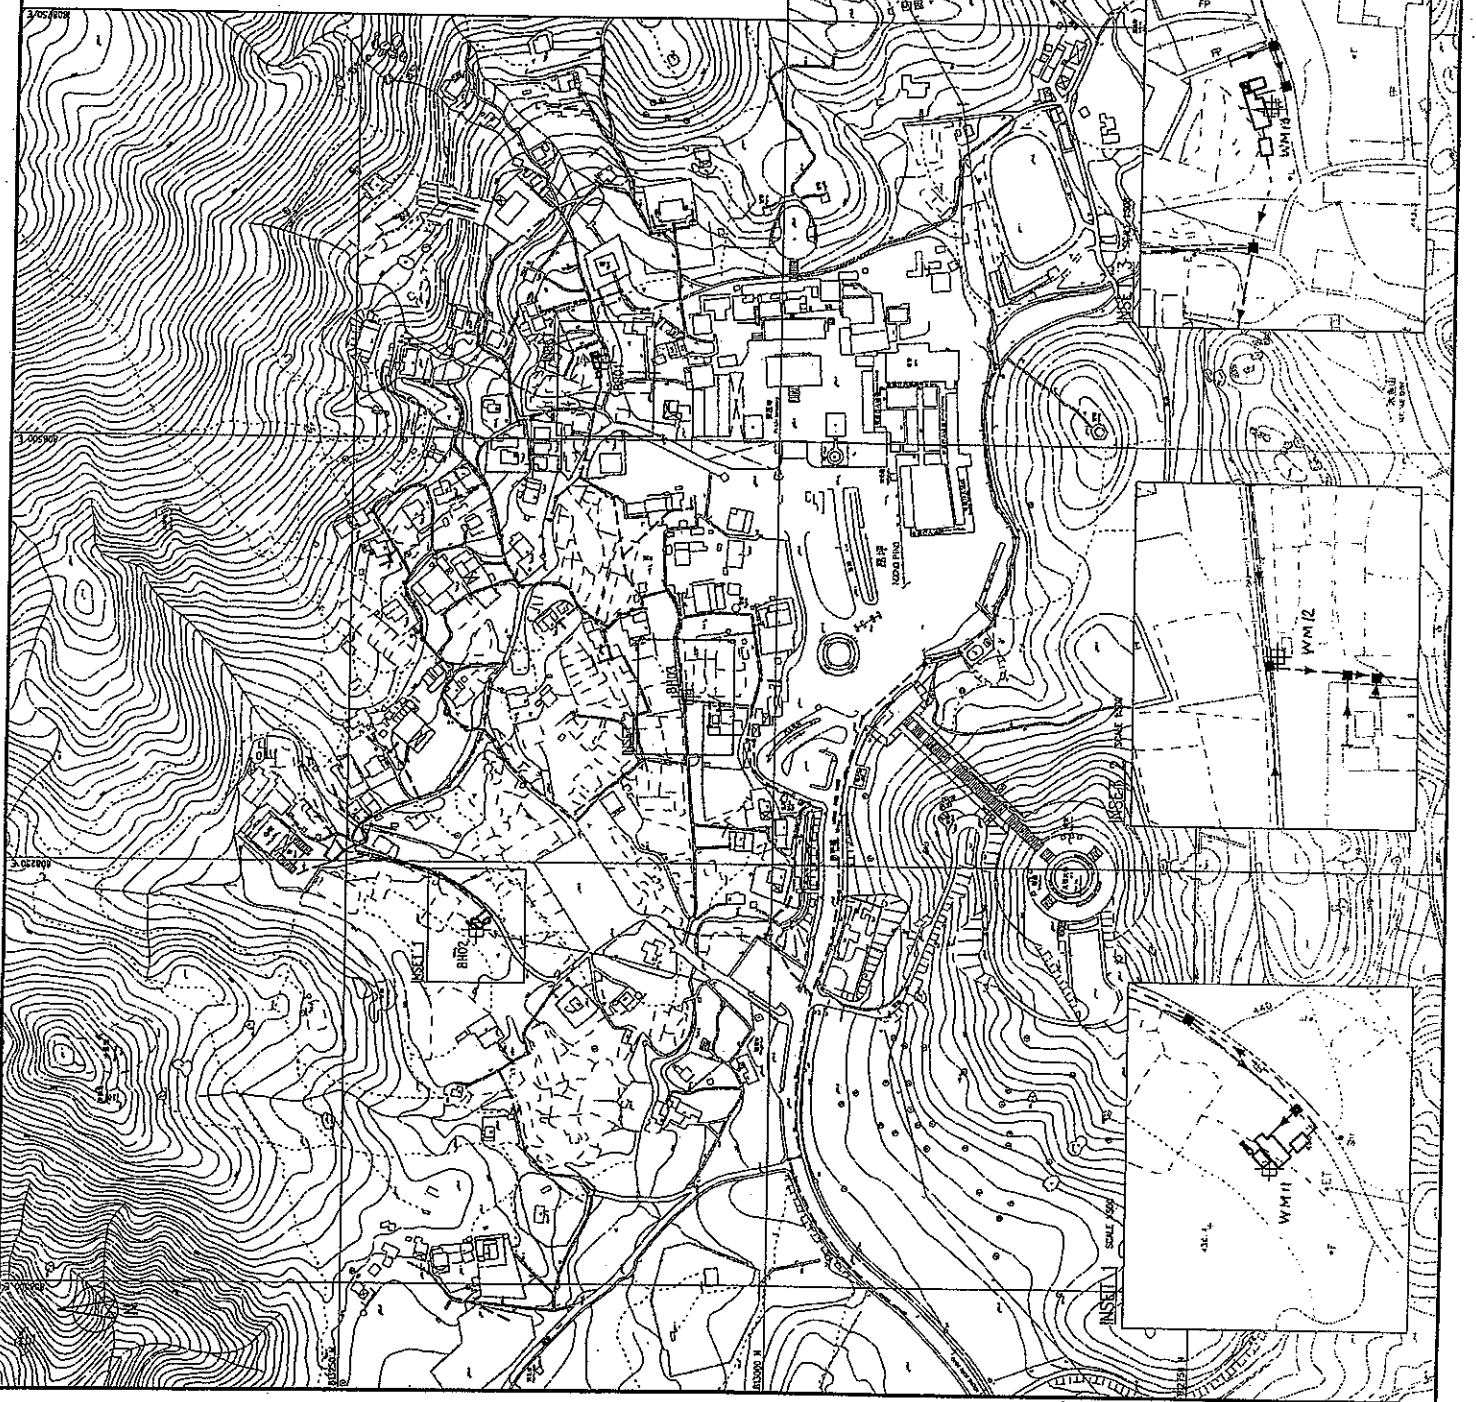
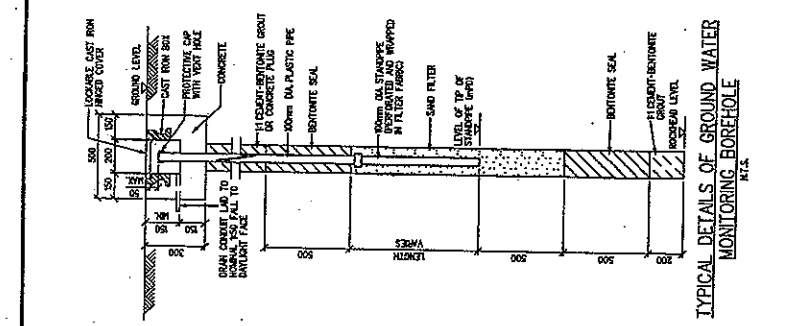
Drawing No. 23400/R/V/S/406      Location & Typical Details of Ground Water Monitoring Borehole

The general layout plan of the project is shown in Appendix D. The groundwater monitoring locations are also shown in the Drawing No. 23400/R/VS/406.
