**CONTRACT NO. DC/2006/15 BUILDING AND
CIVIL MAINTENANCE AND MINOR WORKS OF
DSD PLANTS AND FACILITIES (2007-2009)**

**GROUNDWATER MONITORING AT
NGONG PING STW AND EFFLUENT EXPORT
PIPE**

MONTHLY EM&A REPORT

(JULY 2009)

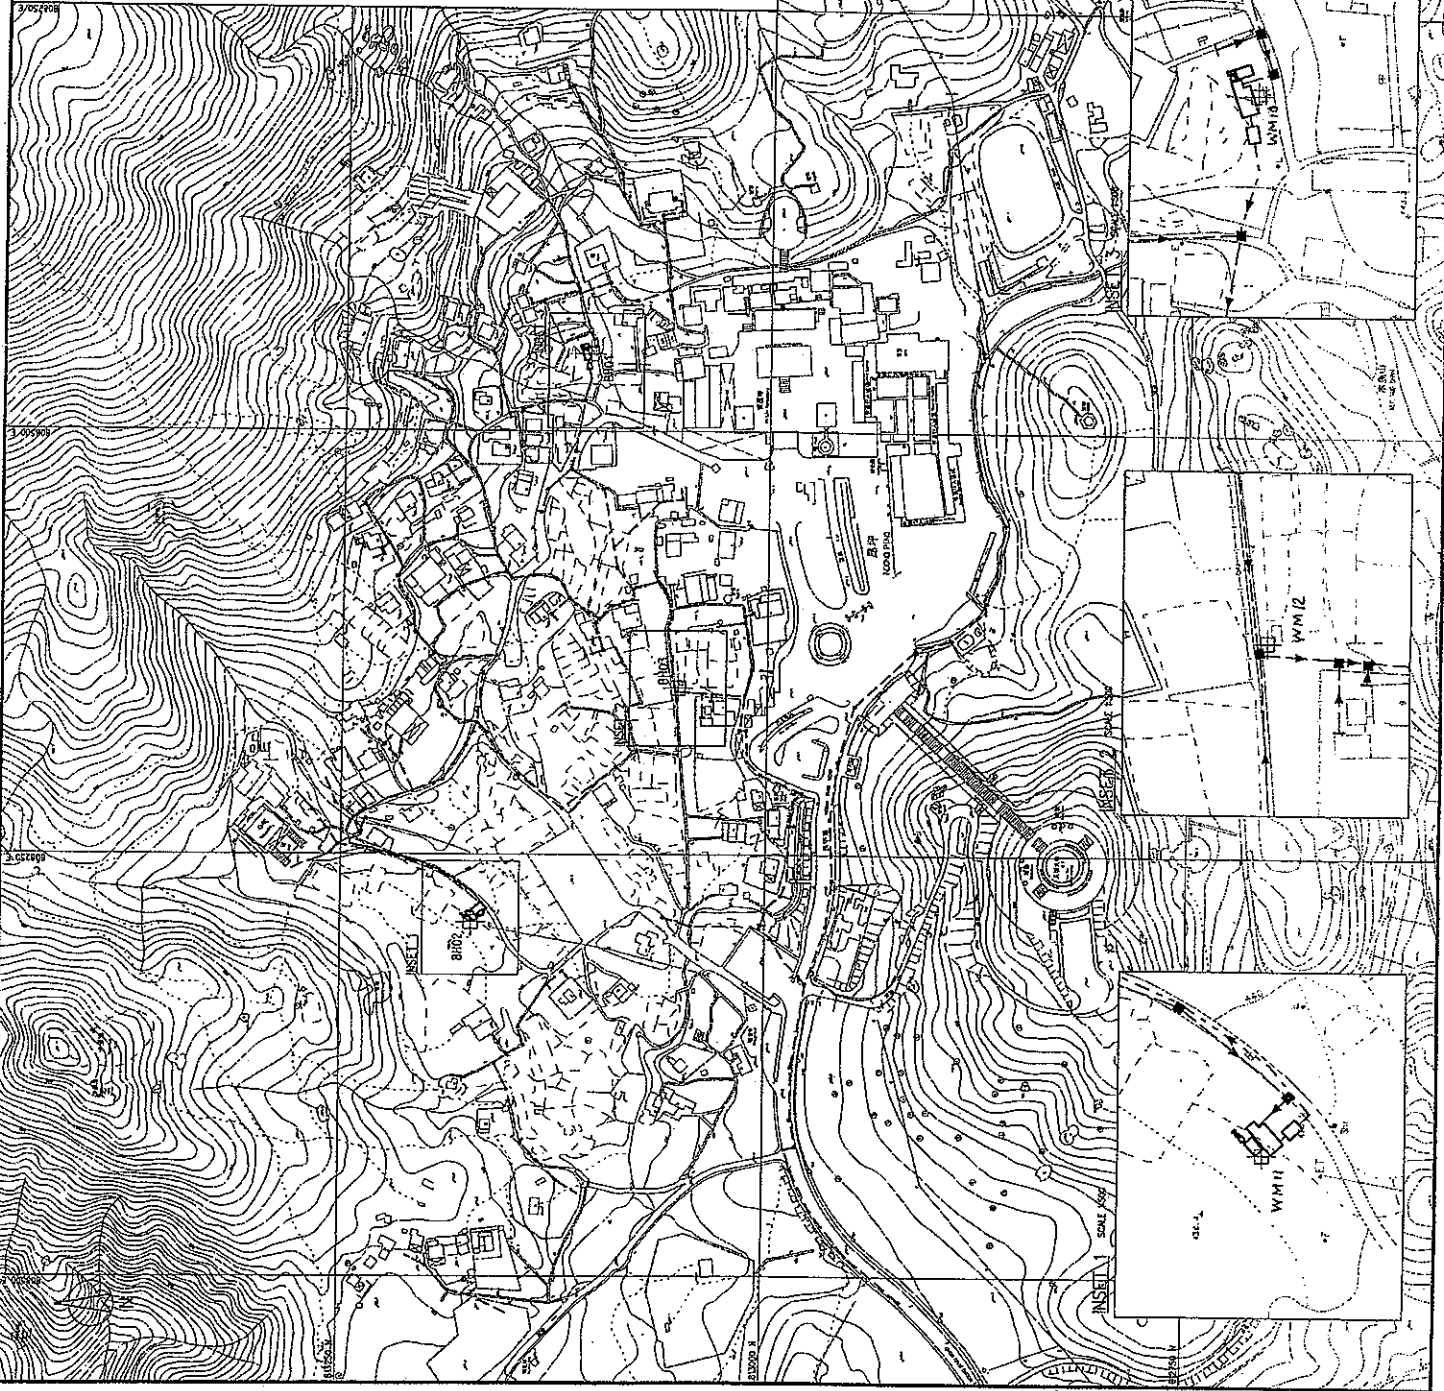
LOCATION & TYPICAL DETAILS OF
 GROUND WATER MONITORING BOREHOLE

The general layout plan of the project is shown in Appendix D. The groundwater monitoring locations are also shown in the Drawing No. 23400/R/VS/406.

TYPICAL DETAILS OF GROUND WATER MONITORING BOREHOLE
 M.S.
