**CONTRACT NO. DC/2006/15 BUILDING AND  
CIVIL MAINTENANCE AND MINOR WORKS OF  
DSD PLANTS AND FACILITIES (2007-2009)**

**GROUNDWATER MONITORING AT  
NGONG PING STW AND EFFLUENT EXPORT  
PIPE**

**MONTHLY EM&A REPORT**

**(AUGUST 2009)**

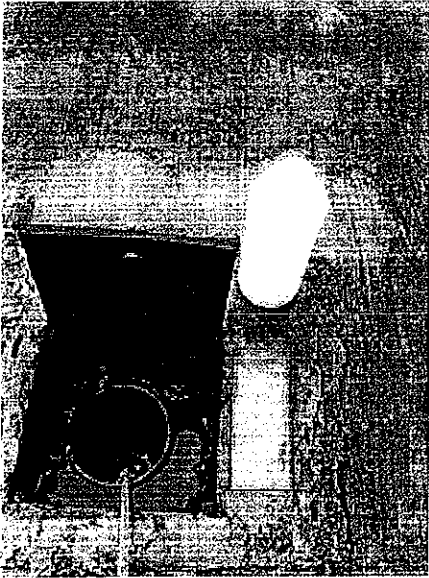
WM10

Project : DC/2006/15 - Building and Civil Maintenance and  
Minor Works to DSD Plants and Facilities (2007-2009)  
Date of sampling and photo taking : 11 August 2009  
Report No. : ENA90630  
Date of issue : 27 August 2009

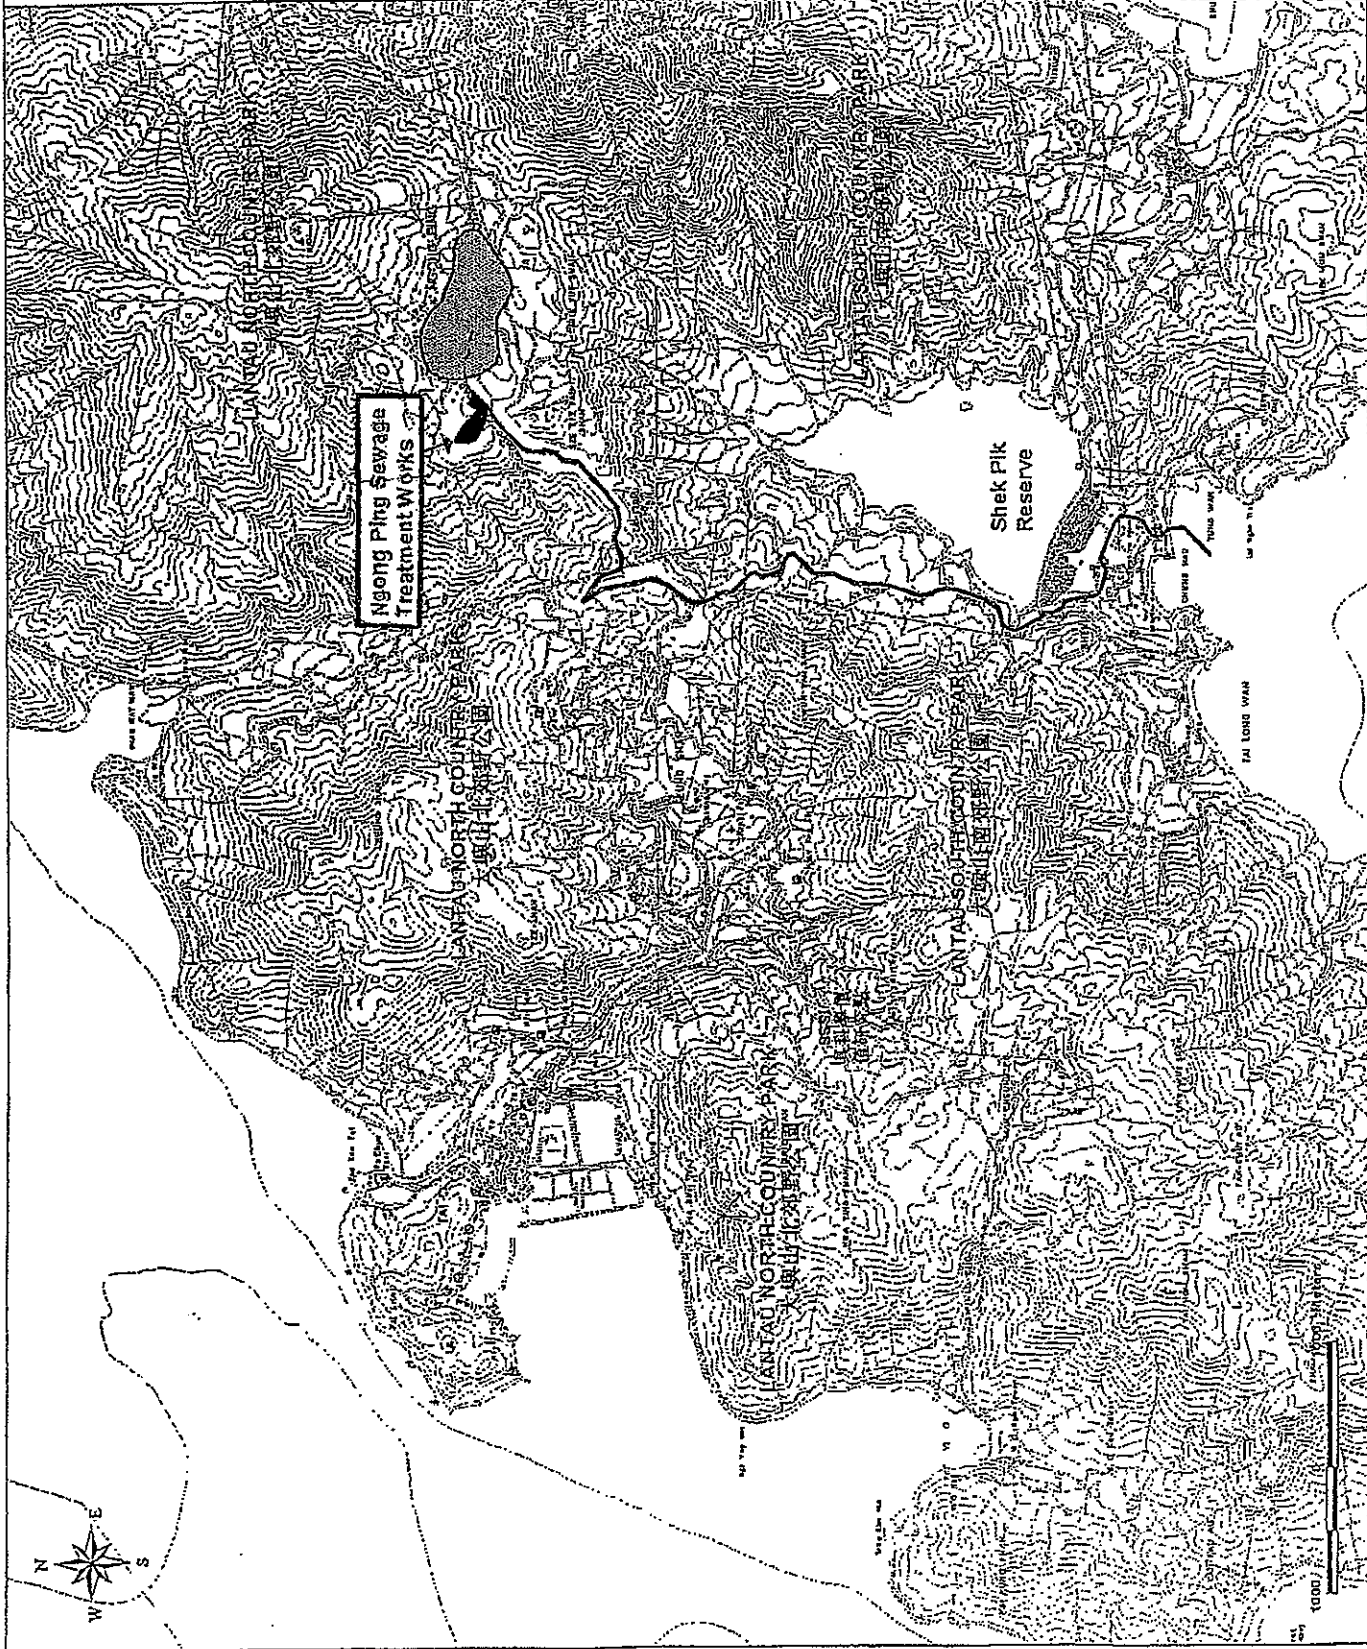
Ngong Ping Sewerage Project  
Scheme - General Layout

This Project only covers the operation phase of Package 1 and Package 2. The general layout plan of the project is shown in Appendix D (Drawing No. 23400/EN/098).

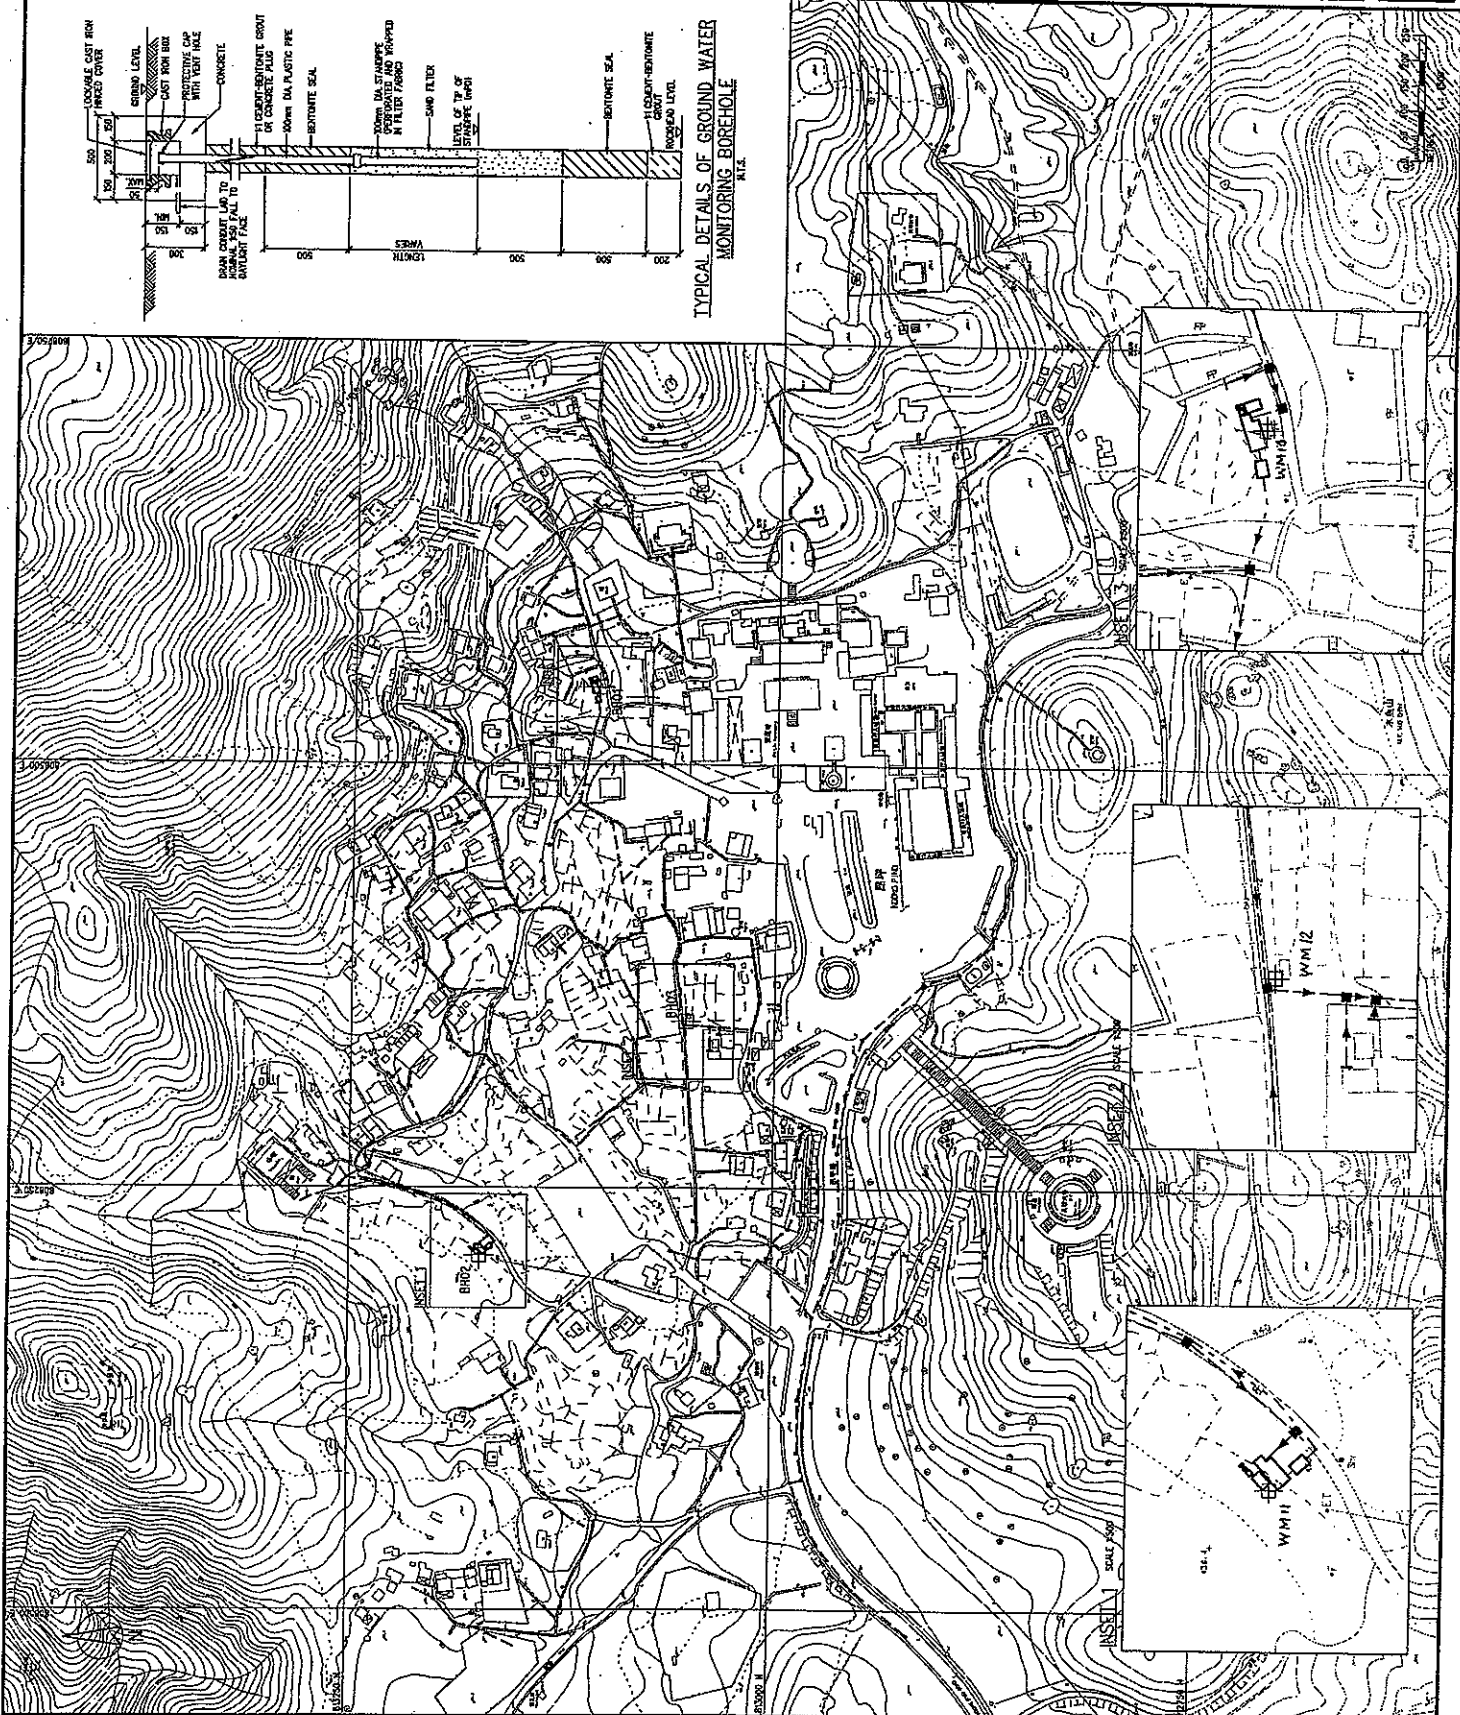
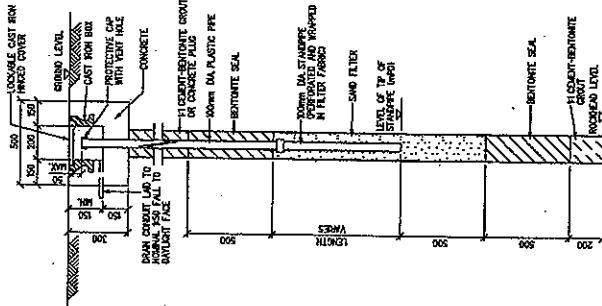
**LOCATION & TYPICAL DETAILS OF GROUND WATER MONITORING BOREHOLE**

The general layout plan of the project is shown in Appendix D. The groundwater monitoring locations are also shown in the Drawing No. 23400/R/VS/406.

**TYPICAL DETAILS OF GROUND WATER MONITORING BOREHOLE**  
M.T.S.
