DSD

Ngong Ping Sewage Treatment Works
Quarterly EM&A Report of Odour Impact Monitoring

February 2007

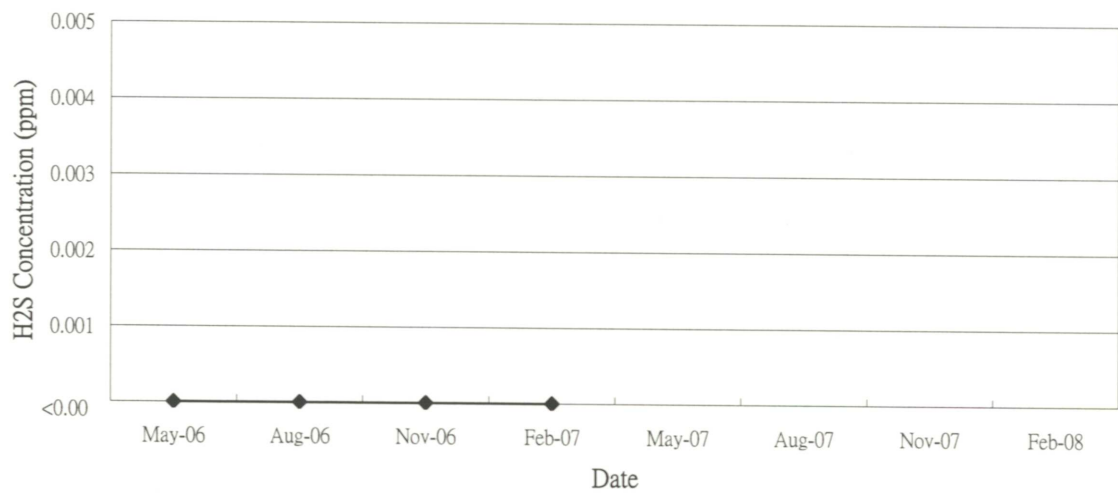
Monitoring Station D2

| Monitoring station | Level of monitoring | Location description |
|---|---|---|
| D2 | 1.0 m | Exhaust point of deodorisation room no. 2 |

| Monitoring station | Average H ₂ S concentration (ppm) |
|---|--|
| D2 | <0.001 |

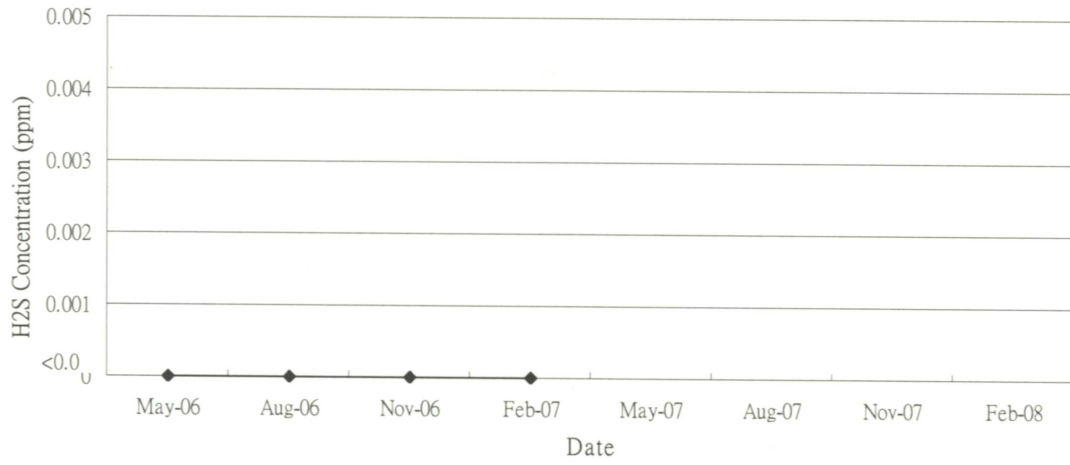
Monitoring Station D4

| Monitoring station | Level of monitoring | Location description |
|---|---|---|
| D4 | 1.0 m | Deodorisation room no. 1 side facing east |

| Monitoring station | Average H ₂ S concentration (ppm) |
|---|--|
| D4 | <0.001 |

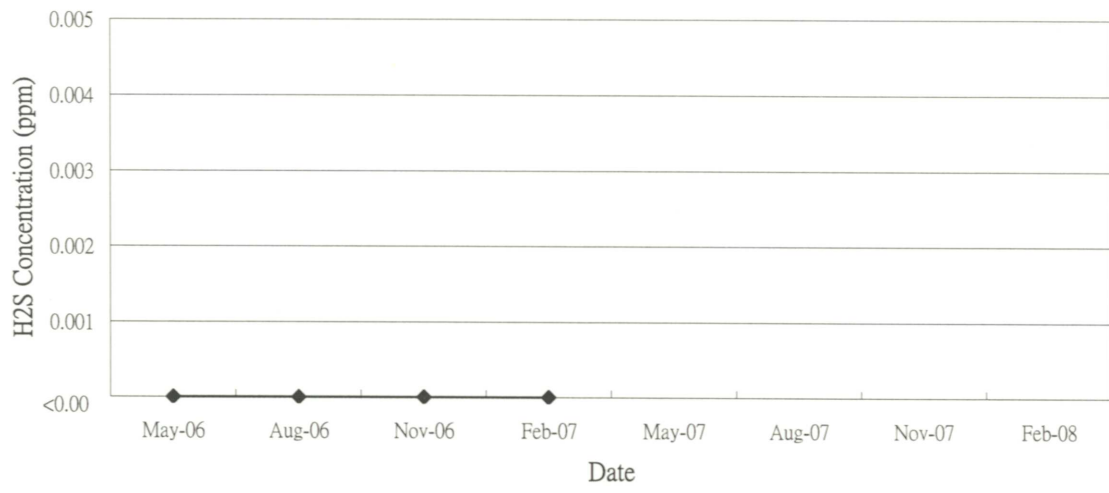
Monitoring Station D7

| Monitoring station | Level of monitoring | Location description |
|---|---|---|
| D7 | 1.0 m | Exhaust point of deodorisation room no. 1 |

| Monitoring station | Average H ₂ S concentration (ppm) |
|---|--|
| D7 | <0.001 |
