Job title: **DC/2006/11 - Drainage Improvement in Southern Lantau**

Document title: **Baseline Monitoring Report**

**Agreement DP05/2005 –  
Employment of  
Consultant for  
Environmental and  
Landscaping Detailed  
Design for Drainage  
Improvement in  
Southern Lantau**

May 2008

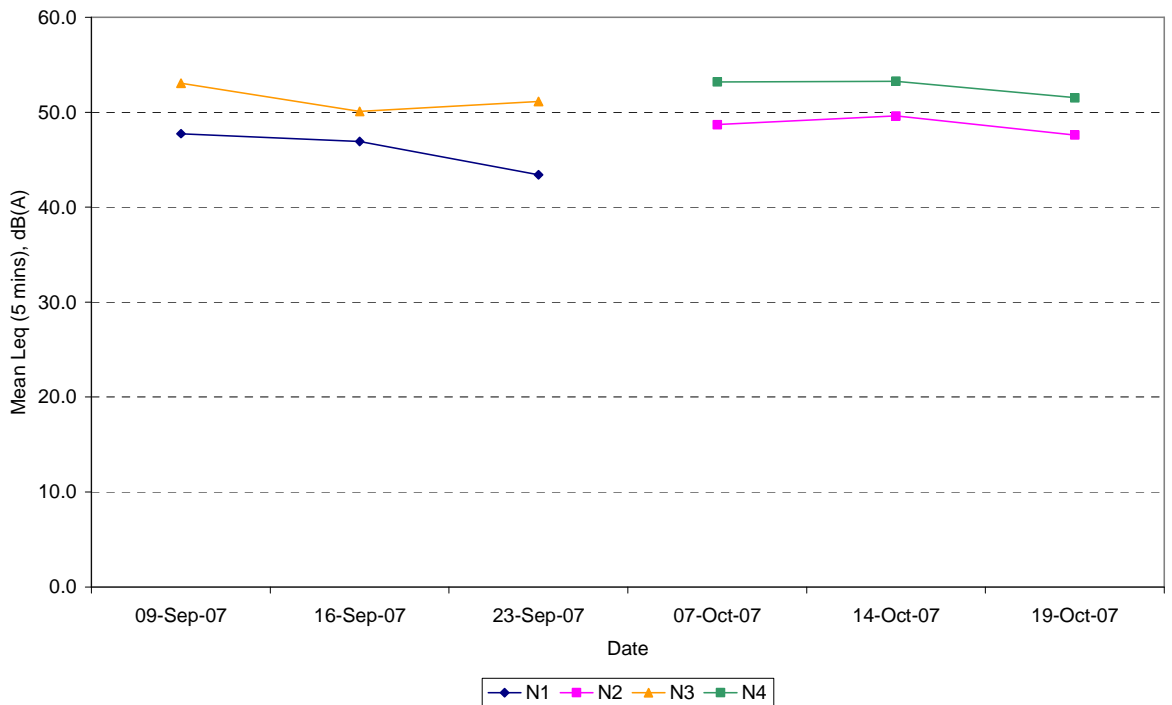
Period	Location	Mean Noise Level, $L_{Aeq, 5mins}$ dB(A)
Evening time (1900-2300 hrs) on normal weekdays	N1	48.3
	N2	51.3
	N3	52.5
	N4	52.3
Night time (2300-0700 hrs) on normal weekdays	N1	47.4
	N2	47.6
	N3	50.9
	N4	51.4
Sunday & public holiday	N1	46.0
	N2	48.6
	N3	51.4
	N4	52.7

**Figure 3-1:** Baseline noise monitoring results (mean  $L_{eq(30mins)}$ , daytime, normal weekday)

**Figure 3-2:** Baseline noise monitoring results (mean  $L_{eq(5mins)}$ , evening, normal weekday)

**Figure 3-3:** Baseline noise monitoring results (mean  $L_{eq(30mins)}$ , nighttime, normal weekday)

**Figure 3-4:** Baseline noise monitoring results (mean  $L_{eq(30mins)}$ , Sunday and public holiday)

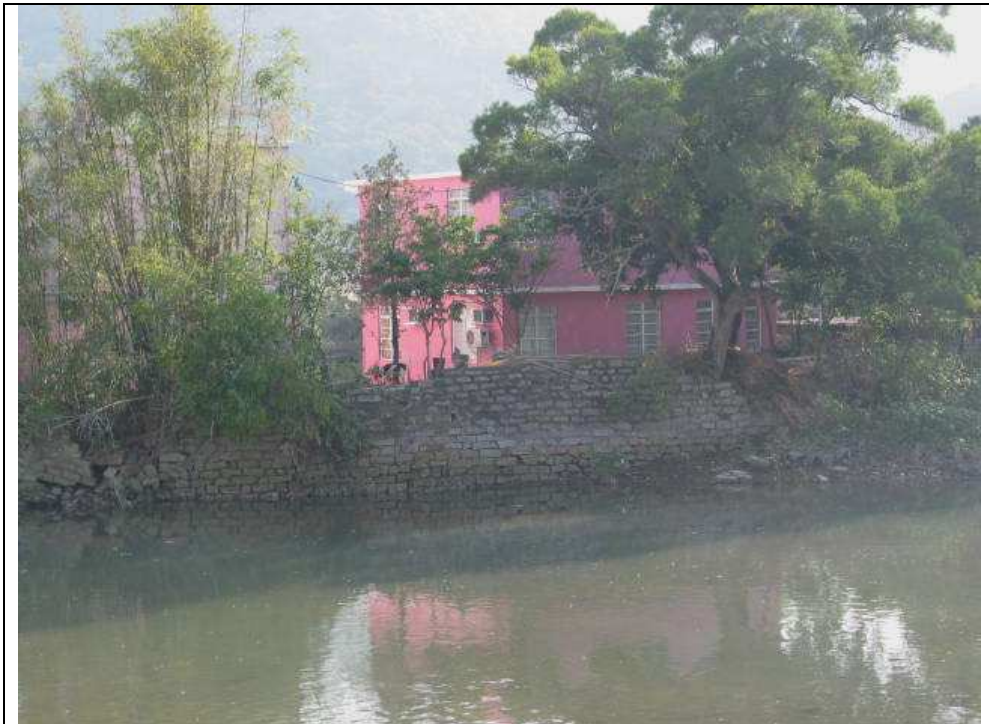
Photo 2: No 2 - Retaining – riverside wall

The condition of the retaining wall is poor and collapsing in the middle section for a length of about 40 metres. The condition of the rest of the wall is fair.

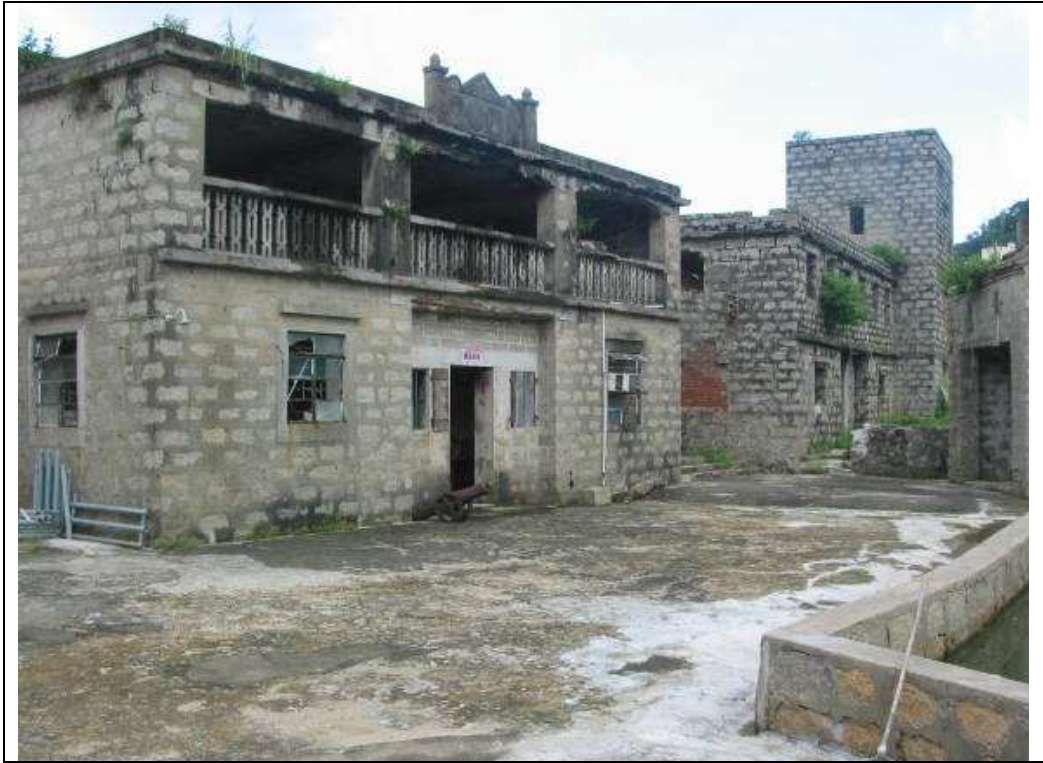
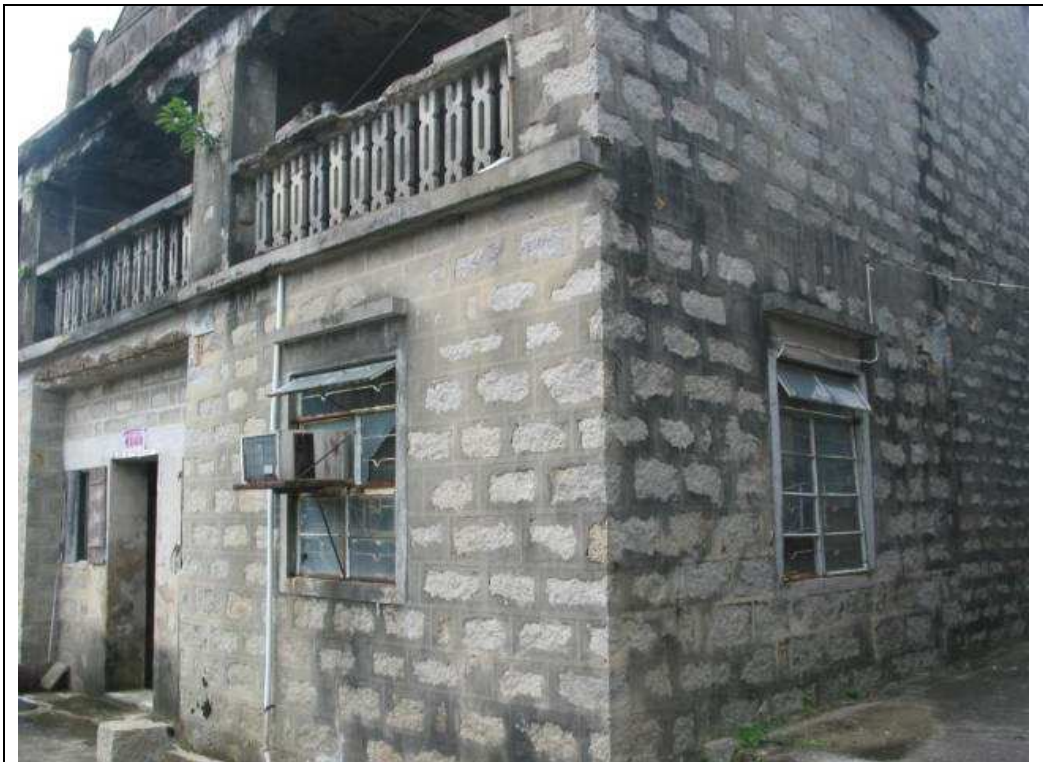
The condition of the building is fair to good with regard to stonework and mortar much of which has been rendered with concrete. There do not appear to be any large cracks within the exterior walls. The ground floor ceiling has been patched with concrete. The conditions of upper second floor particularly the central eaves are fair to poor and appear to have deteriorated since the 2003 survey as have some of the window glass and shutters.

Photo 3: No 3 - Large Central House of "Yu Tak Li Wai" – Front view

Photo 4: No 3 - Large Central House of "Yu Tak Li Wai" – Rear View (NE)

Photo 5: No 3 - Large Central House of "Yu Tak Li Wai" – Rear View

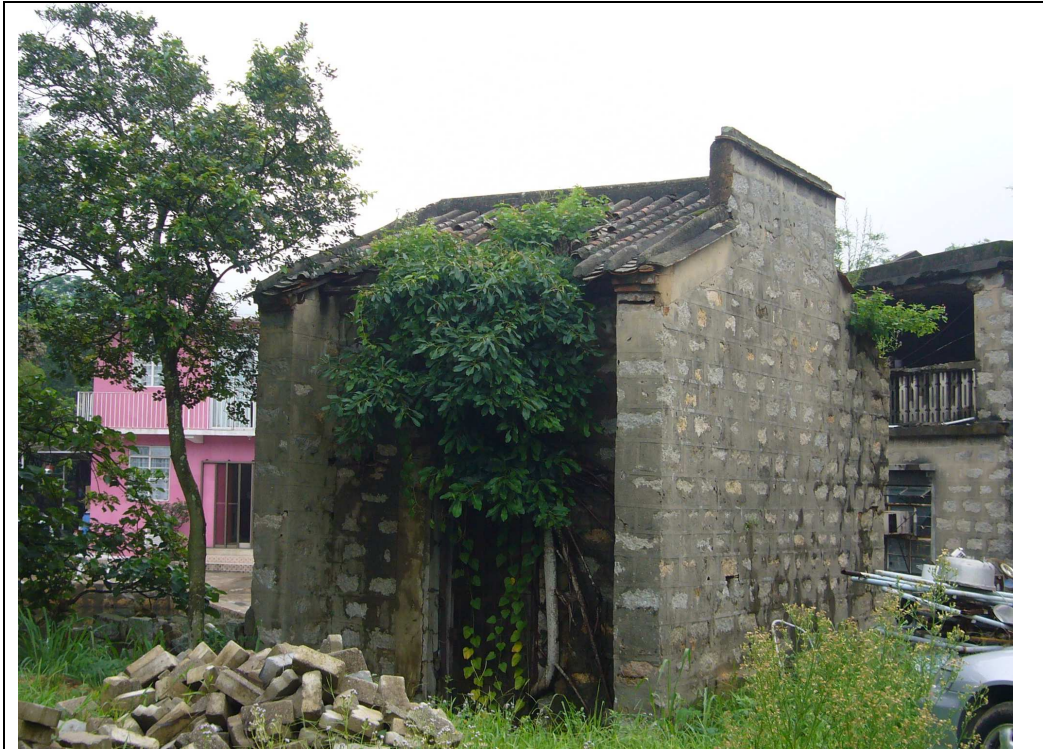
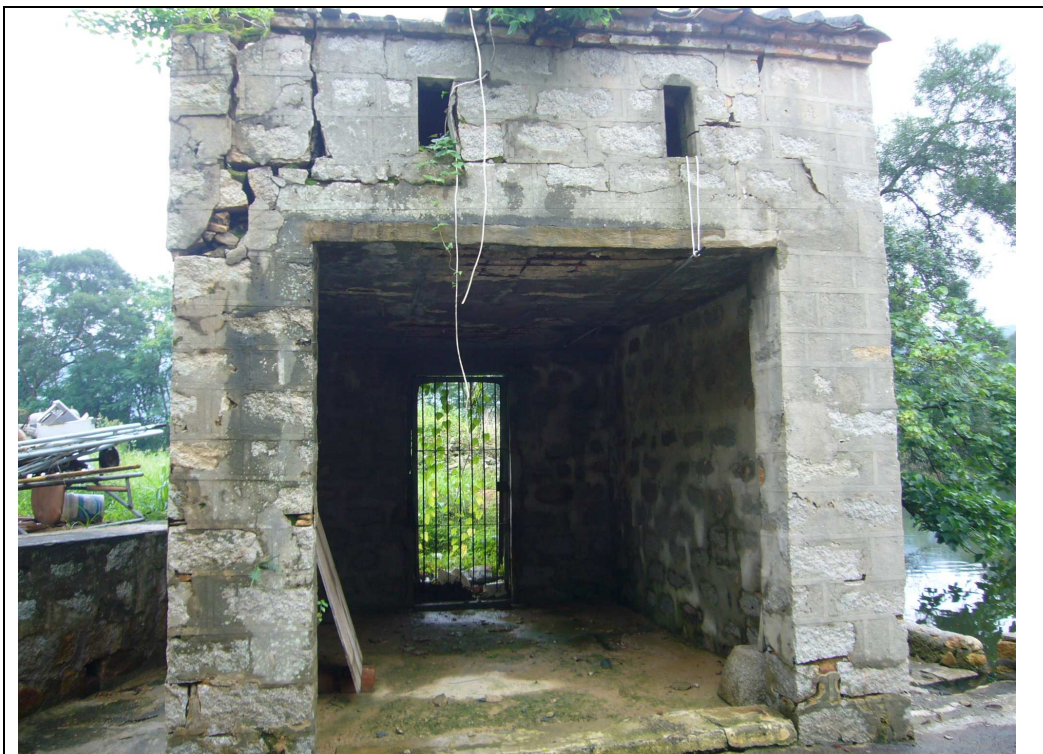
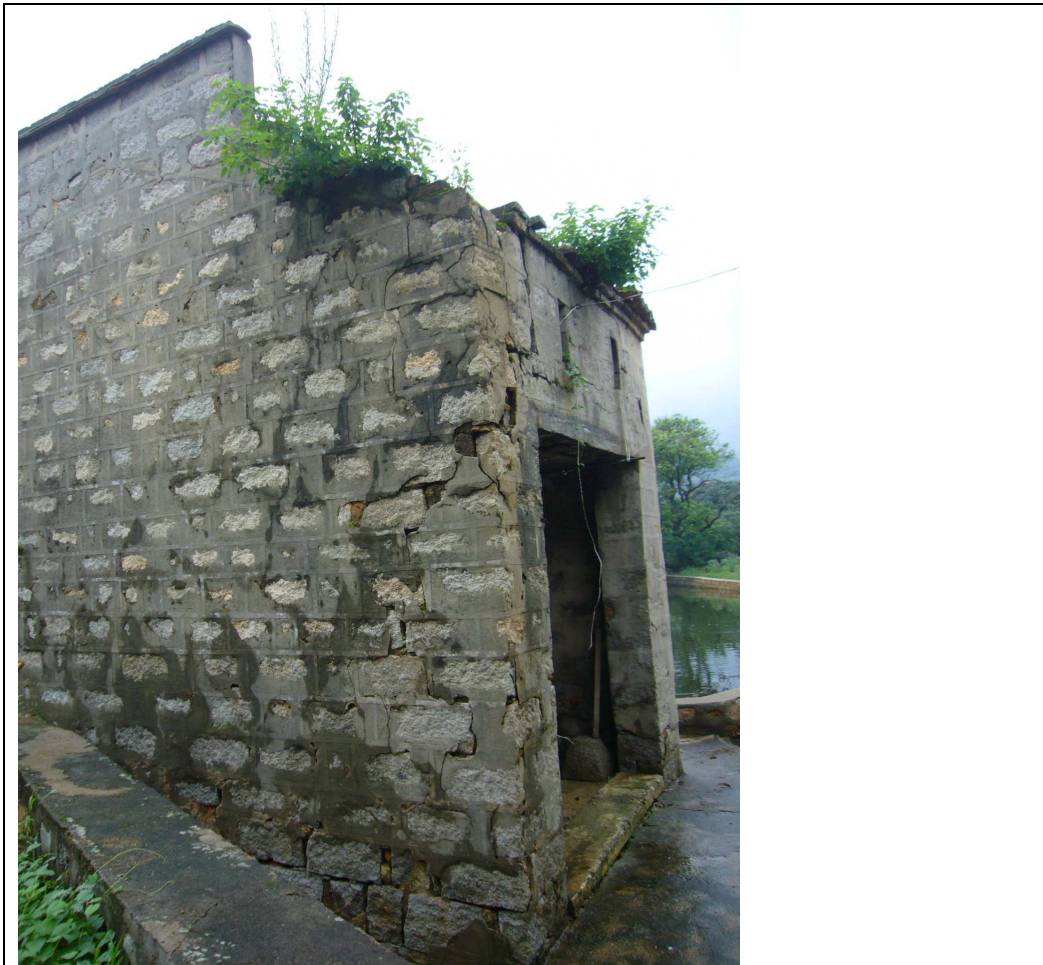
The condition of the small watchtower is fair with cracks in the upper north-east corner of the masonry. The mortaring of the building has been extensively rendered which is likely to conceal further cracks in the stonework. The roof is in poor condition with loss of many tiles along the lower roof to the south.

Photo 6: No 4 - Small Watchtower

Photo 7: No 4 - Small Watchtower (NE corner)

Photo 8: No 4 - Small Watchtower (East wall)

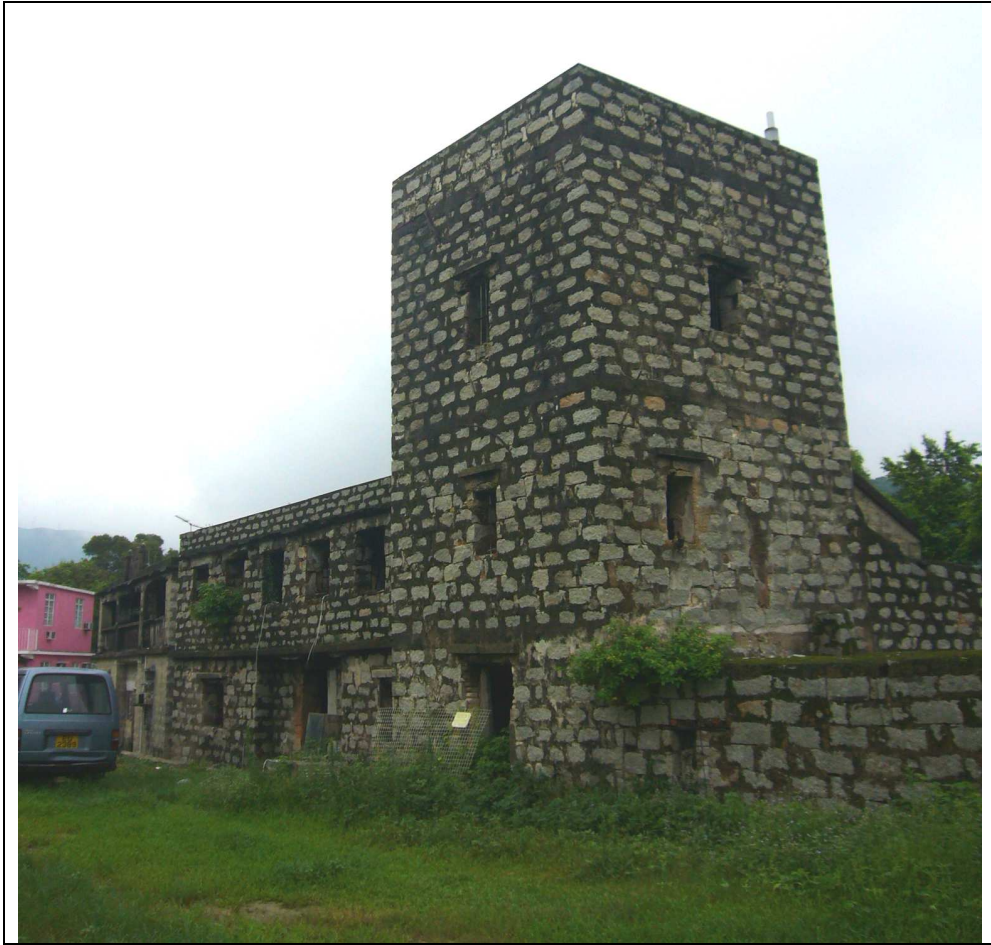
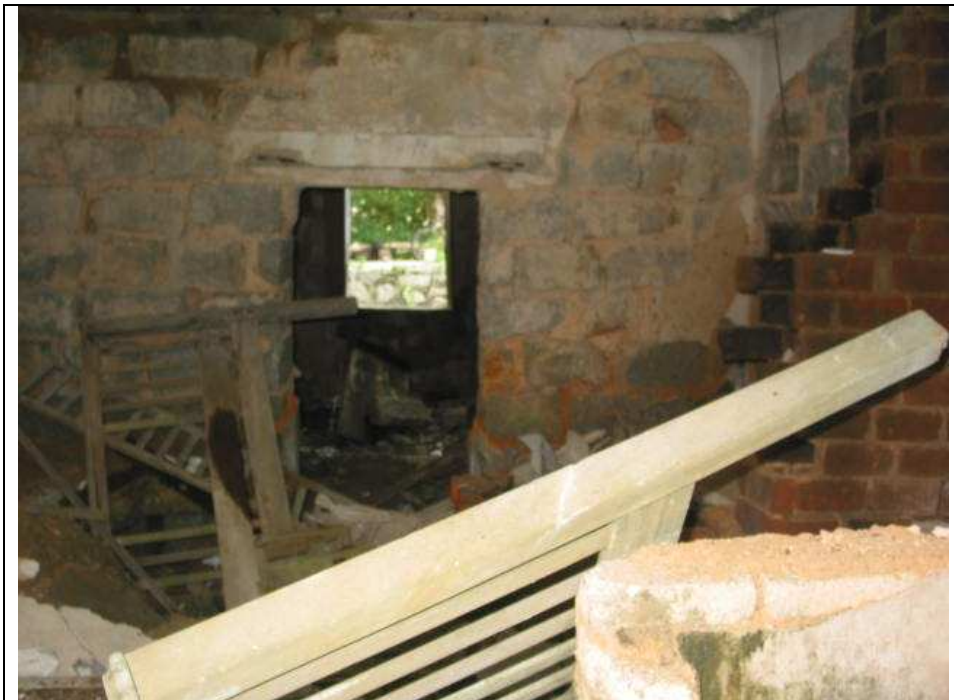
The external condition of the watchtower is poor with prominent cracks in the stonework. The interior ground floor ceiling has collapsed.

Photo 9: No 5 - Large watchtower

Photo 10: No 5 - Large watchtower (Interior)

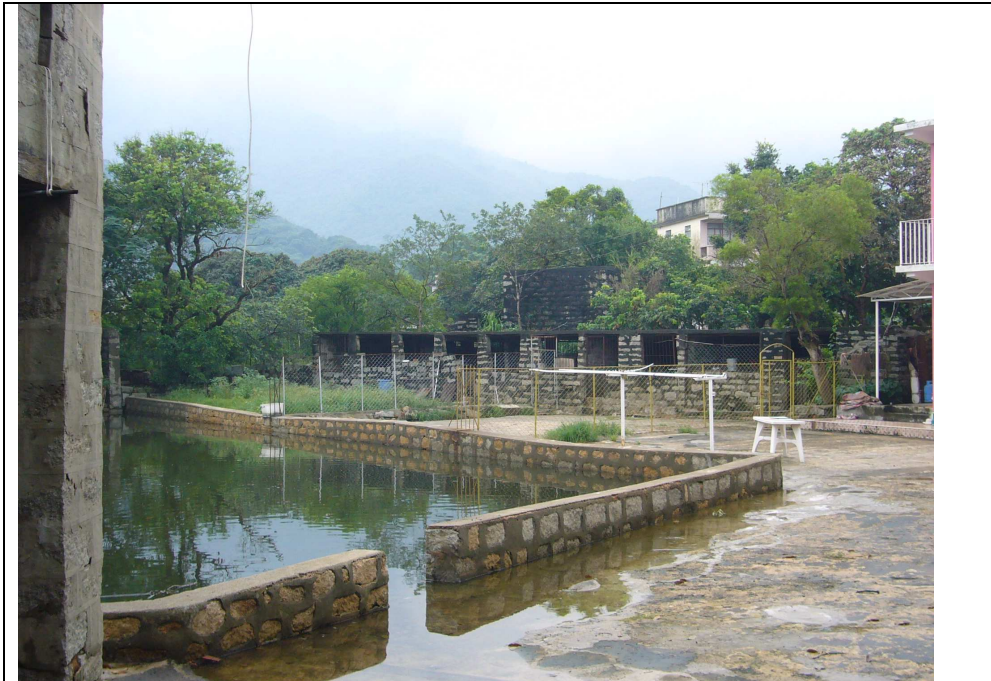
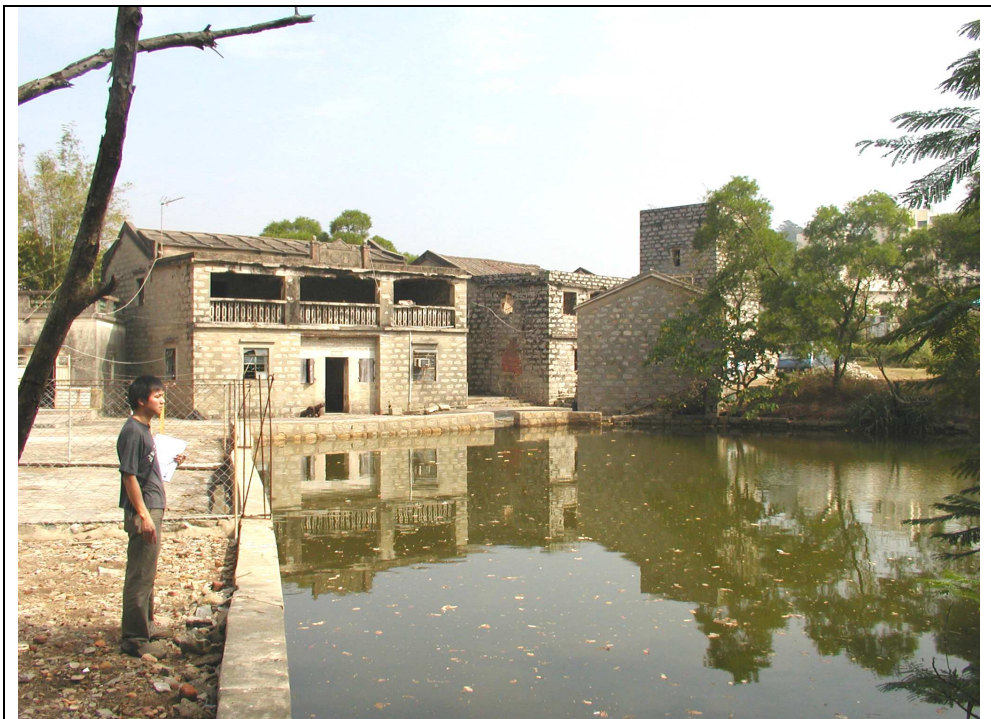
The concrete pavement is deteriorating due to seepage/flooding of the pond immediately (for a metre or so) north of the pond wall. Otherwise the pond wall is in fair to good condition.

Photo 11: No 6 - Pond

Photo 12: No 6 - Pond

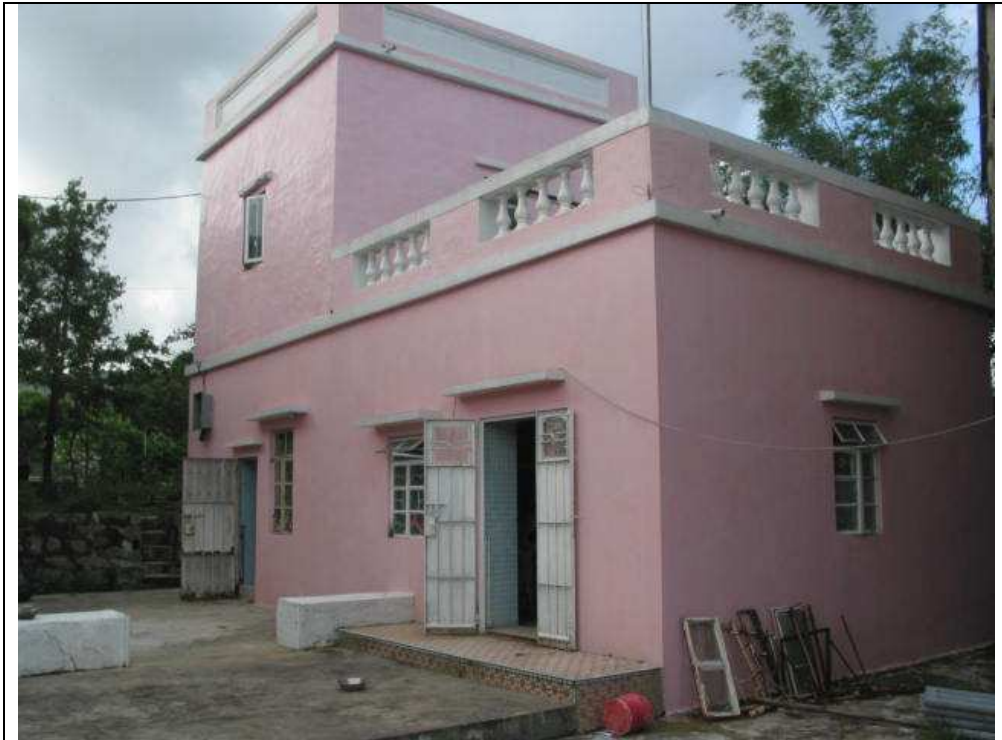
Photo 13: No 7 - House

The House is an irregular rectangular building of granite stone block construction completely covered with concrete render. The northern part of the building is two storeys with a molded concrete parapet while the southern part is one storey but with a flat roof and a green concrete balustrade. The house is currently occupied and was recently renovated and painted pink. The condition of this house is good.

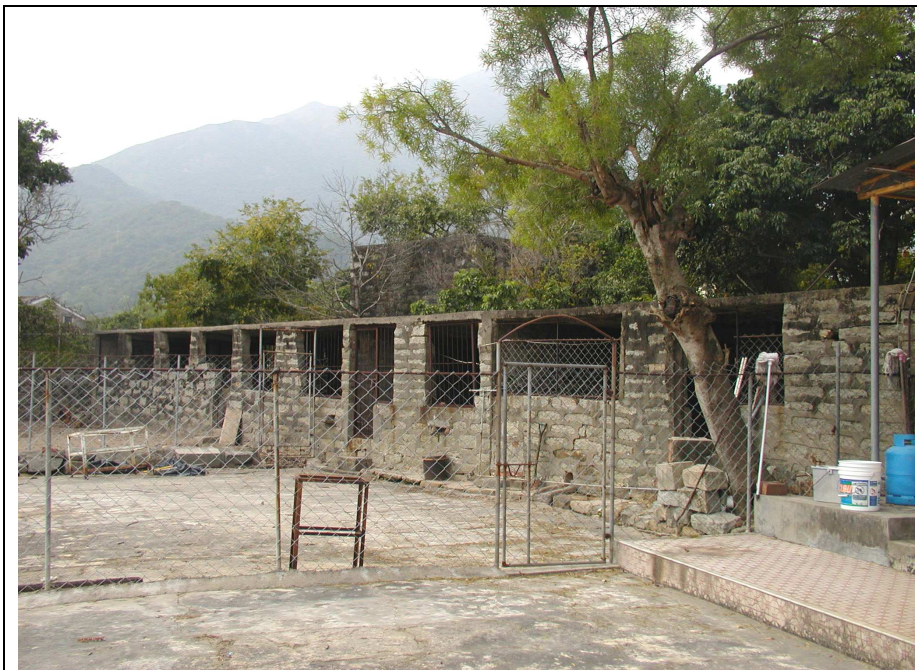
Photo 14: No 8 - Chicken pens

The condition of this building is fair with no large or frequent cracks. The mortar has been mostly rendered with concrete. The building appears in similar condition to 2003.

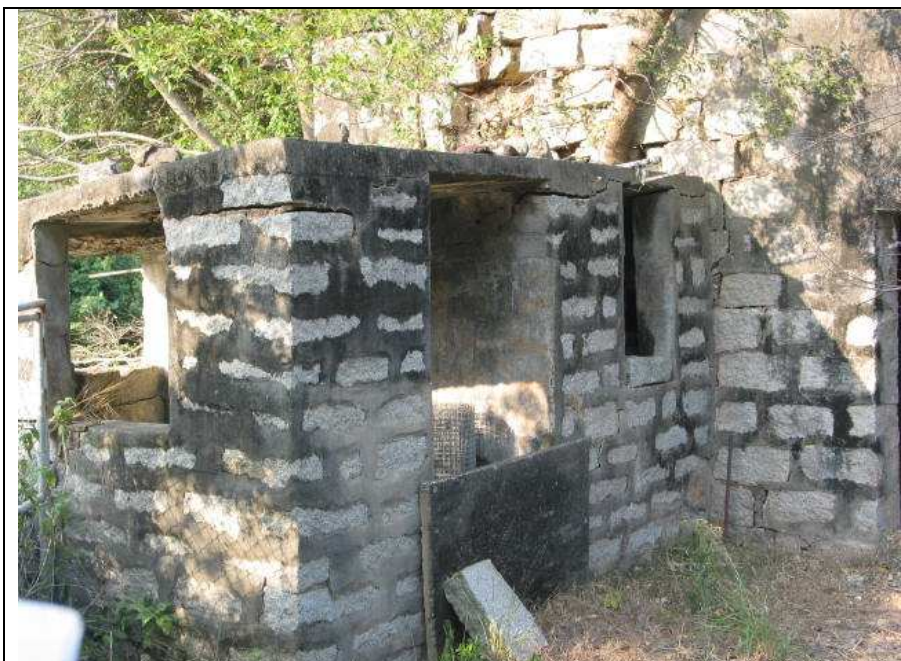
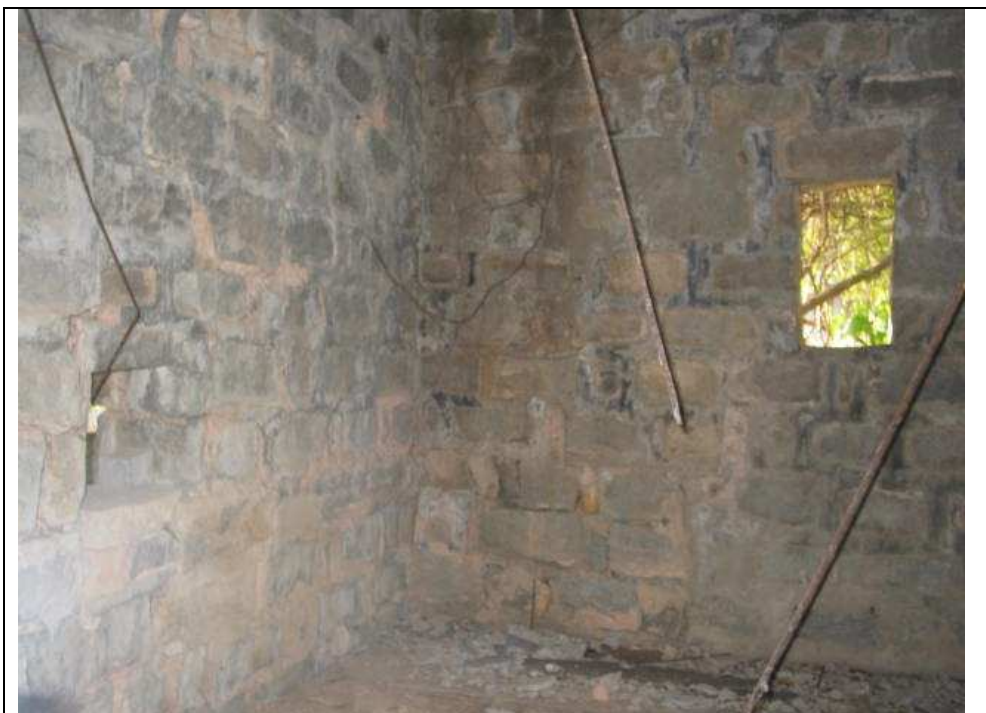
The condition of this building is fair with no large or frequent cracks on the SE side but quite poor and cracked on the river side (NW). The mortar has been mostly rendered with concrete. The interior has a concrete slab floor with common debris on the floor. The interior walls are in fair to poor condition and have been patched with concrete throughout. Some small saplings have grown through the walls in some places. The building appears in similar condition to 2003.

Photo 15: No 9 – Latrine

Photo 16: No 9 – Latrine (interior)

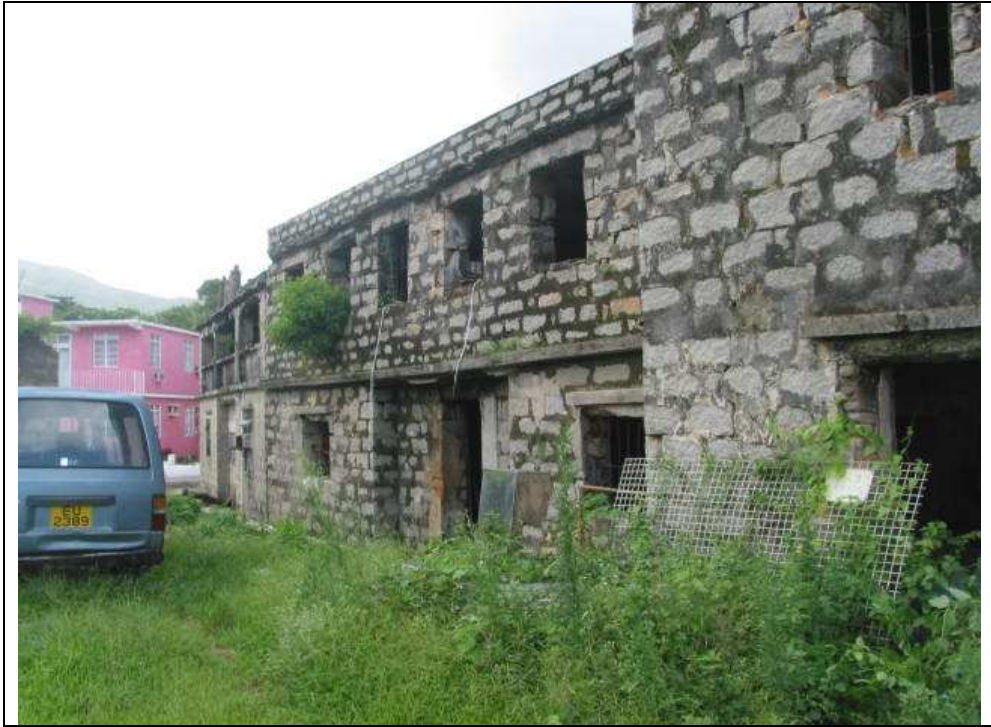
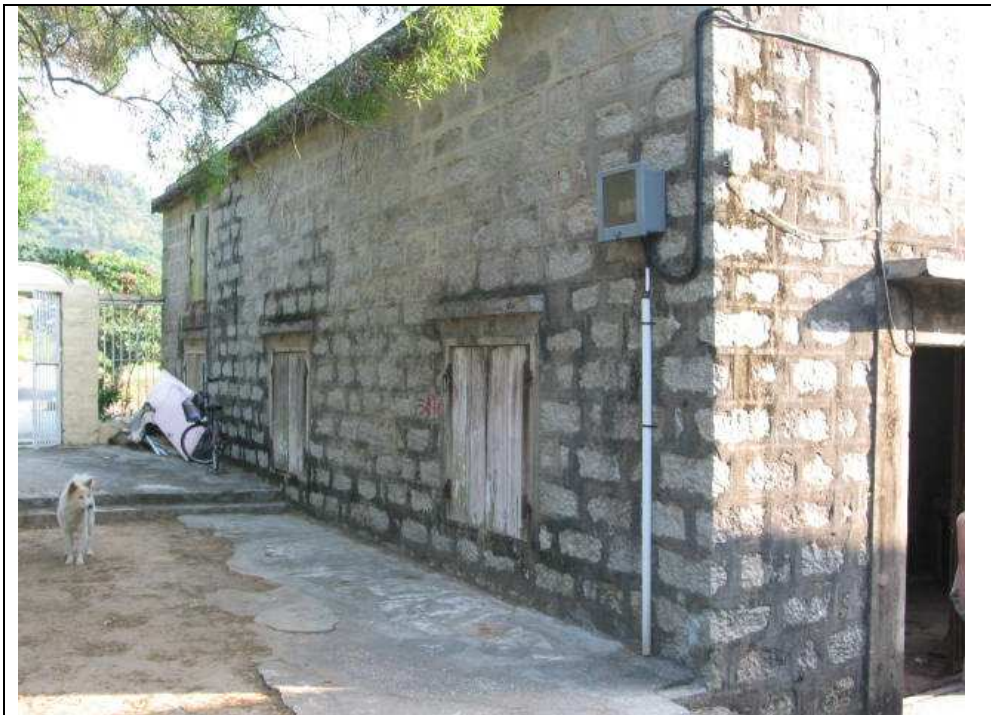
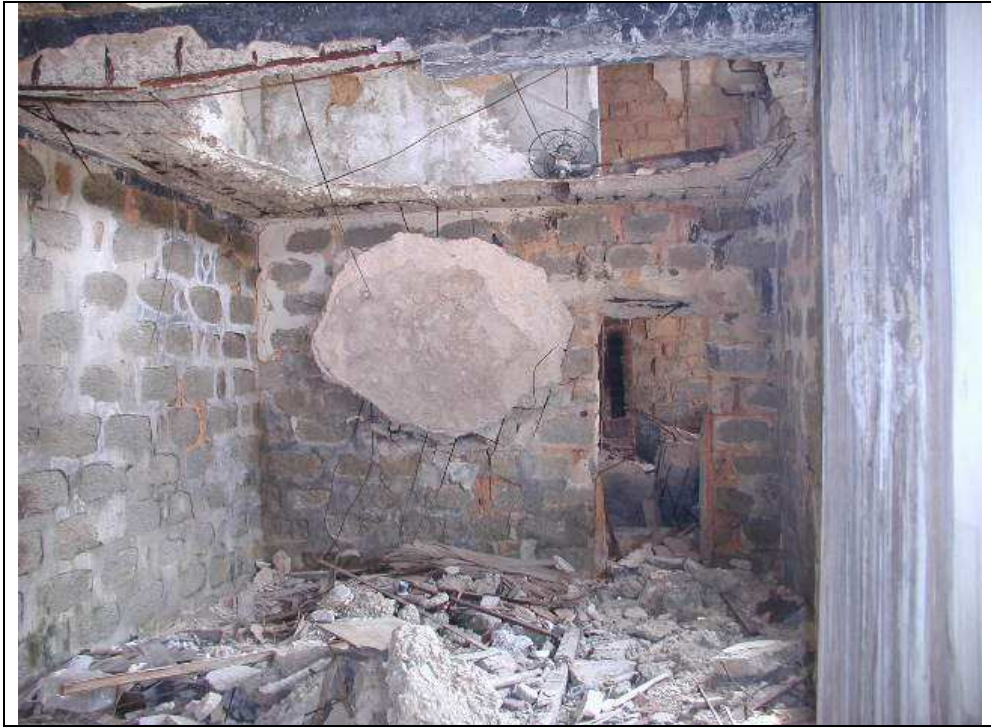
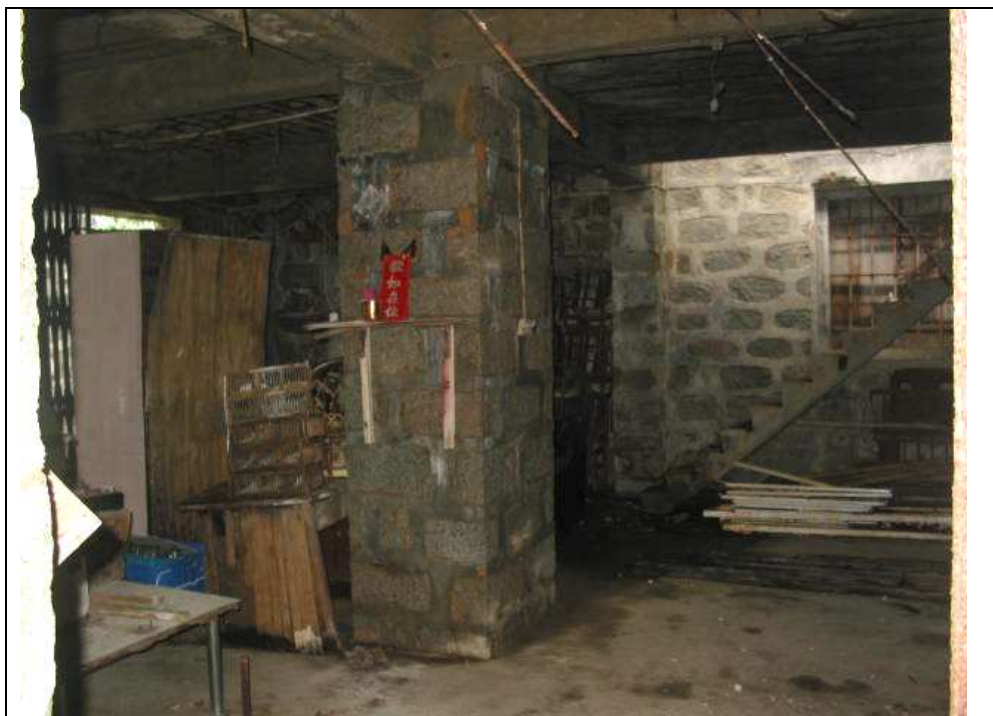
The building is derelict and external walls are in poor condition. Part of the roof is missing from the front left section and there are prominent cracks and loss of mortar particularly obvious in the lower left front wall and on the upper front wall and the NW wall. The rear wall appears to be in fair to good condition. Concrete render has been used throughout to improve the appearance of the building. The interior condition of the front section is poor with collapsed ceiling and large sections of patched concrete walls. The larger main room is in better condition and is currently used for storage. The building appears in similar condition to 2003.

Photo 17: No 10 - Large house

Photo 18: No 10 - Large house (Rear wall)

Photo 19: No 10 - Large house (Interior)

Photo 20: No 10 - Large house (larger main room)

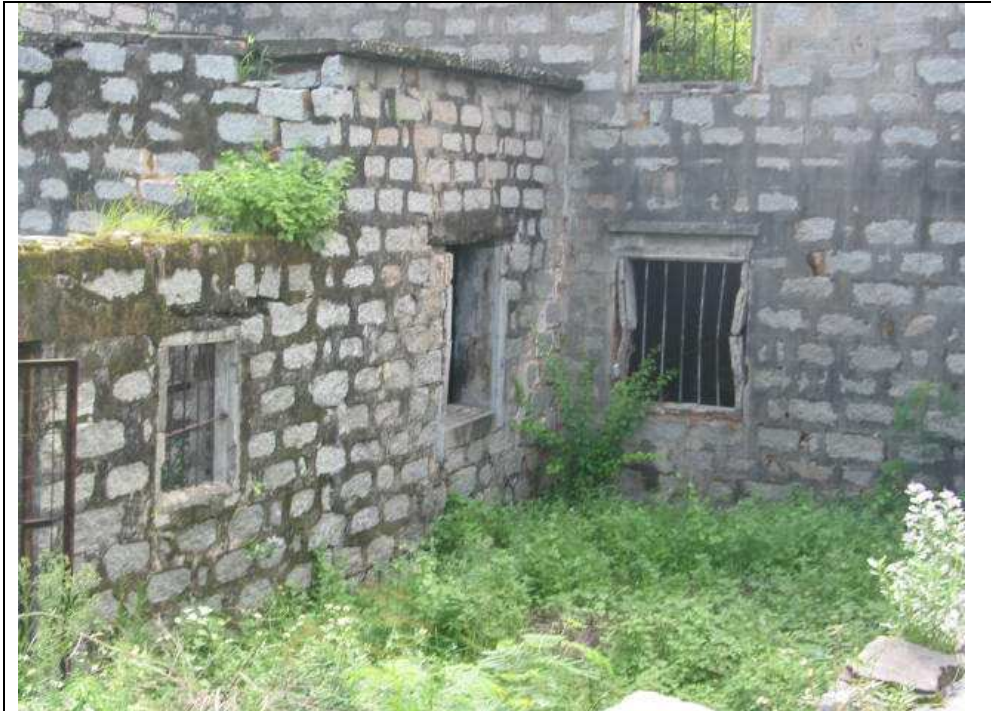
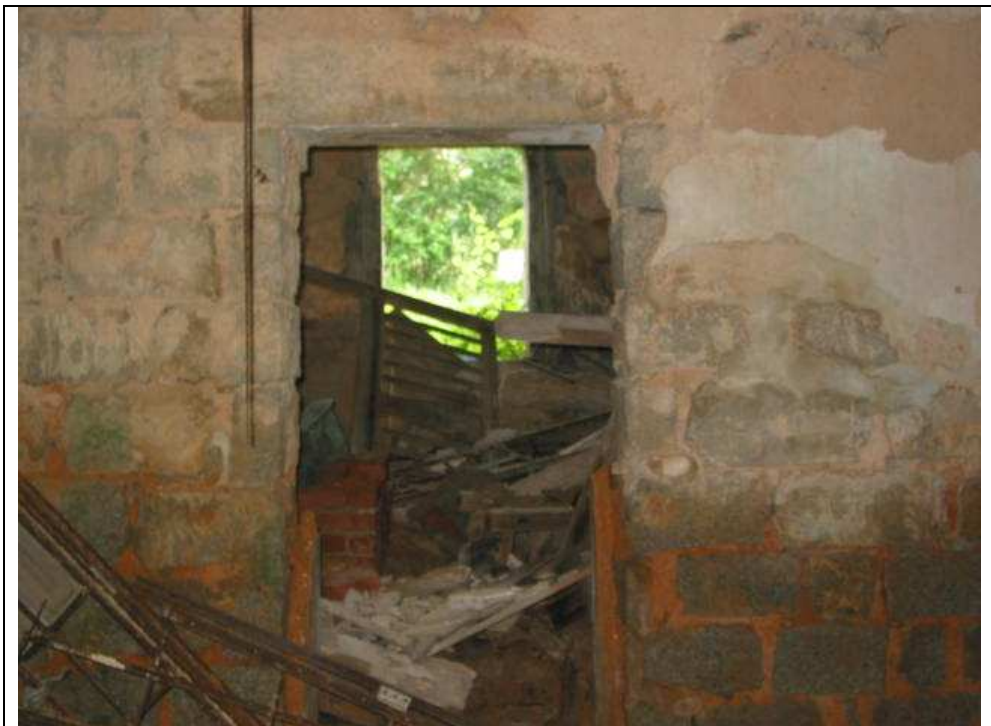
The condition of this building is poor with frequent cracks in the front and side exterior wall. The mortar has been mostly patched with concrete. The interior walls are in fair to poor condition and have been patched with concrete throughout. The building appears in similar condition to 2003.

Photo 21: No 11 - Small room

Photo 22: No 11 - Small room (Interior)

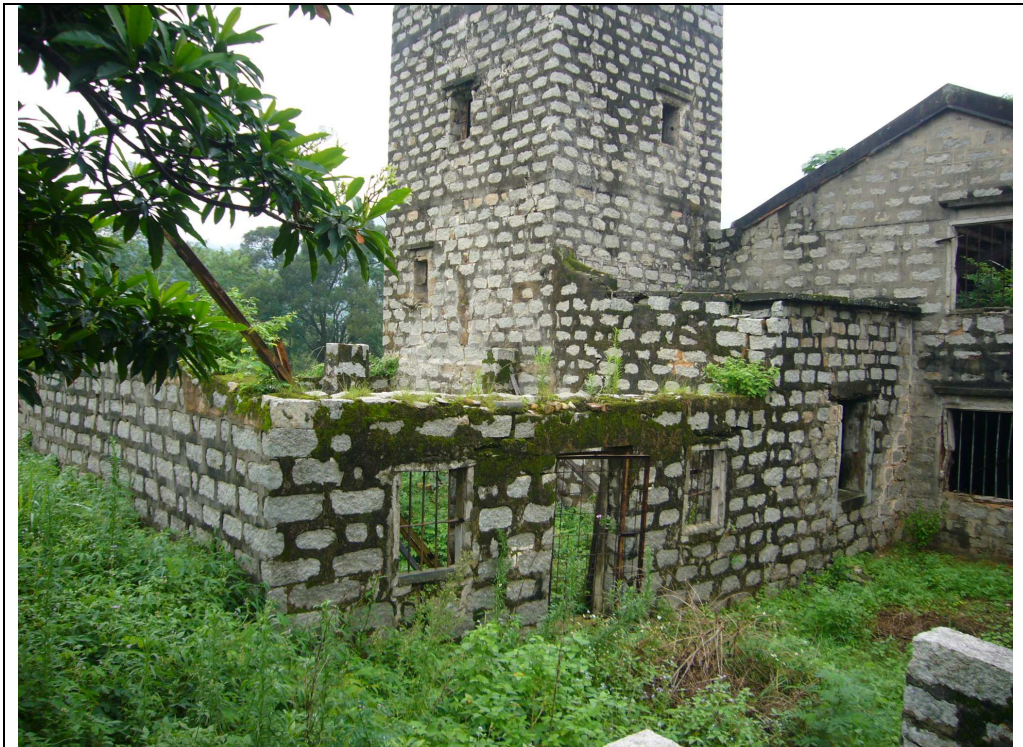
Photo 23: No 12 - Large room

The condition of this building is fair with loose mortar but few large cracks. Much of the mortar work has been patched with concrete. The building appears in similar condition to 2003 although a sapling growing within the room has been removed.
