#### MONTHLY ENVIRONMENTAL MONITORING & AUDIT REPORT

Route 8
Between Tsing Yi and Cheung Sha Wan
Phase 2b East Tsing Yi Viaduct

Monthly Environmental Monitoring & Audit Report (29<sup>th</sup> October 2008 - 28<sup>th</sup> November 2008)

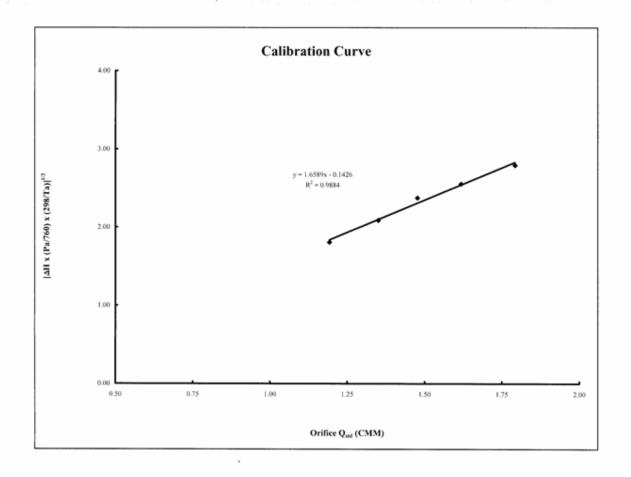
<sup>\*</sup> If the Correlation Coefficient, R is < 0.9900. Checking and Recalibration are require.

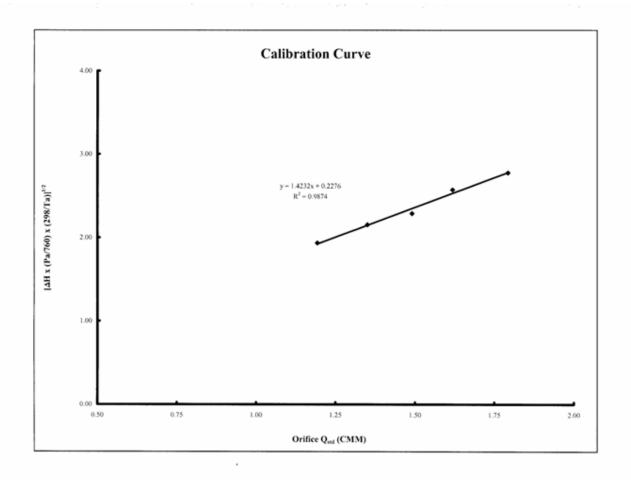
## TSP - Total Suspended Particulates High Volume Sampler In-situ Calibration Report (ASR2)

<sup>\*</sup> If the Correlation Coefficient, R is < 0.9900. Checking and Recalibration are require.

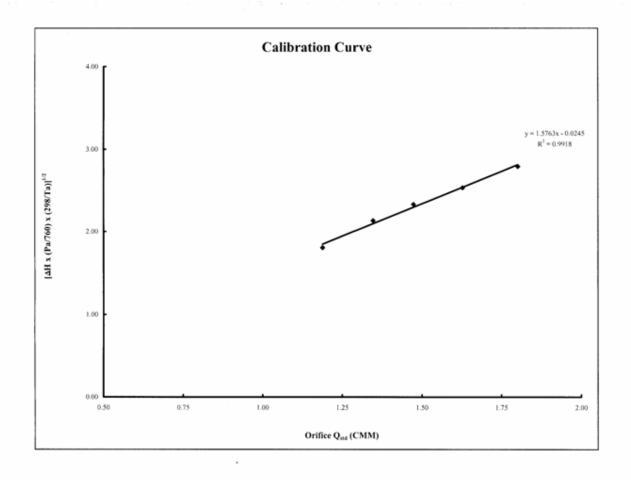
#### TSP - Total Suspended Particulates High Volume Sampler In-situ Calibration Report (ASR3)

<sup>\*</sup> If the Correlation Coefficient, R is < 0.9900. Checking and Recalibration are require.

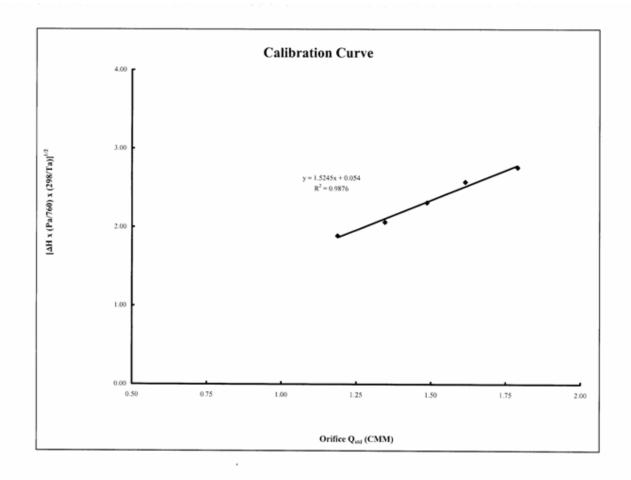
#### TSP - Total Suspended Particulates High Volume Sampler In-situ Calibration Report (ASR4)

<sup>\*</sup> If the Correlation Coefficient, R is < 0.9900. Checking and Recalibration are require.

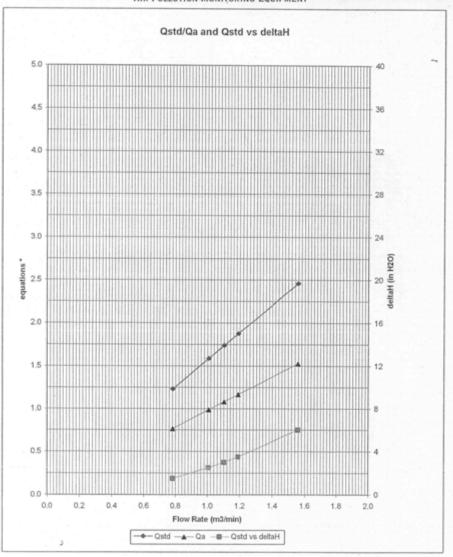
\* y-axis equations:

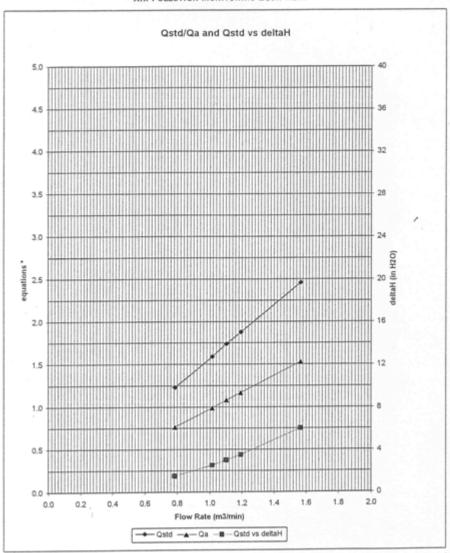
\* y-axis equations:

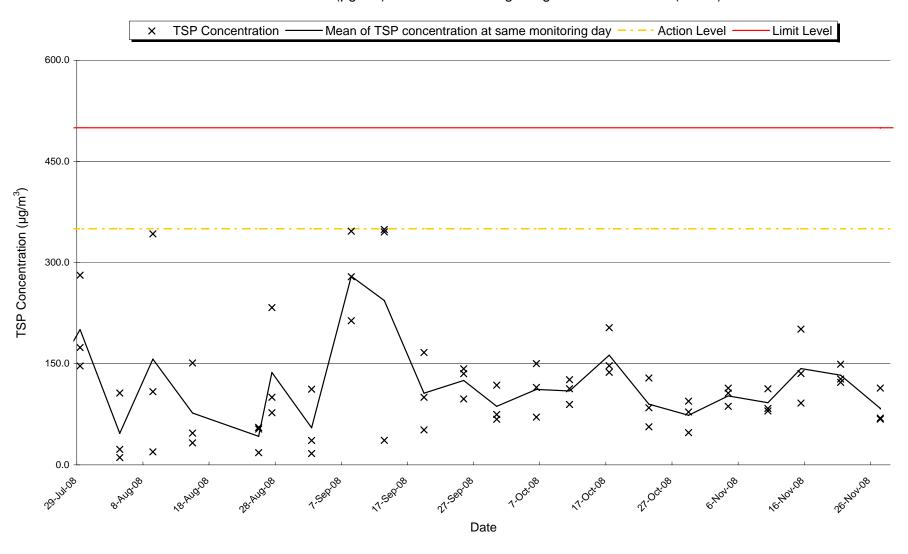
1 hr TSP Concentration (µg/m3) at HKIVE Fok Ying Tung Hall of Residence (ASR1)

6.1.3 No exceedances of the Action/Limit Levels of 1-hour and 24-hour TSP were recorded during the reporting period. The weather conditions recorded during the reporting period are summarized in *Appendix L*.

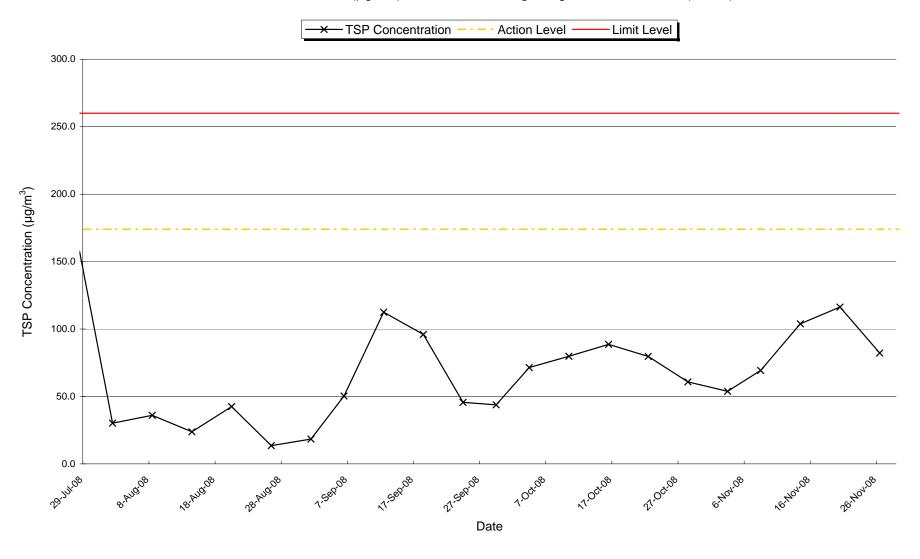
### 24 hrs TSP Concentration (µg/m3) at HKIVE Fok Ying Tung Hall of Residence(ASR1)

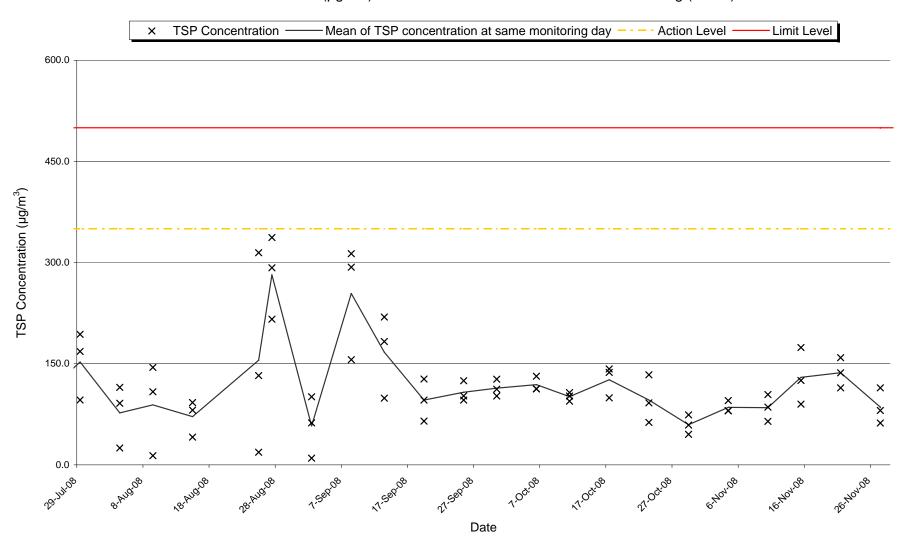
1 hr TSP Concentration (µg/m3) at HKIVE 5th floor Block D of the main Building (ASR2)

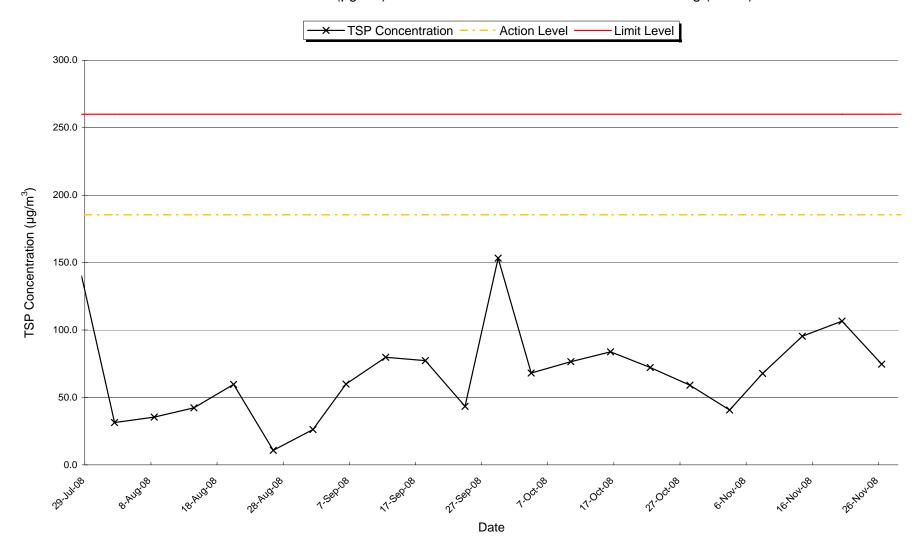
24 hrs TSP Concentration (µg/m3) at HKIVE 5th floor Block D of the main Building (ASR2)

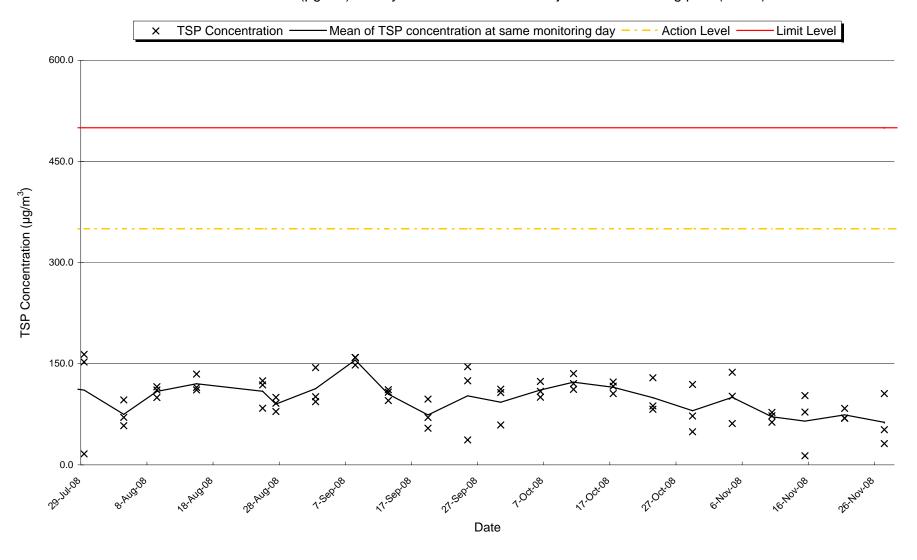
1 hr TSP Concentration (µg/m3) at Mayfair Gardens 1st floor adjacent to swimming pool (ASR3)

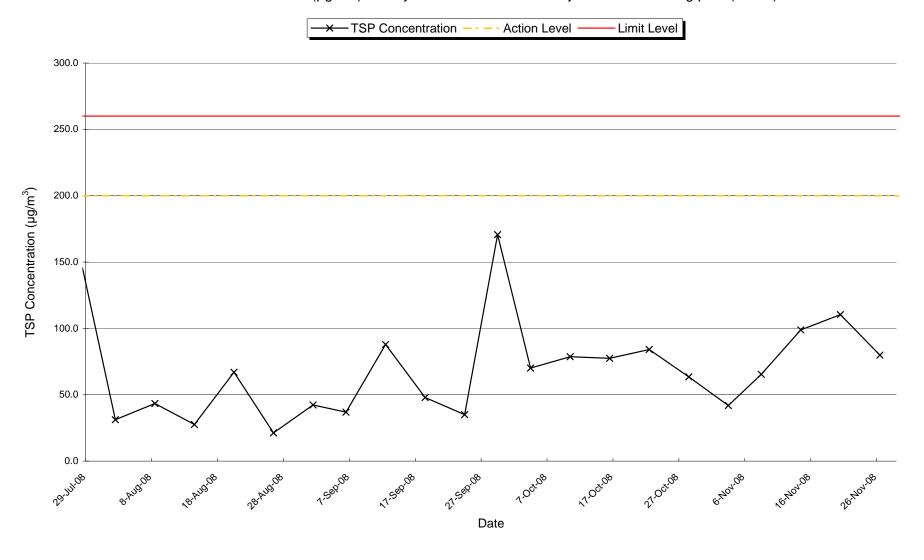
24 hrs TSP Concentration (µg/m3) at Mayfair Gardens 1st floor adjacent to swimming pool (ASR3)

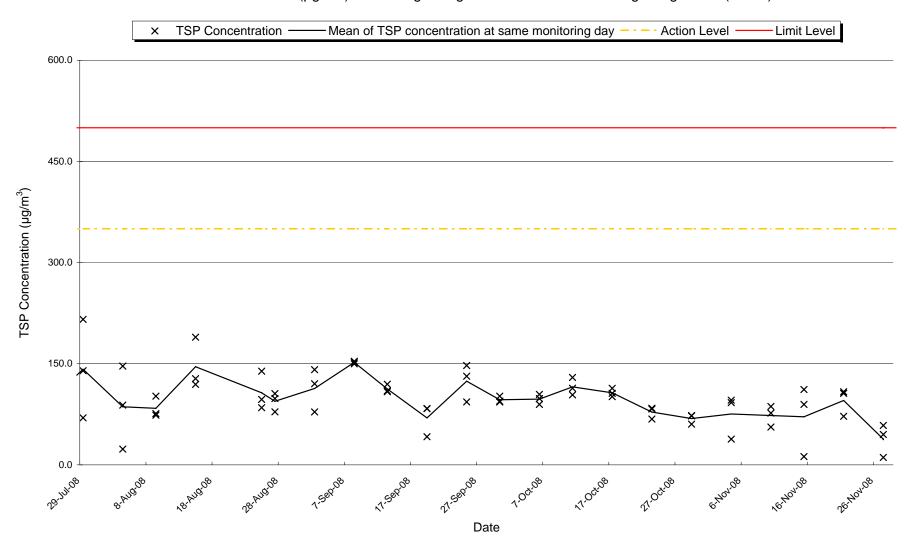
1 hrs TSP Concentration (µg/m3) at Cheung Ching Estate at the roof of Ching Yung House(ASR4)

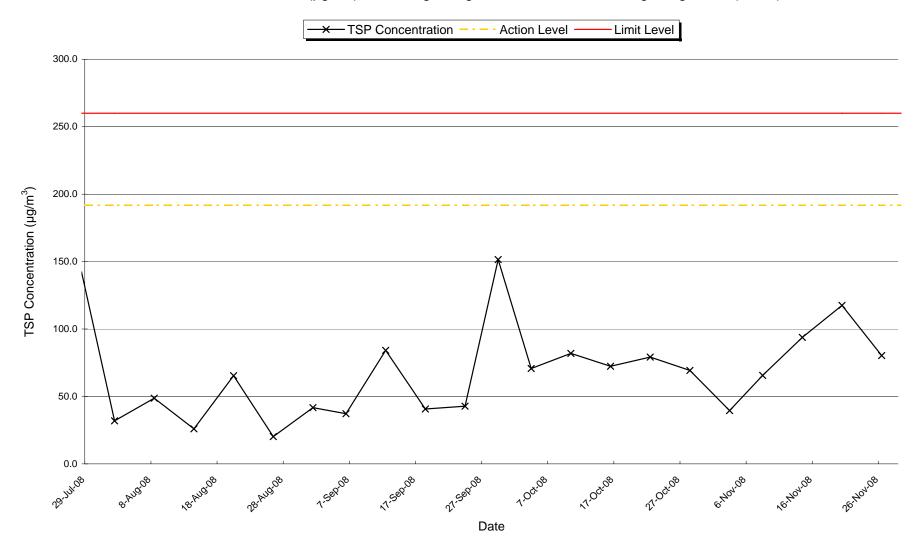
24 hrs TSP Concentration (µg/m3) at Cheung Ching Estate at the roof of Ching Yung House(ASR4)

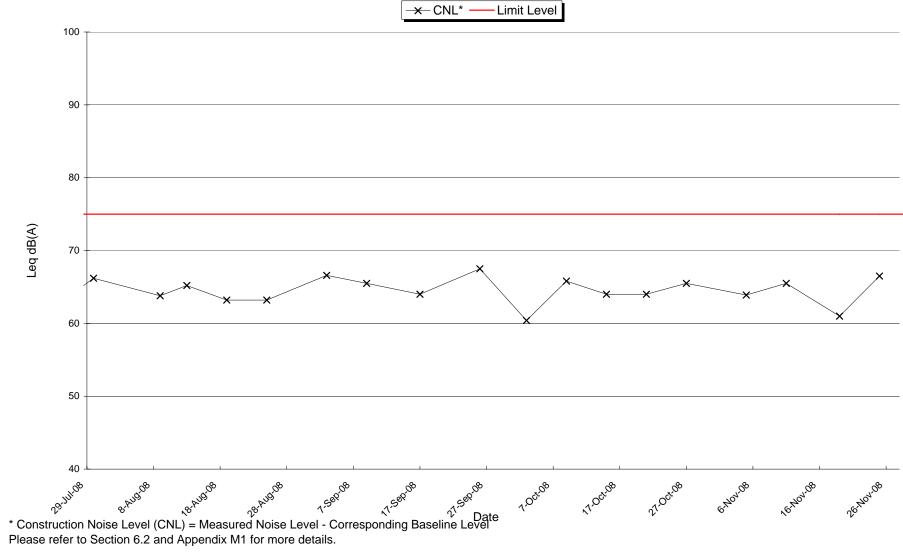
## Day-time Leq<sub>30</sub> (Construction Noise Level) at HKIVE Fok Ying Tung Hall of Residence (NSR1)

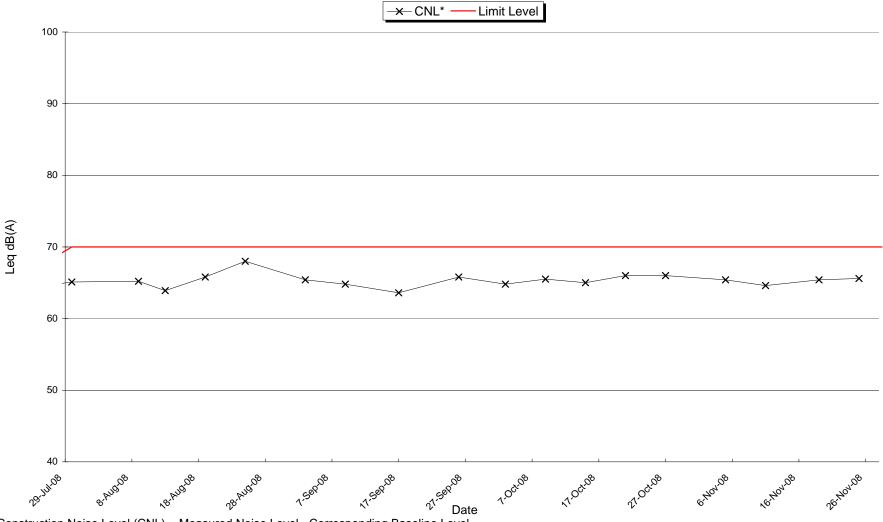
## Day-time Leq<sub>30</sub> (Construction Noise Level) at HKIVE 5th Floor Block D of the Main Education Building (NSR2)

<sup>\*</sup> Construction Noise Level (CNL) = Measured Noise Level - Corresponding Baseline Level Please refer to Section 6.2 and Appendix M1 for more details.

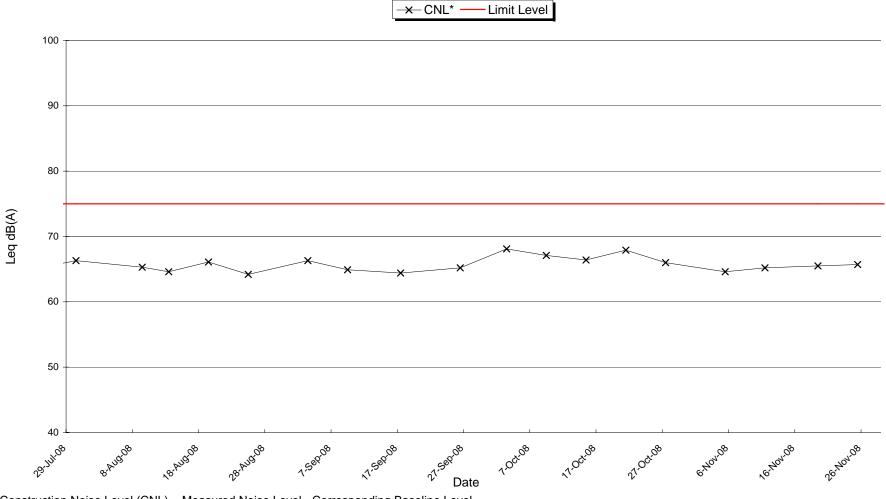
### Day-time Leq<sub>30</sub> (Construction Noise Level) at Mayfair Gardens 1st floor adjacent to swimming pool (NSR3)

<sup>\*</sup> Construction Noise Level (CNL) = Measured Noise Level - Corresponding Baseline Level Please refer to Section 6.2 and Appendix M1 for more details.

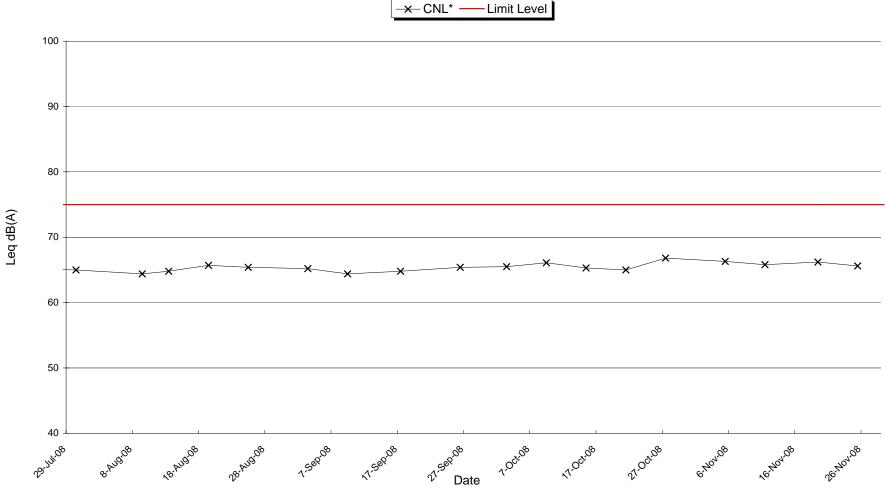
## Day-time Leq<sub>30</sub> (Construction Noise Level) at Cheung Ching Estate at the Roof of Ching Yung House (NSR4)

<sup>\*</sup> Construction Noise Level (CNL) = Measured Noise Level - Corresponding Baseline Level Please refer to Section 6.2 and Appendix M1 for more details.

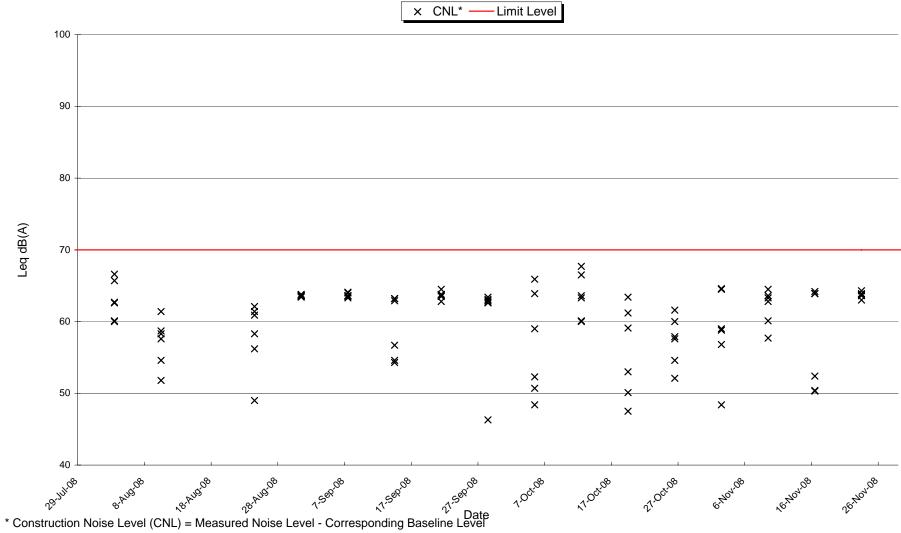
### Public Holiday Leq<sub>5</sub> (Construction Noise Level) at HKIVE Fok Ying Tung Hall of Residence (NSR1)

Please refer to Section 6.2 and Appendix M2 for more details.

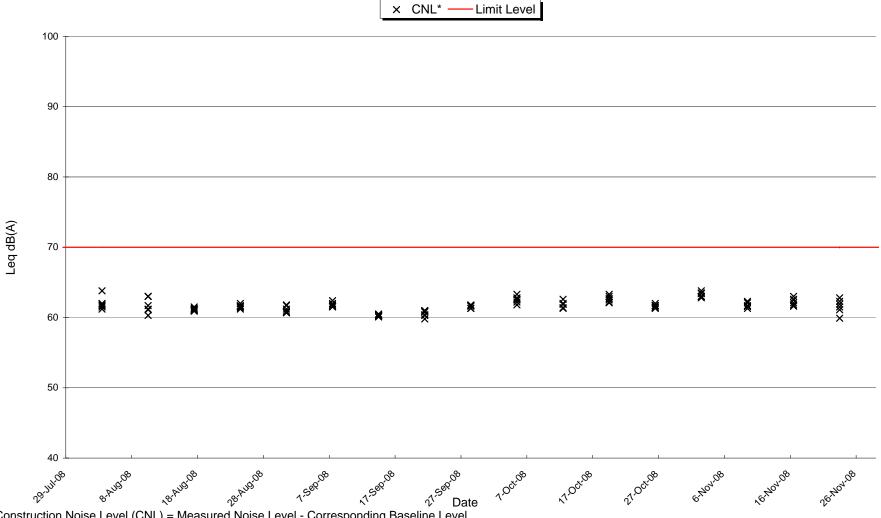
# Public Holiday Leq<sub>5</sub> (Construction Noise Level) at HKIVE 5th Floor Block D of Main Education Building (NSR2)

<sup>\*</sup> Construction Noise Level (CNL) = Measured Noise Level - Corresponding Baseline Level Please refer to Section 6.2 and Appendix M2 for more details.

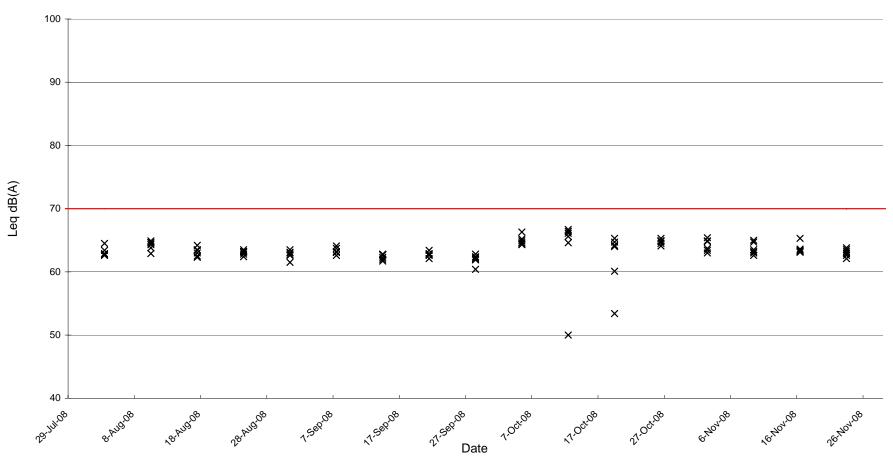
Public Holiday Leq<sub>5</sub> (Construction Noise Level) at Mayfair Gardens 1st Floor adjacent to swimming pool (NSR3)

<sup>\*</sup> Construction Noise Level (CNL) = Measured Noise Level - Corresponding Baseline Level Please refer to Section 6.2 and Appendix M2 for more details.

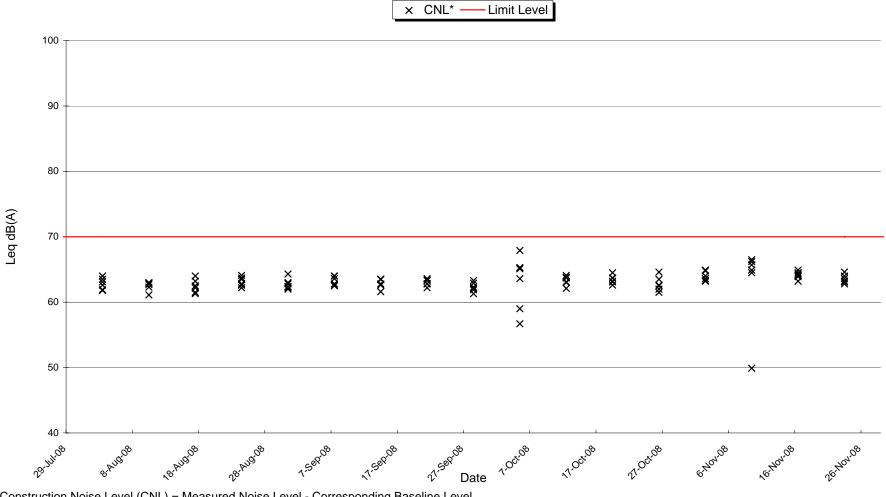
### Public Holiday Leq<sub>5</sub> (Construction Noise Level) at Cheung Ching Estate at roof of Ching Yung House (NSR4)

<sup>\*</sup> Construction Noise Level (CNL) = Measured Noise Level - Corresponding Baseline Level Please refer to Section 6.2 and Appendix M2 for more details.
