MONTHLY ENVIRONMENTAL MONITORING & AUDIT REPORT

Route 8
Between Tsing Yi and Cheung Sha Wan
Phase 2b East Tsing Yi Viaduct

*Monthly Environmental
Monitoring & Audit Report
(29th December 2008 - 28th January 2009)*

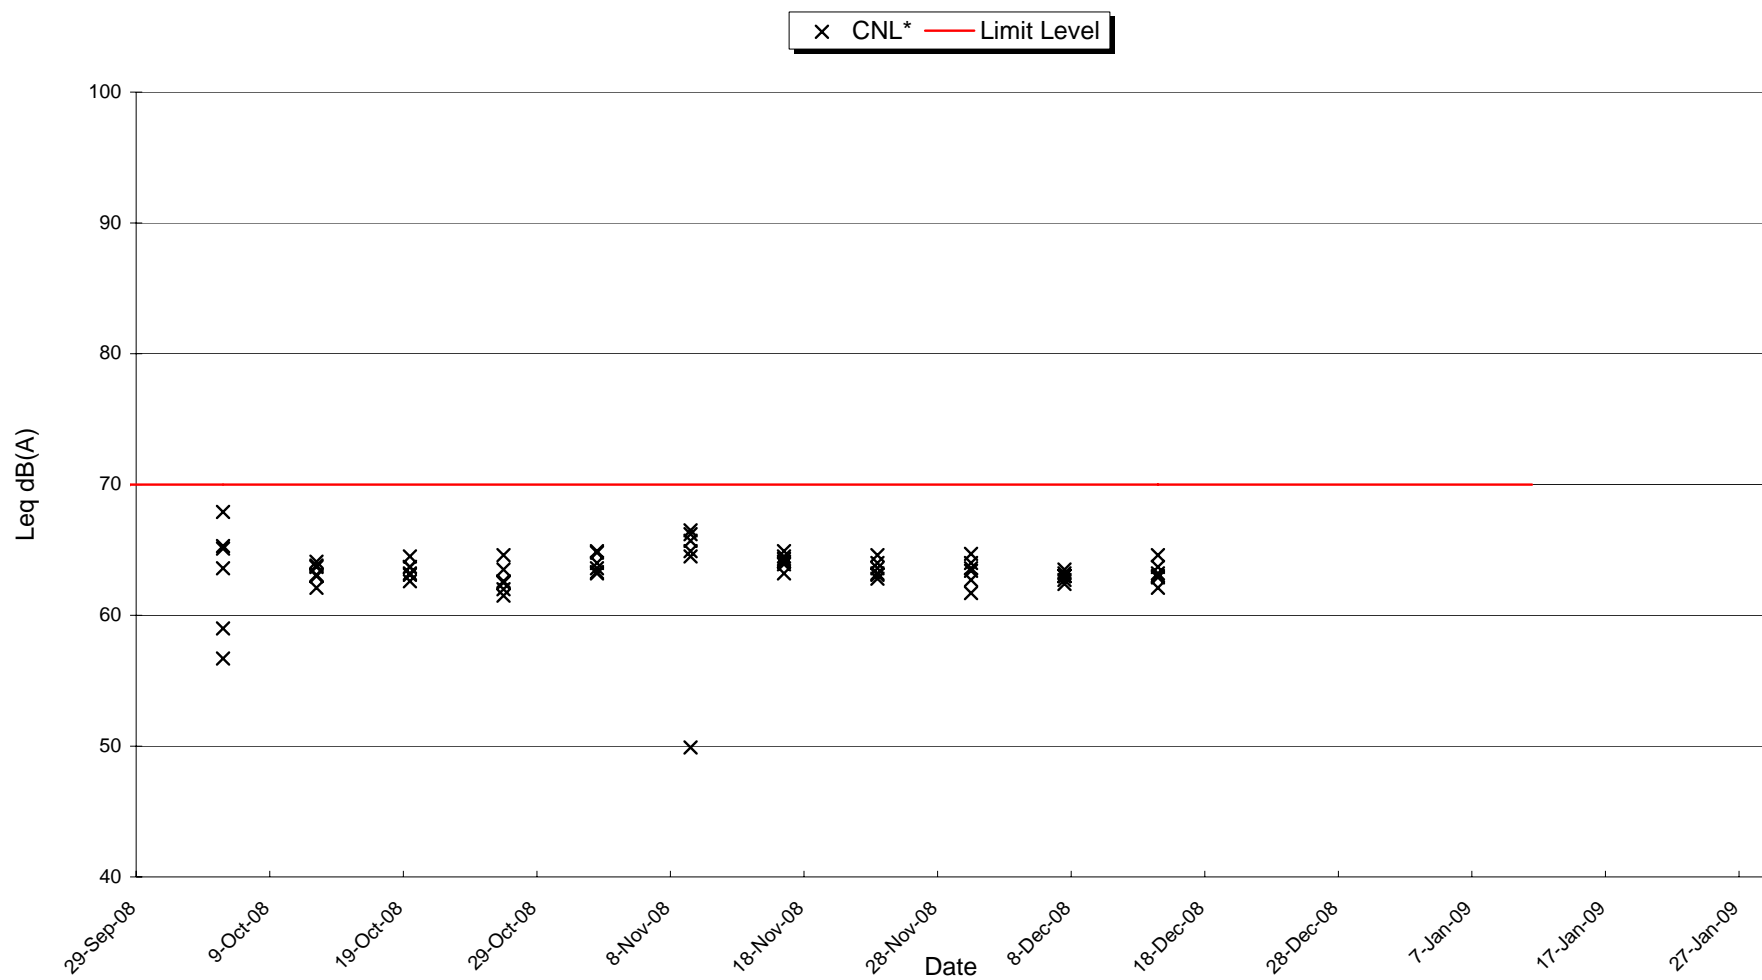
Public Holiday Leq₅ (Construction Noise Level) at Cheung Ching Estate at roof of Ching Yung House (NSR4)

* Construction Noise Level (CNL) = Measured Noise Level - Corresponding Baseline Level
 Please refer to Section 6.2 and Appendix M2 for more details.

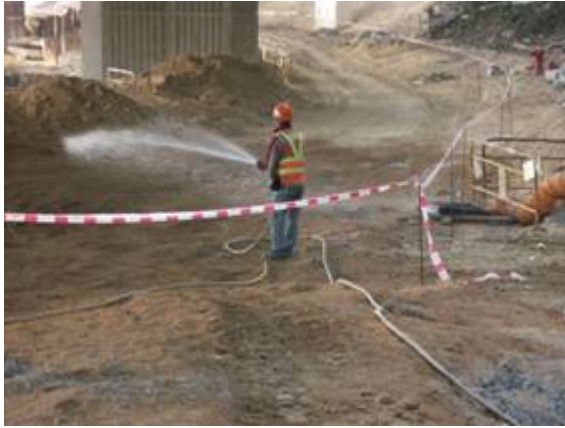
Photo 01 (area P2-SA6B (under the bridge C2/D2))

Item	Findings	DCBJV's Corrective and Preventive measures	Effectiveness of measures
1.	Open stockpiles of dusty material were observed at area P2-SA6B (under C2/D2 Bridge).	All open stockpiles of dusty materials shall be sprayed with sufficient water to maintain the entire surface moist.	Completed and closed. (Please refer to Appendix Q Photo 01).

- i. Open stockpiles of dusty material were observed at area P2-SA6B (under C2/D2 Bridge).

Corrective and Preventive Actions – All open stockpiles of dusty materials shall be sprayed with sufficient water to maintain the entire surface moist. Completed and closed. (Please refer to *Appendix Q* Photo 01).

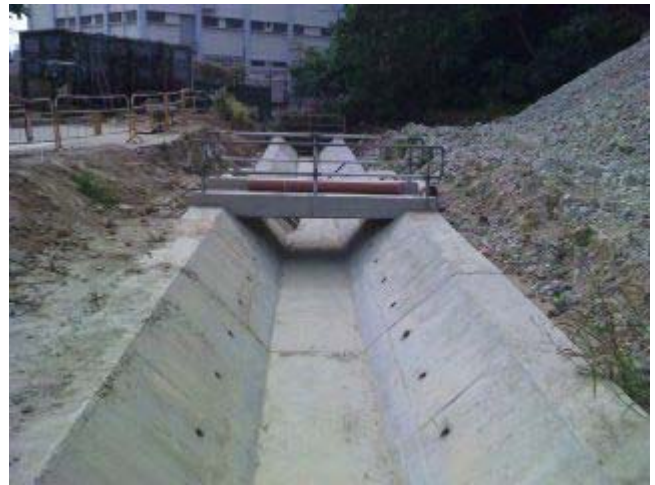
Photo 02 (area P2-SA6B (next to Gate 4))

2.	Silt and sand were accumulated in the trapezoidal channel adjacent to Gate 4 at area P2-SA6B.	All silt and sand had been removed from the trapezoidal channel and sandbags barrier have been deployed in the channel to prevent loose material entering into the storm drain.	Completed and closed. (Please refer to Appendix Q Photo 02).

Corrective and Preventive Actions – All silt and sand had been removed from the trapezoidal channel and sandbags barrier have been deployed in the channel to prevent loose material entering into the storm drain. Completed and closed. (Please refer to *Appendix Q* Photo 02).

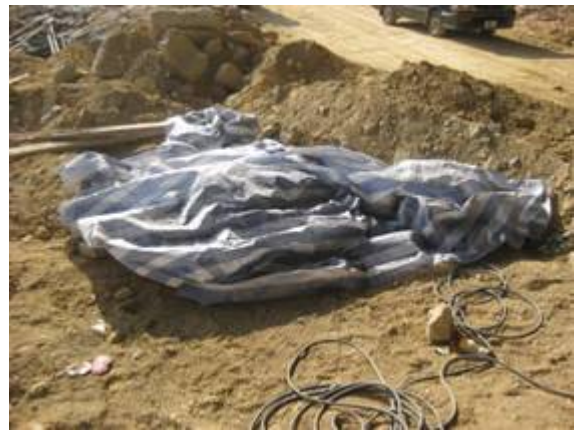
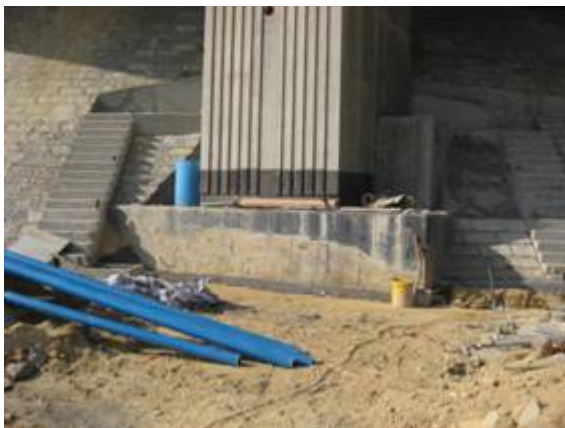
Photo 04 (area P2-SA6B (Old Tsing Yi Road))

4.	More than 20 bags of cement and used cement bags without proper dust control measures were observed at the area P2-SA6B (Old Tsing Yi Road).	All bagged cement had been removed from the concerned area and stored properly. Plastic bags and waste skip have been deployed on site for the temporary storage of used cement bags.	Completed and closed. (Please refer to Appendix Q Photo 04 & 05).

- iv. More than 20 bags of cement and used cement bags without proper dust control measures were observed at the area P2-SA6B (Old Tsing Yi Road).

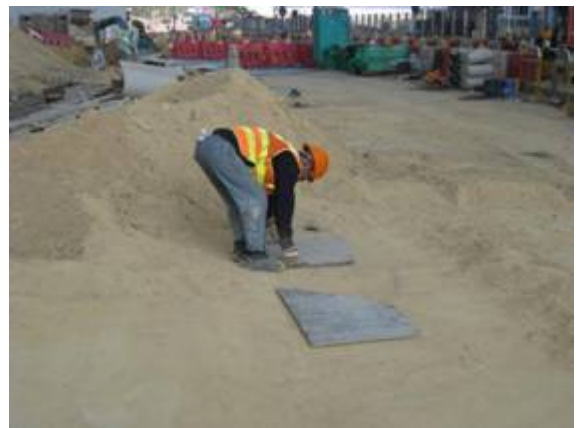
Photo 06 (area P2-SA6B (Tsing Yi Road))

5.	DCBJV was reminded to maintain and protect the existing gullies along the Tsing Yi Road properly.	The gullies had been cleaned up immediately after the site audit. In addition, geo-textile has been deployed to protect the existing gullies in order to avoid sub-standard effluent or loose material entering into the storm drain.	Completed and closed. (Please refer to Appendix Q Photo 06).

Corrective and Preventive Actions – The gullies had been cleaned up immediately after the site audit. In addition, geo-textile has been deployed to protect the existing gullies in order to avoid sub-standard effluent or loose material entering into the storm drain. Completed and closed. (Please refer to *Appendix Q* Photo 06).
