MONTHLY ENVIRONMENTAL MONITORING & AUDIT REPORT

Highways Department

Route 8  
Between Tsing Yi and Cheung Sha Wan  
Phase 2b East Tsing Yi Viaduct

*Monthly Environmental  
Monitoring & Audit Report  
(1<sup>st</sup> March 2009 - 28<sup>th</sup> March 2009)*

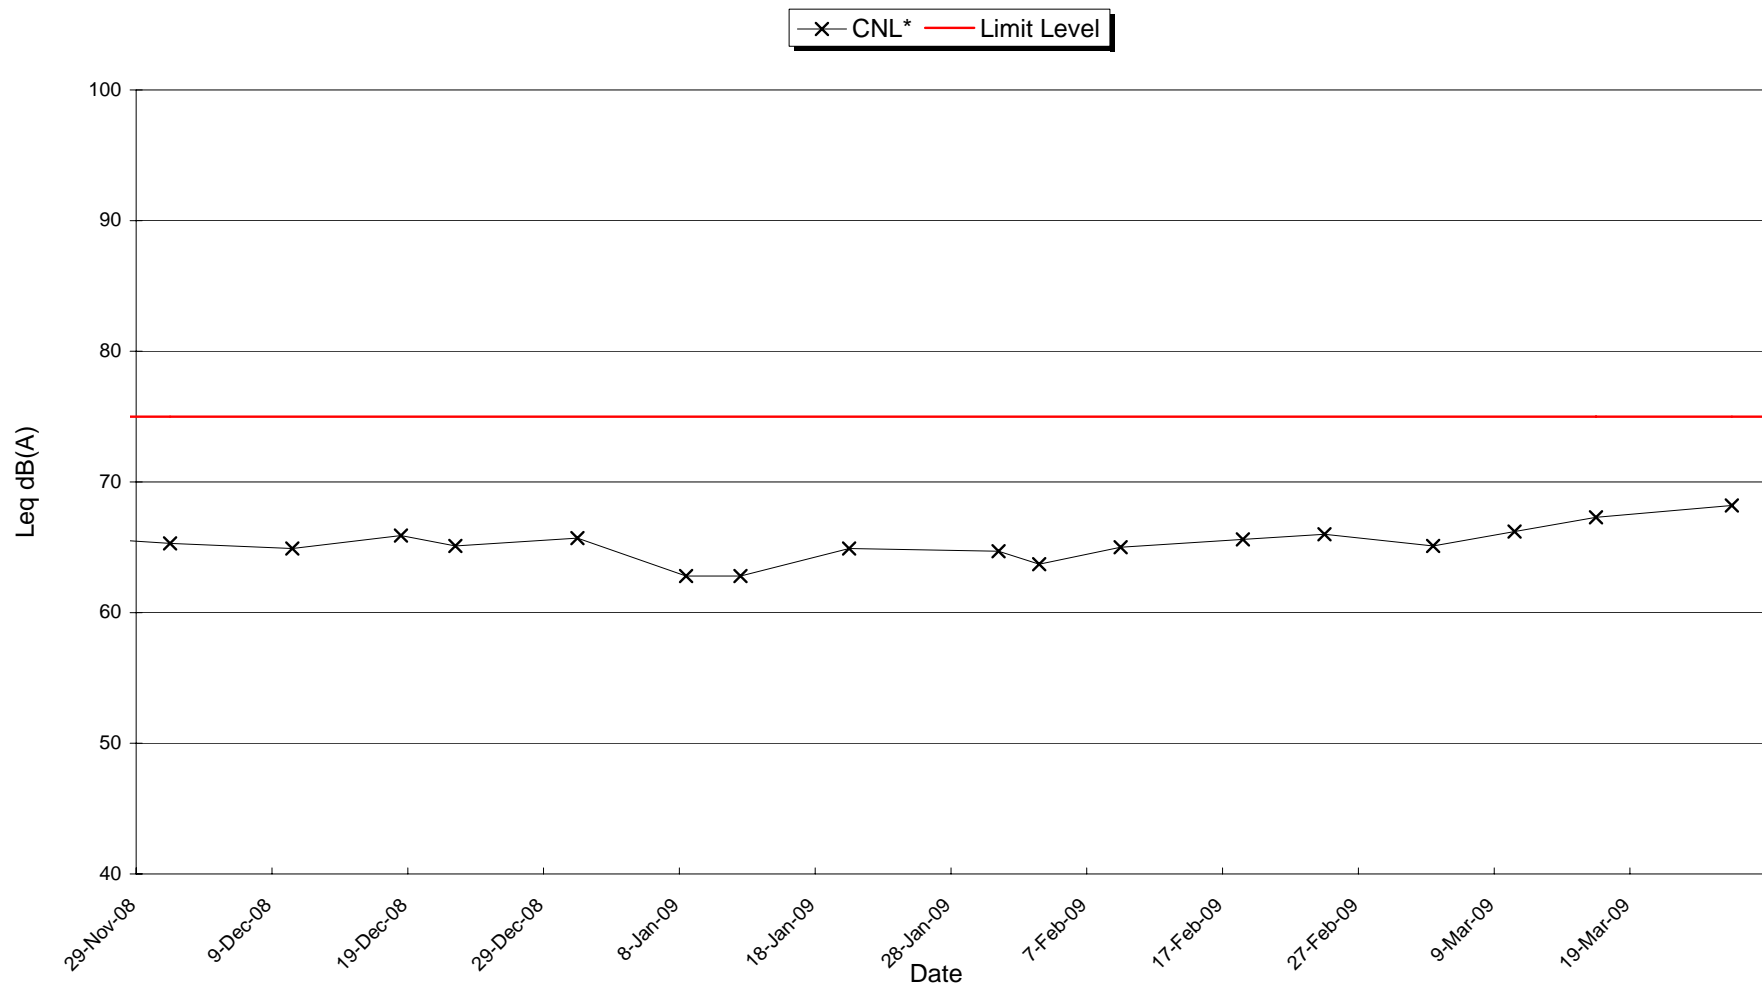
### Day-time Leq<sub>30</sub> (Construction Noise Level) at Mayfair Gardens 1st floor adjacent to swimming pool (NSR3)

\* Construction Noise Level (CNL) = Measured Noise Level - Corresponding Baseline Level  
Please refer to Section 6.2 and Appendix M1 for more details.
