**CONTRACT NO. CV/2009/02
HANDLING OF SURPLUS PUBLIC FILL**

TUEN MUN 38 FILL BANK

**QUARTERLY EM&A SUMMARY REPORT
NO.1**

**(FROM 14 DECEMBER 2009 TO 28
FEBRUARY 2010)**

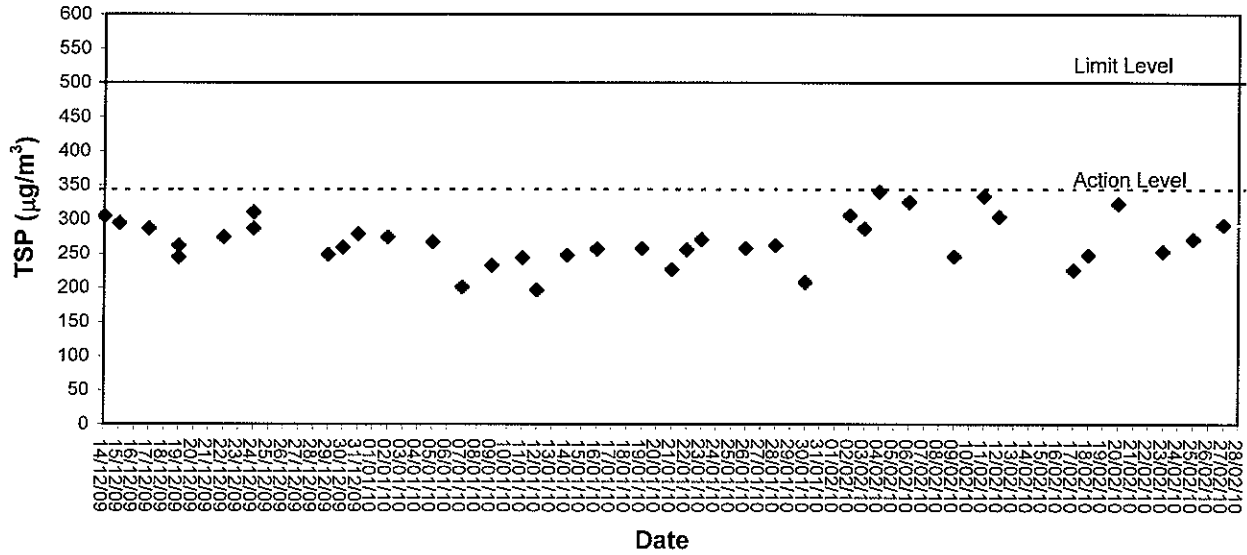
1-hour TSP level at TM-A1

During the reporting quarter, no exceedances of Action and Limit levels were recorded for 24-hr and 1-hr TSP monitoring. The air quality during the operation hours of the Fill Bank was considered acceptable.

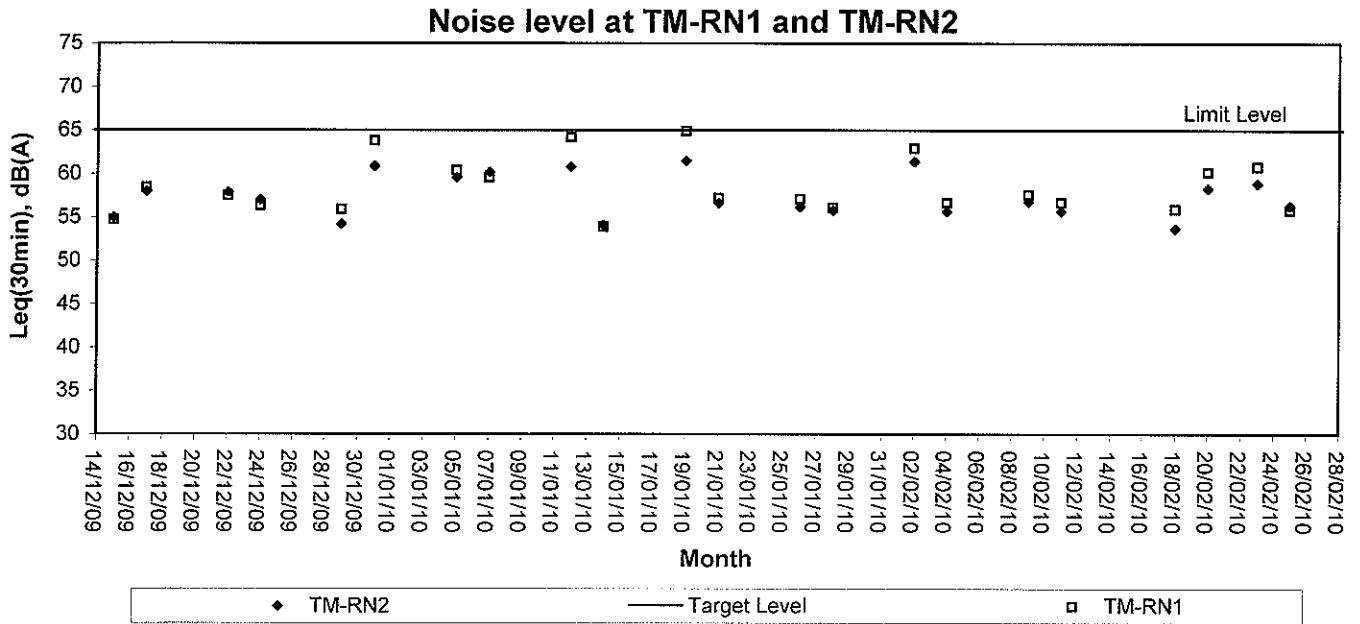
Noise Monitoring (Day-time)

No exceedances were recorded in this reporting quarter.

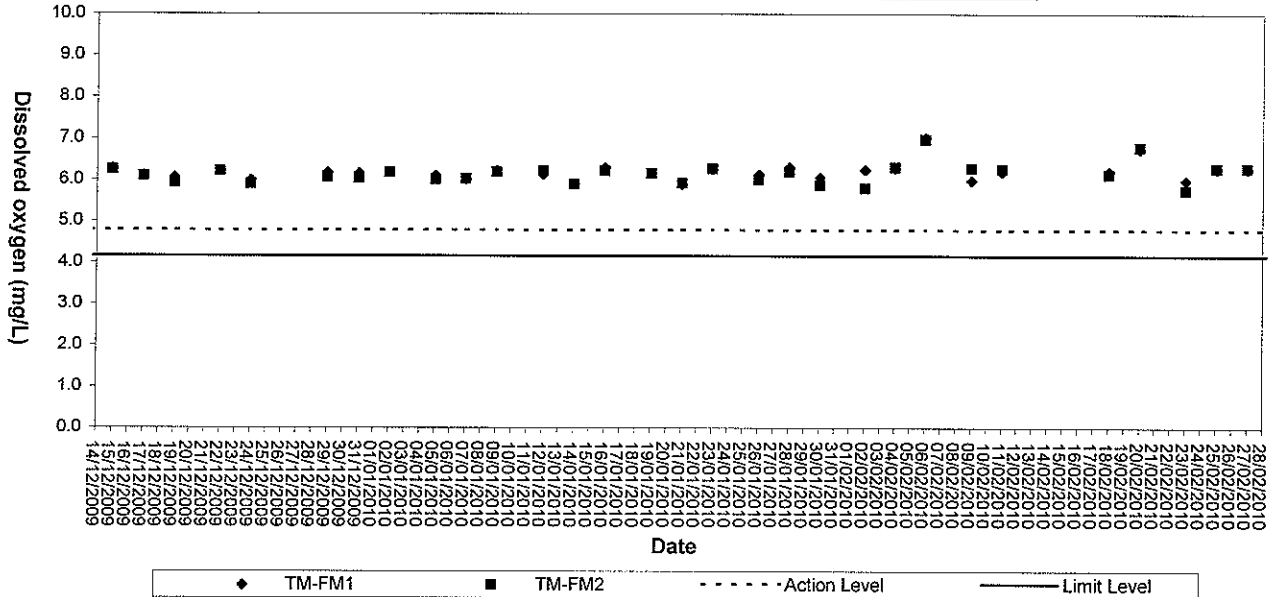
Dissolved Oxygen (Surface & Middle) at Mid-Flood Tide

No exceedances of all marine water quality monitoring parameters were recorded in this quarter.

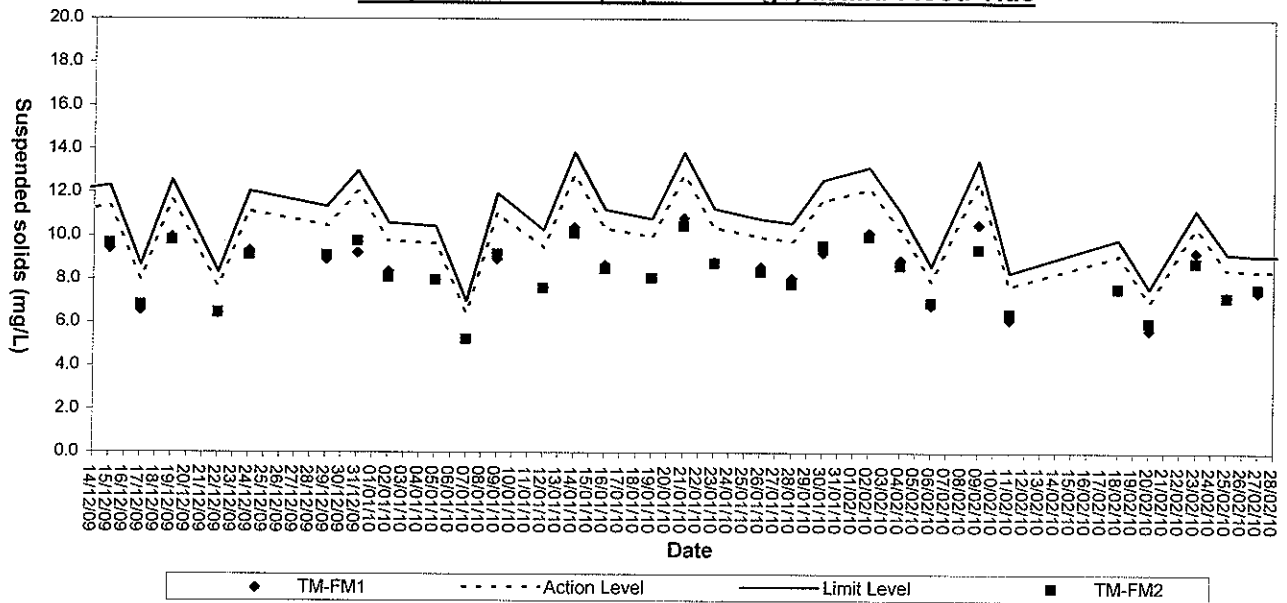
Suspended solids (Depth-average) at Mid-Flood Tide

A comparison between the quarterly mean/median of SS and the 1.3 times of the baseline mean was made for each tide at each station. The statistical analysis results are given in Appendix I and it shows that the quarterly mean of SS during impact monitoring was found greater than 130% of the baseline mean. Since there is no significant difference between the control and impact monitoring stations in SS level, higher level in SS level is not project related. Monitoring stations with significant difference ($p < 0.05$) is summarized in Table 4.3.

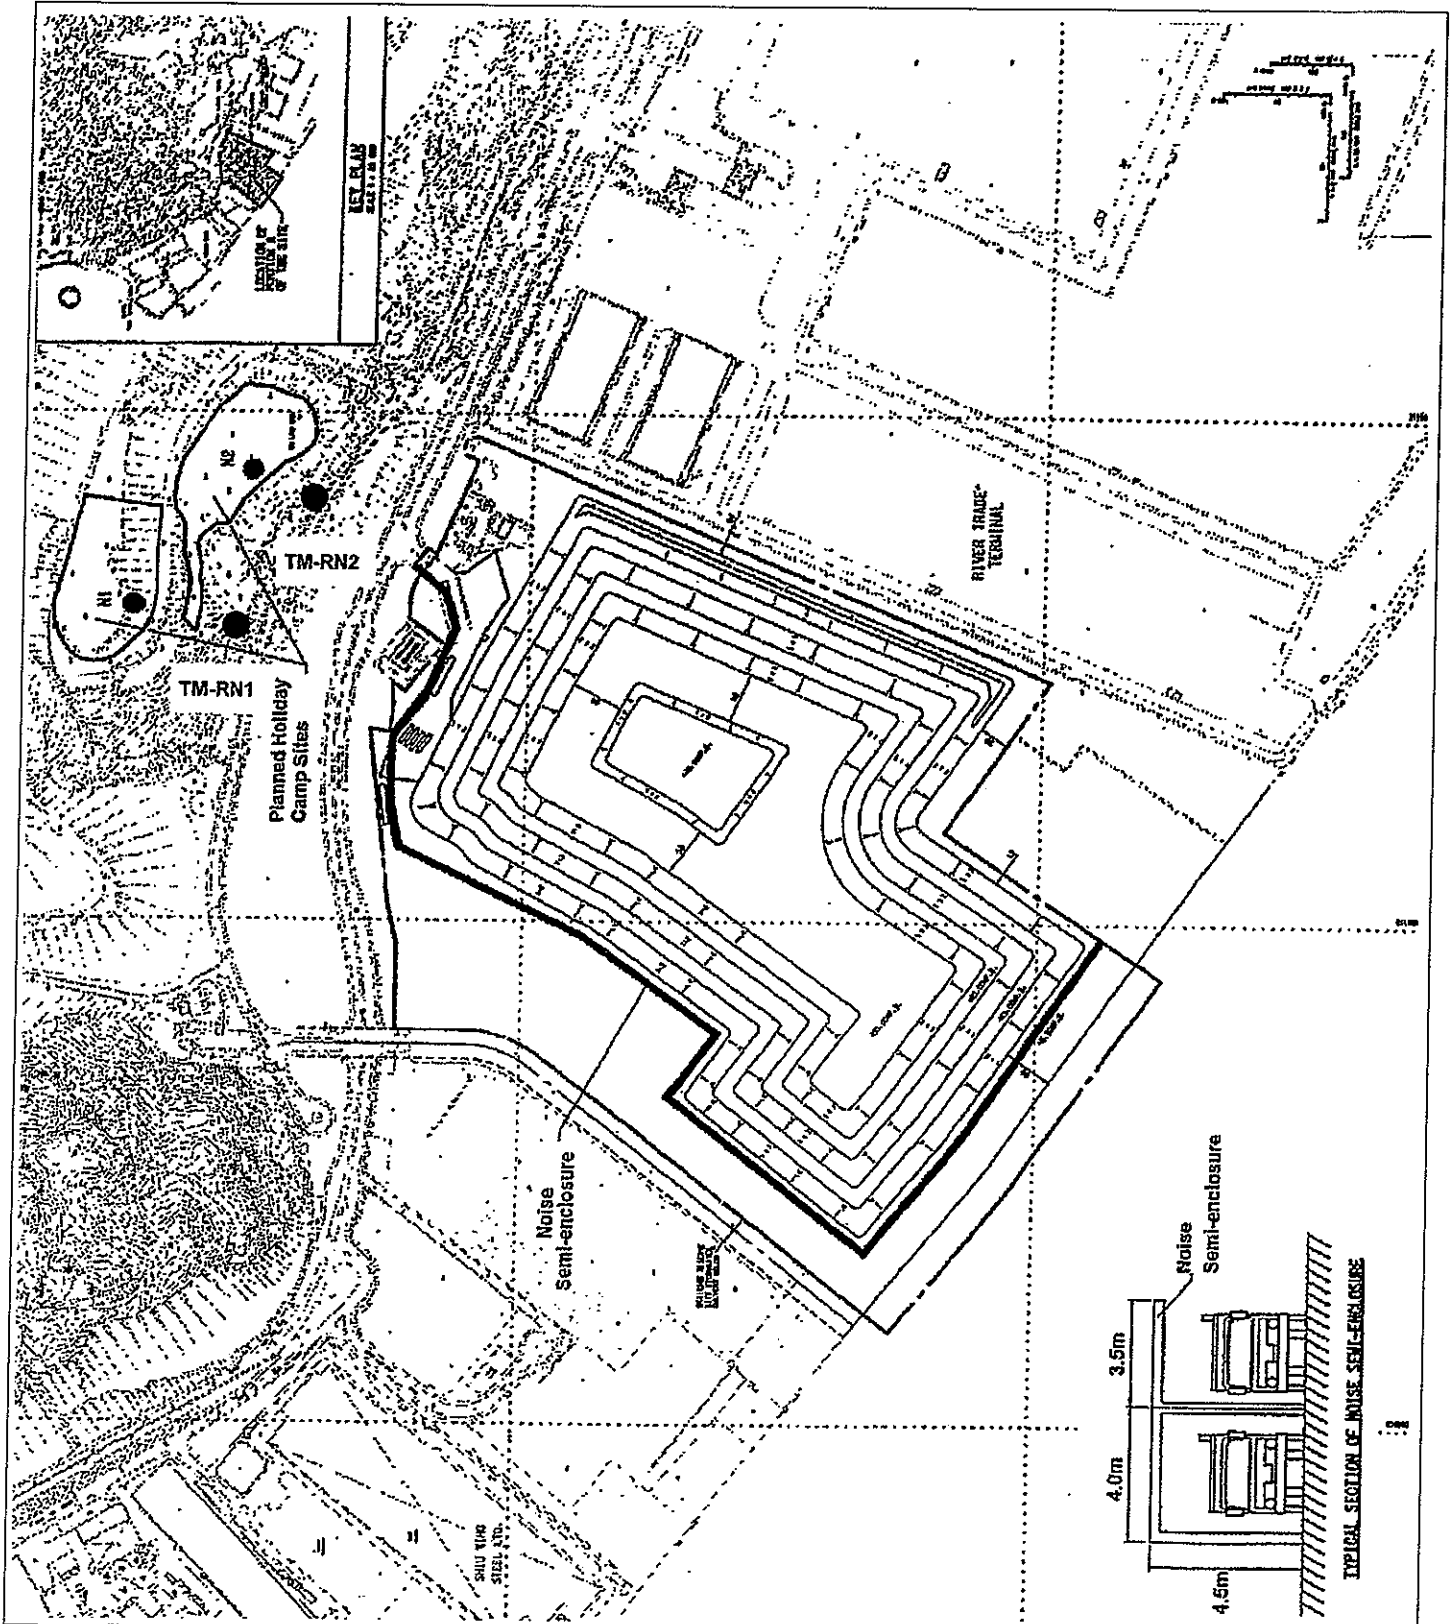
Figure 3
 Locations of Noise Quality Monitoring Stations –
 Tuen Mun Area 38 Fill Bank

Since Lands Dept did not approve to carry out noise monitoring at their own area where the noise monitoring stations TM-N1 and TM-N2 located due to the security, noise monitoring carried out at two noise monitoring stations TM-RN1 and TM-RN2 (refer to the figure attached) temporarily from 18 December 2007 and before Lands Department's approval.

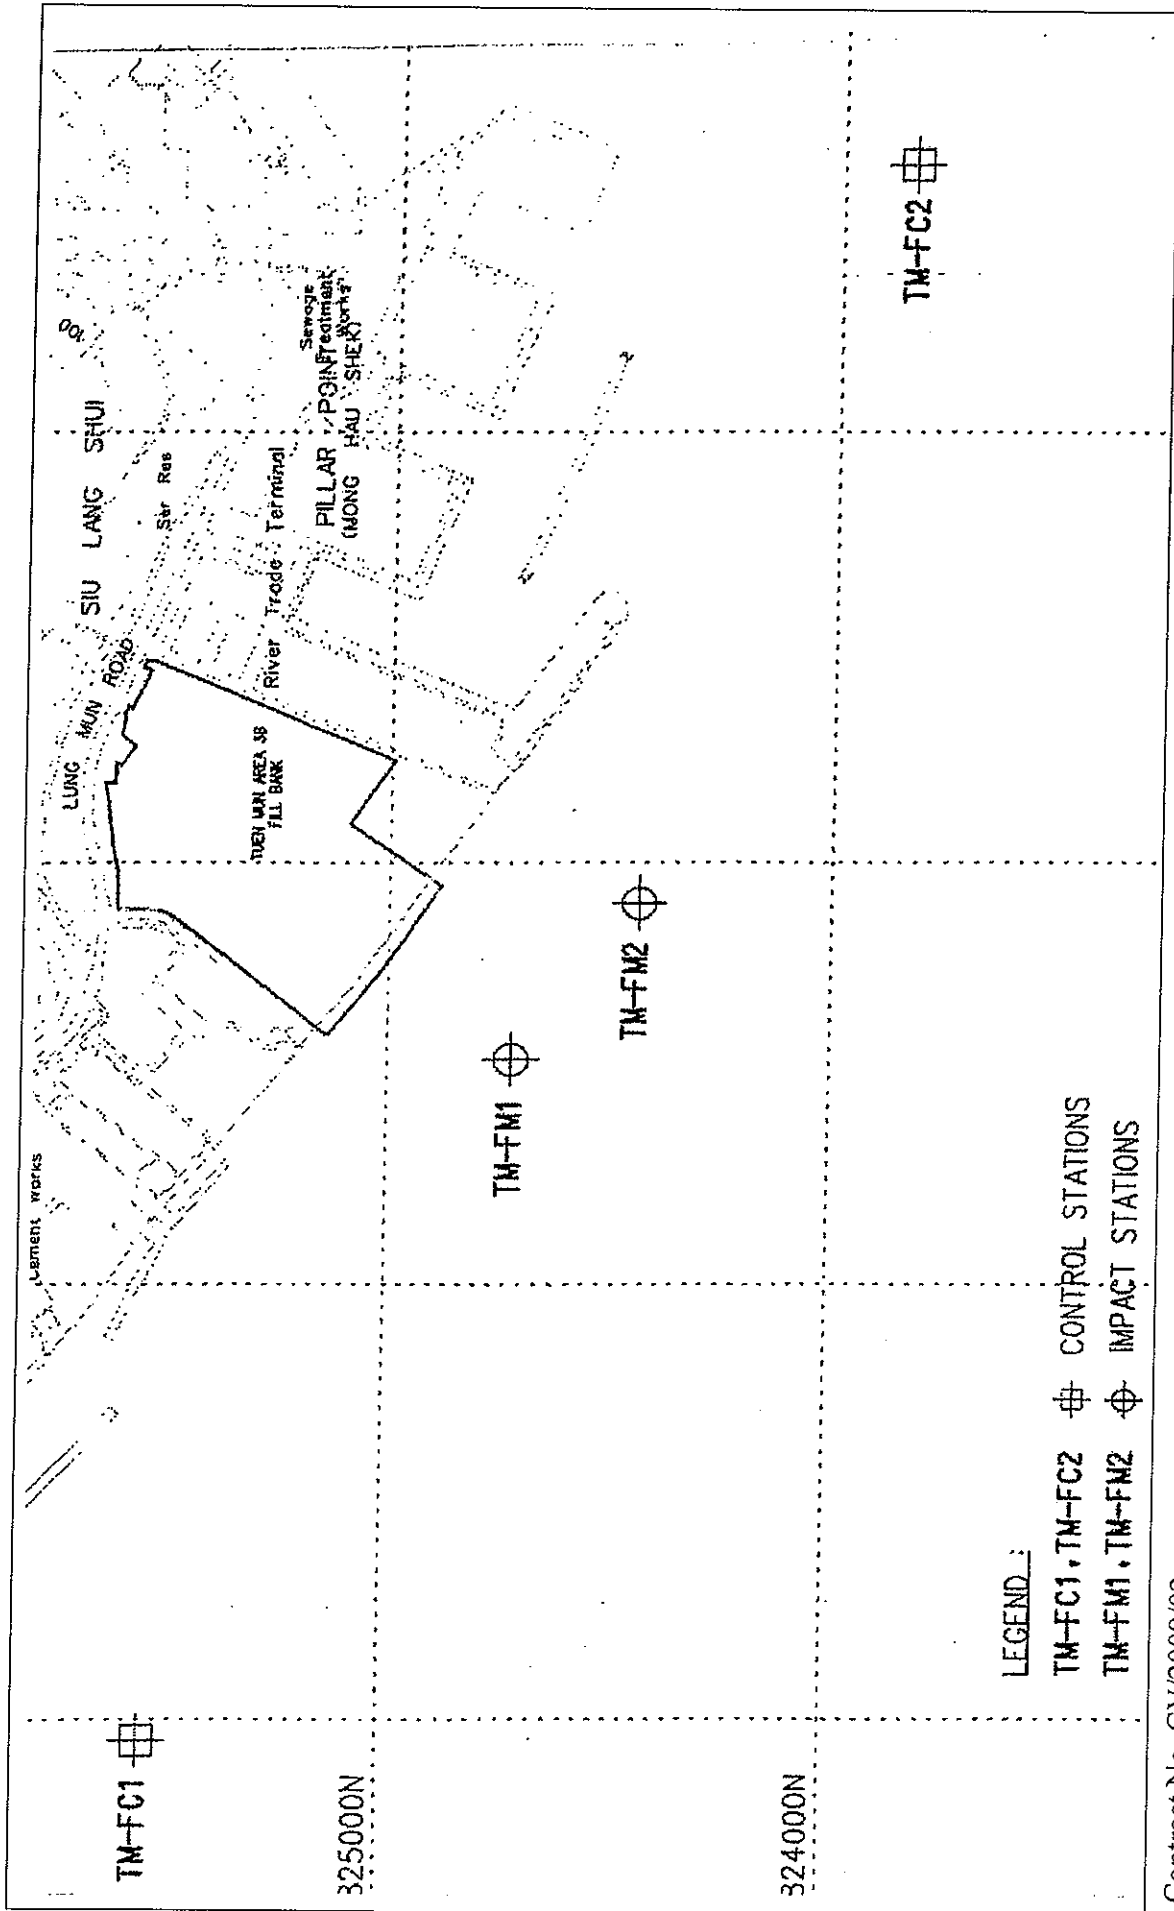
Figure 2
 Locations of Water Quality Monitoring Station –
 Tuén Mun Area 38 Fill Bank

In accordance with the Project Profile, impact marine water quality monitoring was conducted at two control monitoring stations (TM-FC1 and TM-FC2) and two impact monitoring stations (TM-FM1 and TM-FM2) in this quarter.
