**TEST REPORT**

**China Harbour – China State Joint Venture**

**CONTRACT NO. CV/2009/02**  
**HANDLING OF SURPLUS PUBLIC FILL**  
**TUEN MUN AREA 38 FILL BANK**  
**MONTHLY EM&A REPORT NO.38**  
**(JANUARY 2013)**

Report No.: ENA30497

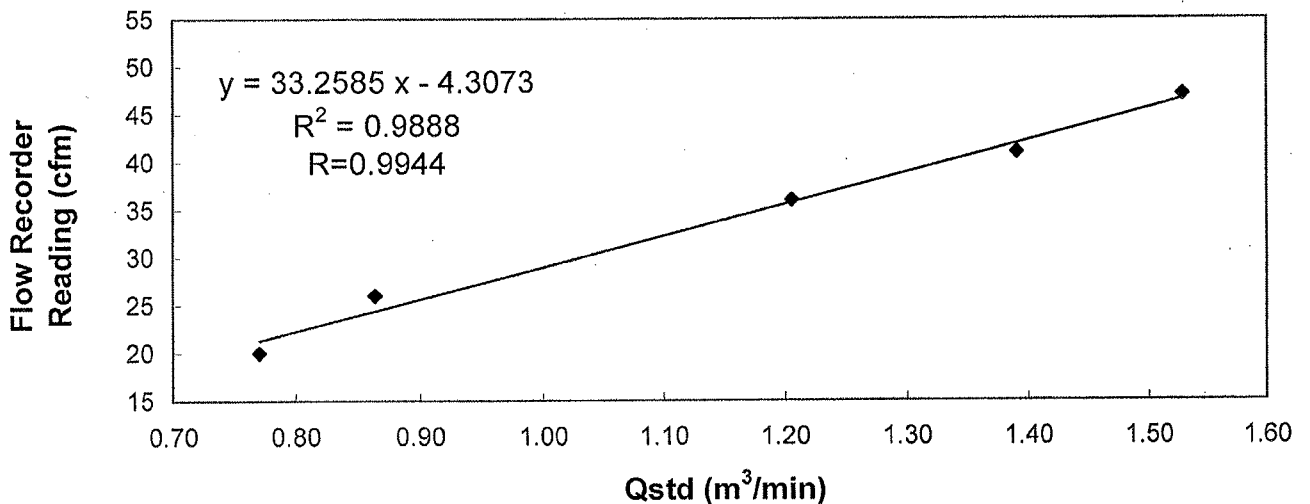
**Sampler 9795 Calibration Curve**  
Site: Tuen Mun (A1)

Flow recorder reading (cfm)	47	41	36	26	20
Qstd (Actual flow rate, m <sup>3</sup> /min)	1.53	1.39	1.21	0.86	0.77
Pressure :	757.56 mm Hg			Temp. :	294 K

Acceptance Criteria : Correlation coefficient (r) of the calibration curve greater than 0.990 after a 5-point calibration

The high volume sampler complies\* / does not comply\* with the specified requirements and is deemed acceptable\*/ unacceptable\* for use.

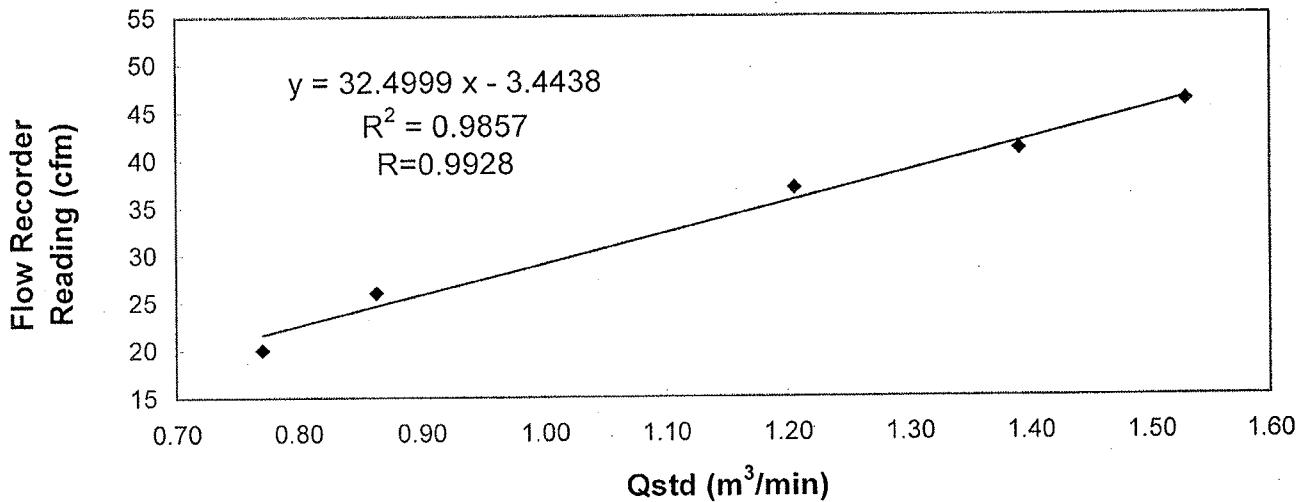
**Sampler 9795 Calibration Curve**  
Site: Tuen Mun (A1)

Results	Flow recorder reading (cfm)	46	41	37	26	20
	Qstd (Actual flow rate, m <sup>3</sup> /min)	1.53	1.39	1.21	0.86	0.77
	Pressure : 760.56 mm Hg	Temp. : 295 K

Acceptance Criteria : Correlation coefficient (r) of the calibration curve greater than 0.990 after a 5-point calibration

The high volume sampler complies\* / does not comply\* with the specified requirements and is deemed acceptable\* / unacceptable\* for use.

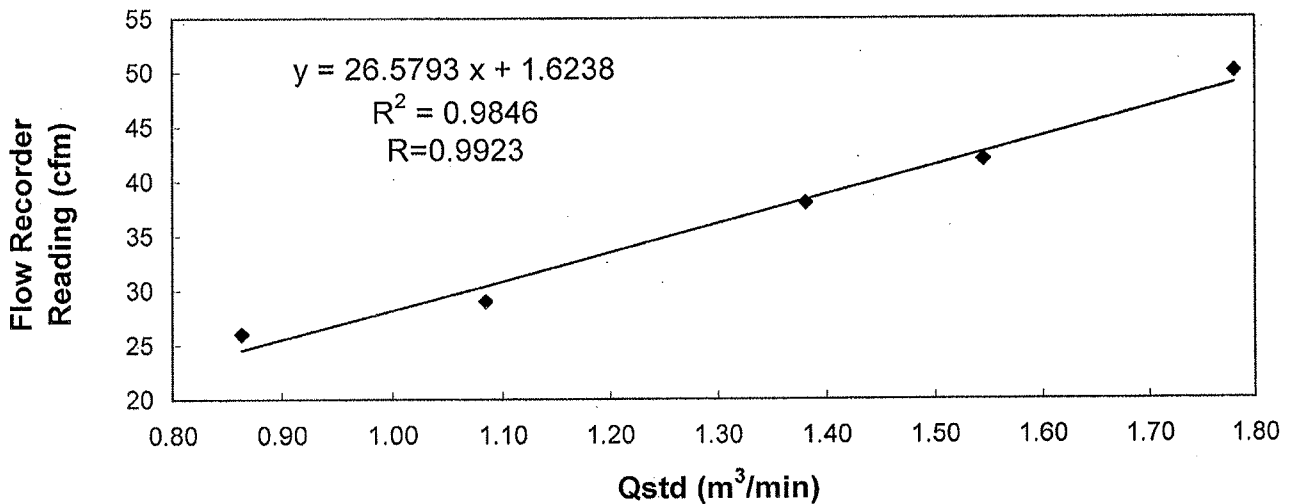
**Sampler 9864 Calibration Curve  
Site: Tuen Mun (A2)**

Results	Flow recorder reading (cfm)	50	42	38	29	26
	Qstd (Actual flow rate, m <sup>3</sup> /min)	1.78	1.55	1.38	1.08	0.86
	Pressure :	757.56 mm Hg		Temp. :	294 K

Acceptance Criteria : Correlation coefficient (r) of the calibration curve greater than 0.990 after a 5-point calibration

The high volume sampler complies\* / does not comply\* with the specified requirements and is deemed acceptable\* / unacceptable\* for use.

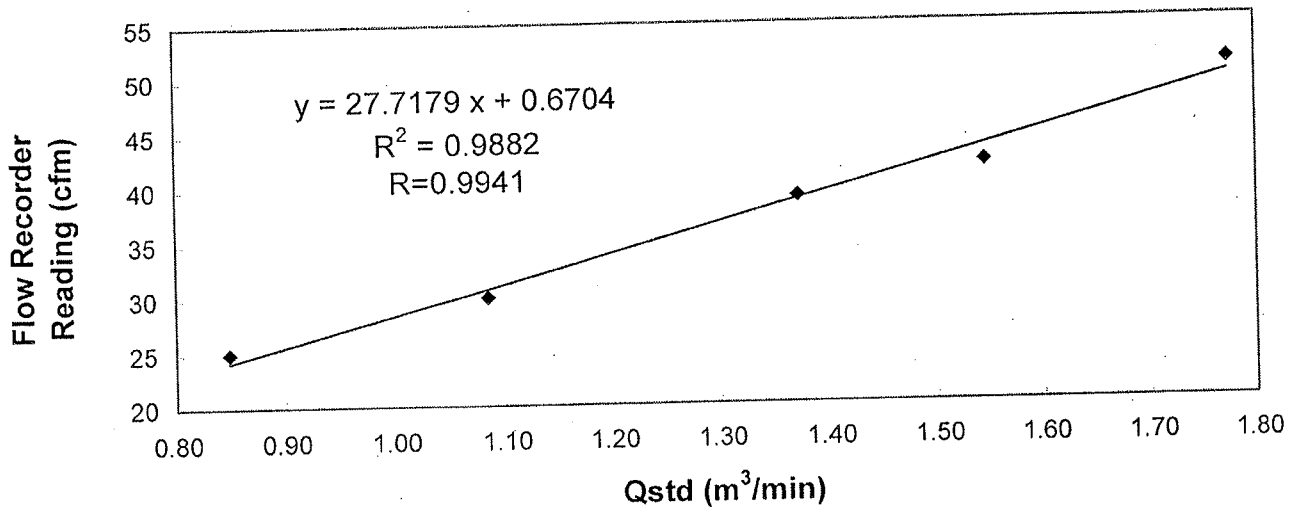
**Sampler 9864 Calibration Curve**  
Site: Tuen Mun (A2)

Results	Flow recorder reading (cfm)	51	42	39	30	25
	Qstd (Actual flow rate, m <sup>3</sup> /min)	1.77	1.55	1.37	1.08	0.85
Pressure :		760.56 mm Hg		Temp. :		295 K

Acceptance Criteria : Correlation coefficient (r) of the calibration curve greater than 0.990 after a 5-point calibration

The high volume sampler complies\* / ~~does not comply\*~~ with the specified requirements and is deemed acceptable\* / unacceptable\* for use.

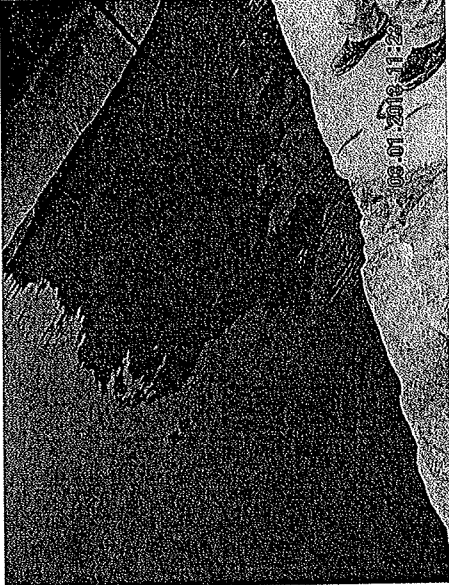
<p>Photo 130103_003 (Discharge point of main drainage channel) (improved)</p>

<b>Date</b>	<b>Key Findings</b>	<b>Action(s) Taken recommended by IEC</b>	<b>Action(s) Taken by the Contractor during the site audit</b>	<b>Rectification Status by IEC</b>
03 January 2013	Muddy water was noted discharged to seafront from the discharged point of main drainage channel near tipping hall No.3. (Previous item)	To divert the muddy water to appropriate treatment facilities before discharge.	No muddy water was noted discharged to seafront from the discharged point of main drainage channel near tipping hall No.3.	Closed
	Skirt curtain for a generator at weight bridge near tipping hall No.2 was covered the drip trip improperly. (New item)	To cover drip tray with skirt curtain properly.	---	Follow-up
	Fill materials were observed accumulated on the concrete embankment near tipping hall No.3. (New item)	To clean up the fill materials as soon as each unloading activity is completed to avoid the fill materials from being washed into the sea.	---	Follow-up

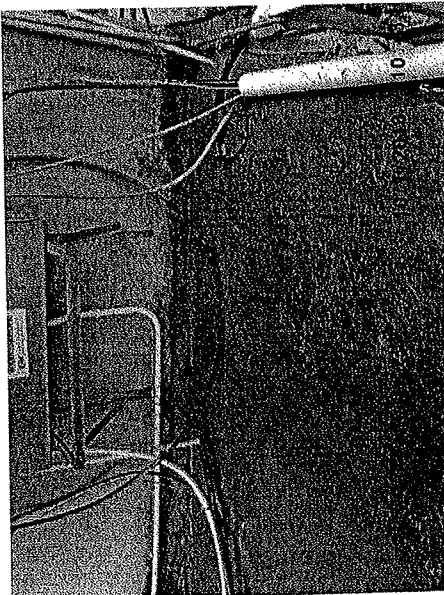
<p>Photo 130110_001 (Weight bridge near site entrance) (Improved)</p>

10 January 2013	Standing water and mud were found accumulated under the weight bridge near site entrance. (Previous item)	To clean up the standing water and mud accumulated.	Standing water and mud accumulated under the weight bridge near site entrance were cleaned up.	Closed
	Skirt curtain for a generator at weight bridge near tipping hall No.2 was covered the drip trip improperly. (Previous item)	To cover drip tray with skirt curtain properly.	Skirt curtain for a generator at weight bridge near tipping hall No.2 was covered the drip trip properly.	Closed
	Fill materials were observed accumulated on the concrete embankment near tipping hall No.3. (Previous item)	To clean up the fill materials as soon as each unloading activity is completed to avoid the fill materials from being washed into the sea.	Fill materials accumulated on the concrete embankment near tipping hall No.3 were cleared.	Closed

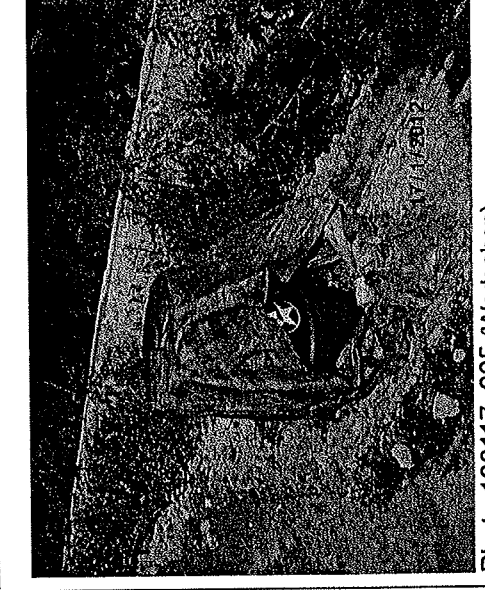
Photo 130117\_005 (Work shop)

<b>Date</b>	<b>Key Findings</b>	<b>Action(s) Taken recommended by IEC</b>	<b>Action(s) Taken by the Contractor during the site audit</b>	<b>Rectification Status by IEC</b>
17 January 2013	Oil leakage was noted from a repairing machine at work shop. (Previous item)	To clean up the leaked oil and contaminated material as chemical waste and provide impermeable sheets during repairing and maintenance works.	Tarpaulin sheet was provided and no oil leakage was noted from a repairing machine at work shop.	Closed
	Oil leakage was noted from a repairing machine near chemical waste storage area. (New item)	To clean up the leaked oil and contaminated material as chemical waste and provide impermeable sheets during repairing and maintenance works.	---	Follow-up
	A 200L oil drum was discarded near work shop. (New item)	To store the oil drum at appropriate chemical storage area or provide an appropriate drip tray.	---	Follow-up

The Contractor should provide sufficient preventive measures during equipment maintenance works so as to avoid oil leakage on the ground. In the event of any oil leakage, the Contractor should clean up the polluted soil and handle all the materials used for this cleaning works as chemical waste.

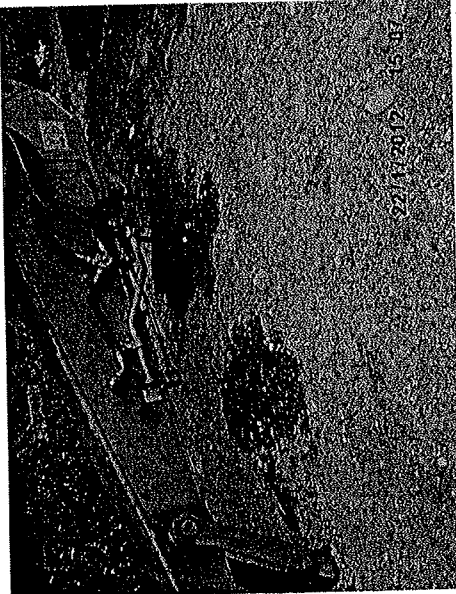
<p>22/11/2012 15:05 Photo 130122_001 (Chemical waste storage area)</p>

22 January 2013	Oil leakage was noted from a repairing machine near chemical waste storage area. (Previous item)	To clean up the leaked oil and contaminated material as chemical waste and provide impermeable sheets during repairing and maintenance works.	---	Follow-up
	A 200L oil drum was discarded near work shop. (Previous item)	To store the oil drum at appropriate chemical storage area or provide an appropriate drip tray.	The 200L oil drum discarded near work shop was collected.	Closed
	C&D waste (e.g. tyre, used tarpaulin sheets and idle chemical buckets) was discarded on beside the haul road near ECO Park. (New item)	To collect and store / disposed of the waste properly.	---	Follow-up
29 January 2013	Oil leakage was noted from a repairing machine near chemical waste storage area. (Previous item)	To clean up the leaked oil and contaminated material as chemical waste and provide impermeable sheets during repairing and maintenance works.	No oil leakage was noted from a repairing machine near chemical waste storage area, and tarpaulin sheet and oil bucket were provided for the maintenance and repairing work.	Closed
