## MONTHLY ENVIRONMENTAL MONITORING & AUDIT REPORT

Reprovisioning and Upgrading of Salt Water Service Reservoirs in Western District for Water Supplies Department: *Eighteenth Monthly Environmental Monitoring and Audit Report*

February 2009

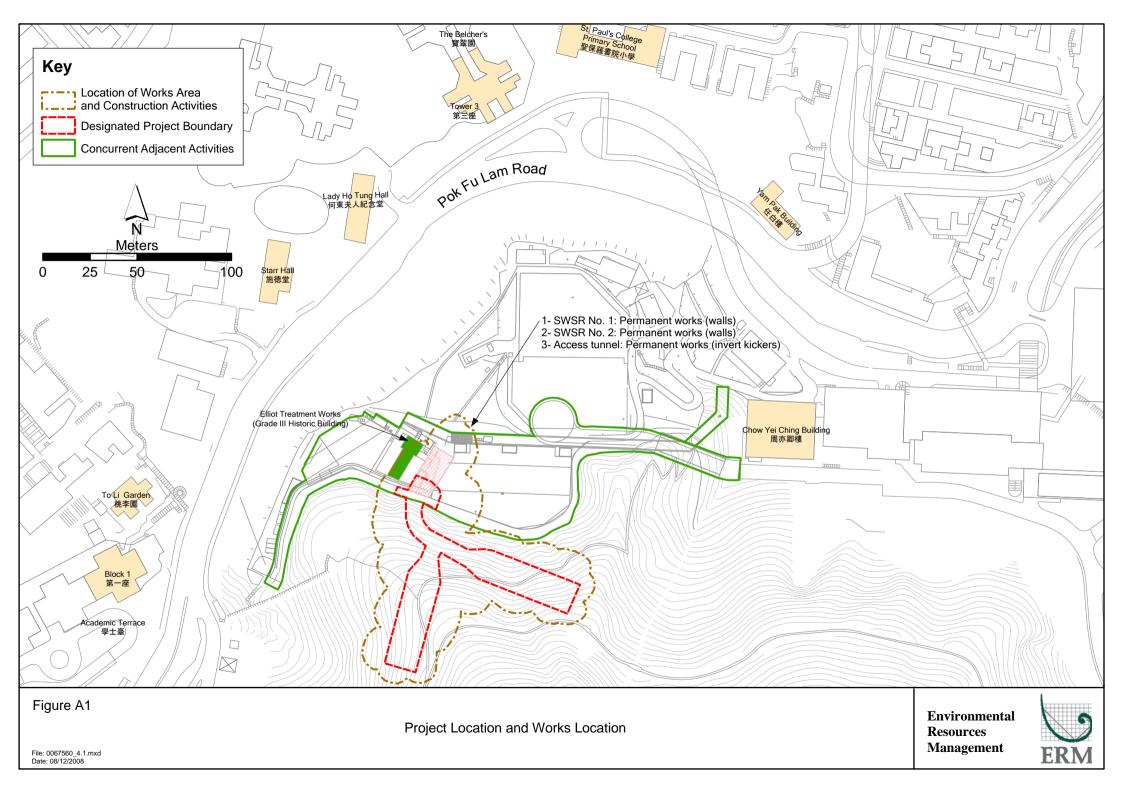
Locations of Works Areas and Construction Activities during the Reporting Period, and updated Construction Programme

The major construction works undertaken during this reporting period were permanent works (walls) for SWSR Nos.1 and 2; and permanent works (invert kickers) for access tunnel.

A summary of the major construction activities undertaken in this reporting period is shown in *Table 2.1*. The locations of the construction activities are shown in *Annex A*.

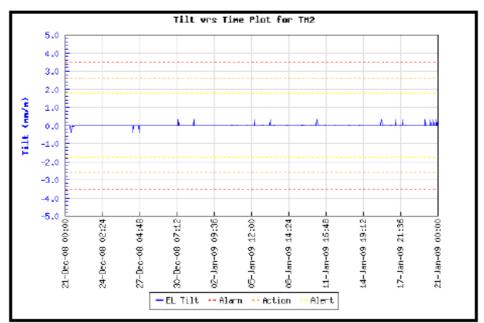
Initial Level: 92.664 mPD

Remark : Radio Transmitter Serial No. 50348; +ve Reading => Rotation towards West South

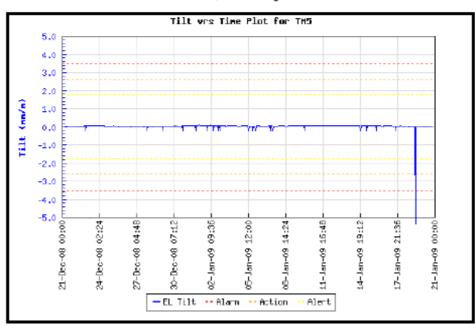
Initial Level: 92.714 mPD

Remark : Radio Transmitter Serial No. 50194; +ve Reading => Rotation towards West South

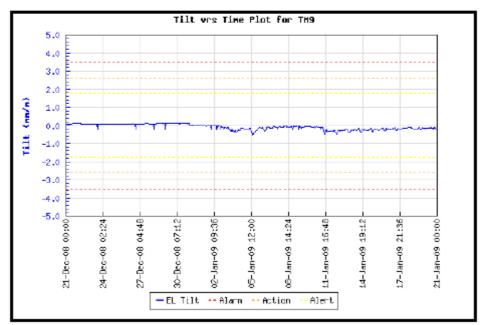
Initial Level: 92.709 mPD

Remark : Radio Transmitter Serial No. 50284; +ve Reading => Rotation towards North East

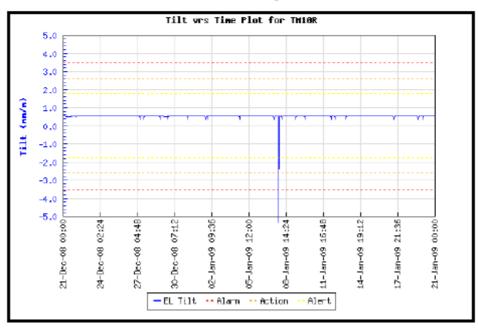
Initial Level: 92.744 mPD

Remark : Radio Transmitter Serial No. 50270; +ve Reading => Rotation towards West North

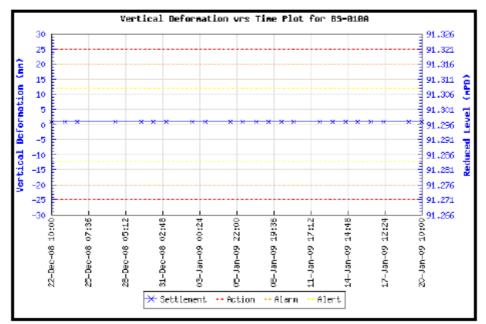
Instrument ID : BS-010A Easting : 831808.247 Location : Valve House Remark : Type : Building Settlement Marker Type DMP5 Northing : 816016.001 Initial Level : 91.296 mPD

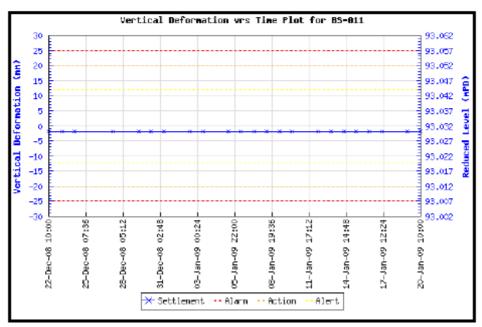
Instrument ID : BS-011 Easting : 831795.830 Location : Valve House Remark : Type : Building Settlement Marker Type DMP5 Northing : 815997.133 Initial Level : 93.032 mPD

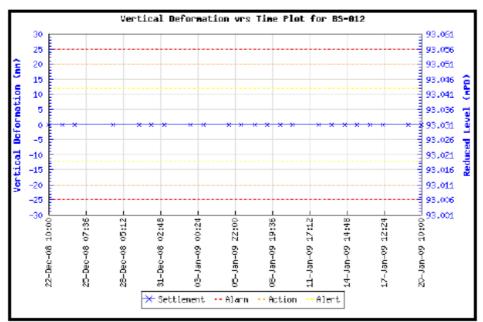
Instrument ID : BS-012 Easting: 831796.239 Location : Valve House Remark :

Type : Building Settlement Marker Type DMP5 Northing : 816000.503 Initial Level: 93.031 mPD

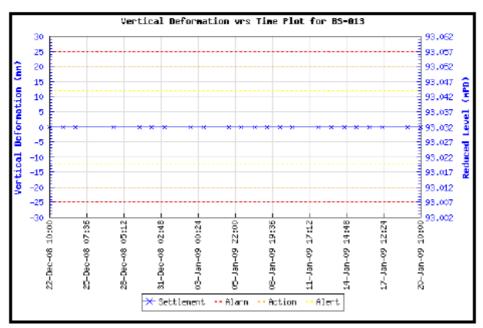
Instrument ID : BS-013 Easting: 831800.605 Location : Valve House Remark :

Northing: 816020.664 Initial Level: 93.032 mPD
