MONTHLY ENVIRONMENTAL MONITORING & AUDIT REPORT

Reprovisioning and Upgrading of Salt Water Service Reservoirs in Western District for Water Supplies Department: *Twenty-third Monthly Environmental Monitoring and Audit Report*

July 2009

Environmental Resources Management

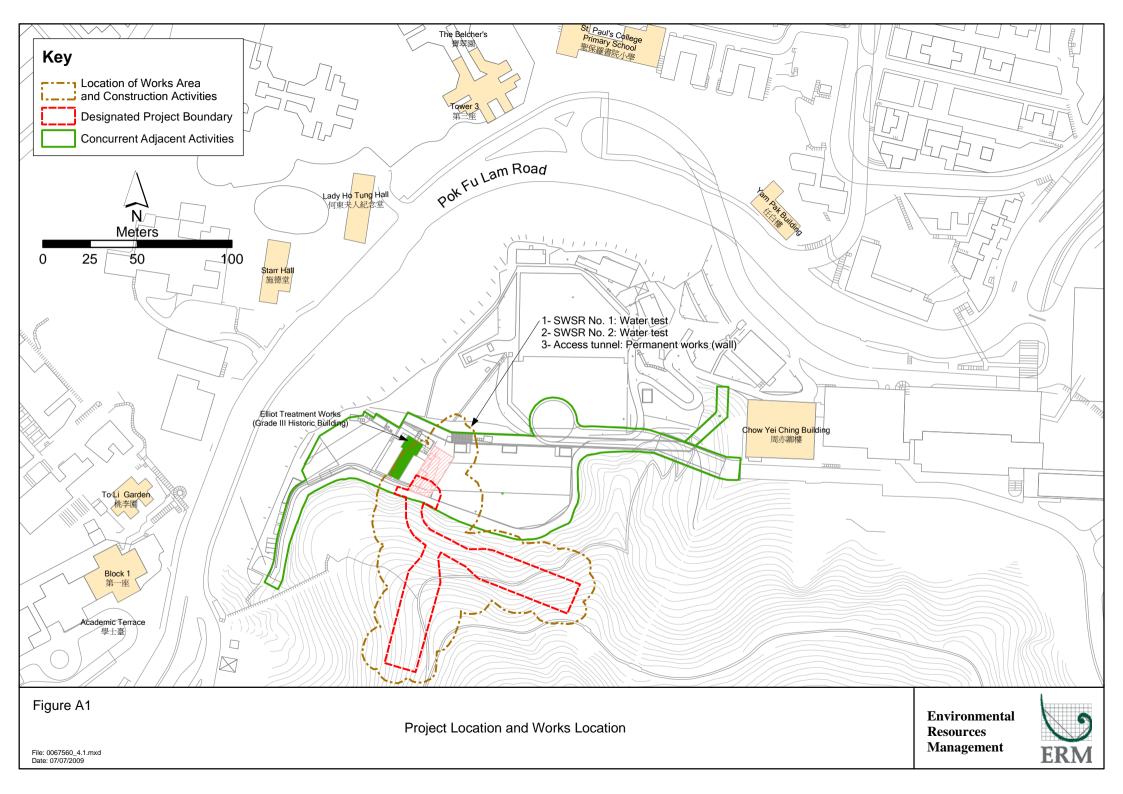
Locations of Works Areas and Construction Activities during the Reporting Period, and updated Construction Programme

A summary of the major construction activities undertaken in this reporting period is shown in *Table 2.1*. The locations of the construction activities are shown in *Annex A*.

Co	Construction Activities Undertaken		
•	Water test for Salt Water Service Reservoir (SWSR) Nos. 1 and 2; and		
•	Permanent works (wall) for access tunnel.

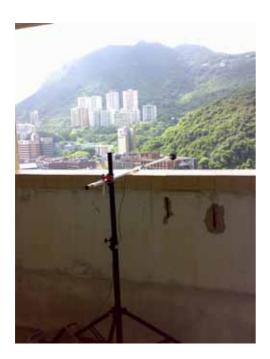
Baseline Noise Monitoring Station (NM2)

Monitoring Station	Description
NM1	Tower 3 of The Belcher's
NM2	Starr Hall, HKU

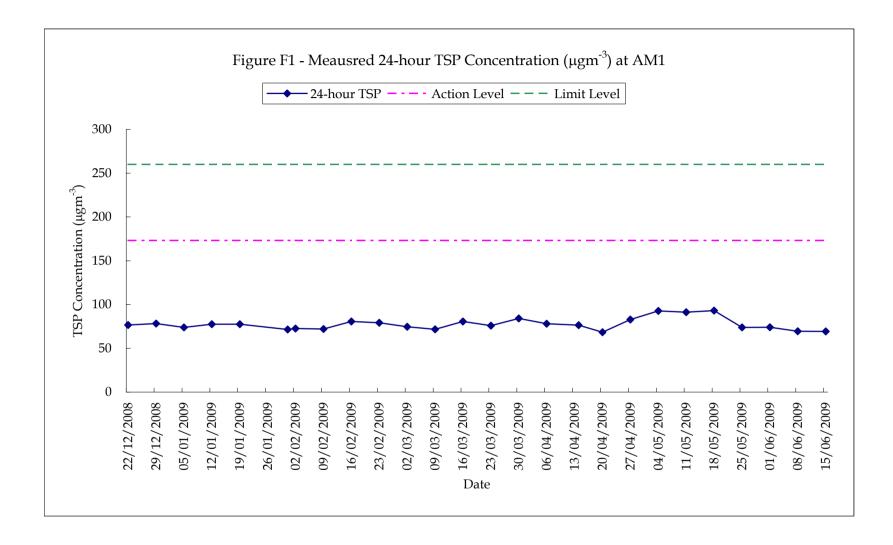
Four sets of 24-hour TSP measurements were carried out at the monitoring station AM1 during the reporting period. The monitoring data for 24-hour TSP together with wind data and graphical presentations are presented in *Annex F*. The weather condition during the monitoring period varied from sunny to cloudy. The local impacts near the monitoring station were mainly associated with vehicular emissions from the road traffic along Pok Fu Lam Road. No exceedance of the Action and Limit Levels for 24-hour TSP was recorded during the reporting period.

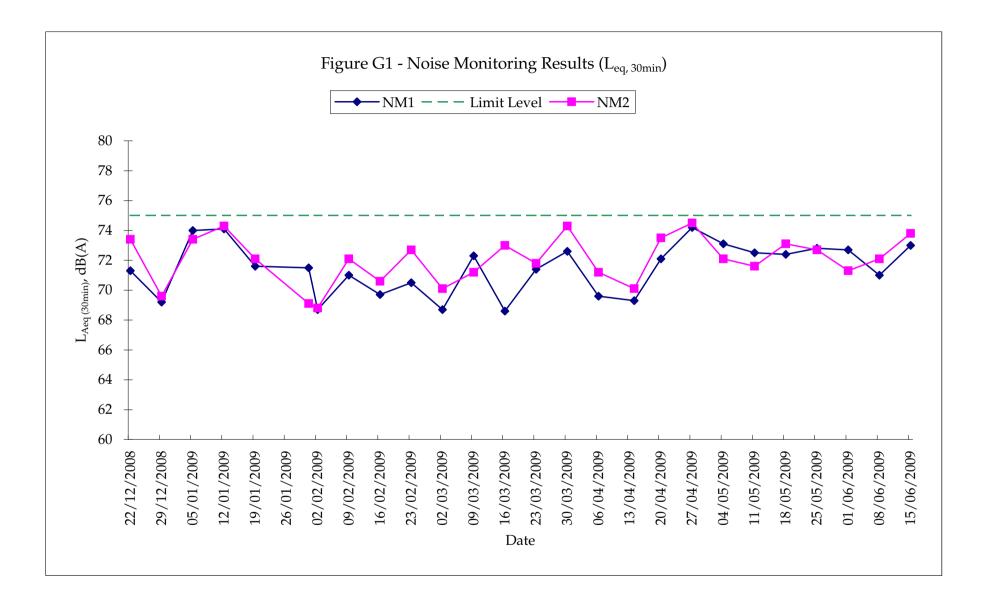
Monitoring Location: NM2 - Roof of Starr Hall

Four sets of 30-minute construction noise measurements were carried out at monitoring stations NM1 & NM2 during the reporting period. The monitoring results together with graphical presentations are presented in *Annex G*. The local impacts observed near the monitoring stations were mainly traffic noise from Pok Fu Lam Road and the concurrent projects undertaken in the vicinity. No exceedance of the Action and Limit Levels for construction noise was recorded during the reporting period.

Date	Measurement	Period, hours	Measure	Measured Noise Level, dB(A)		Noise Criteria,	Compliance	
	Start	End	L _{eq}	L ₁₀	L ₉₀	L _{eq(30mins)} , dB(A)		Remark
25-May-09	14:14	14:44	72.7	74.6	70.5	75.0	Y	-
01-Jun-09	11:15	11:45	71.3	73.4	68.4	75.0	Y	-
08-Jun-09	14:10	14:40	72.1	74.2	69.5	75.0	Y	-
15-Jun-09	11:10	11:40	73.8	77.4	67.5	75.0	Y	-

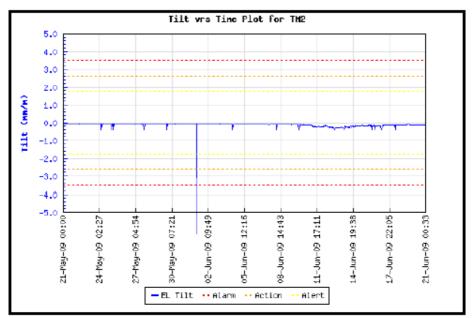
Initial Level: 92.664 mPD

Remark : Radio Transmitter Serial No. 50348; +ve Reading => Rotation towards West South

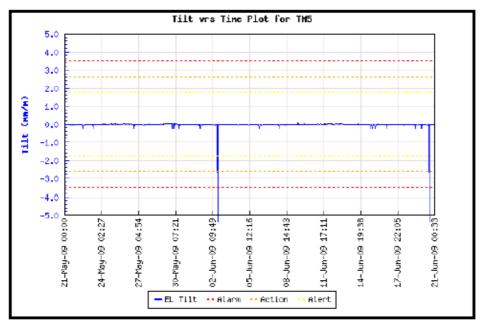
Initial Level: 92.714 mPD

Remark : Radio Transmitter Serial No. 50194; +ve Reading => Rotation towards West South

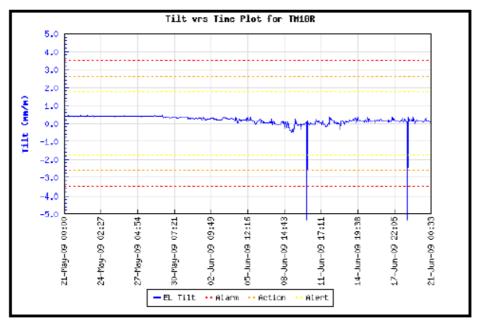
Initial Level: 92.744 mPD

Remark : Radio Transmitter Serial No. 50270; +ve Reading => Rotation towards West North

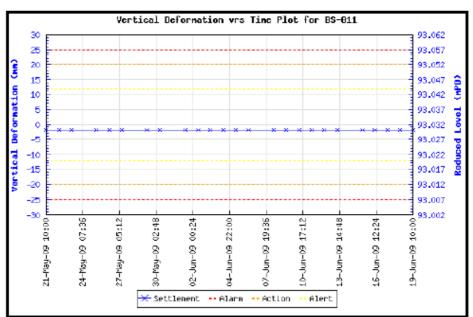
Instrument ID : BS-011 Easting: 831795.830 Location : Valve House Remark :

Type : Building Settlement Marker Type DMP5 Northing: 815997.133 Initial Level: 93.032 mPD

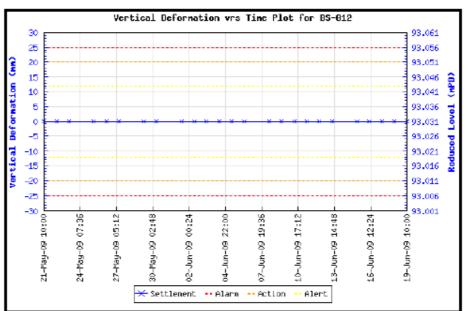
Instrument ID : BS-012 Easting : 831796.239 Location : Valve House Remark : Type : Building Settlement Marker Type DMP5 Northing : 816000.503 Initial Level : 93.031 mPD

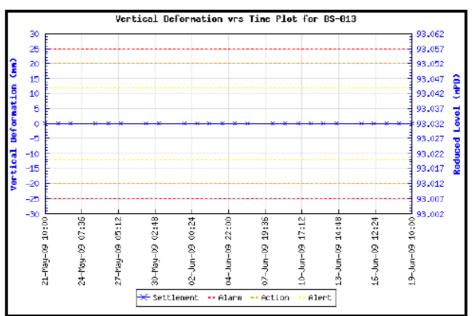
Instrument ID : BS-013 Easting : 831800.605 Location : Valve House Remark : Type : Building Settlement Marker Type DMP5 Northing : 816020.664 Initial Level : 93.032 mPD
