Reprovisioning and Upgrading of Salt  
Water Service Reservoirs in Western  
District for Water Supplies Department:  
*Final Environmental Monitoring and  
Audit Report*

December 2009

Reference 0067560

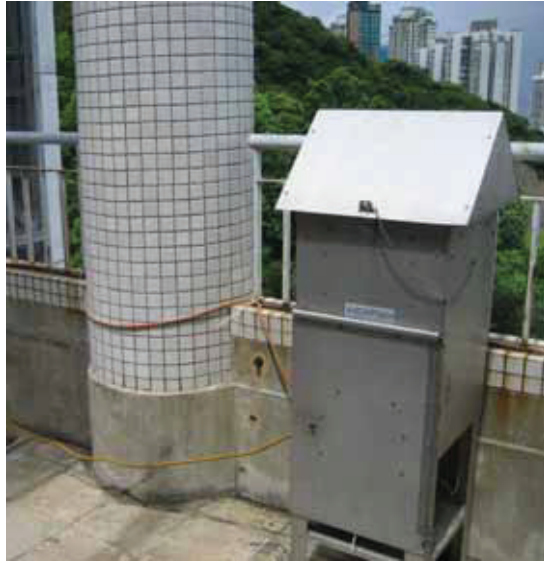
Air Quality Monitoring Station (AM1)

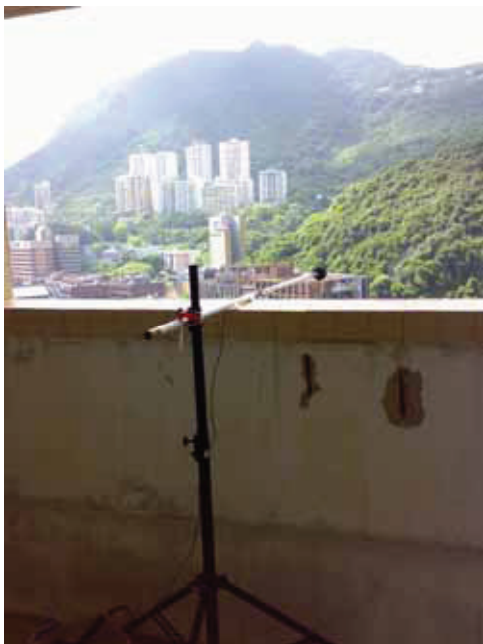
Noise Monitoring Station (NM1)

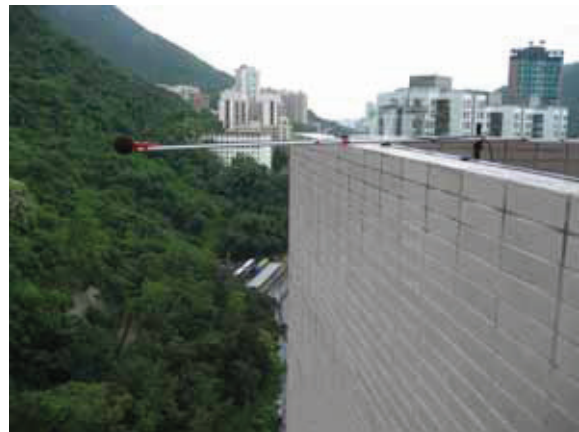
Baseline Noise Monitoring Station (NM2)

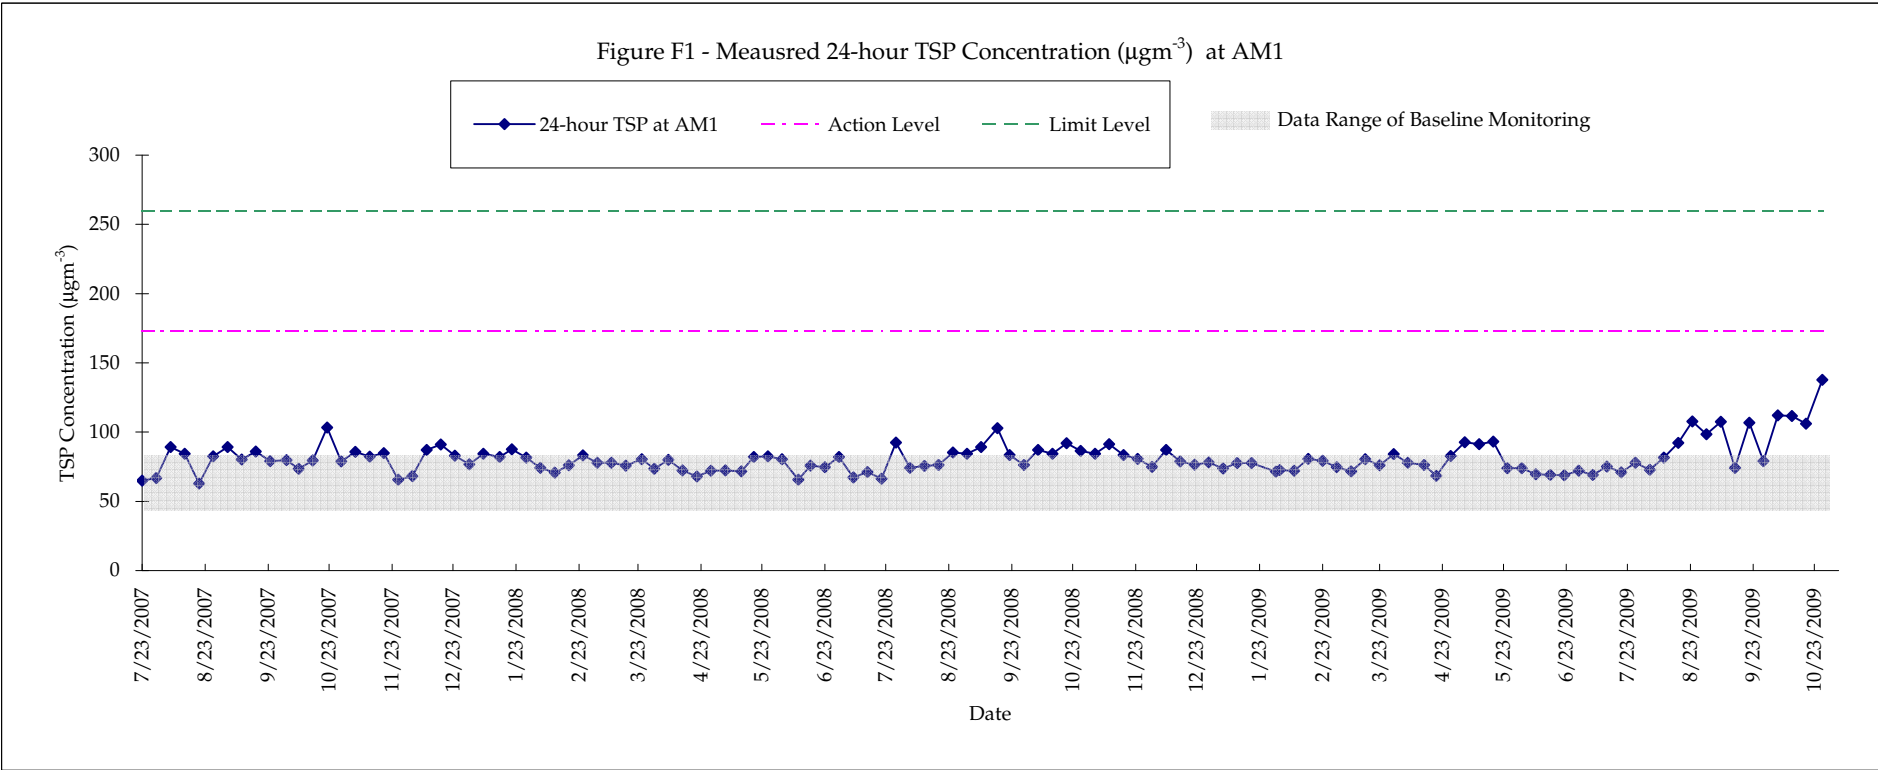
# 24-hour TSP Monitoring Results

The monitoring data for the 24-hour TSP levels at the monitoring station AM1 for the construction phase of the Project are presented in *Figure F1* in *Annex F*. No exceedance of action or limit level was recorded during the entire construction phase. The weather conditions during the air quality monitoring for the construction phase of the Project varied from sunny to rainy. Local influence near the monitoring station was mainly associated with vehicular emissions from the road traffic along Pok Fu Lam Road.

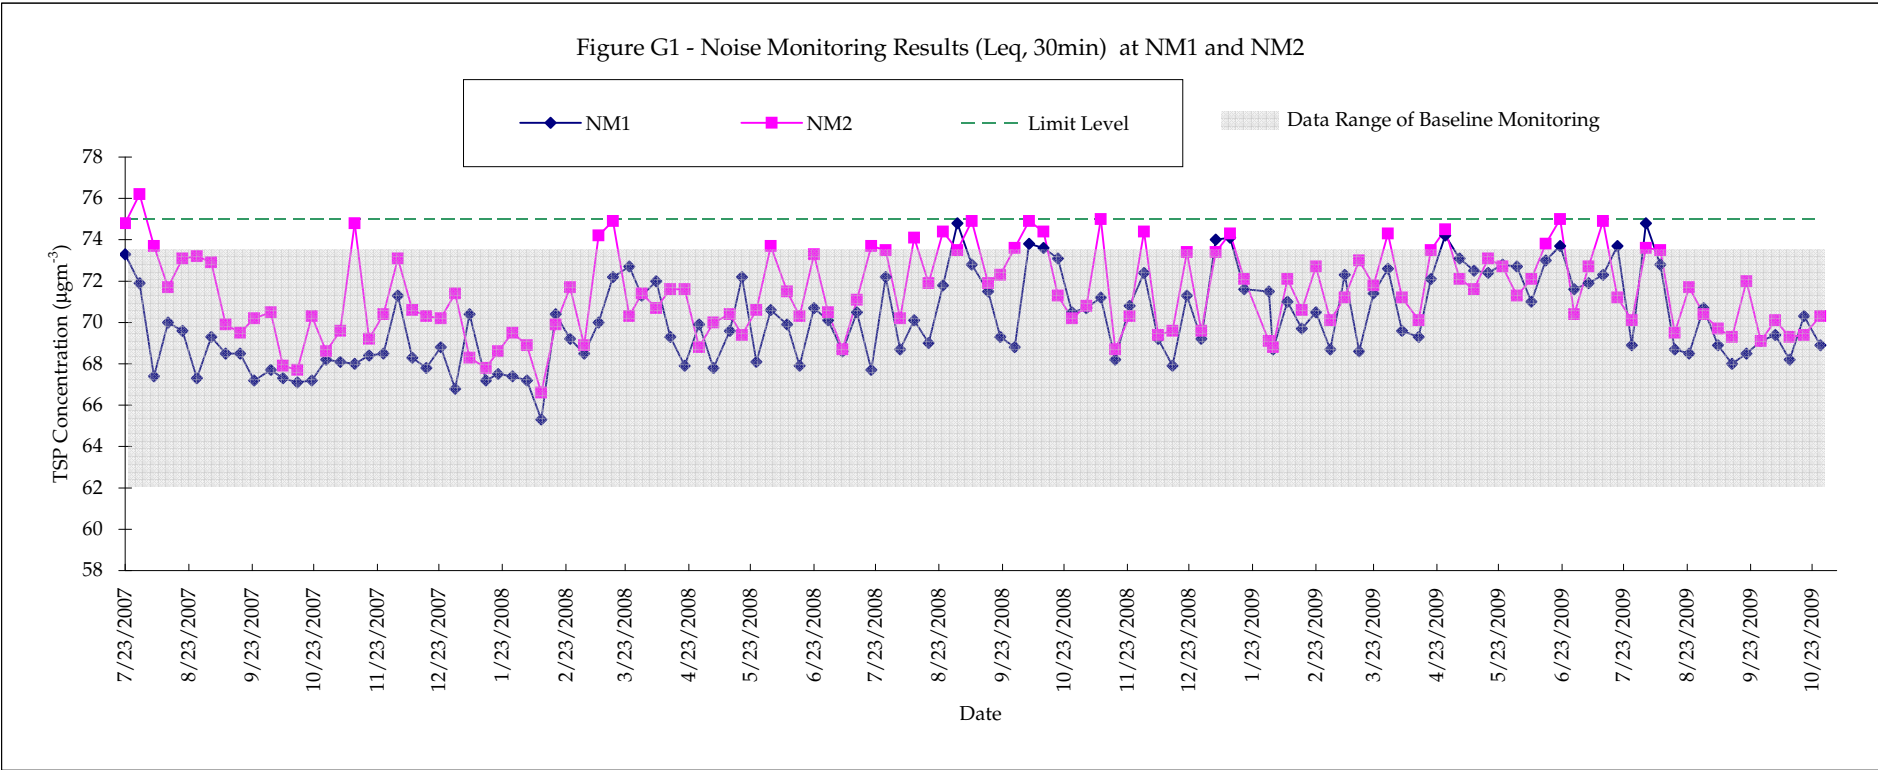
Annex G1 - Measured Noise Monitoring Data

## Construction Noise Monitoring Results

influence observed near the monitoring stations was mainly traffic noise from Pok Fu Lam Road and construction activities of the concurrent projects in the vicinity. Only one isolated exceedance of the Limit Level was recorded at Starr Hall, HKU (NM2) on 30 July 2007 with the recorded noise level at 76.2dB(A). Details of the exceedance are provided in *Section 6*. No other construction noise exceedance was recorded during the entire construction phase of the Project.

Only one isolated noise exceedance was recorded at Starr Hall, HKU (NM2) on 30 July 2007 within the first reporting period (ie 21 July to 20 August 2007). This was found not due to the works of the Project from the investigations conducted in accordance with the requirements of the EM&A Manual.
