Monthly Environmental Monitoring & Auditing report for

Contract No.DC/2006/11

Drainage Improvement in Southern Lantau

April 2009

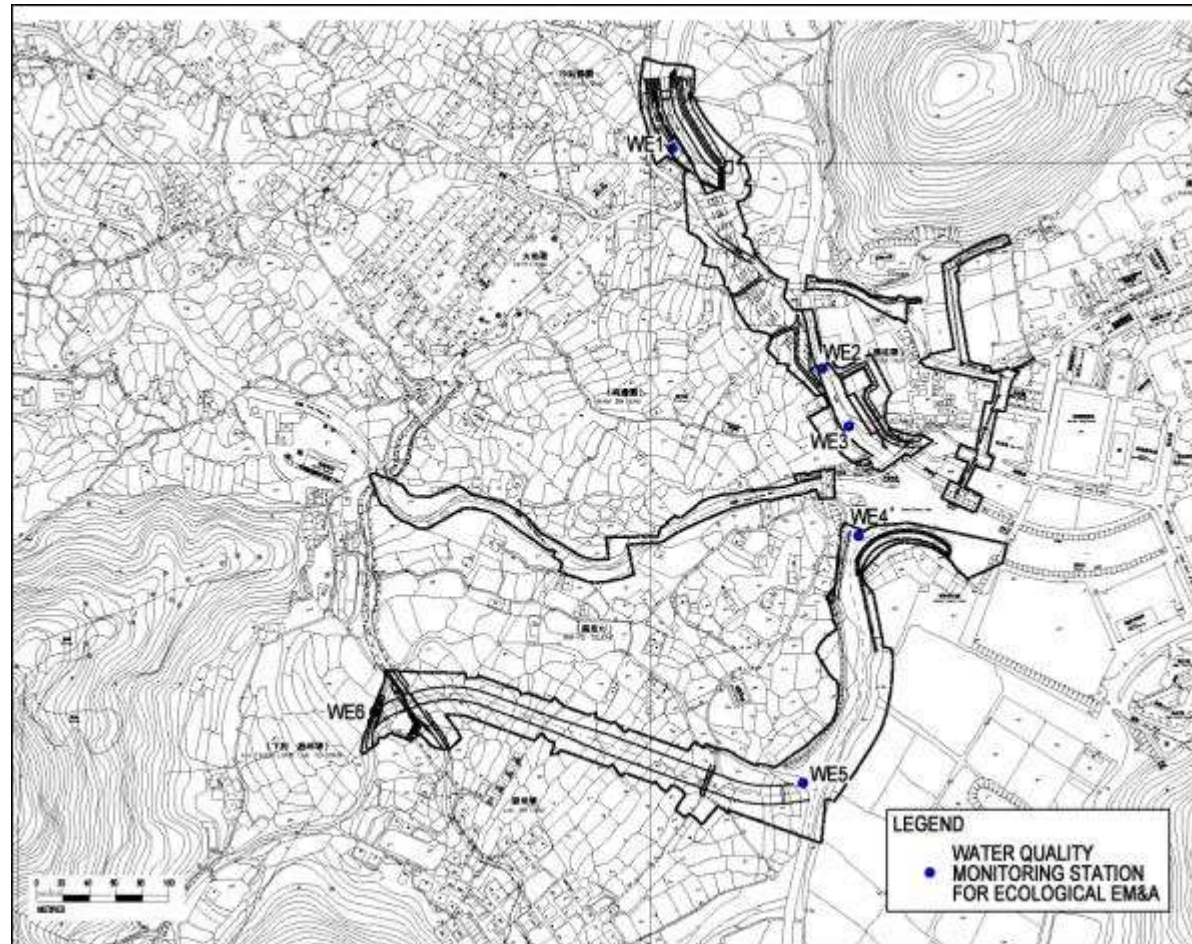
Figure 6.2 Ecological Water Quality monitoring locations

- Three points for existing of PNH river
- Three points for existing of Luk Tei Tong River

The Location Plan for ecological water monitoring is shown in Figure 6.2 for reference.

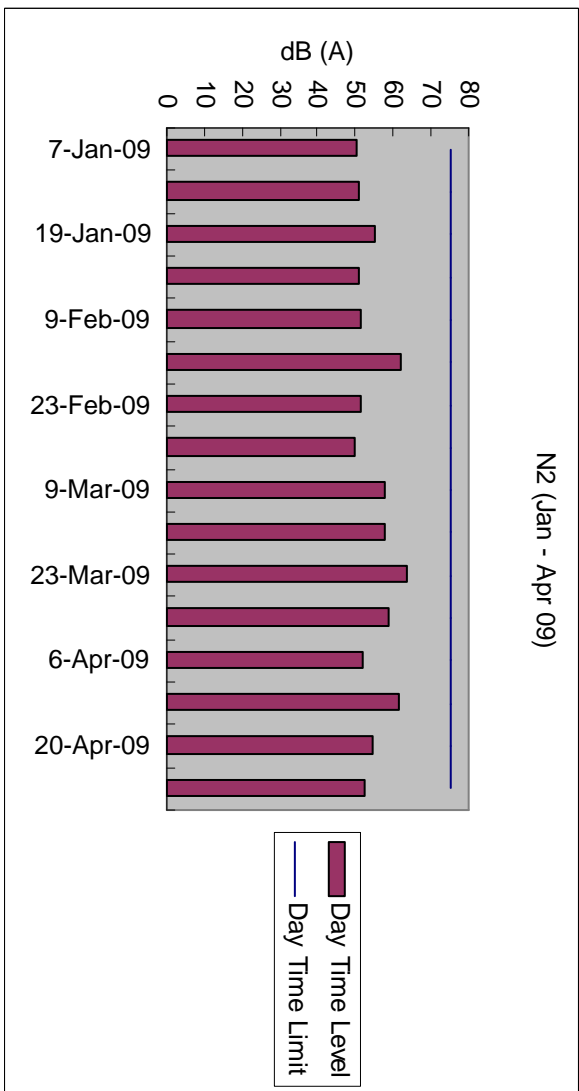
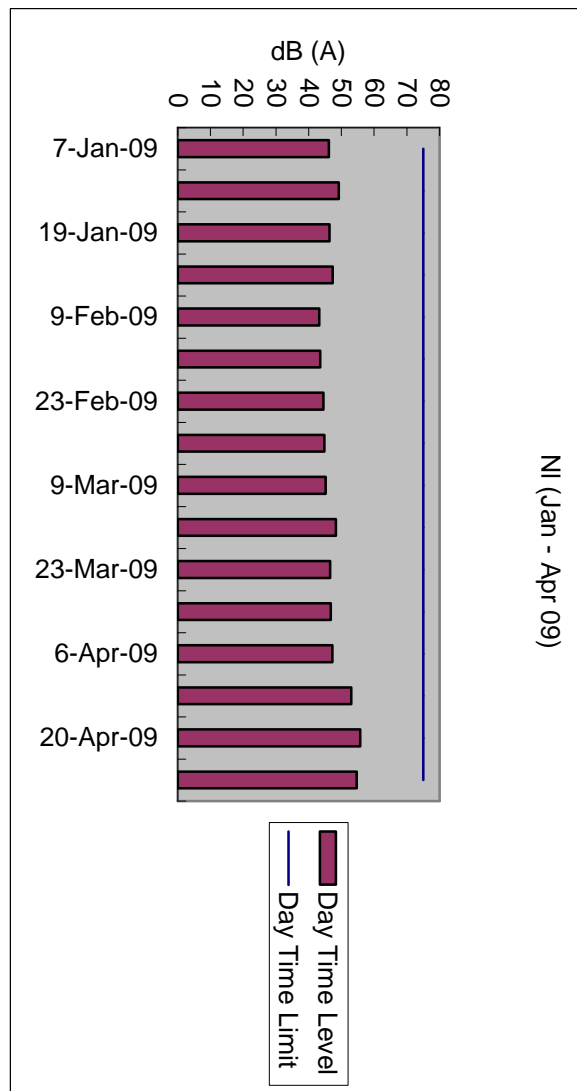
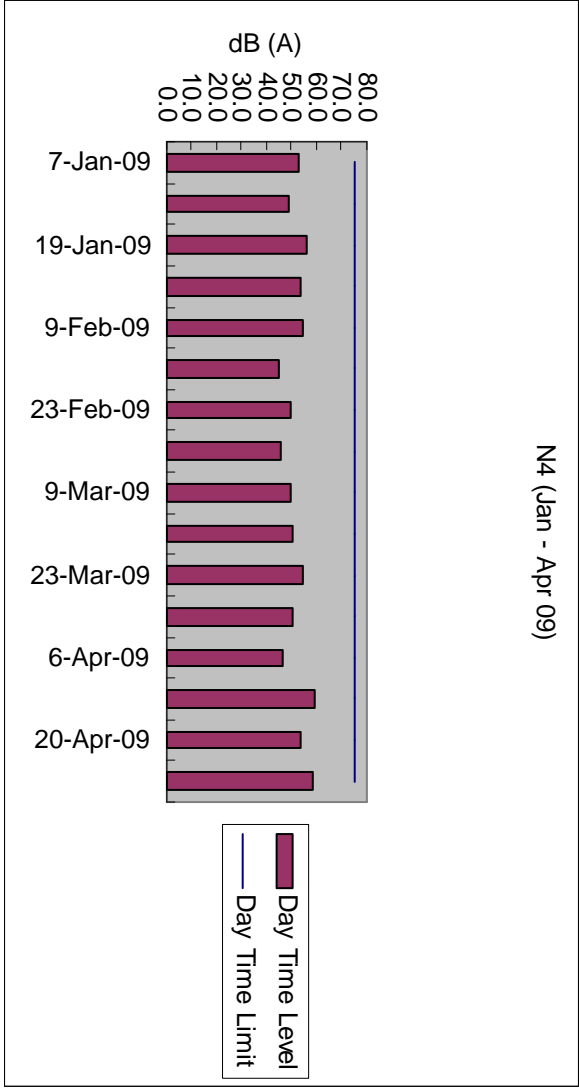
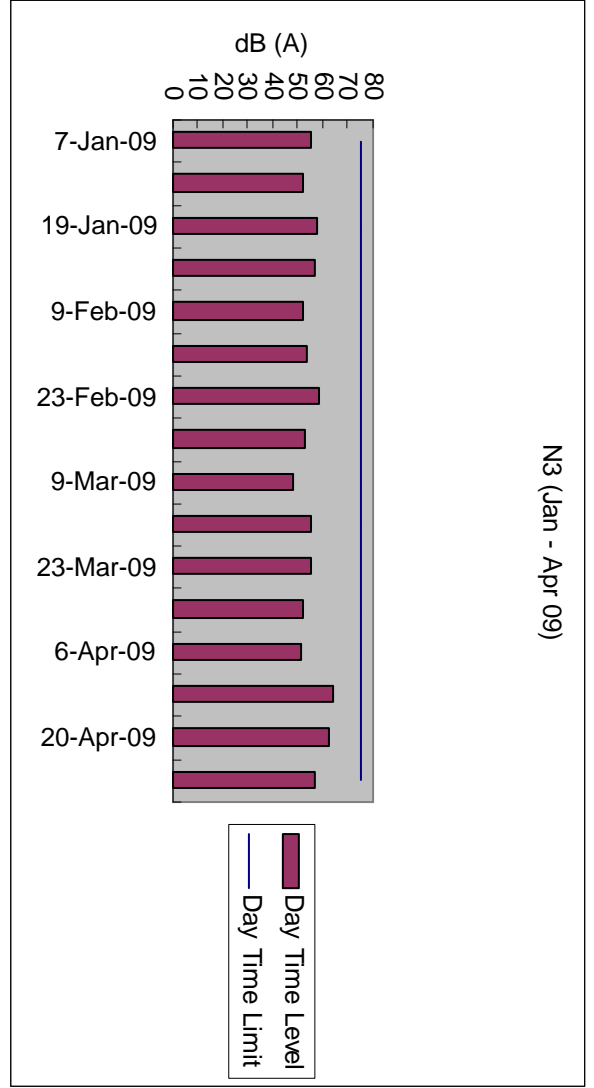
Graphical plot of noise
monitoring results

Relevant details of the noise monitoring results are presented in table 4.4.1. The results, ranged between 46.3 dB (A) and 64.1 dB (A), were within the limit levels and therefore, no exceedance was found.
