**Monthly Environmental Monitoring & Auditing report for**

**Contract No.DC/2006/11**

**Drainage Improvement in Southern Lantau**

**June 2009**

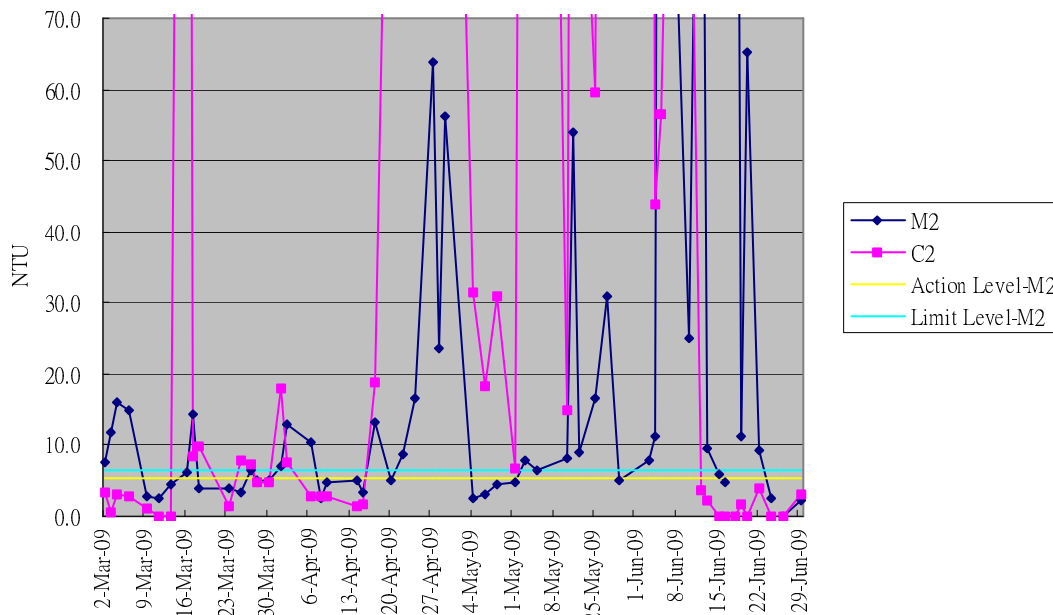
**Graphical Plot of Turbidity Trend M2&C2 (Mar - June 09)**

Remarks: The reading of M2 on 5<sup>th</sup>, 8<sup>th</sup>, 12<sup>th</sup> and 18<sup>th</sup> June 2009 is 328.4, 76.4, 151.3 and 204.3, C2 on 3<sup>rd</sup>, 8<sup>th</sup> and 10<sup>th</sup> June 2009 is 313.7, 162.4 and 114.3, which was over the range of the plot.

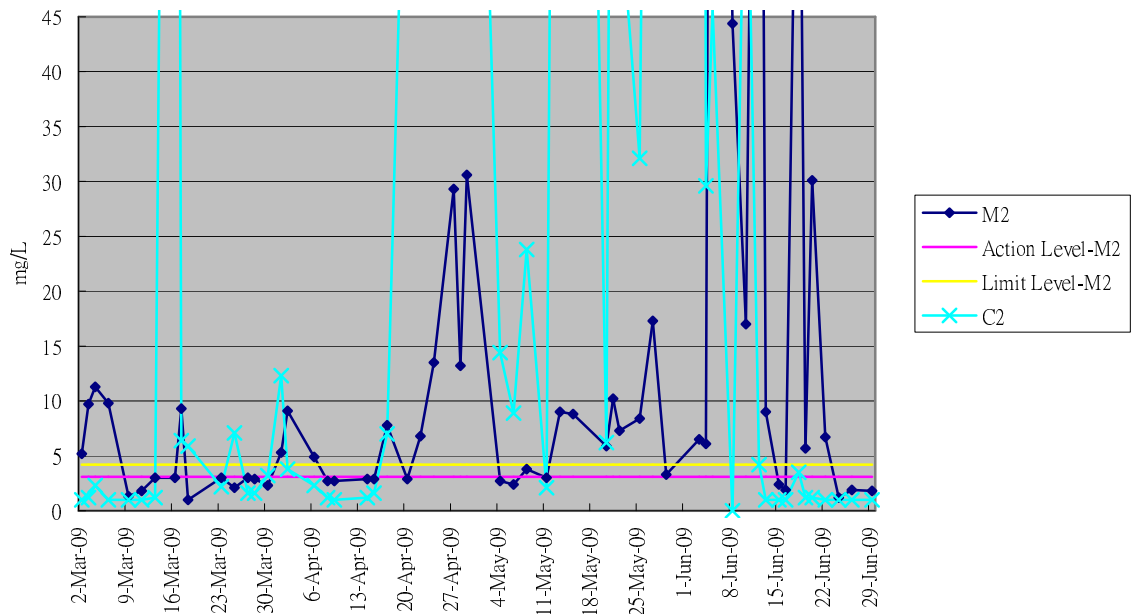
**Graphical Plot of Suspended Soild M2&C2 (Mar - June 09)**

Remarks: The reading of M2 on 5<sup>th</sup>, 12<sup>th</sup> and 18<sup>th</sup> June 2009 is 173.2, 128.6 and 80, C2 on 3<sup>rd</sup>, 5<sup>th</sup>, 8<sup>th</sup> and 10<sup>th</sup> June 2009 is 360, 45.6, 123.6 and 68.2, which was over the range of the plot.

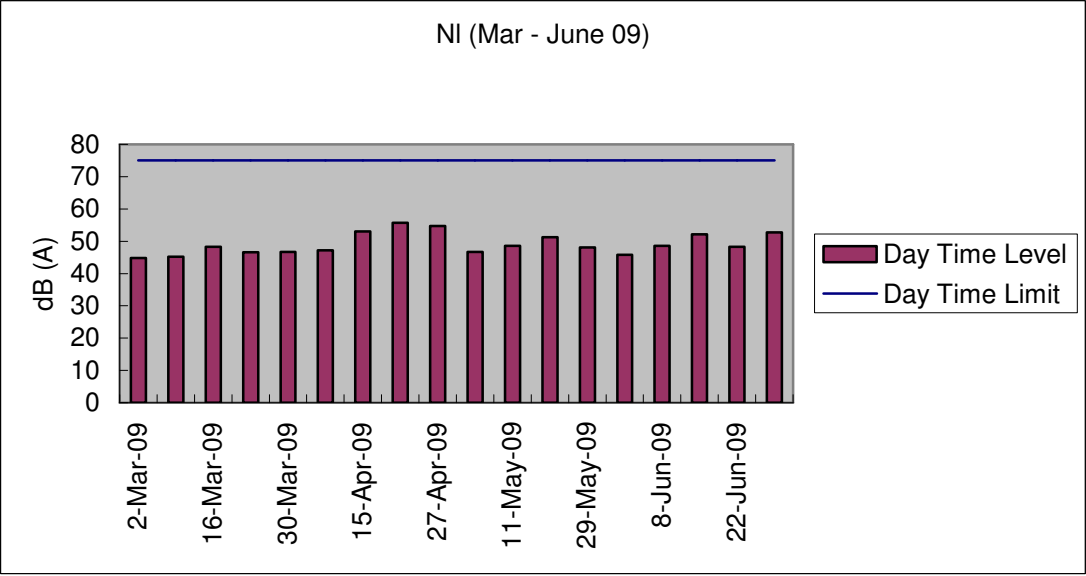
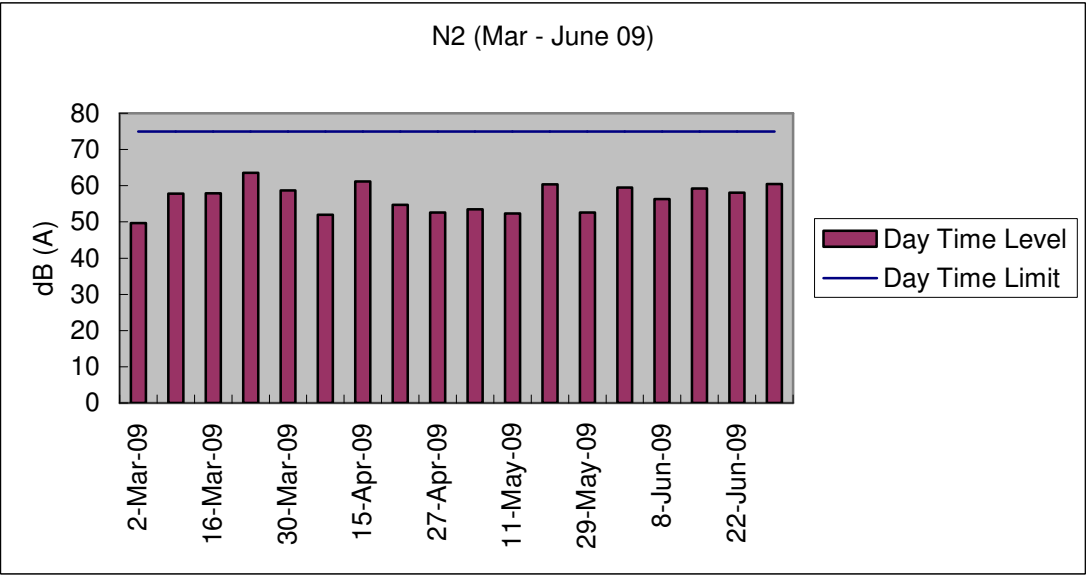
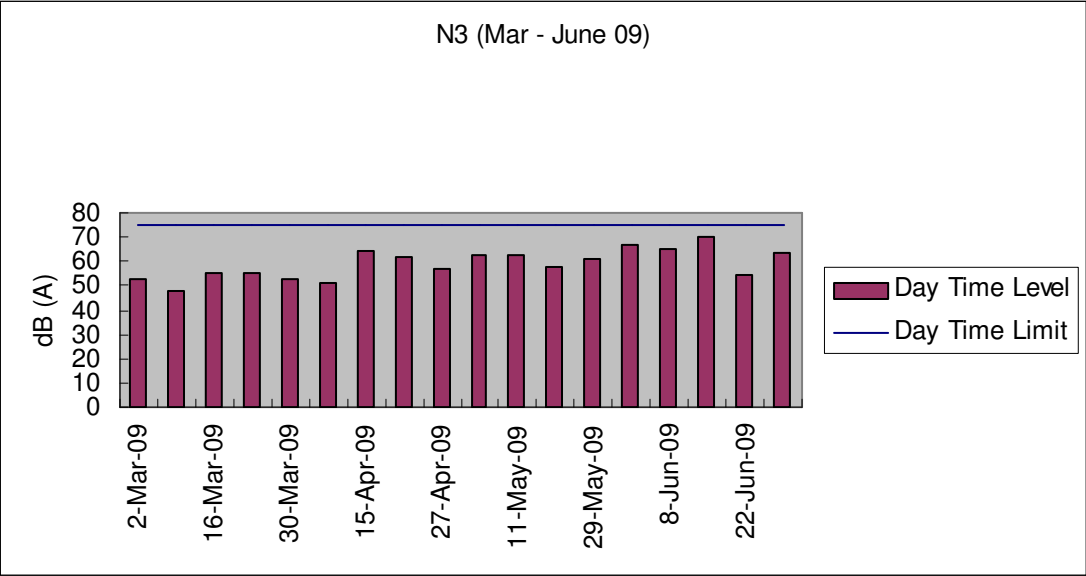
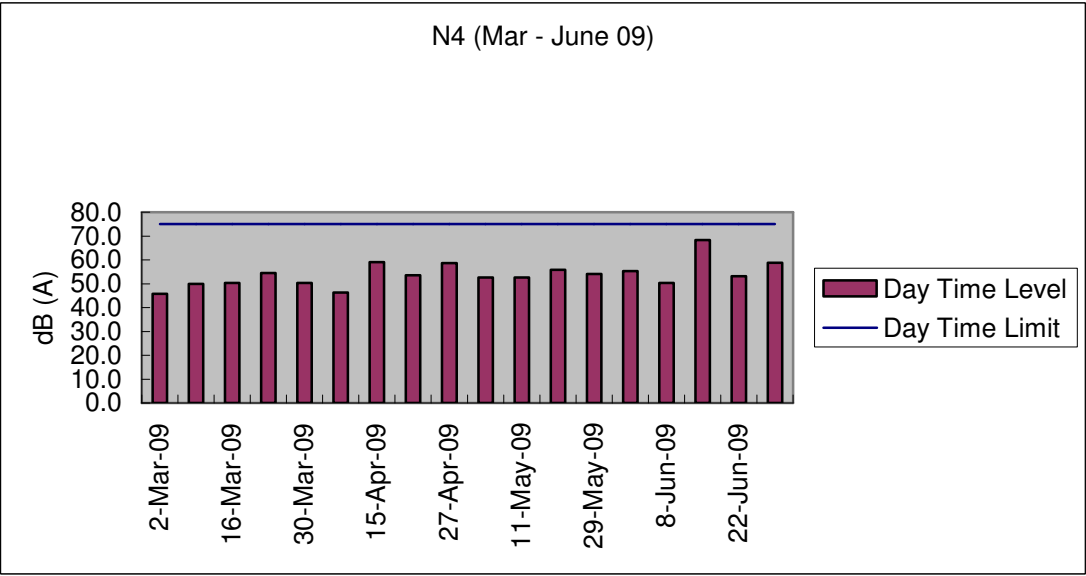
Graphical plot of noise  
monitoring results

Relevant details of the noise monitoring results are presented in Table 4.4.1. The results, ranged between 45.8 dB (A) and 70.5 dB (A), were within the limit levels and therefore, no exceedance was found.

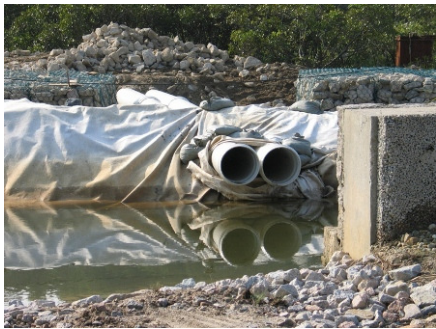
5	6	7	8

The installed inlet pipes were in good condition, and no obstruction was observed at both ends of the pipes (**Photo 5**). During the morning survey the water level was below the pipe openings, and therefore no water flow between the mangroves and was observed. On the other hand, it was observed that water was being pumped into the mangrove areas through temporary pipelines (**Photo 6**).

Since the inlet pipes have been installed and under operation, it is recommended that pumping of water can be stopped.

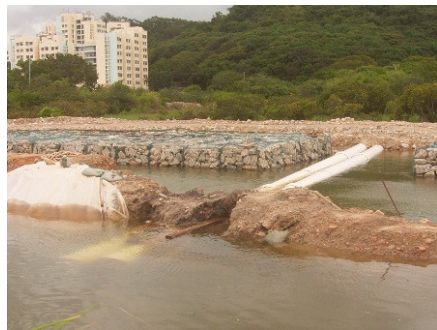
13

pipes was observed. The end of the pipes on the river side was fully immersed in water (**Photo 13**), while water was observed flowing through the pipes to the mangrove area (**Photo 14**). The mangrove communities were flooded during the current survey (**Photo 15**), and the exposed portion of the dominant mangrove or mangrove associated species, including *Aegiceras corniculatum*, *Phragmites australis* and *Acrostichum aureum* were in fair conditions. No signs of mortality or adverse health conditions of these mangrove were observed. But mortality of *Acanthus ilicifolius* continued (**Photo 16**). A few mangrove crabs and fishes were observed at the mangrove area during the survey period.
