Monthly Environmental Monitoring & Auditing report for

Contract No.DC/2006/11

Drainage Improvement in Southern Lantau

Aug 2009

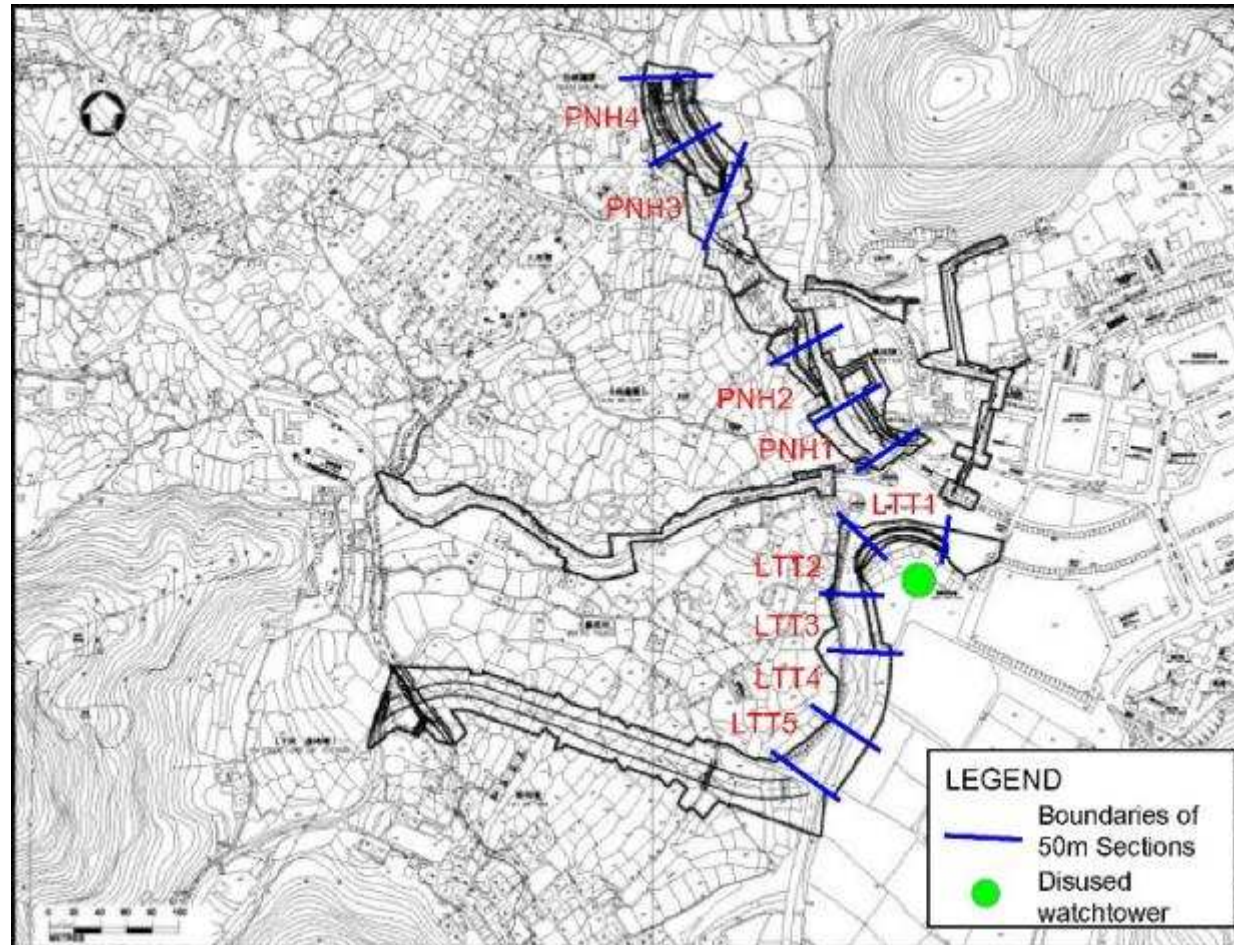
Figure 6.1 Ecological Monitoring Locations

- Three points for existing of PNH river
- Three points for existing of Luk Tei Tong River

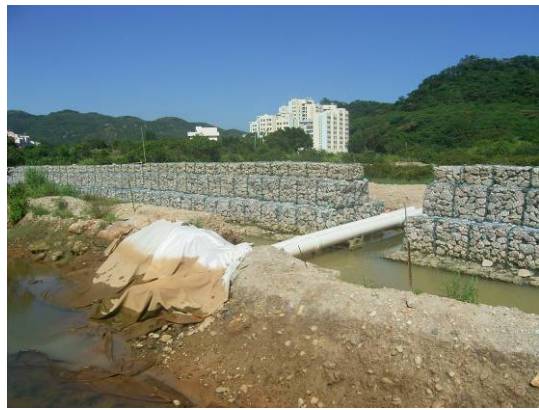
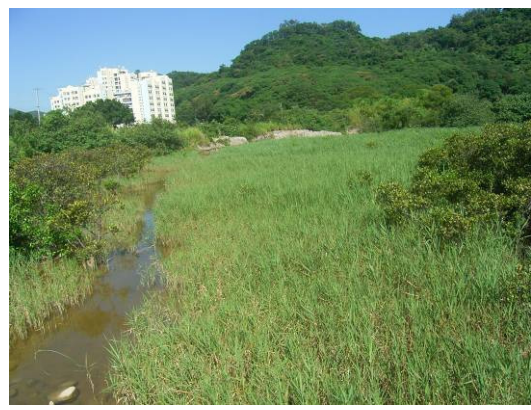
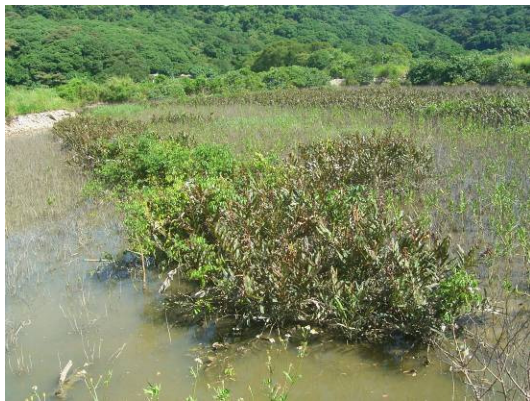
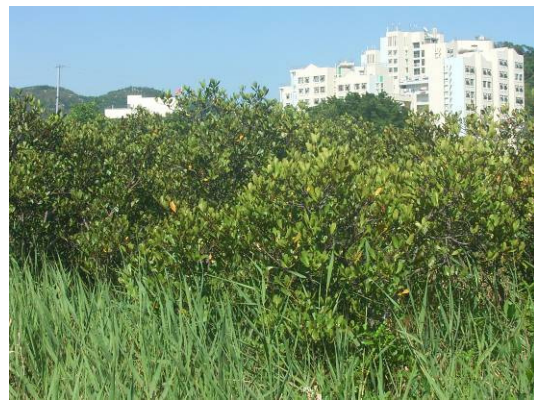
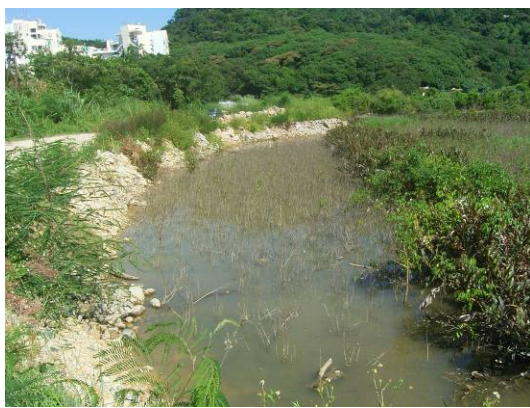
The majority of the mangrove plants inside the concerned area were still in good conditions, but mortality of a dominant mangrove associate, *Acanthus ilicifolius*, was stabilised. With the reinstatement of the box culvert, it is expected that these mangrove associate plants would recover gradually after.
