Monthly Environmental Monitoring & Auditing report for

Contract No.DC/2006/11

Drainage Improvement in Southern Lantau

August 2009

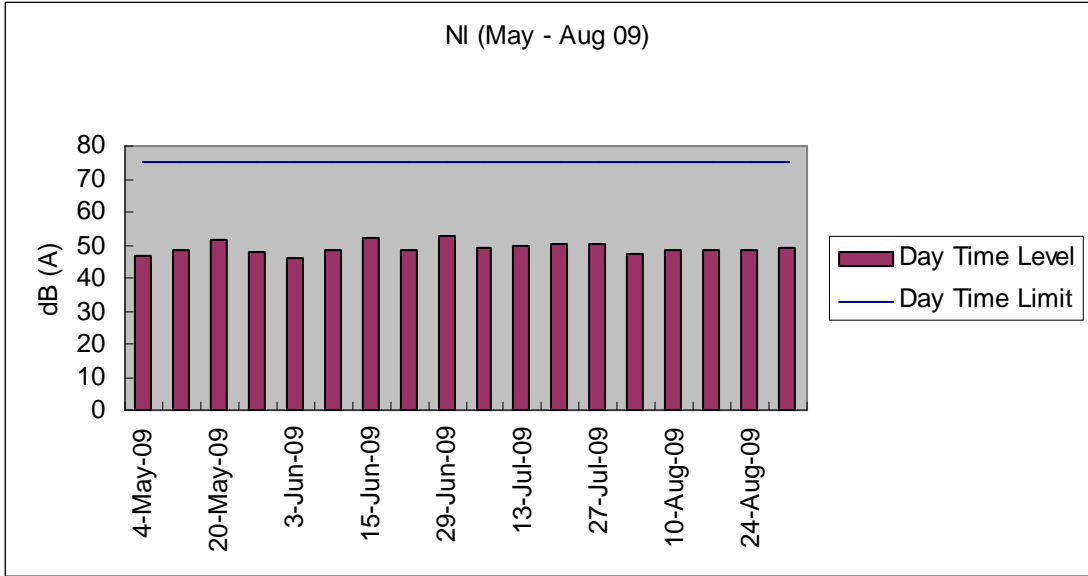
Graphical plot of noise
monitoring results

Relevant details of the noise monitoring results are presented in Table 4.4.1. The results, ranged between 47.4 dB (A) and 66.4 dB (A), were within the limit levels and therefore, no exceedance was found.
