Drainage Service Department

Monthly Environmental Monitoring & Auditing report for

Contract No.DC/2006/11

Drainage Improvement in Southern Lantau

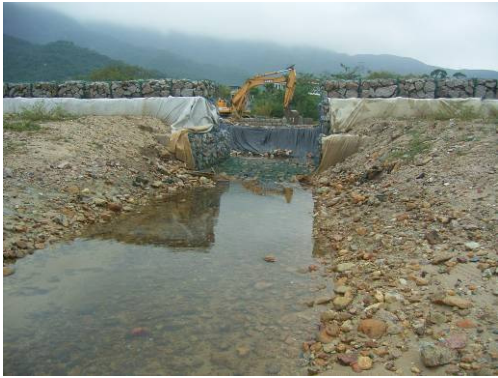
Photo 1

The tidal inlet was of its original level before construction. During the survey stream water was flowing out from the mangrove area to the stream channel (**Photo 1**).

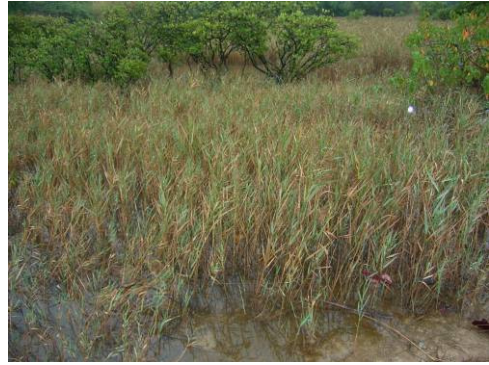
Photo 2

The mangrove communities were exposed during the current survey. The dominant mangrove or mangrove associated species in Area 1 (i.e. the western pond adjacent to the inlet at the rock gabion) were in good conditions. Blooming of *Phragmites australis* (**Photos 2**) was completed, while *Aegiceras corniculatum* (**Photos 3**) was in good health condition with little yellowing leaves compared with before. Other plant species were also in good condition. An individual of *Excoecaria agallocha* was observed flowering.

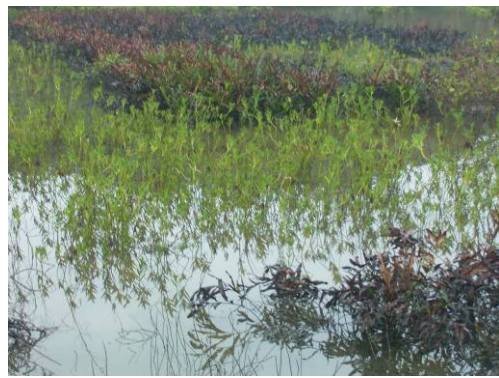
Photo 4

Recovery of mangrove community in Area 2 (i.e. the eastern pond separated from the western pond by a pond bund) varied by species. *Phragmites australis* and *Hibiscus tiliaceus* were in good condition. *Aegiceras corniculatum* on the periphery and *Acanthus ilicifolius* in the middle section was in fair condition (**Photo 4**). The population of *Acanthus ilicifolius* on the periphery withered, and regeneration was slow. Mortality of many individuals of Mangrove Fern *Acrostichum aureum* (**Photo 5**) continued since November 2009. ,.

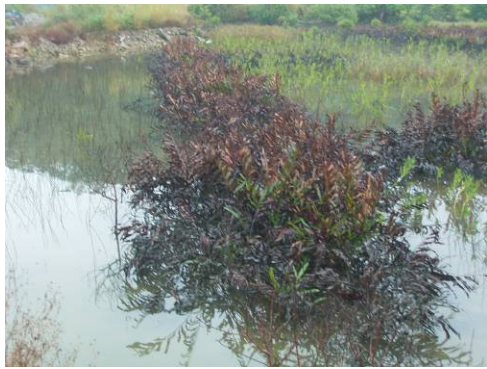
Photo 5

Mortality of Mangrove Fern at Area 2 was not observed in previous months. Impedance in tidal water exchange could be the reason of poor conditions of the mangroves in this area as standing water, although shallow, was always observed in this area even in low tide condition.

the tidal exchange. Recovery of mangrove communities is satisfactory in Area 1, while more mangrove and mangrove associates were in poor condition in Area 2. It is recommended that water samples be taken at both areas for water quality checking. Should water quality and exchange be identified as the factor, measures should be proposed to restore the hydrological conditions. For example, connection between Area 1 and Area 2 by breaking the in-between old bund could be considered, to improve the tidal water circulation.

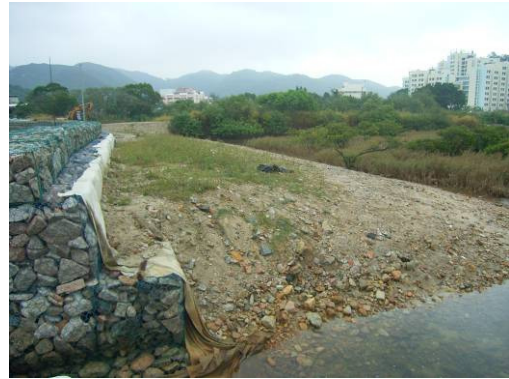
Photo 6

The works between the new gabion and the mangrove areas have been reinstated to form a gentle slope covered with sediments (Photo 6). Weeds started to colonise and establish on the bare slope.

It is also recommended that a planting programme be implemented at the reinstated area between the mangrove area and the gabion to avoid growth of weeds. Potential species can include mangrove backshore species such as *Hibiscus tiliaceus* and *Pandanus tectorius*. An alternative is to remove the surplus sediment to about high tide level in order to allow natural colonisation of the mangrove community.
