Monthly Environmental Monitoring & Auditing report for

Contract No.DC/2006/11

Drainage Improvement in Southern Lantau

February 2010

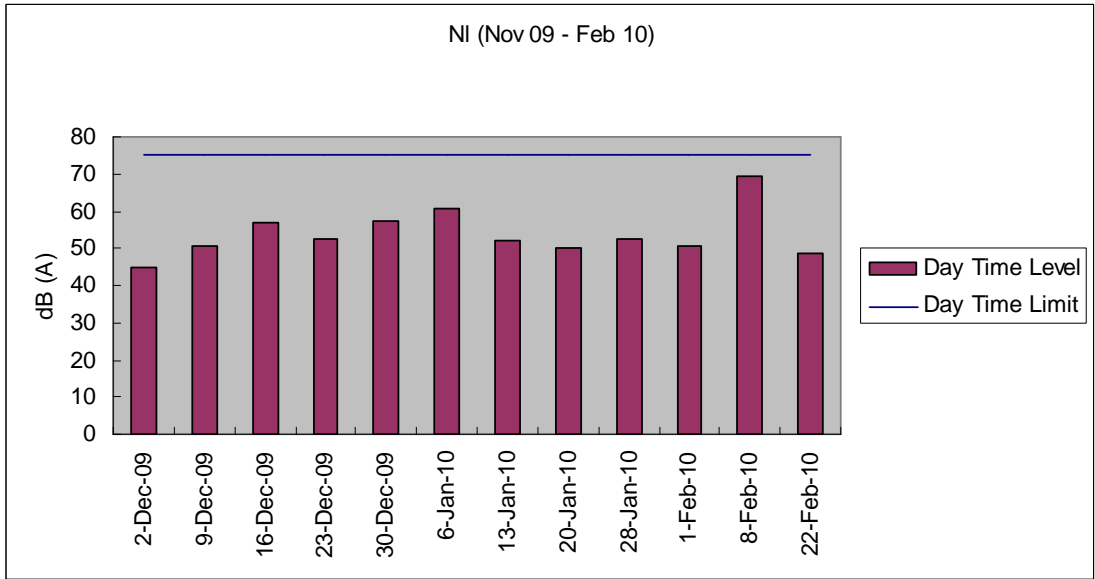
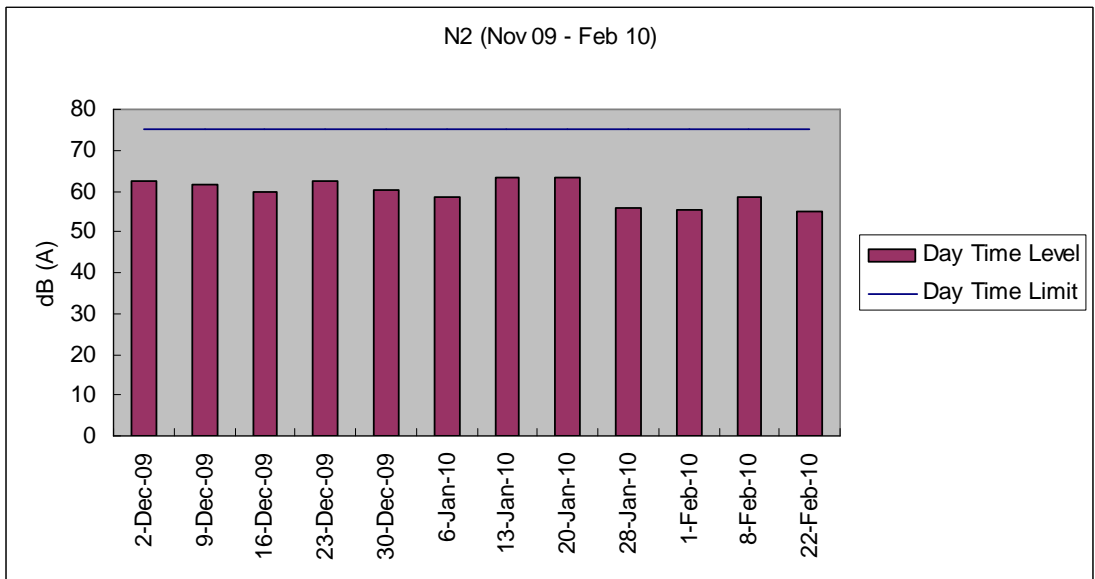
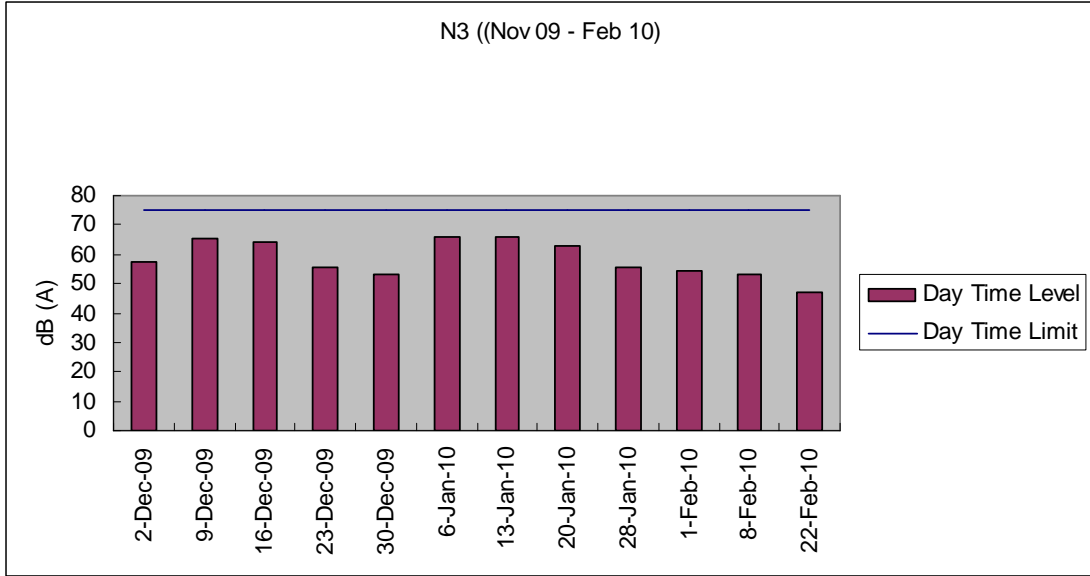
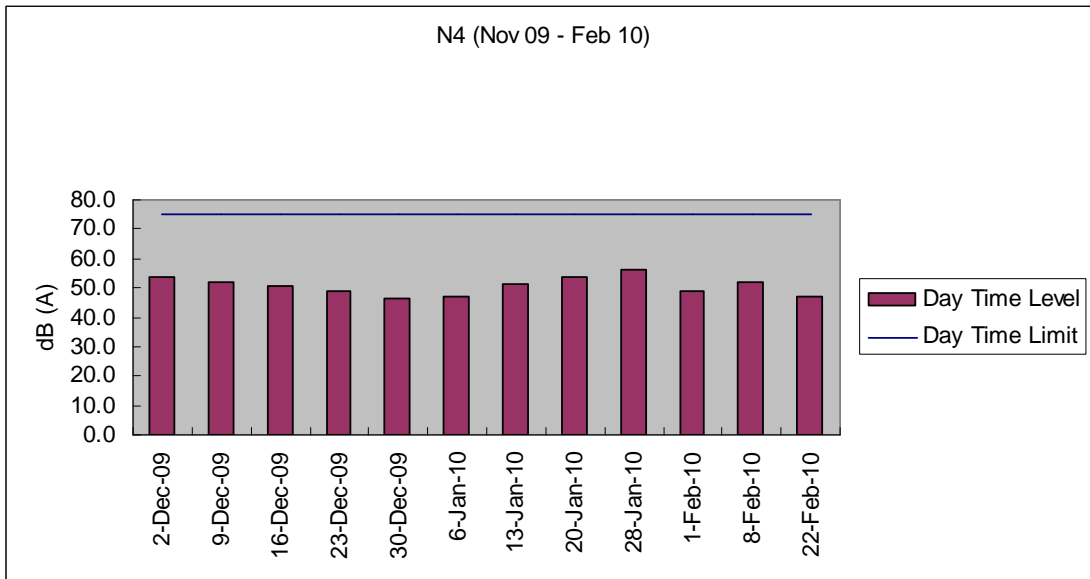
Graphical plot of noise
monitoring results

Relevant details of the noise monitoring results are presented in Table 4.4.1. The results, ranged between 47.0 dB(A) and 69.5 dB(A), were within the limit levels and therefore, no exceedance was found.
