Monthly Environmental Monitoring & Auditing report for

Contract No.DC/2006/11

Drainage Improvement in Southern Lantau

July 2011

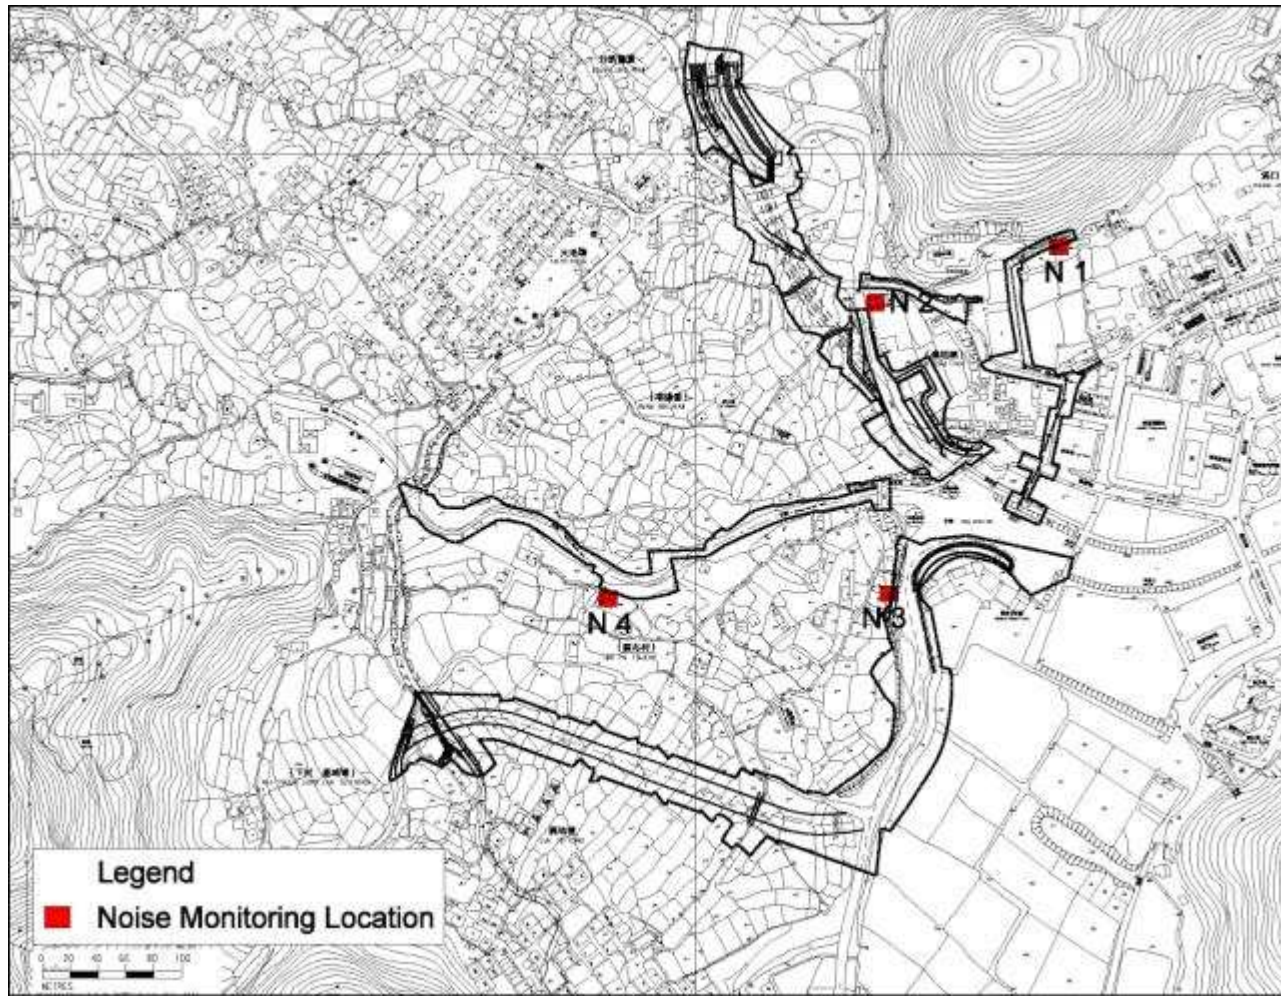
Figure 4.3.1 Impact noise monitoring locations

According to the Baseline Monitoring Report issued in May 2008 for the captioned project, four locations were alternative from the locations proposed in EM&A manual, were designated for baseline noise monitoring. For the data validation, impact noise monitoring was undertaken in the same locations during the construction phase of the project. The proposed monitoring locations are summarized in Table 4.3.1. Figure 4.3.1 shows the Noise Monitoring Locations

Identification No.	Noise Monitoring Locations
N1	No. 73, Village House, Ling Tsui Tau Tsuen (ground level)
N2	No. 31, Village House, Ling Tsui Tau Tsuen (ground level)
N3	Fence wall outside No. 5 village house adjacent to Luk Tei Tong River Outlet (ground level)
N4	No. 23, Village House, Tai Tei Tong River (ground level)

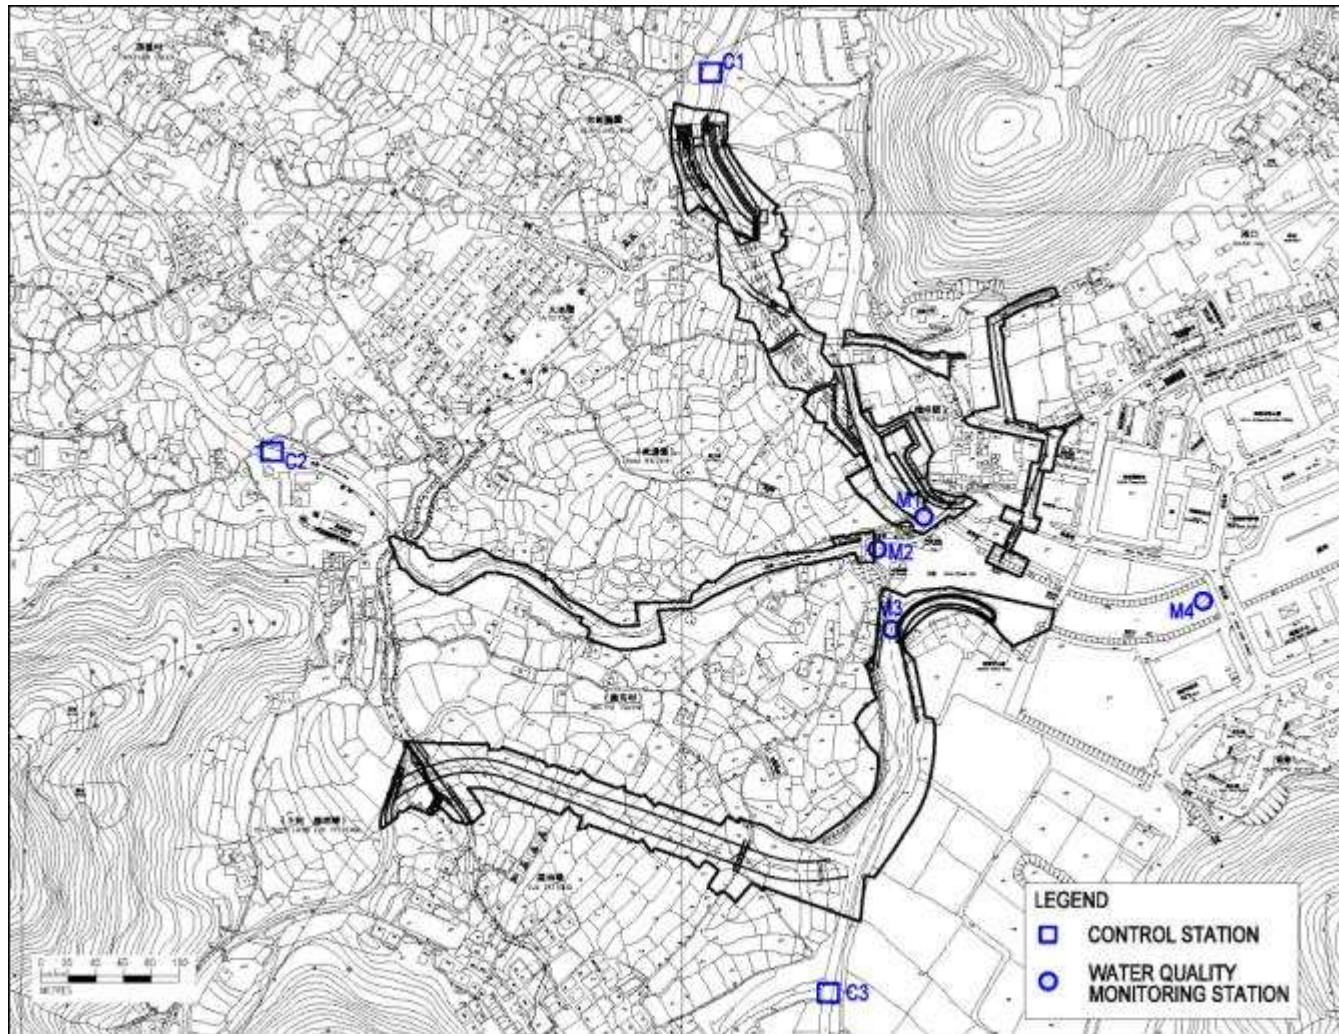
Figure 5.3.1 Water Quality Monitoring Locations

Seven locations included a control station in upstream of each stream/ river, a monitoring station at the end of each stream/ river of the works area and a monitoring station at Silver River were proposed for the impact water quality monitoring. Water samples were collected at mid-depth of each proposed monitoring stations for measurements and sample collection. The Location Plan is shown in Figure 5.3.1 for reference.

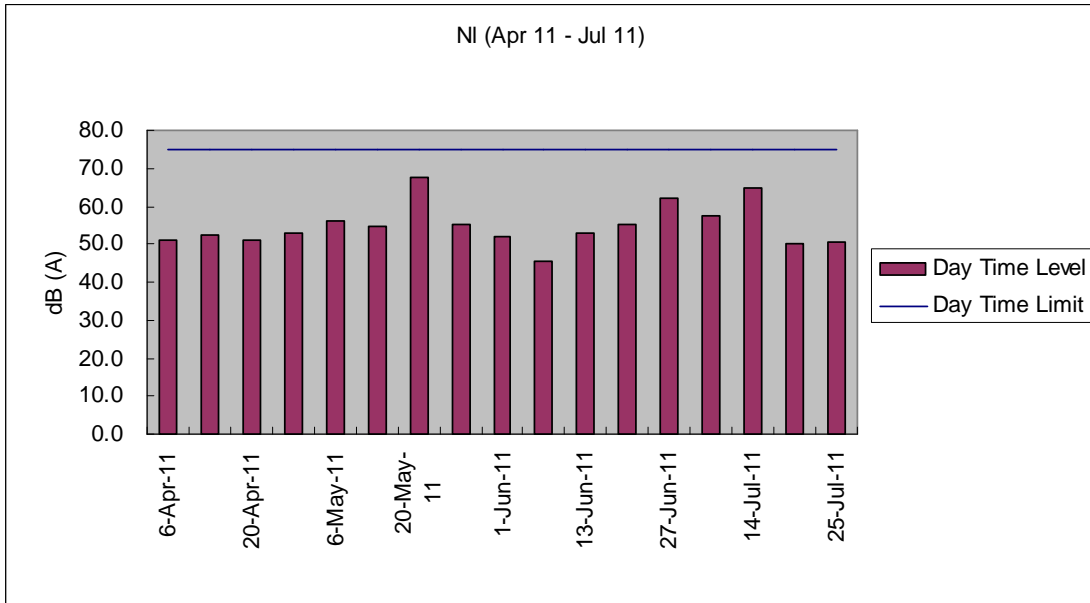
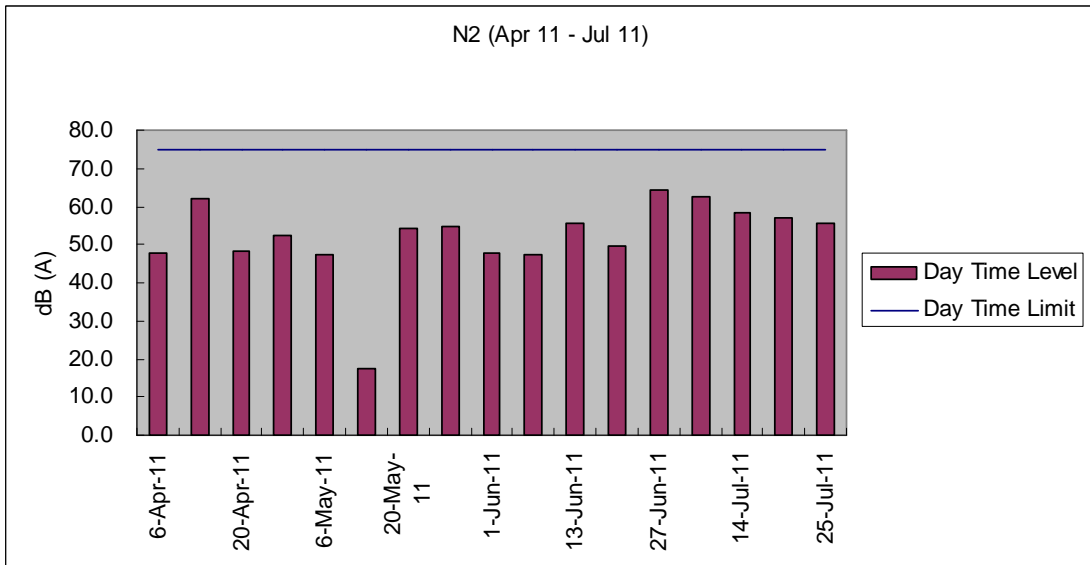
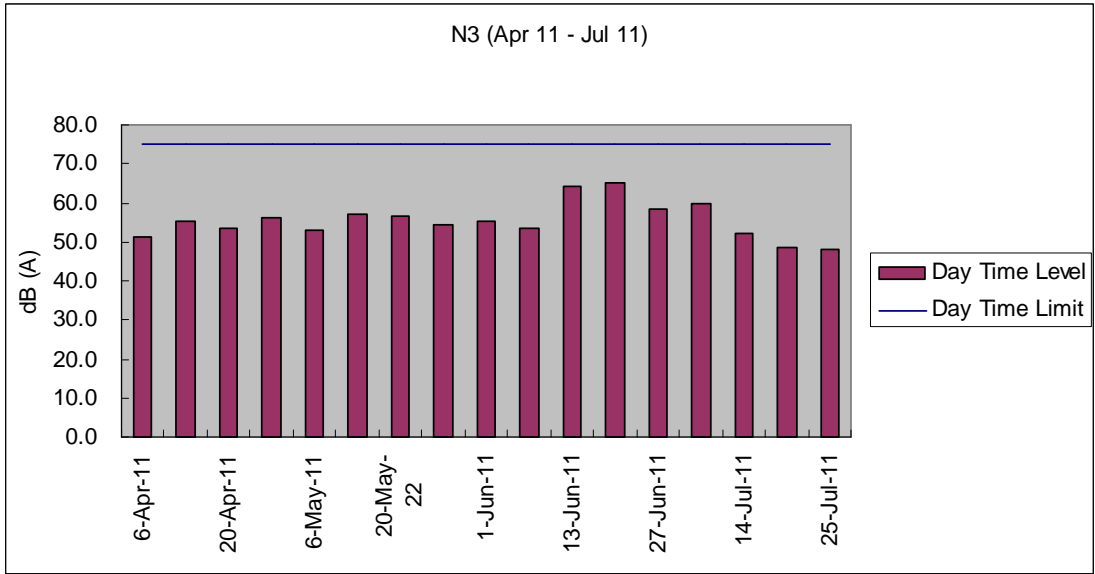
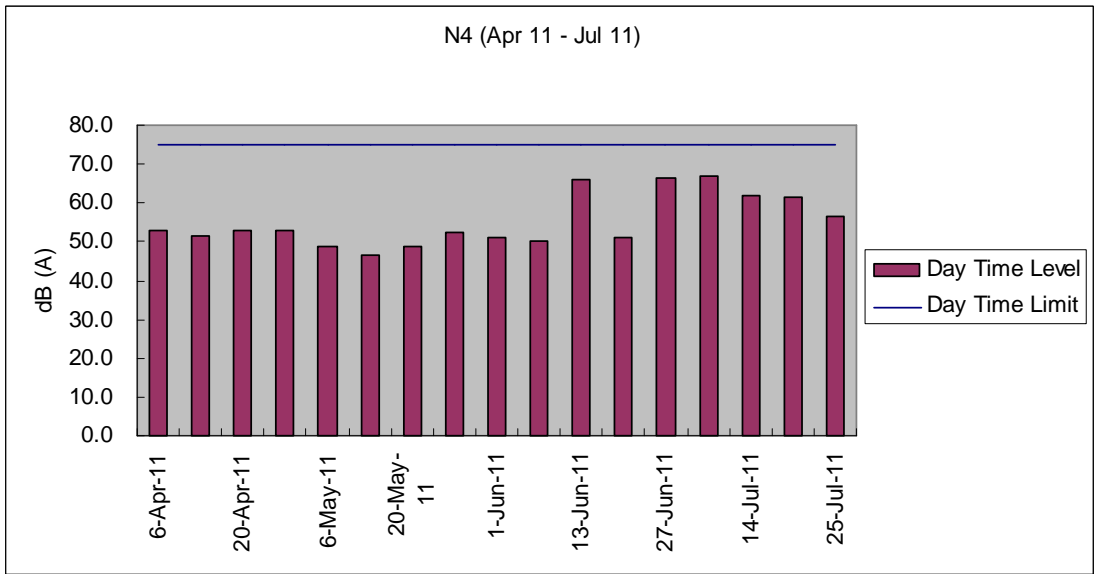
Appendix I

Graphical plot of noise
monitoring results

Relevant details of the noise monitoring results are presented in Table 4.4.1. The results, ranged between 50.3(A) and 67.1(A), were within the limit levels and therefore, no exceedance was found.
