**Monthly Environmental Monitoring & Auditing report for**

**Contract No.DC/2006/11**

**Drainage Improvement in Southern Lantau**

**September 2011**

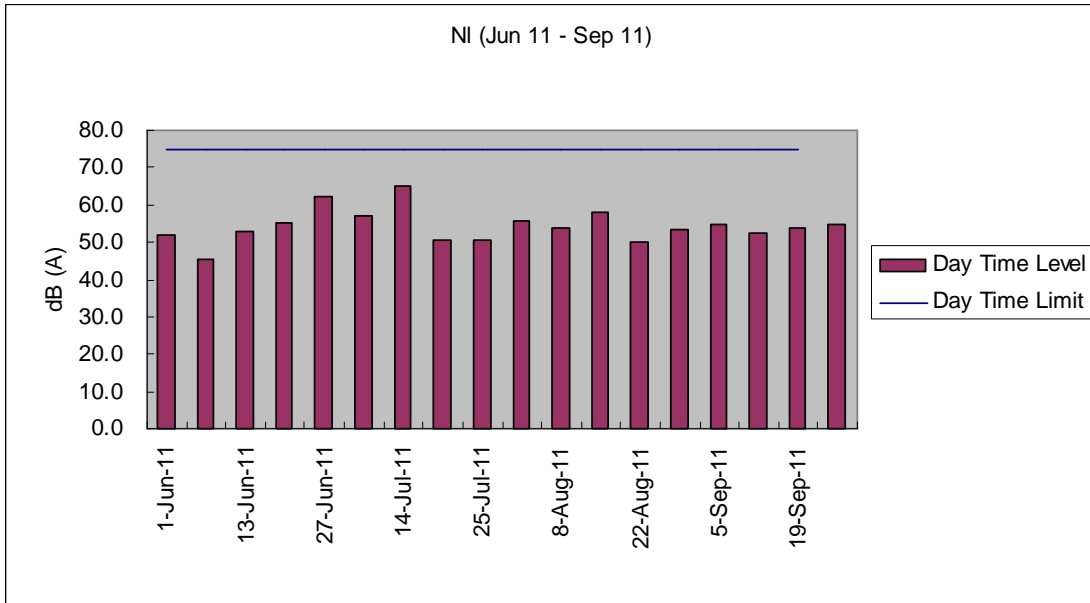
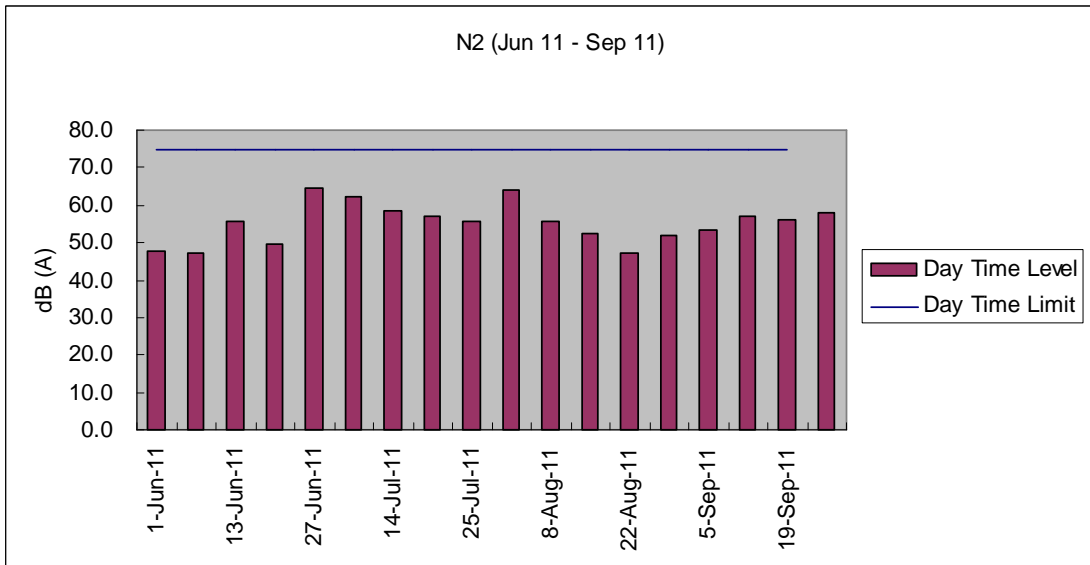
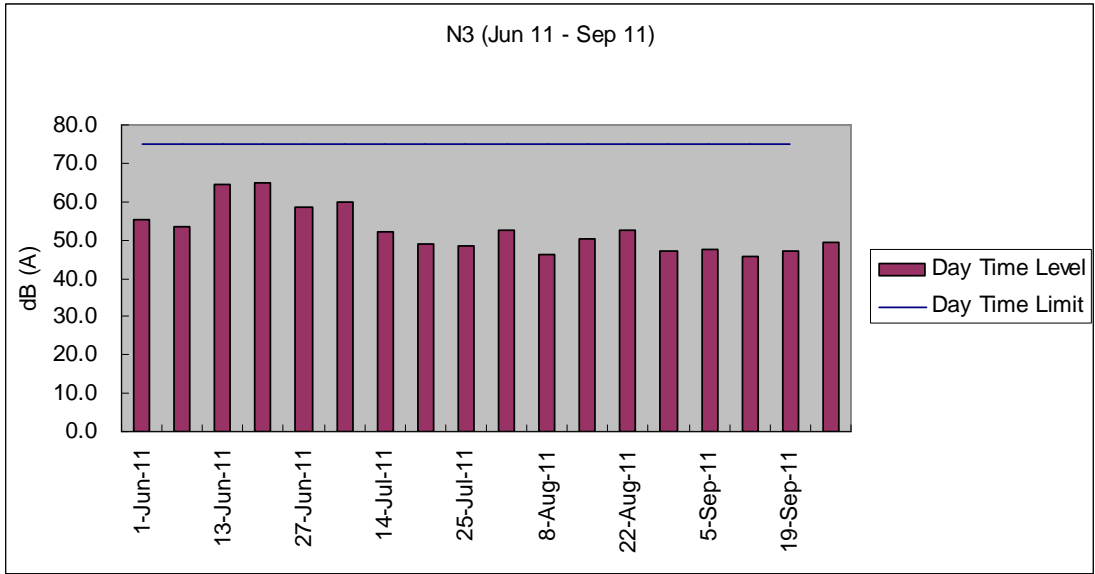
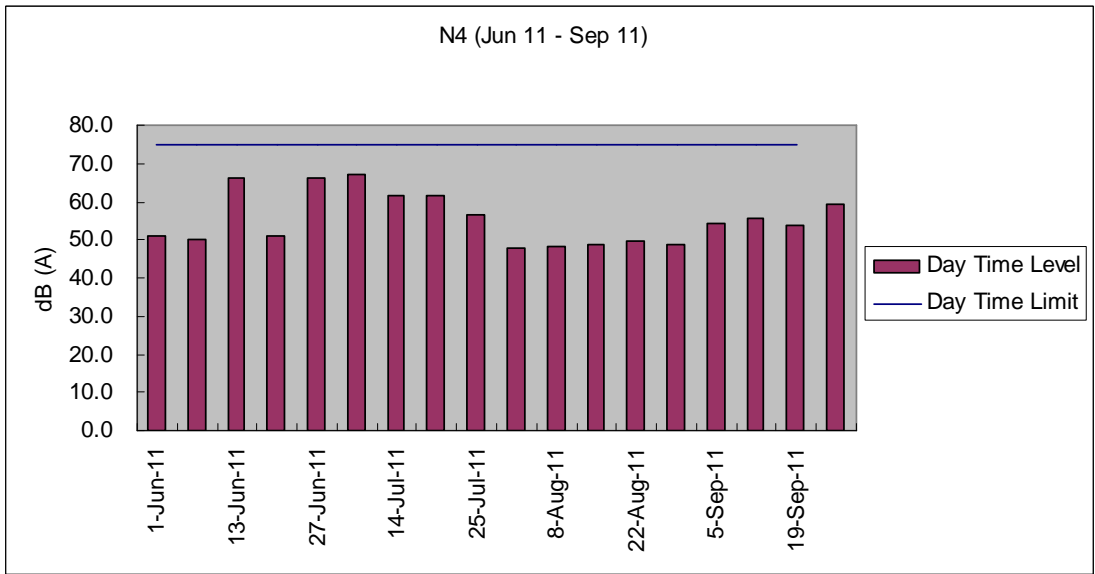
Graphical plot of noise  
monitoring results

Relevant details of the noise monitoring results are presented in Table 4.4.1. The results, ranged between 48.6(A) and 59.1 (A), were within the limit levels and therefore, no exceedance was found.
