Monthly Environmental Monitoring & Auditing report for

Contract No.DC/2006/11

Drainage Improvement in Southern Lantau

October 2011

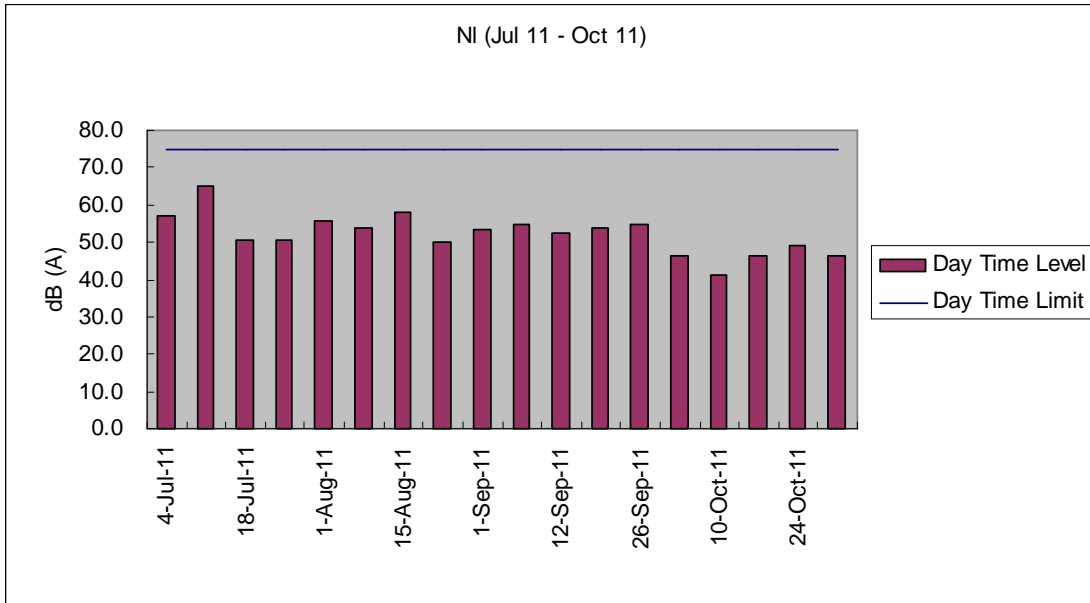
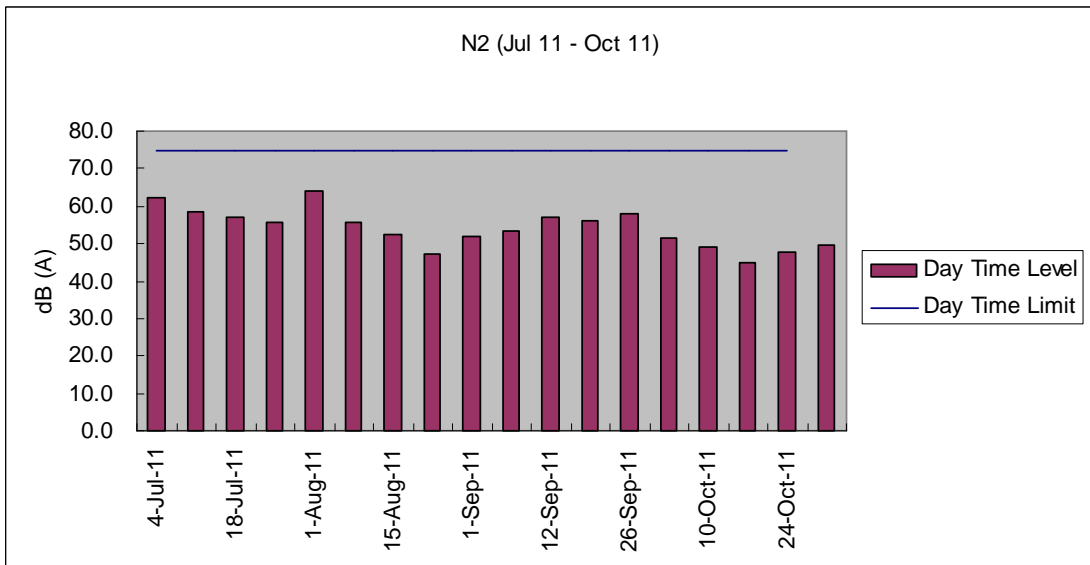
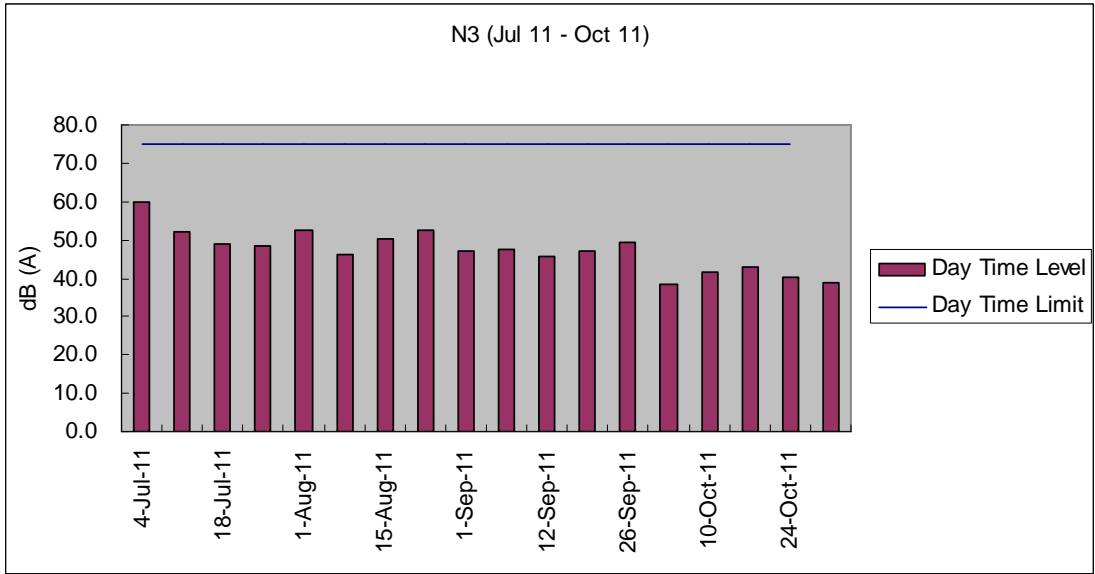
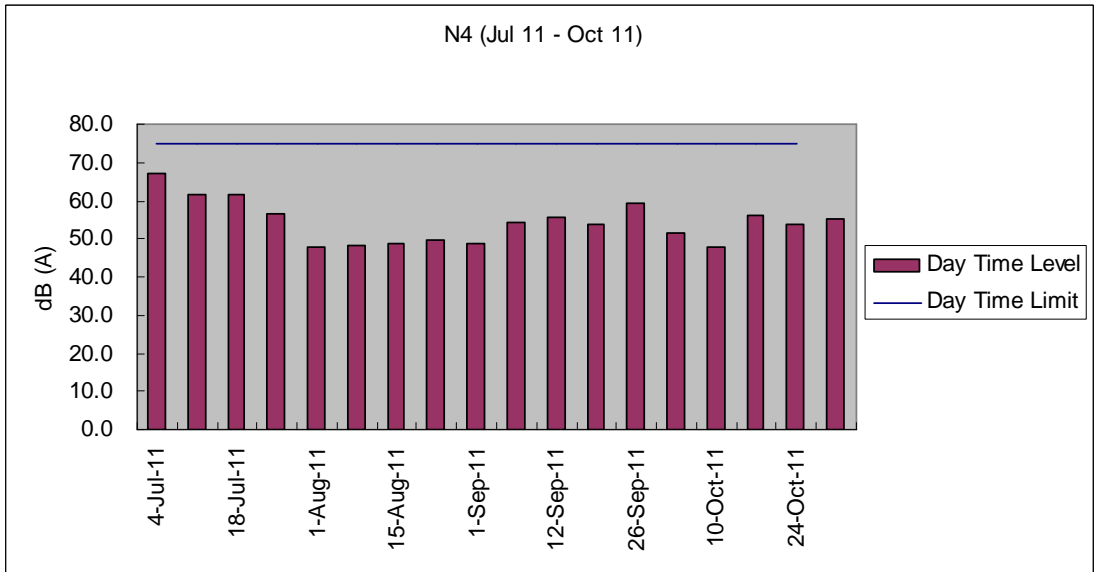
Graphical plot of noise
monitoring results

Relevant details of the noise monitoring results are presented in Table 4.4.1. The results, ranged between 38.5.dB (A) and 56.3dB (A) were within the limit levels and therefore, no exceedance was found.
