Monthly Environmental Monitoring & Auditing report for

Contract No.DC/2006/11

Drainage Improvement in Southern Lantau

November 2011

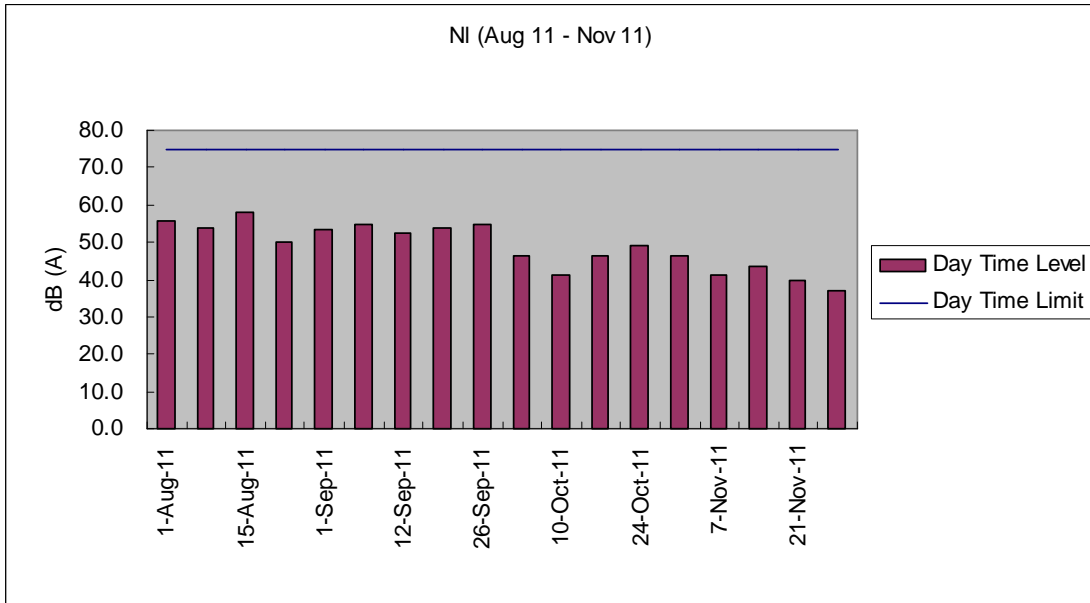
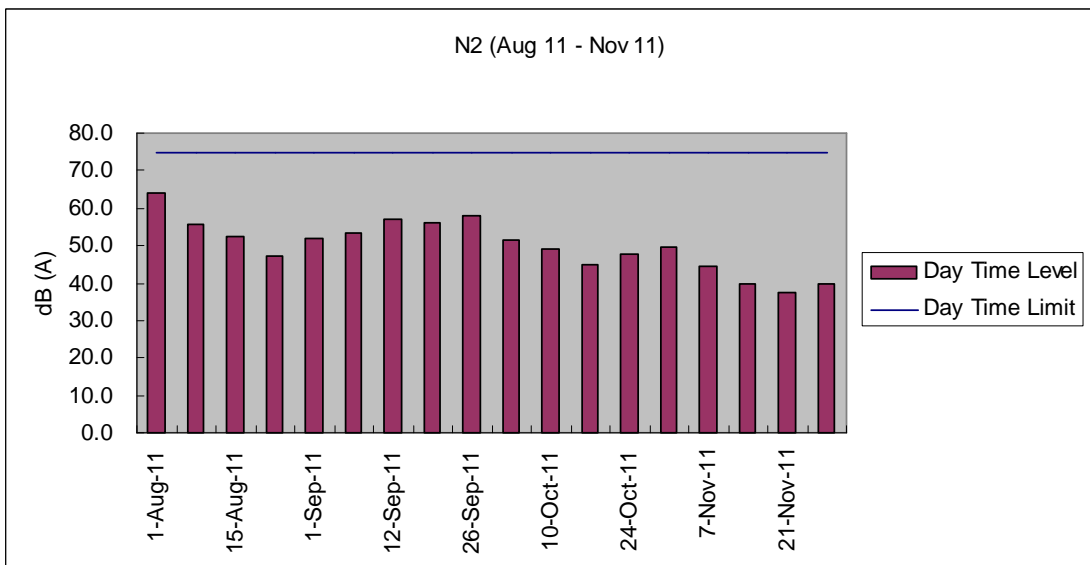
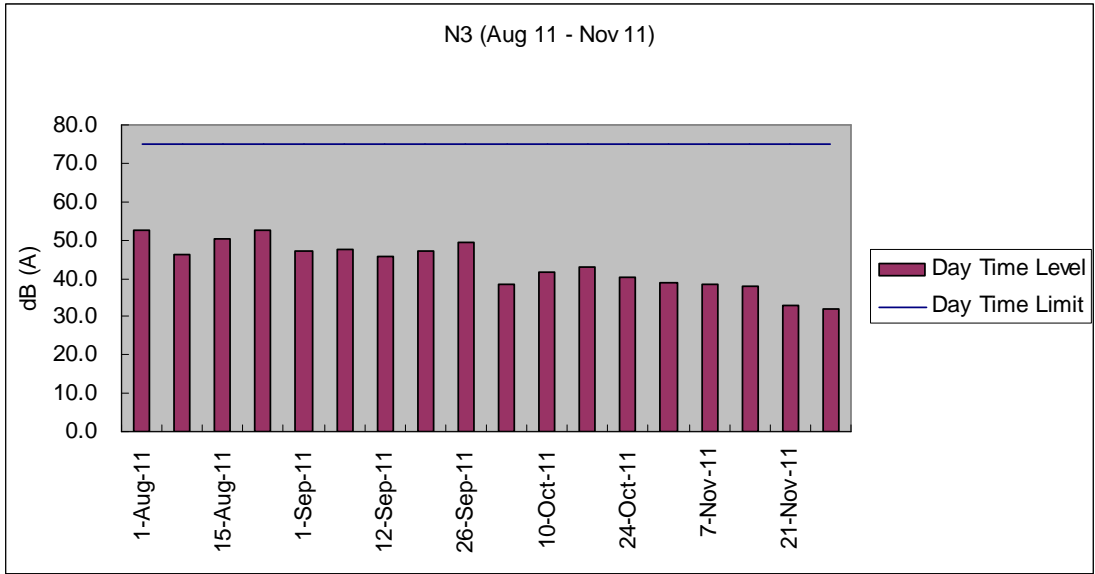
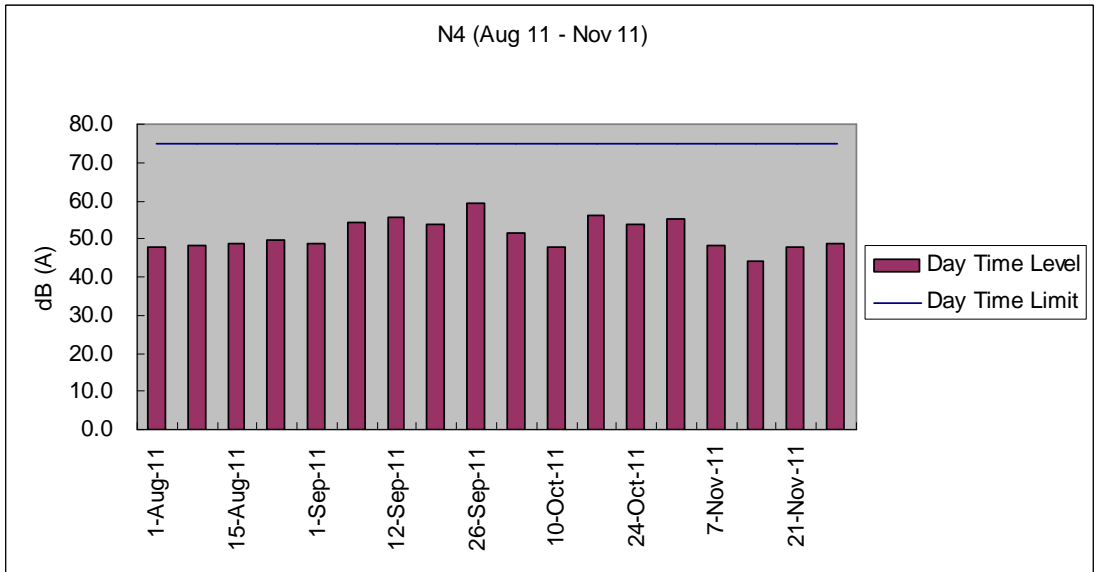
Graphical plot of noise
monitoring results

Relevant details of the noise monitoring results are presented in Table 4.4.1. The results, ranged between 35.1(A) and 48.7 (A), were within the limit levels and therefore, no exceedance was found.
