Agreement No. DP 04/2012
Post-Construction Ecological Monitoring
of Drainage Improvement Works in Southern Lantau
Implemented under 4128CD in Contract DC/2006/11

Monthly EM&A Report – February 2016

March 2016

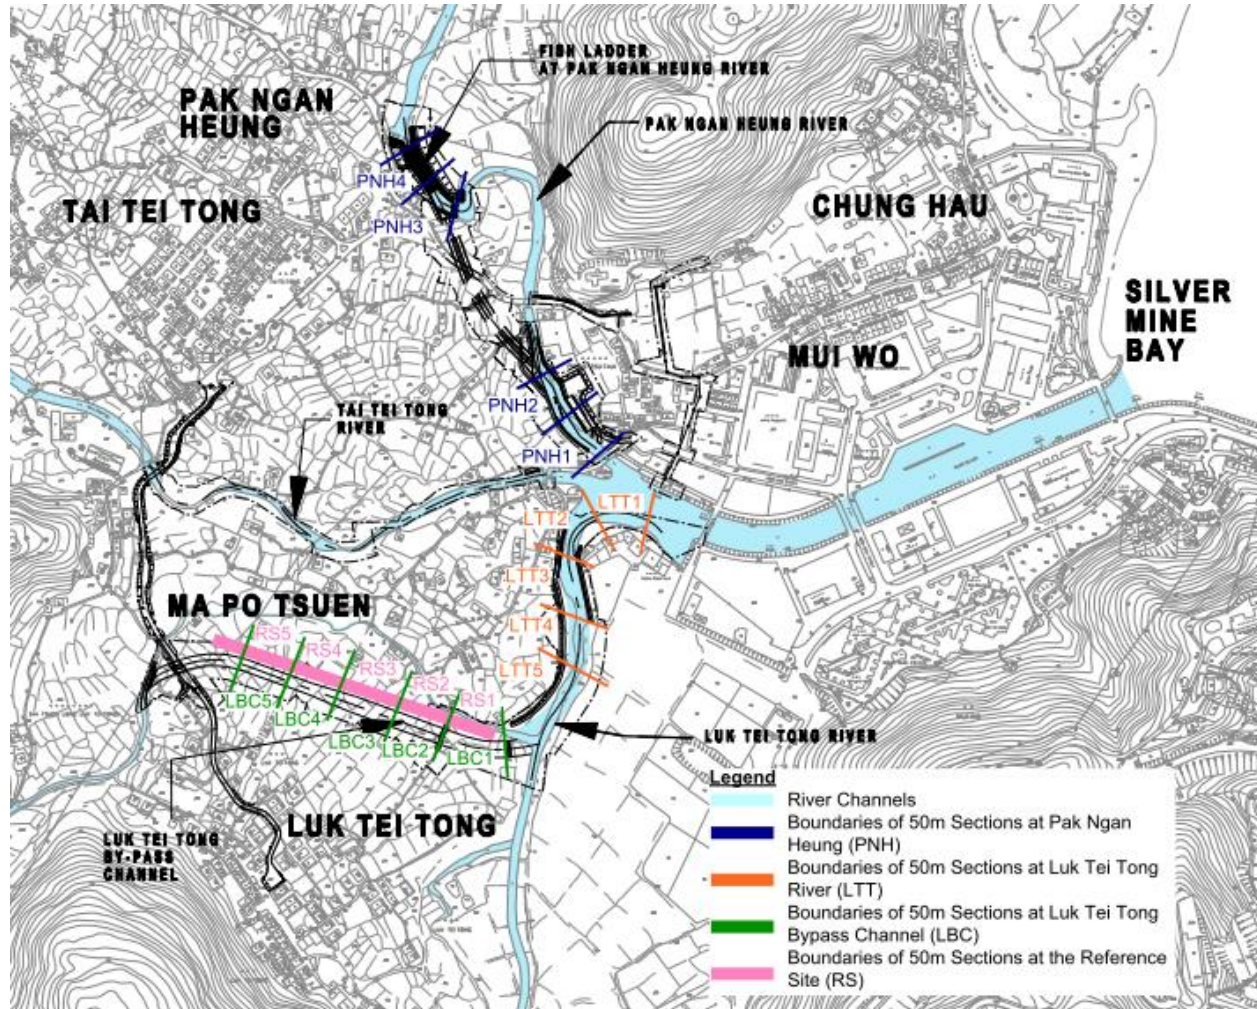
Figure 1 Ecological Monitoring Locations at Pak Ngan Heung River, Luk Tei Tong River, Luk Tei Tong Bypass Channel and the Reference Site

2.1.2. The ecological survey for these two rivers was divided into nine 50 m sections and comprised the following:

- Two sections for downstream of PNH (PNH1 and 2), two sections for upstream of PNH (PNH3 and 4);
- Five sections for LTT (LTT1 to 5).

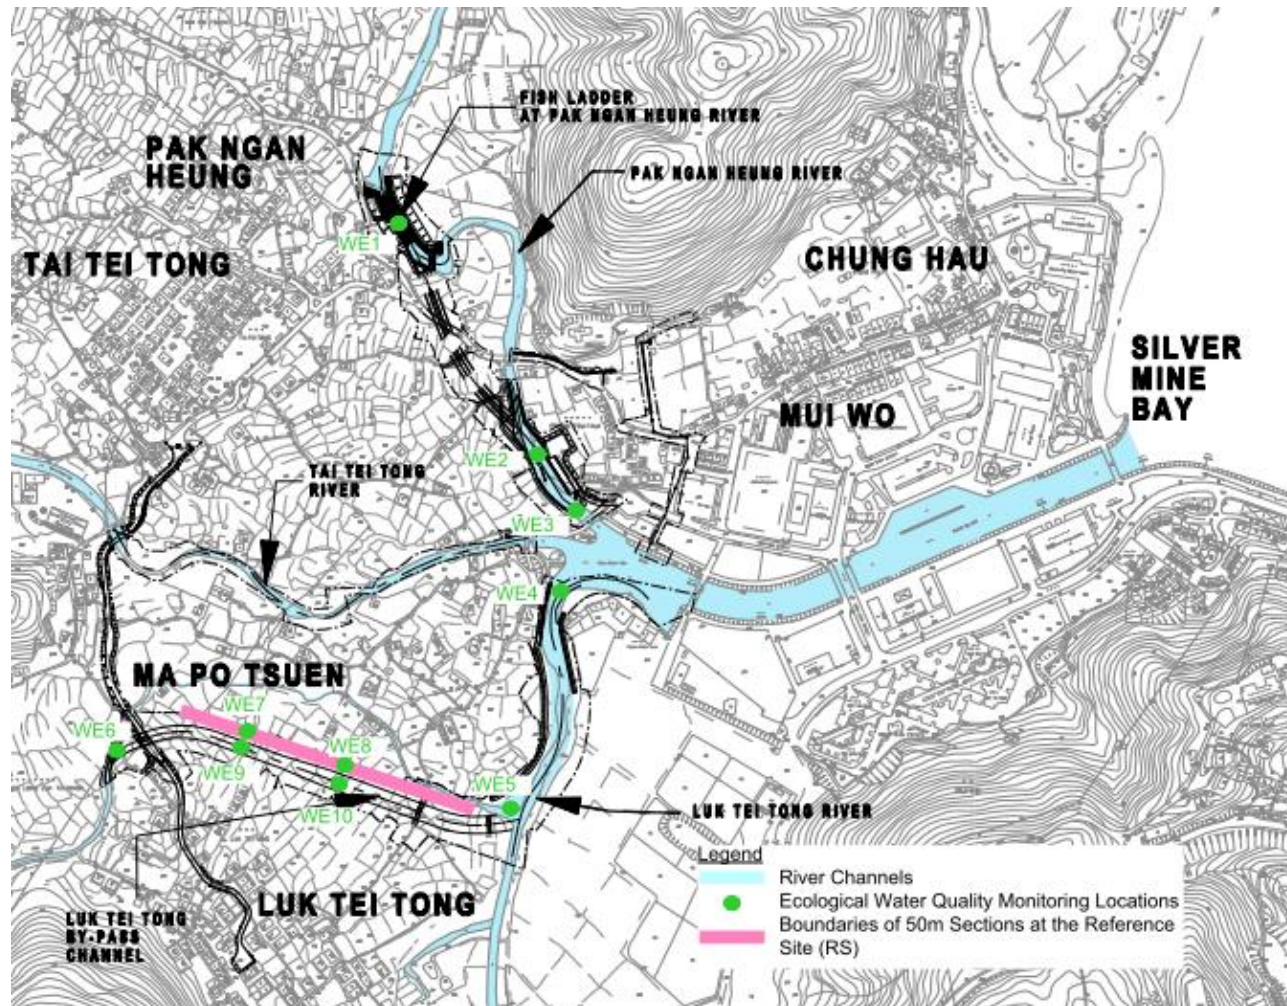
Figure 2 Ecological Water Quality Monitoring Locations at Pak Ngan Heung River, Luk Tei Tong River, Luk Tei Tong Bypass Channel and the Reference Site

2.2.1. Ecological water quality monitoring along PNH, LTT, LBC, and RS was carried out. Ten locations were selected and comprised the following:

- Three locations for existing PNH (WE1 to 3);
- Three locations for existing LTT (WE4 to 6);
- Two locations for RS (WE7 to 8);
- Two locations for existing LBC (WE9 to 10).

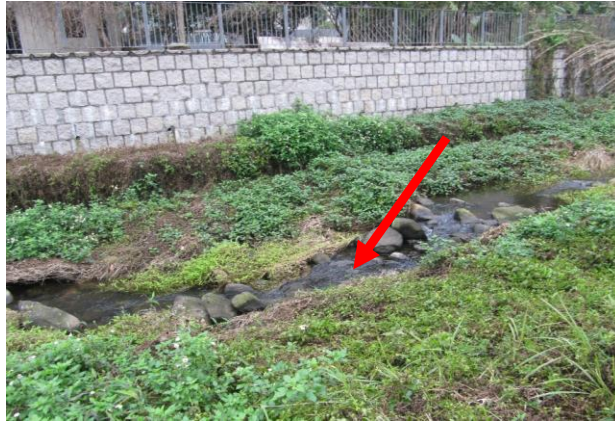
- 3.1.5. At PNH3 and PNH4, a total of 19 plant species were recorded. Exotic Mile-a-minute (*Mikania micrantha*) remained the dominant species on the banks of the PNH3 pool, the gabion of the PNH4 and the two edges of the cascade/fish ladder. In addition, herb species such as *Bidens alba*, Diffuse Day-Flower (*Commelina diffusa*) and *Wedelia trilobata* were also commonly recorded along the gabion of the PNH3, the sides of PNH3 pool and PNH4 cascade. The overgrown Mile-a-minute along the fish ladder that previously blocked the water flow had been cleared since the last monitoring period. Although vegetation started to overgrow at the edges of the PNH4 cascade/fish ladder, water could still flow freely along the fish ladder (refer to **Appendix 5**).

Vegetation was overgrown, but water can still freely flow along the fish ladder

- 5.7. Significant coverage of exotic Mile-a-minute (*Mikania micrantha*) is observed at the banks of the PNH3 pool, the gabion of the PNH4 and the two edges of the cascade/fish ladder (refer to **Appendix 5**). The overgrown Mile-a-minute along the fish ladder that previously blocked the water flow had been cleared since the last monitoring period. While vegetation continued to grow at the edges of the PNH4 cascade/fish ladder, water could still flow freely. The presence of vegetation growing on the fish ladder can hinder the use and movement by fish or freshwater community along PNH3 and PNH4, therefore regular weed removal is recommended to keep the fish ladder free from vegetation.

- 5.8. As any vegetation clearance of the cascade/fish ladder upstream of PNH3 has the potential to result in water quality impacts downstream (e.g. leakage of diesel from trimming machine), hand removal of vegetation is recommended at areas adjacent to the fish ladder and pools. In addition, the removed plants should be disposed properly (i.e. no trimmed/removed vegetation should be allowed to be washed downstream).

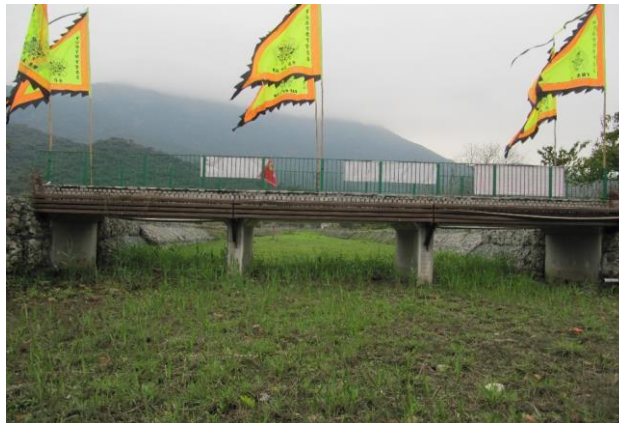
3.1.23. Re-establishment of the majority of vegetation has still been observed since the vegetation removal works in October 2015 when compared to the last monitoring period (December 2015) from LBC1 to LBC5. The vegetation coverage in LBC increased from 7% to 84% compared to the last monitoring. A total of 34 plant species were recorded in LBC, of which 16 species were recorded in the quadrats sampled. The list of plant species is presented in **Appendix 2b**. Among all the recorded species, about 38% were exotic species (**Table 3.5**). Similar to the last monitoring survey in December, half of the LBC1 section included a patch of open water. Other sections were dry.

Re-establishment of vegetation along LBC

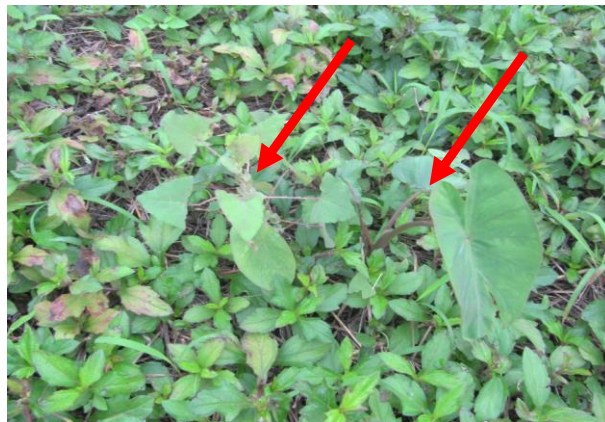
Wetland species were occasionally recorded at LBC2 to LBC5

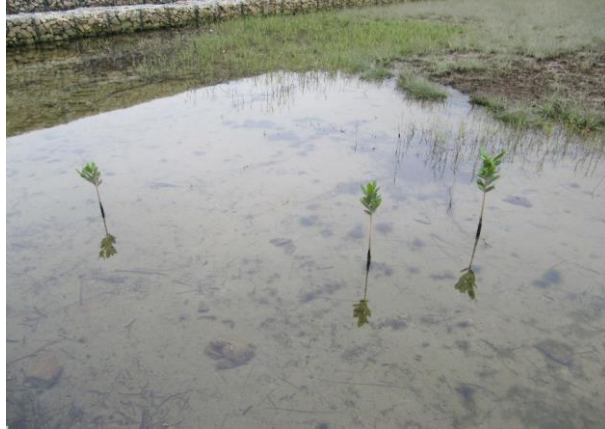
3.1.24. The habitat at LBC1 is different from the remaining LBC sections in terms of vegetation type. It adjoined LTT5 and had a pool of open water at the eastern tip. LBC1 may be subject to tidal influence during high tide because it is located immediately next to LTT. The sedge Ferruginous-scale Fimbristylis (*Fimbristylis sieboldii*) was re-established and became dominated at LBC1. Native Leather Fern (*Acrostichum aureum*), Reed (*Phragmites vallatorius*) and *Ruellia coerulea* were also common at the dry section west to the open water at LBC1. Four saplings of *Kandelia obovata* were recorded at the open water at LBC1.

Saplings of *Kandelia obovata* were recorded at LBC1

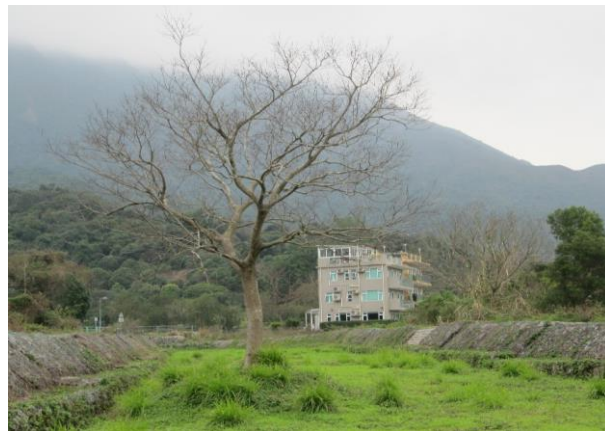
Trees recorded at LBC2 and LBC4 may hinder the re-establishment of marsh habitat

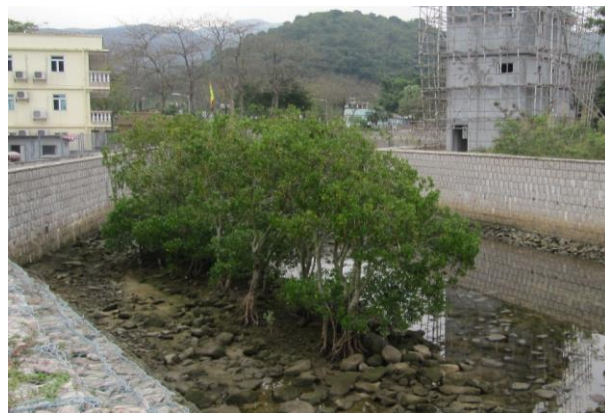
- 5.9. Mangrove stands of Spiny Bears Breech and *Kandelia obovata* were observed inside the river channel at LTT2 and LTT3 (refer to **Appendix 5**). Several *Kandelia obovata* seedlings were also observed at LTT1, LTT2, LTT3, and LTT5 and LBC1, indicating a natural re-colonization of mangrove at those sites.

Mangrove stands inside the river channel at LTT2 and LTT3
