## QUARTERLY EM&A REPORT

March 2016 – May 2016

**Contract Name** : Environmental Monitoring Works for  
Contract KL/2014/03 – Kai Tak Development  
– Stage 3 Infrastructure Works for Developments  
at the Southern Part of the Former Runway

**Report No.** : 0405/15/ED/0491B

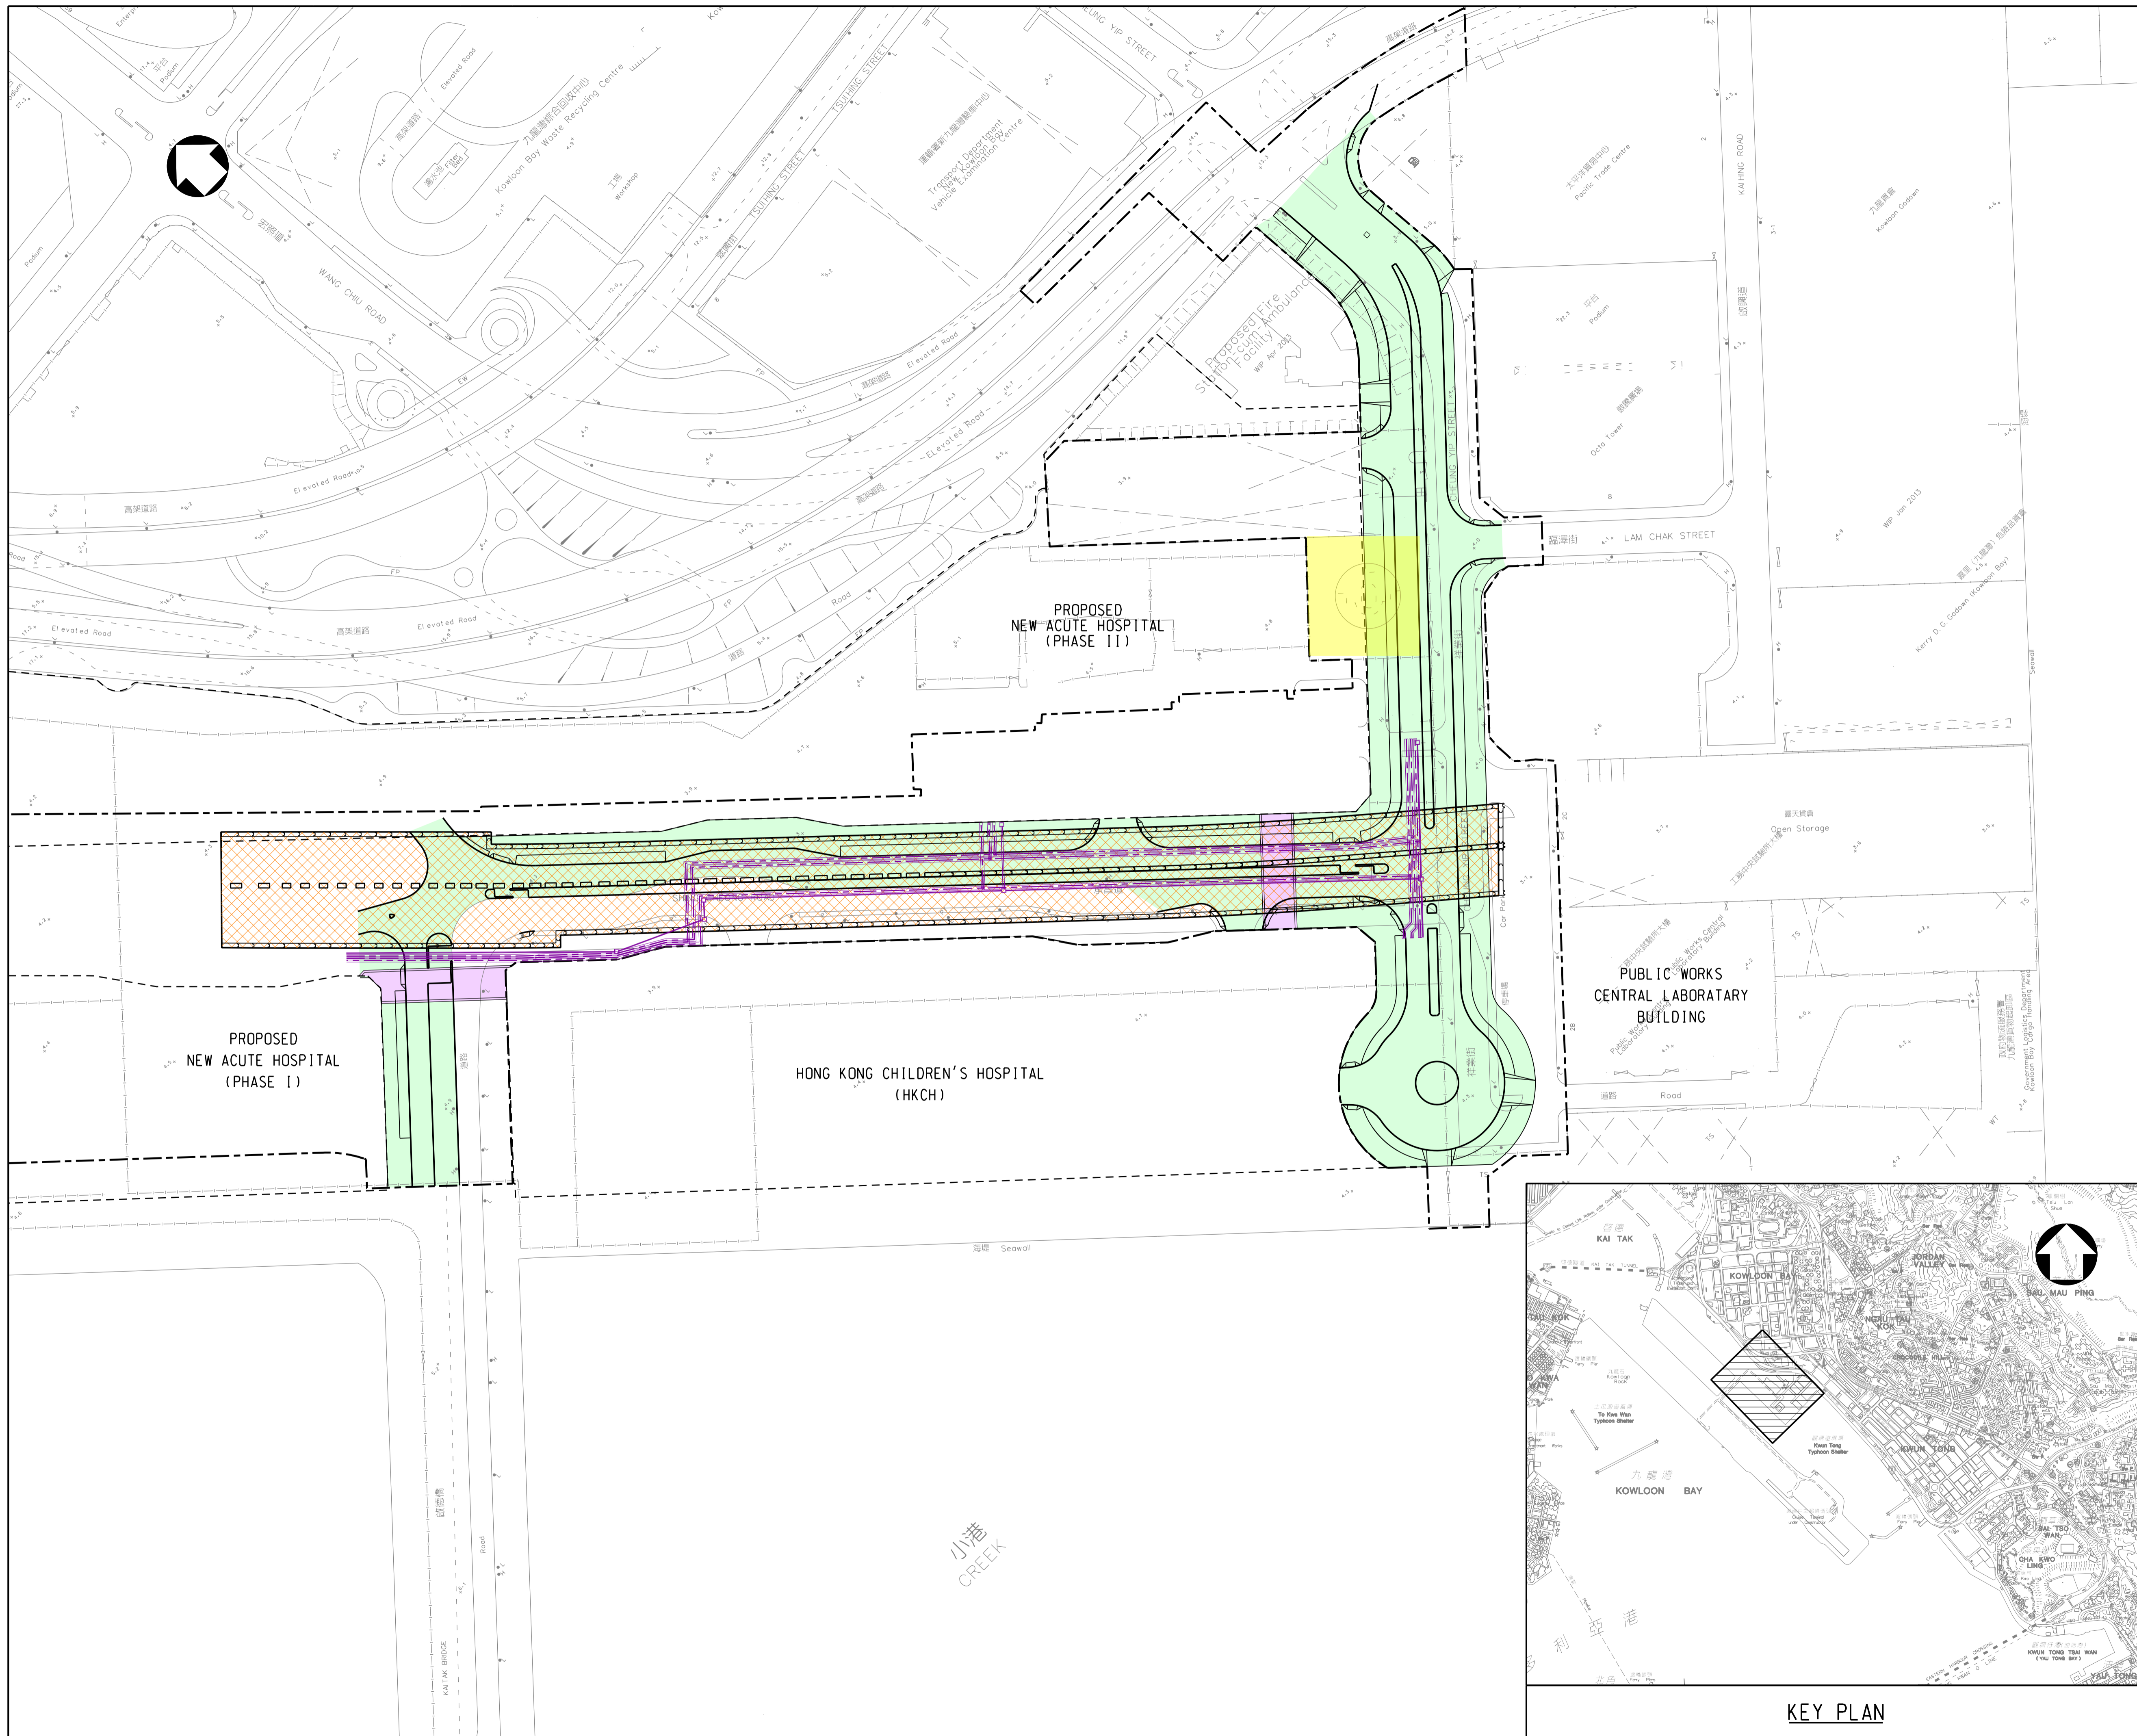
### **Figure 1**

1.1.3 The location and boundary of the site is shown in **Figure 1**.

### **Project General Layout**

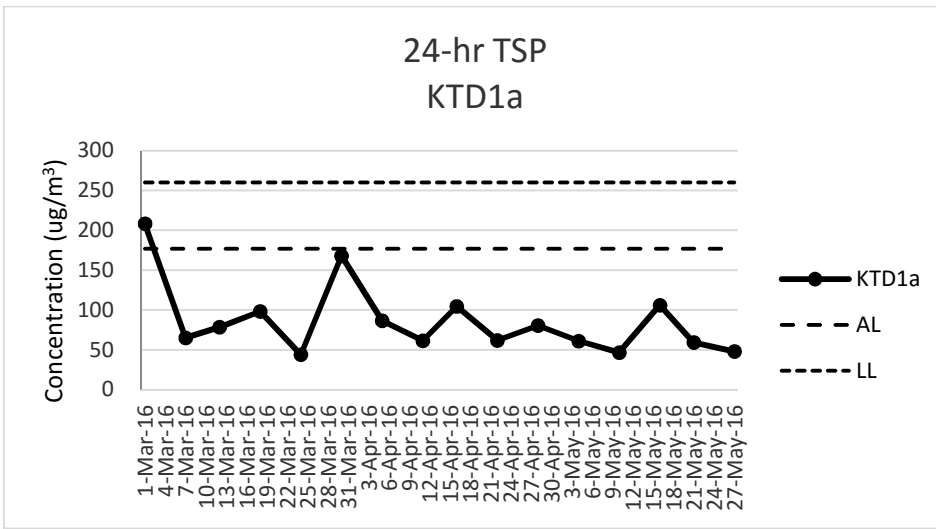
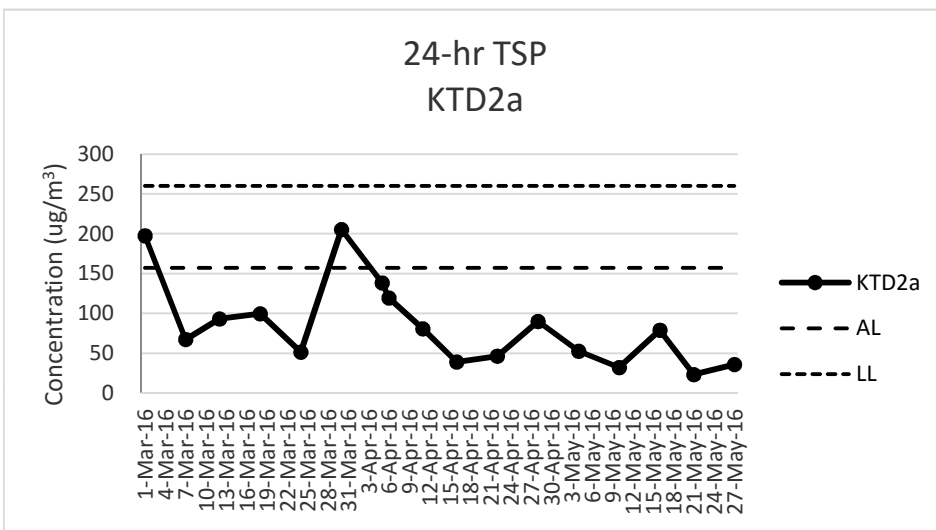
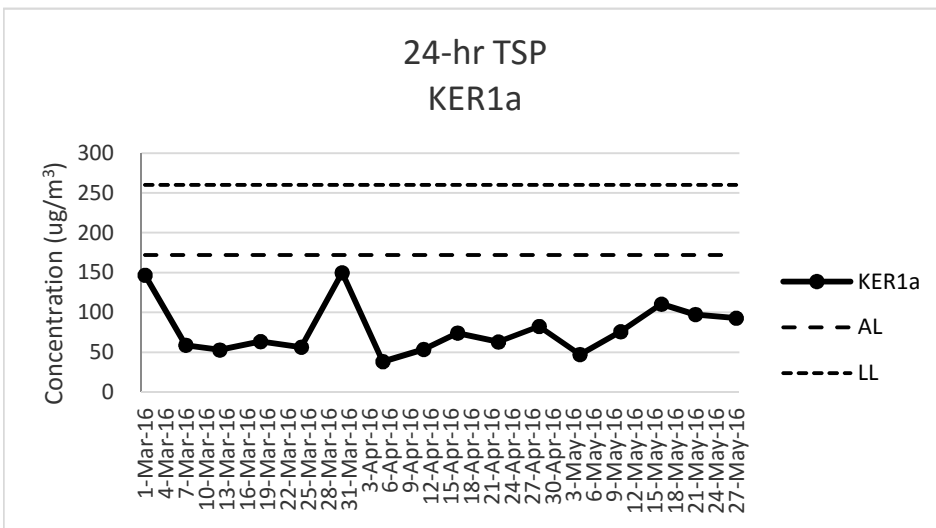
## Graphical Presentation on 24-hr TSP Monitoring Results

- 2.3.9 Graphical presentation of the monitoring data in the reporting period is presented in **Appendix D**.
- 2.4 Comparison of Monitoring Results with EIA Predictions**
