**Supplementary Contamination
Assessment Report (CAR)
for the remaining areas in
Radar Station**

Contract No. : KL/2008/02

Rev. No. : 3

Effective Date : 10 December 2009

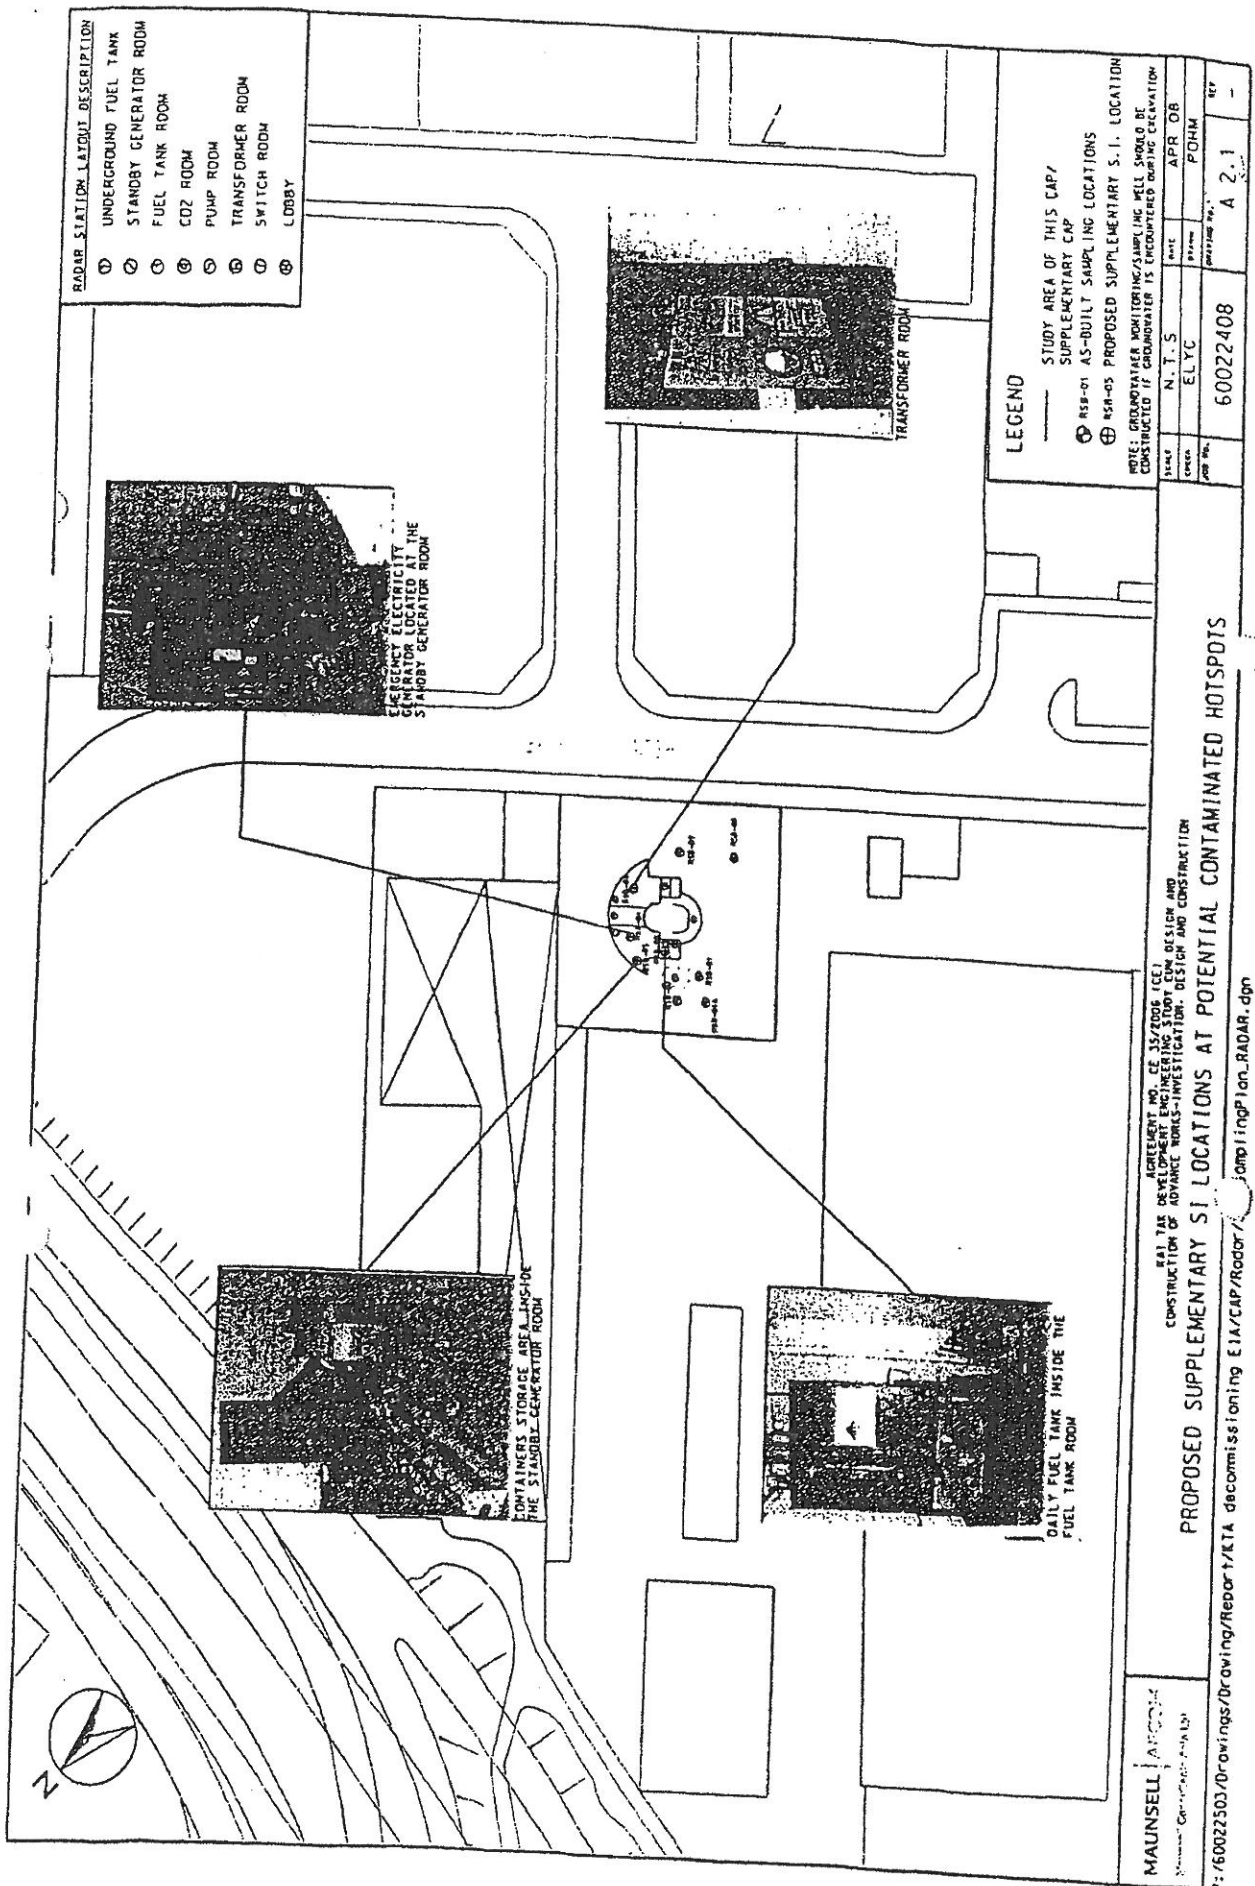
Drawing A2.1

**Proposed Supplementary SI
Locations at Potential
Contaminated Hotspots**

①	UNDERGROUND FUEL TANK
②	STANDBY GENERATOR ROOM
③	FUEL TANK ROOM
④	CO2 ROOM
⑤	PUMP ROOM
⑥	TRANSFORMER ROOM
⑦	SWITCH ROOM
⑧	LOBBY

EMERGENCY ELECTRICITY GENERATOR LOCATED IN THE STANDBY GENERATOR ROOM

CONTAINERS STORAGE AREA INSIDE THE STANDBY GENERATOR ROOM

TRANSFORMER ROOM

DAILY FUEL TANK INSIDE THE FUEL TANK ROOM

3.1.2 Only 2 trial pits were constructed within the Study Area as illustrated in Drawing 2.1. Water samples were collected inside the concrete chambers for trial pits located at RSB-05 and RSB-06 to determine any sign of contamination. As the underground concrete chamber at RSB-05 covers the sampling locations RSB-03 and RSB-04, no soil or water sample was taken RSB-03 and RSB-04.

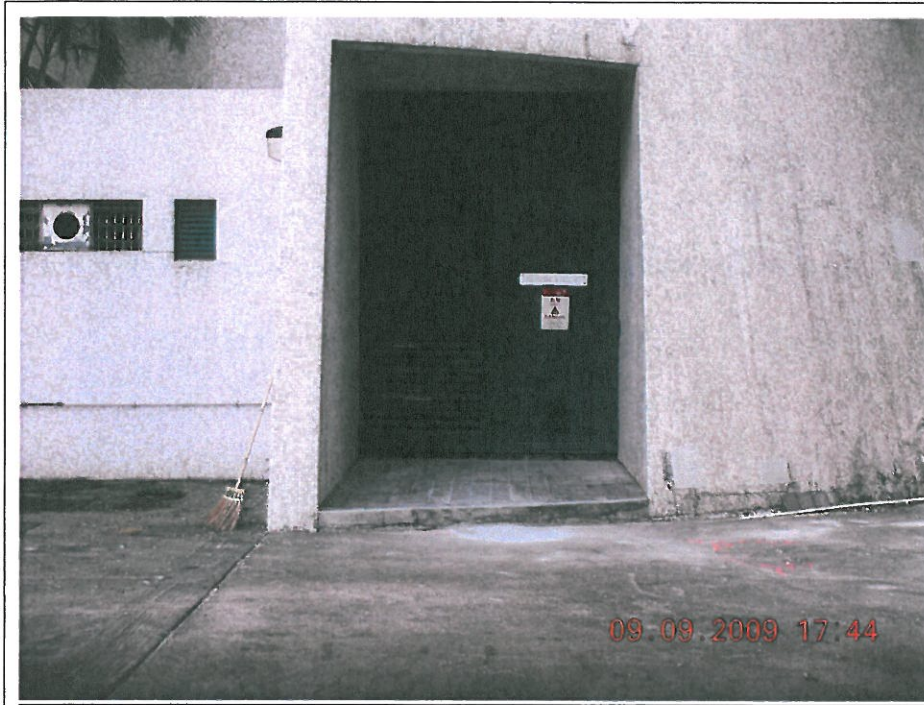
2.1.4 The floor of the Radar Station is well paved with concrete, visual inspection on the floors of the generator room, the fuel tank room and the transformer room also revealed no apparent sign of oil leakage.

General view
of Transformer
Room

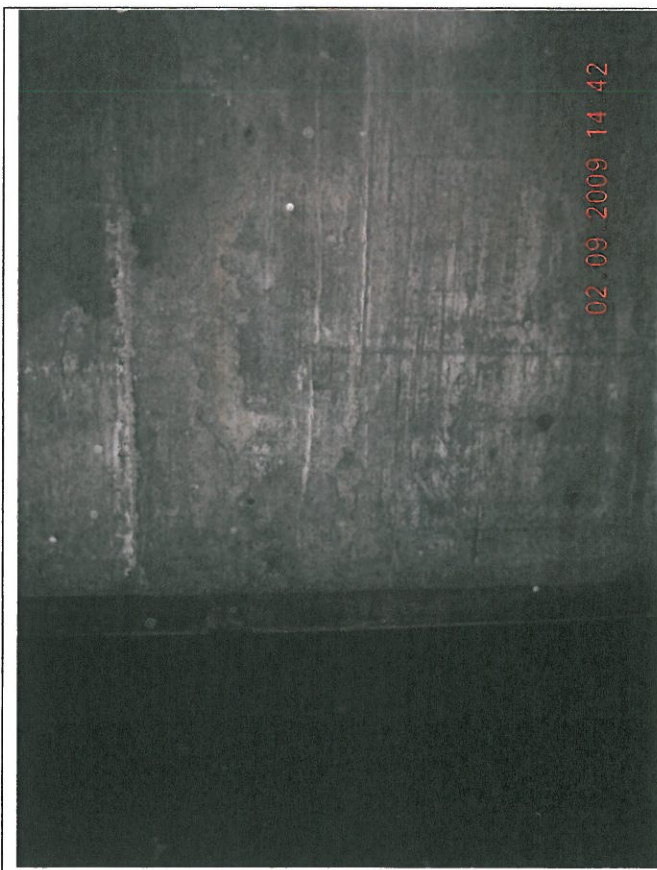
2.1.3 The concrete floors of sampling locations RSB-05 and RSB-06 were broken up during the site investigation. Large concrete chambers with extents covering the entire transformer room, the standby generator room and fuel tank room were discovered. Visual inspection of the underground chambers (i.e. void between concrete floor slab and top side of the concrete footing) identified no apparent evidence of oil staining and oil leakage. The presence of underground chambers has prevented a direct contact of potential contaminants with the soil underneath. No issue of land contamination is therefore expected and thus no soil sampling was proposed at the proposed sampling locations. However, the underground chambers were filled with small amount of residual water (2.5m³) and no free product was observed on the surfaces of the water. Water samples were then taken for laboratory analysis to confirm findings of the visual inspection. Record photos taken during the site investigation at the underground chambers underneath the fuel tank room and transformer room are presented in Appendix B.

4.1 The floor of the Radar Station is well paved with concrete, the concrete floors of sampling locations RSB-05 and RSB-06 were broken up during the site investigation and underneath void chambers were observed from the underneath of the generator room, the fuel tank room and the transformer room. They revealed no apparent sign of oil leakage during visual inspection.

4.3 Small amount of residual water was observed (no free product was observed on the top) and water samples were taken for laboratory analysis to confirm findings of the visual inspection.

View Inside
Concrete
Chamber of
Transformer
Room

4.5 As direct discharge of the residual water is not allowed under the WPCO, and in view of the small quantity of the residual water (2.5m³), it is recommended to take a conservative approach to have it collected by a licensed chemical waste collector prior to demolition of the concrete chamber.

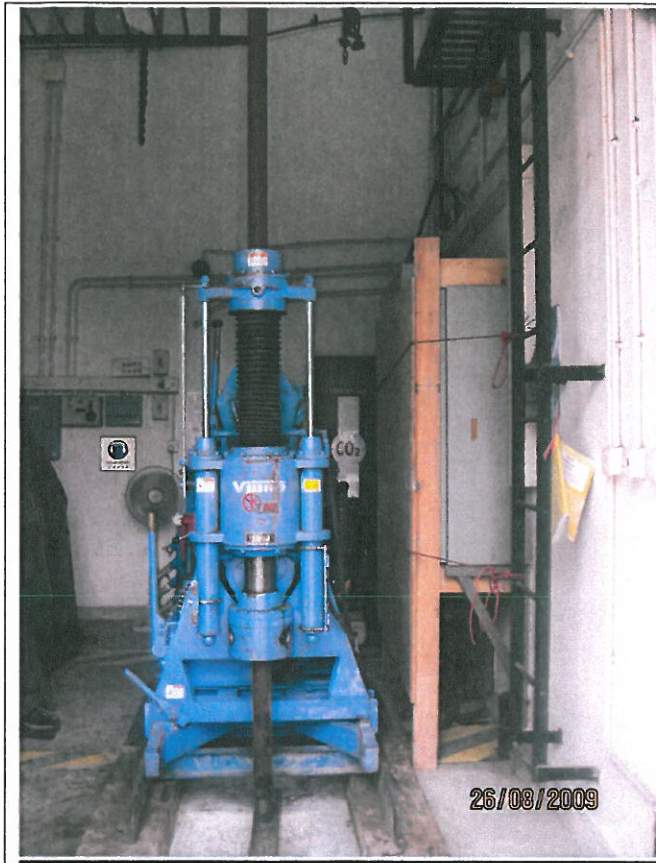
General view of
Generator
Room

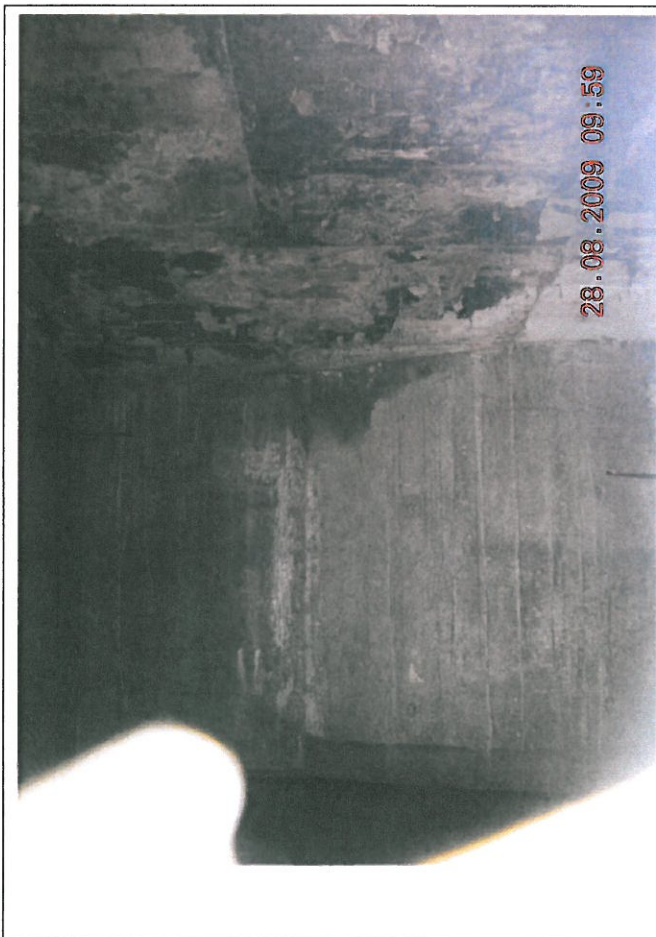
View Inside
Concrete
Chamber of
Generator
Room
