CONTRACT NO: KL/2009/01
SITE FORMATION FOR
KAI TAK CRUISE TERMINAL DEVELOPMENT

QUARTERLY ENVIRONMENTAL MONITORING & AUDIT
REPORT

- MARCH TO MAY 2011 -

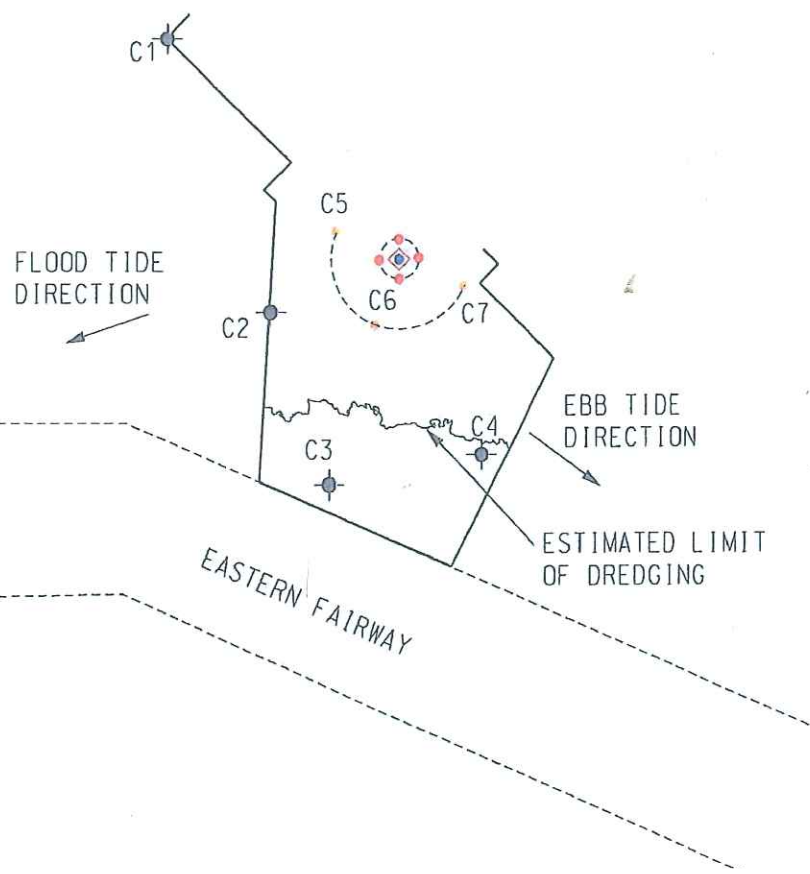
Figure 4.1

Layout of Monitoring Stations for Water Quality Surveillance System

1. The water quality monitoring works comprised of Set A and Set B. The Contractor shall carry out both sets of works (7 sampling stations in total).
2. Set A (4 sampling stations), the water quality monitoring works shall be taken at the Control Points (i.e. C1 to C4). Set B (3 sampling stations), the water quality monitoring works shall be taken at approximate 100m outside the silt curtain (i.e. C5 to C7) which the locations shall be changed from time to time to follow the movement of silt curtain.

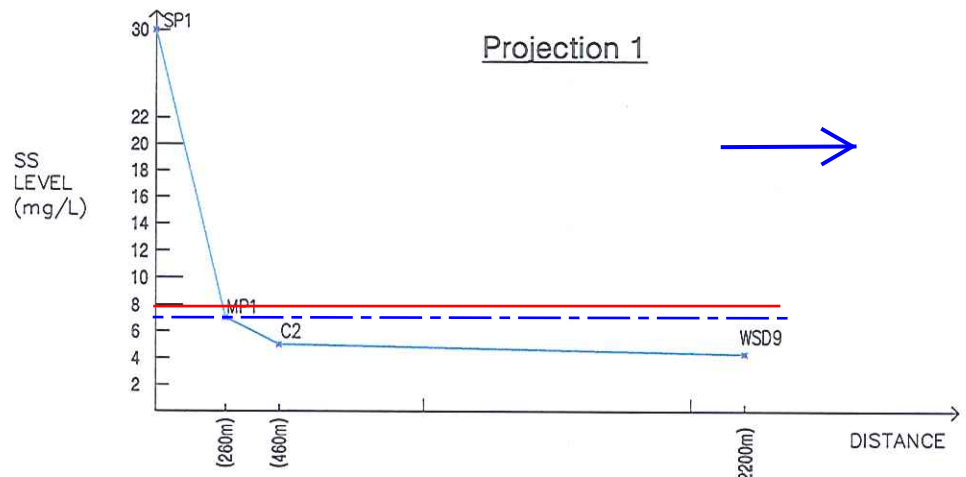
Description: WSD9 was located at downstream which had a SS level below SP1, MP3 and Control Point. The value is well within the Action Level.

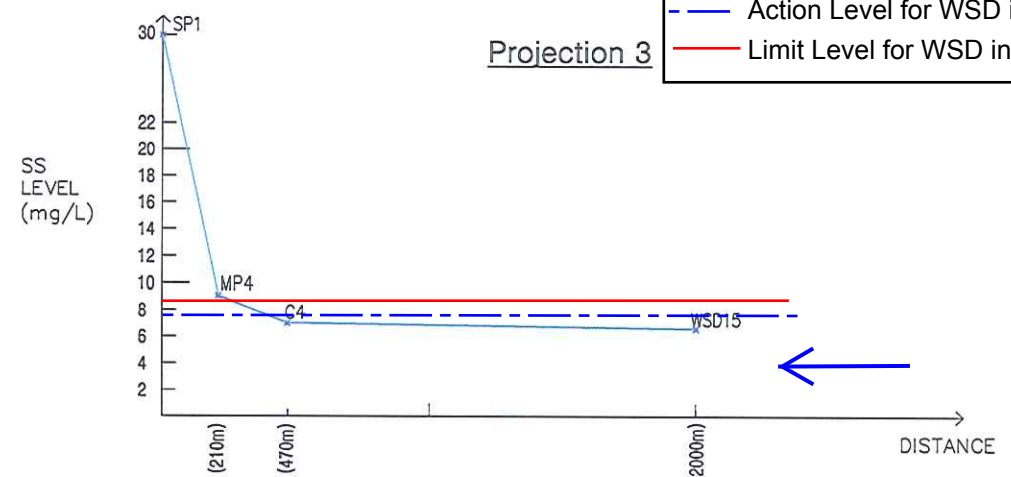
Description: WSD15 was located at upstream which had the lowest SS level to Control Point - C2.

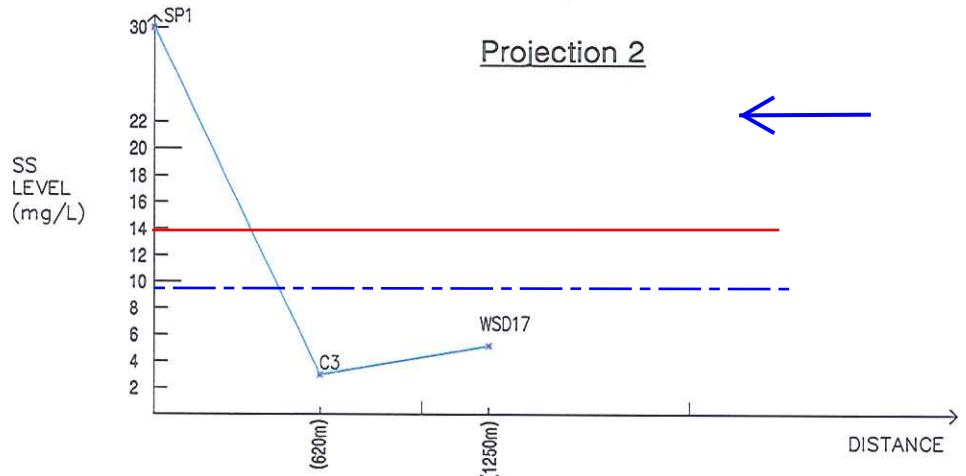
Description: WSD17 was located at upstream which was well within the Action Level.

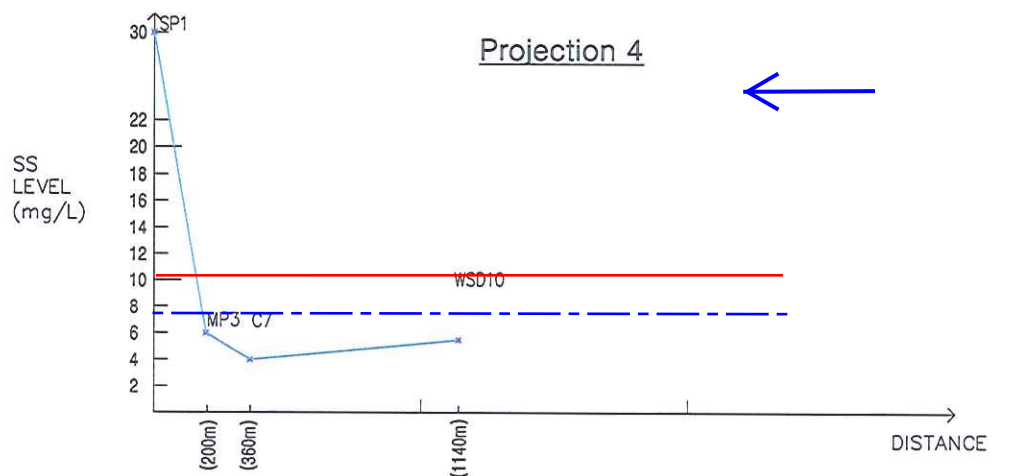
Description: WSD10 was located at upstream which had a similar SS level to Control Point - C7.

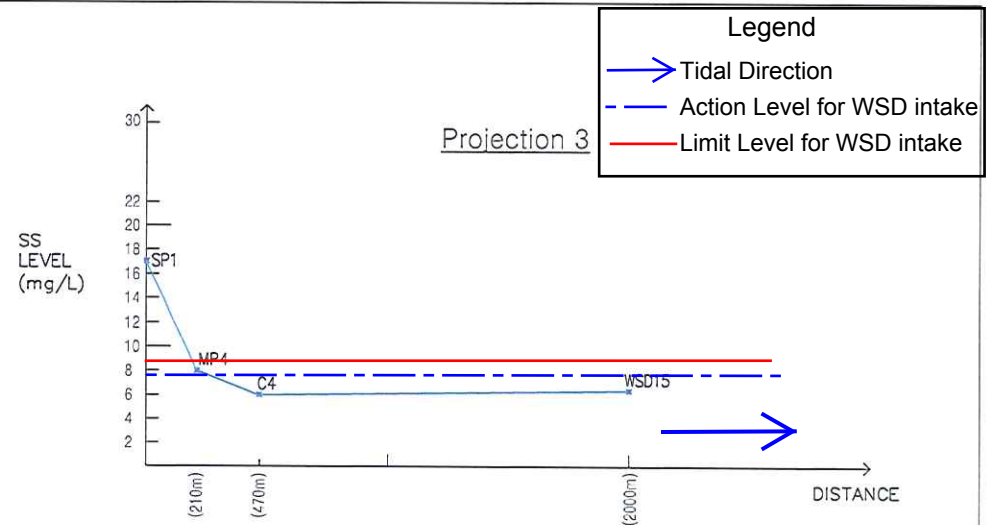
Description: WSD15 was located at downstream which had a SS level below SP1 and MP3 . The SS value was similar to Control Point - C4 and well within the Action Level.

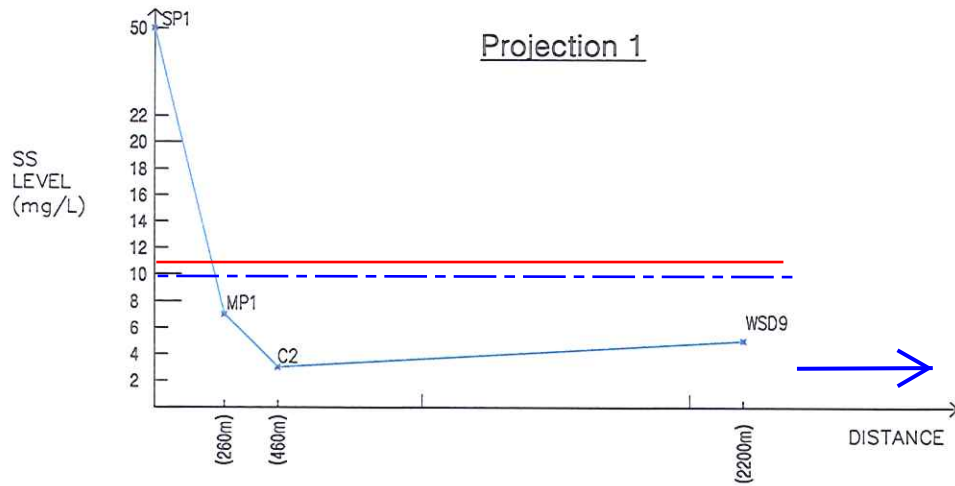
Description: WSD9 was located at downstream which had a SS level below SP1 and MP3. The value is well within the Action Level.

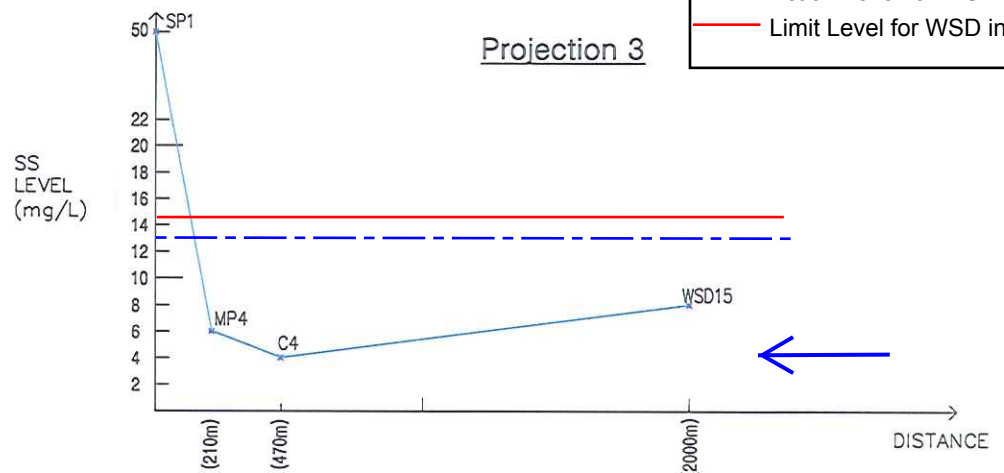
Description: WSD15 was located at upstream which was well within the Action Level.

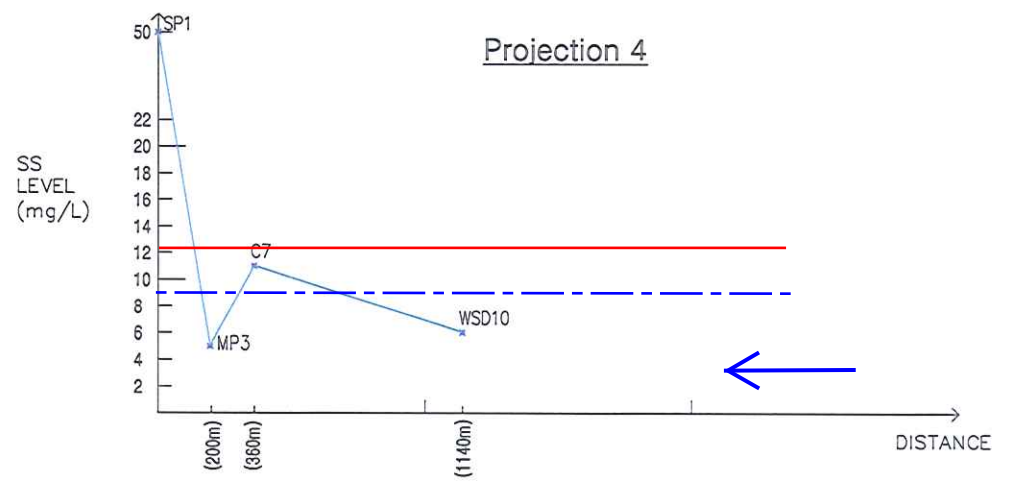
Description: WSD10 was located at upstream which was well within the Action Level.

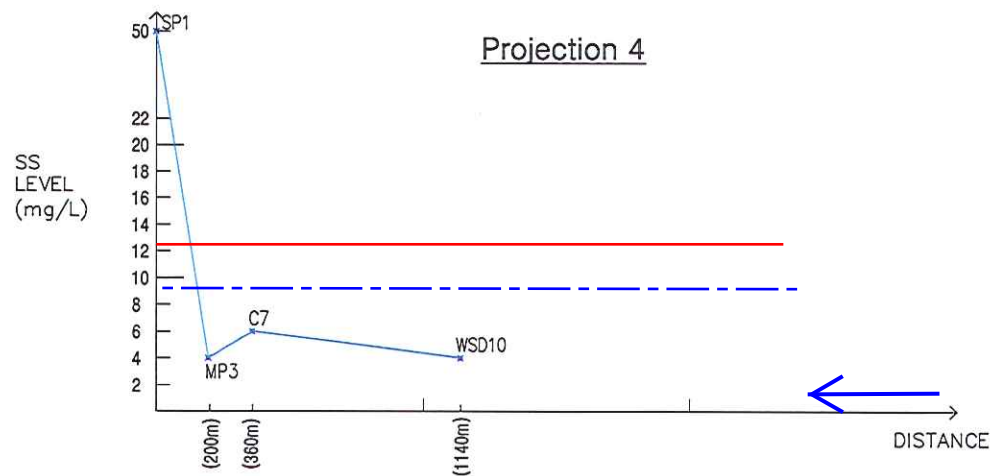
Description: WSD10 was located at upstream which was well within the Action Level.

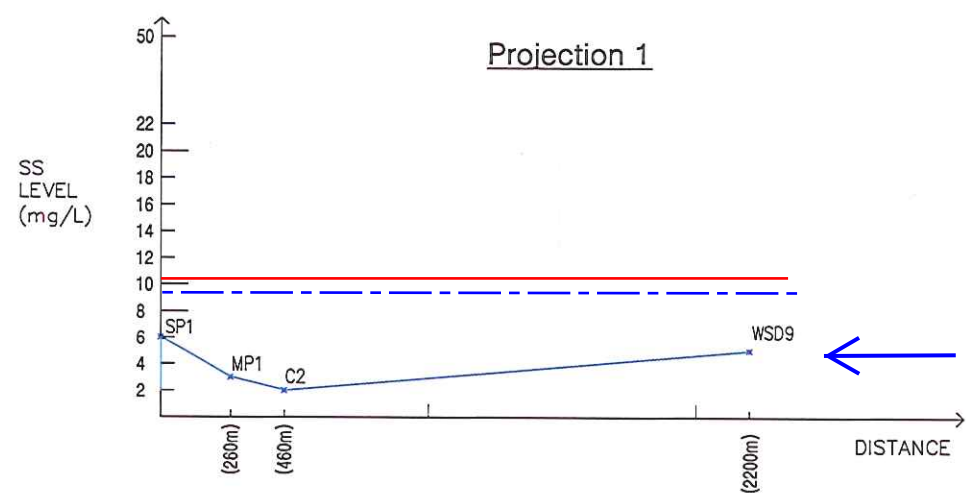
Description: WSD9 was located at upstream which was well within the Action Level.

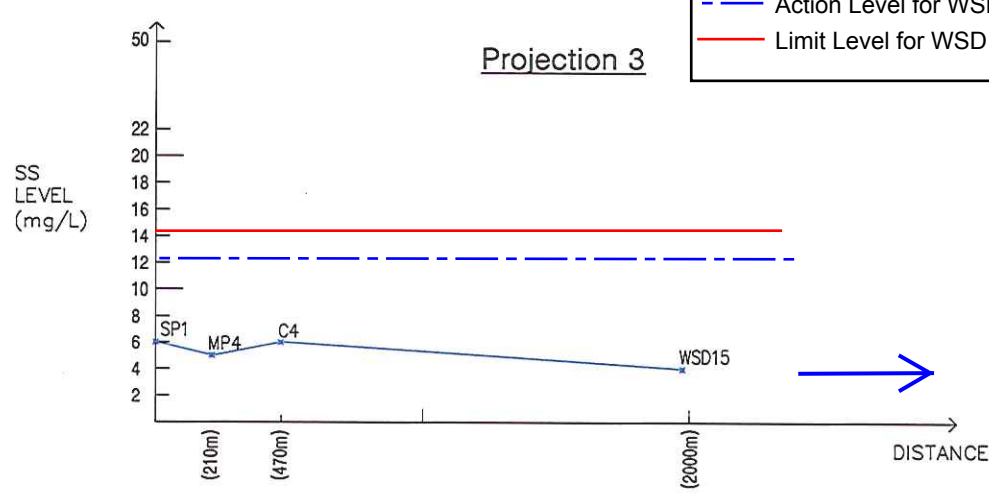
Description: WSD15 was located at downstream which had a SS level below SP1 and MP4. The SS value was similar to Control Point - C4 and well within the Action Level.

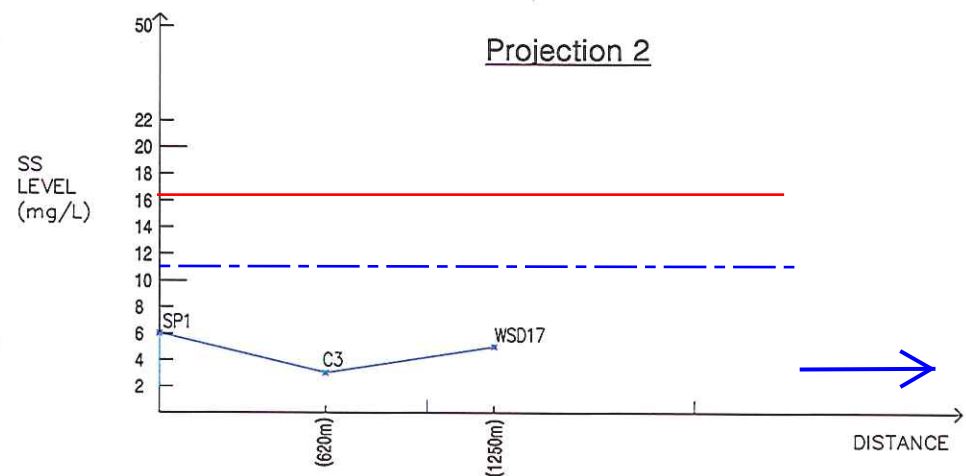
Description: WSD17 was located at downstream which had a SS level higher than the SP1 and control point. It can concluded there is existing variation in the vicinity of

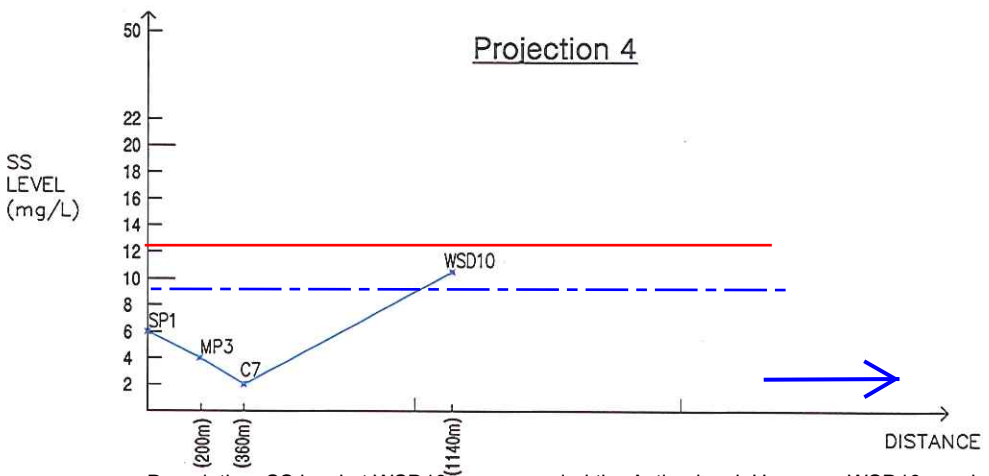
Description: SS level at WSD10 was exceeded the Action level. However, WSD10 was located at downstream which had a SS level higher than the MP3, control point and even SP1. It can concluded there was definitely existing variation in the vicinity of WSD10.

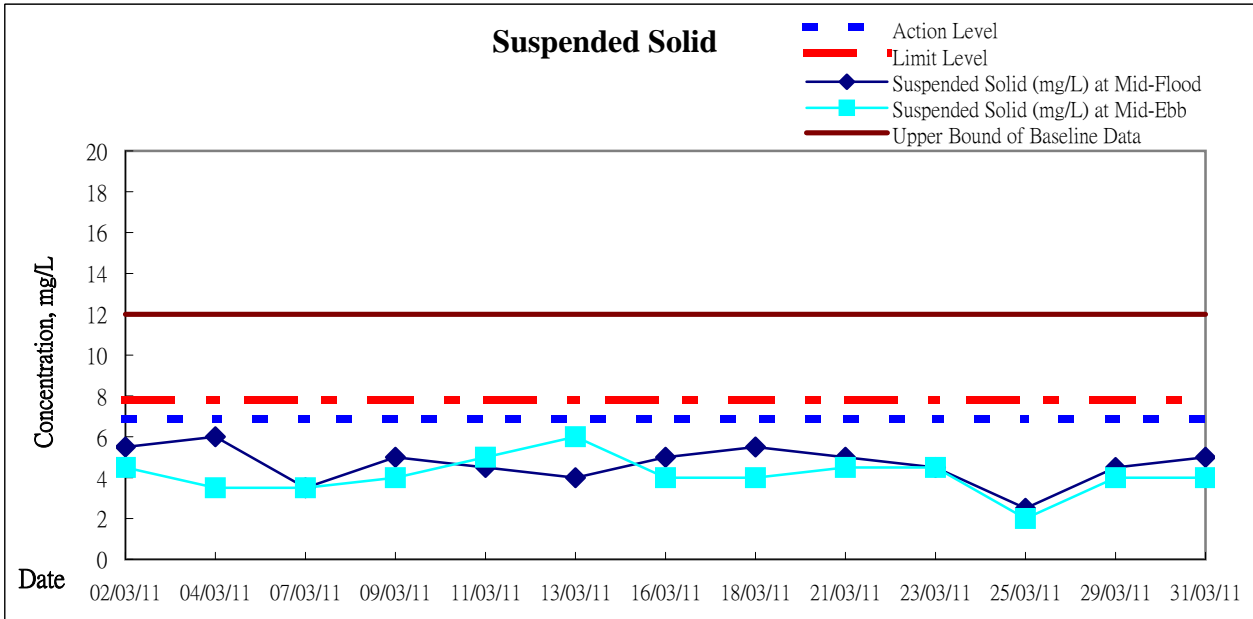
Graphic Presentation of Water Quality Result of WSD9 - Tai Wan with respect to Local Variation

Remarks: WSD9 is located at upstream during the ebb tides while at downstream during flood tides.

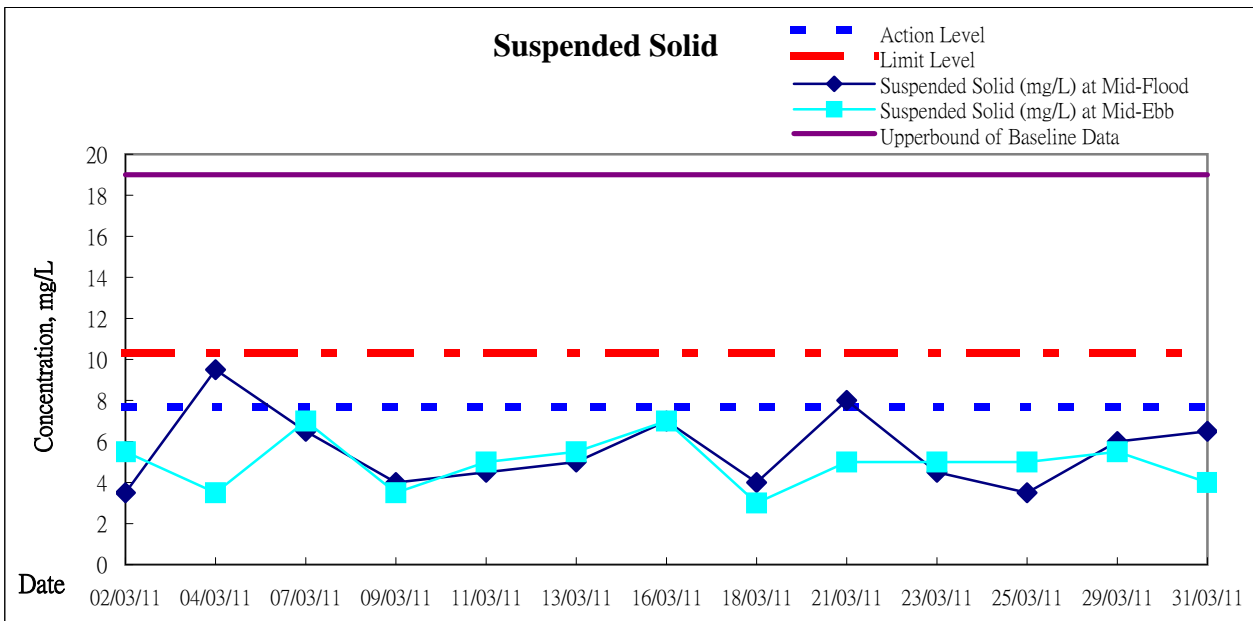
Graphic Presentation of Water Quality Result of WSD10 - Cha Kwo Ling with respect to Local Variation

Remarks: WSD10 is located at upstream during the flood tides while at downstream during ebb tides.

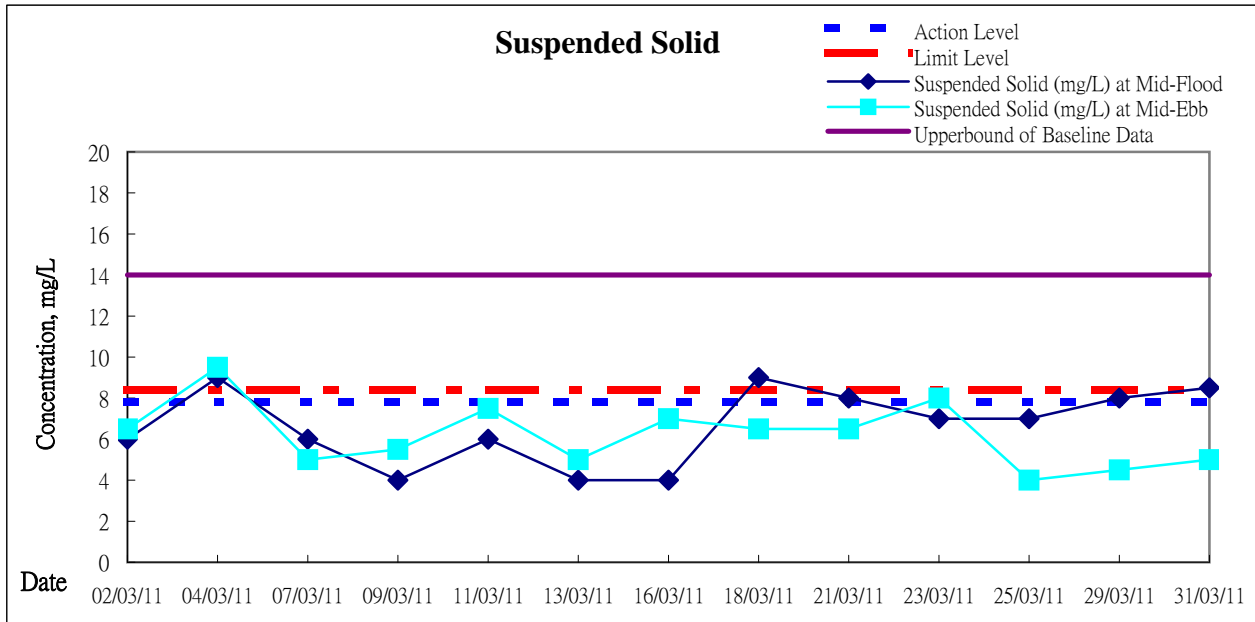
Graphic Presentation of Water Quality Result of WSD15 - Sai Wan Ho with respect to Local Variation

Remarks: WSD15 is located at upstream during the flood tides while at downstream during ebb tides.

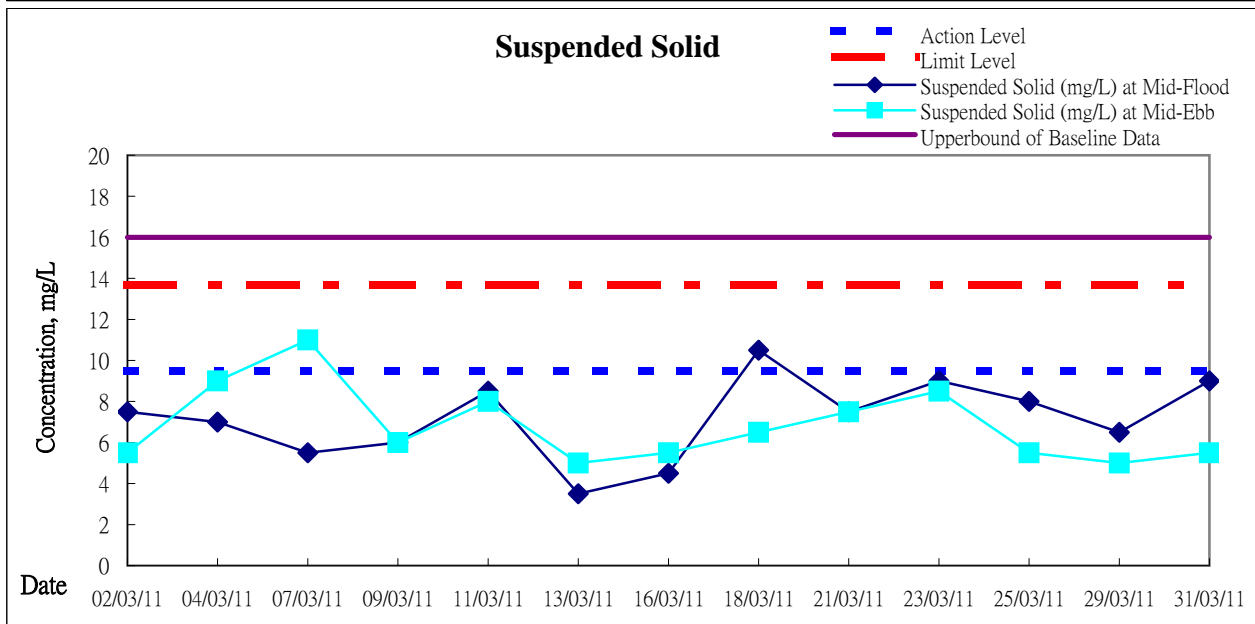
Graphic Presentation of Water Quality Result of WSD17 - Quarry Bay with respect to Local Variation

Remarks: WSD17 is located at upstream during the flood tides while at downstream during ebb tides.

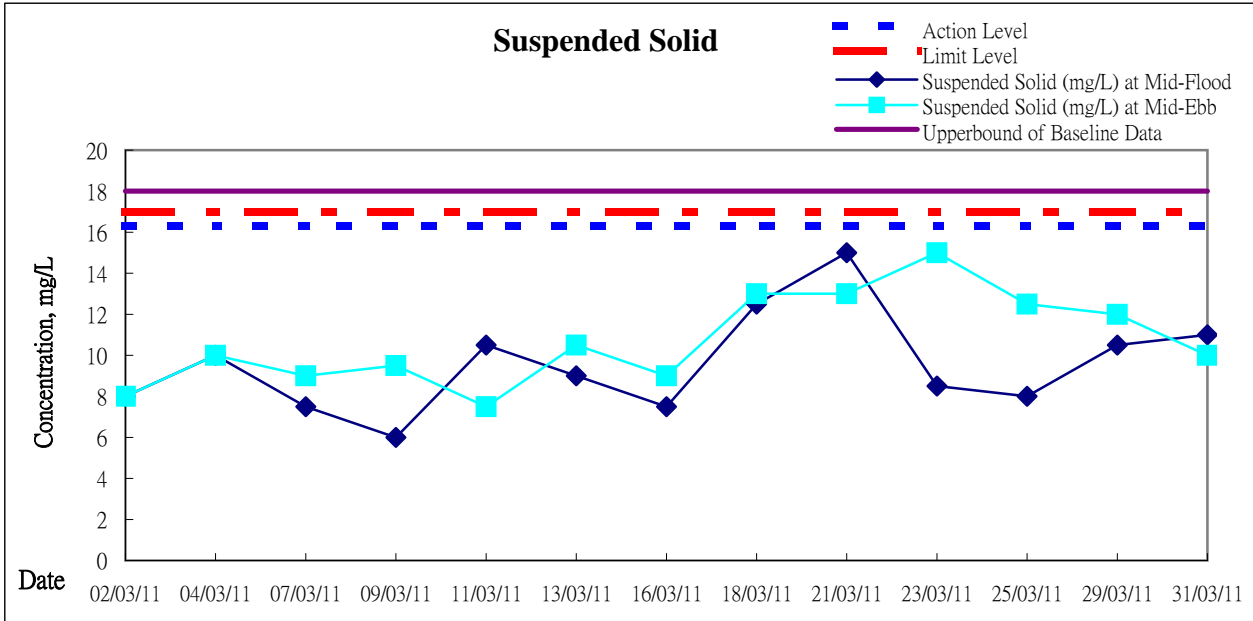
Graphic Presentation of Water Quality Result of WSD19 - Sheung Wan with respect to Local Variation

Remarks: WSD19 is located at upstream during the ebb tides while at downstream during flood tides.

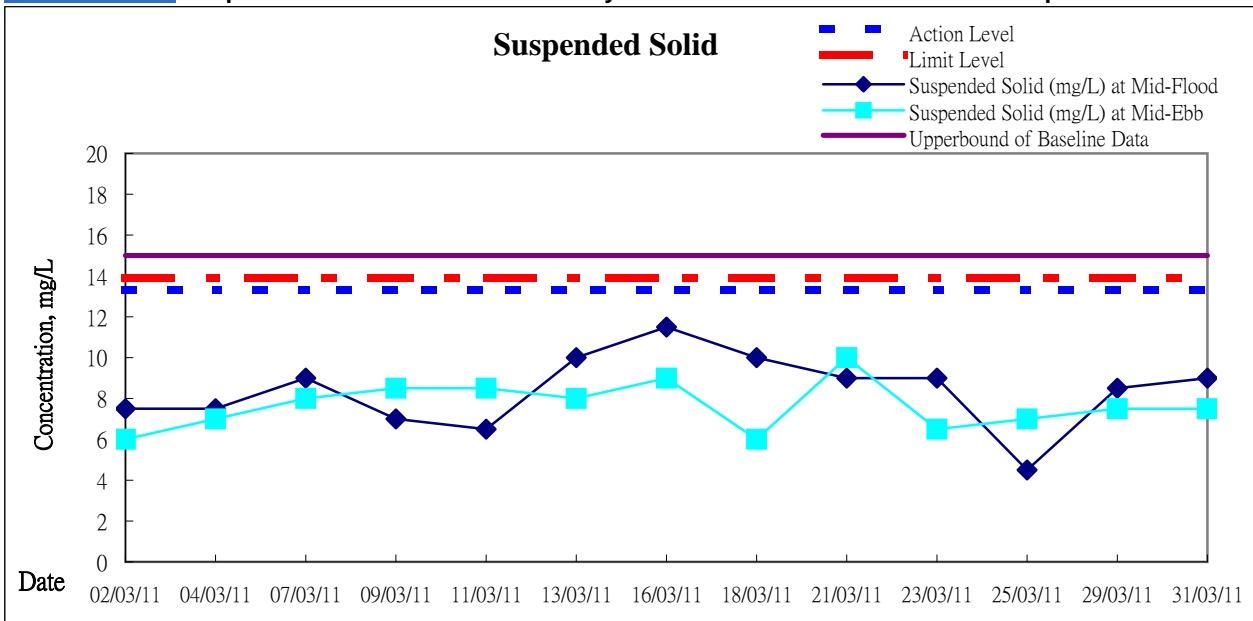
Graphic Presentation of Water Quality Result of WSD21 - Wan Chai with respect to Local Variation

Remarks: WSD21 is located at upstream during the ebb tides while at downstream during flood tides.
