Contract No. CV/2013/02

**CEDD Maintenance Contract for Seawalls
and Navigation Channels (2013-2016)**

Dredging at Cruise Terminal Stage 2

Monthly EM&A Report

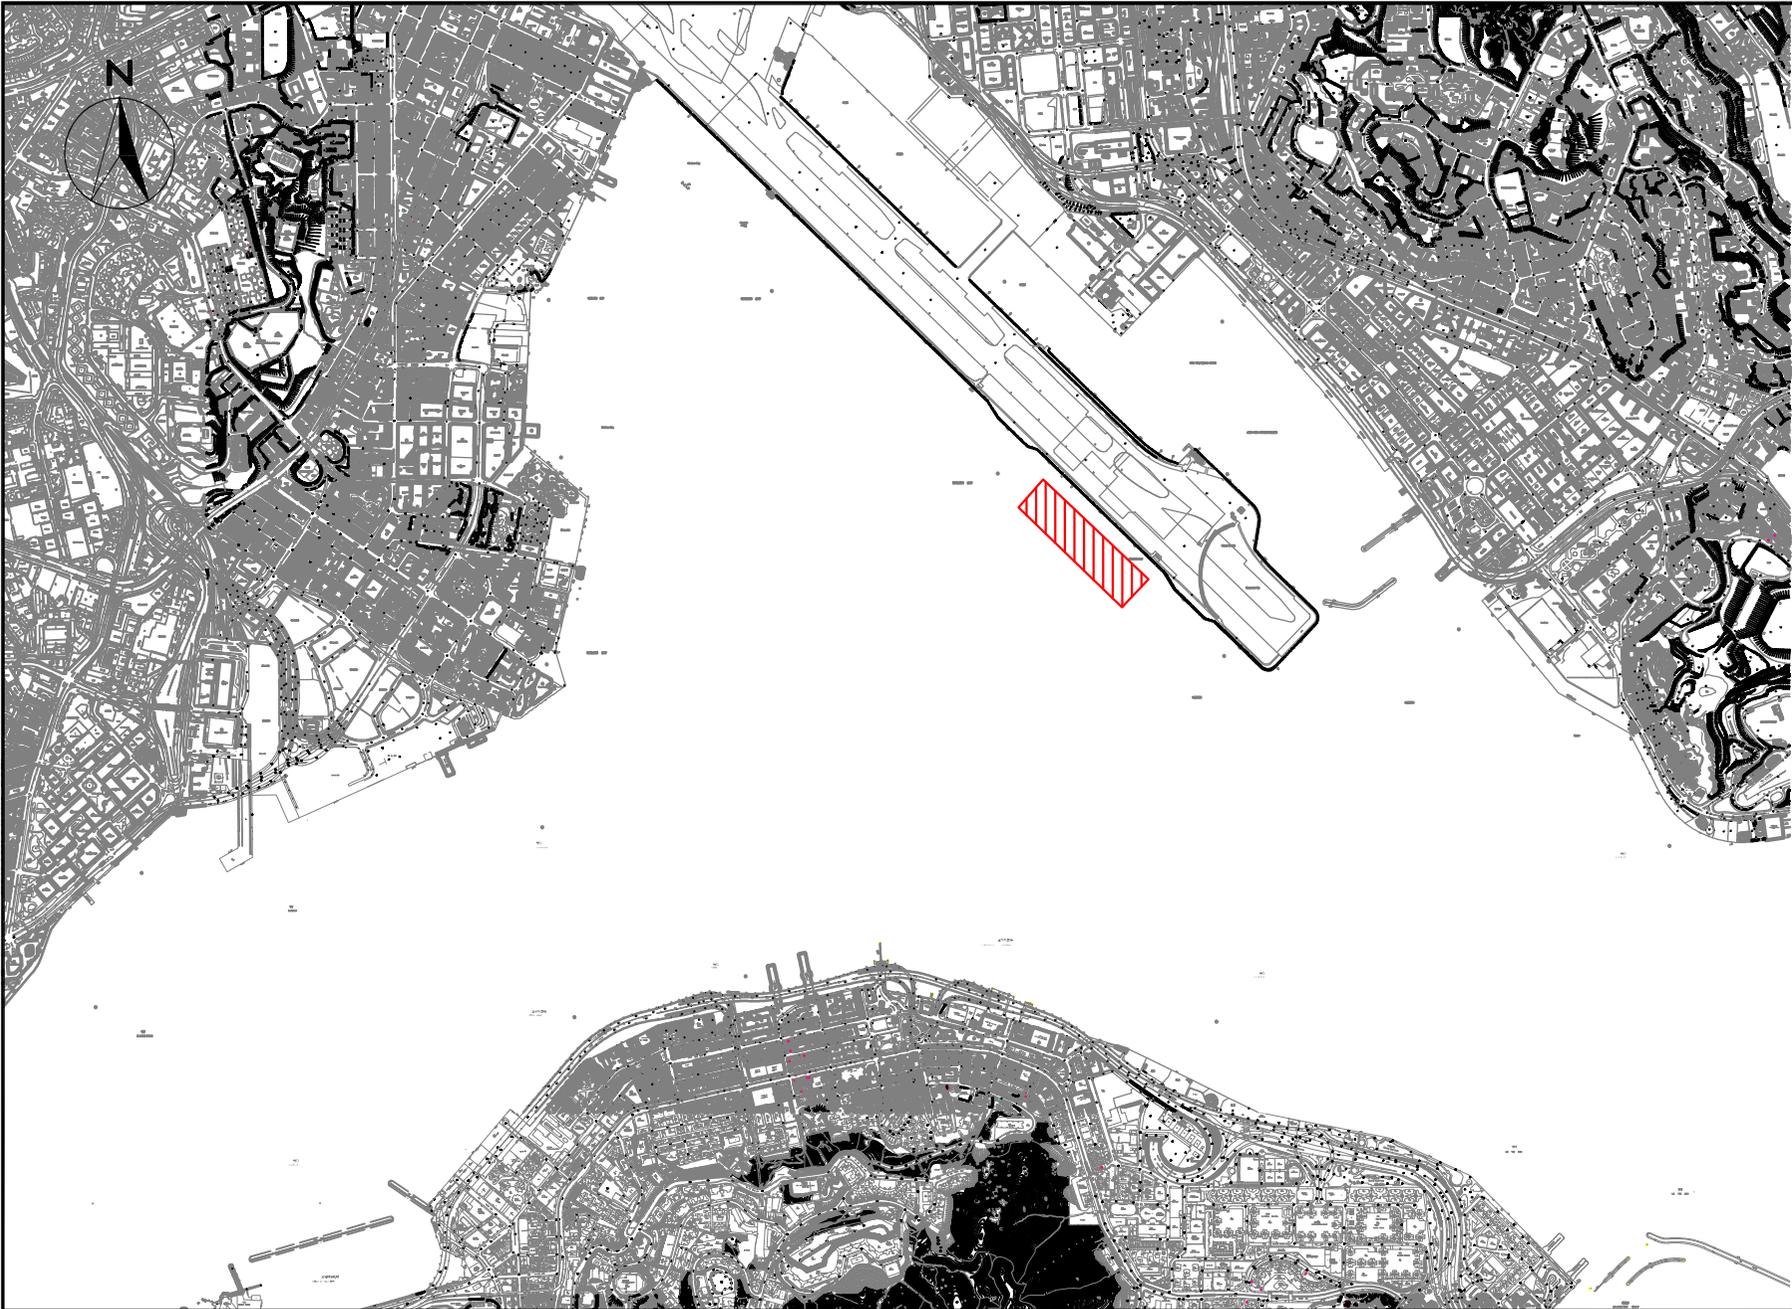
SCALE	1:25000@A4	DATE	MAR 14	
CHECK	IT	DRAWN	JW	
JOB No.	MA14015	FIGURE NO.	1	REV -

- 2.3 Development of the cruise terminal at Kai Tak would require dredging at the existing seawall at the southern tip of the former Kai Tak Airport runway for construction of a quay deck structure for two berths, and dredging the seabed fronting the new quay to provide necessary manoeuvring basin. The general layout of the proposed cruise terminal construction is shown in **Figure 1**.

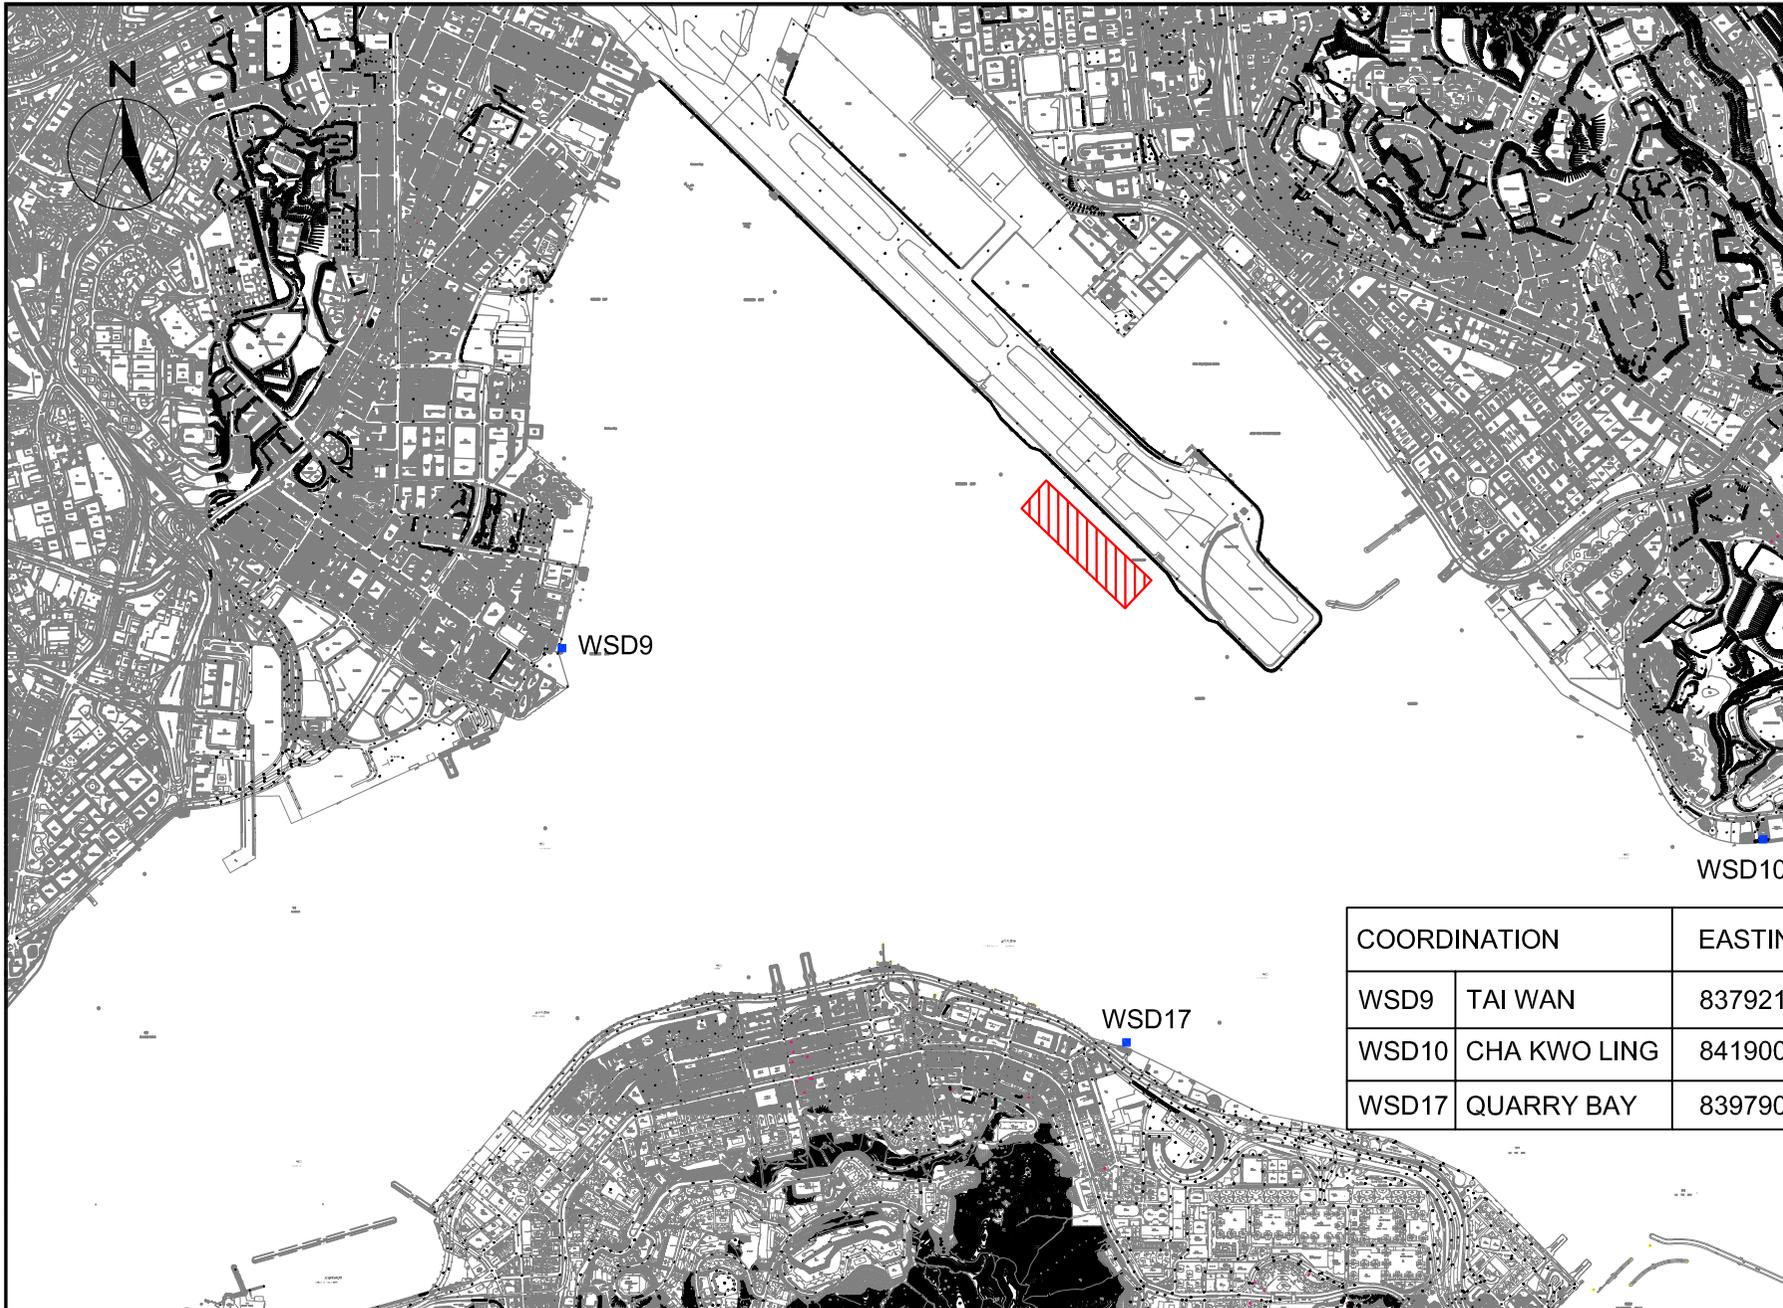
WATER QUALITY MONITORING STATION

COORDINATION		EASTING (m)	NORTHING (m)
WSD9	TAI WAN	837921.0	818330.0
WSD10	CHA KWO LING	841900.9	817700.1
WSD17	QUARRY BAY	839790.3	817032.2

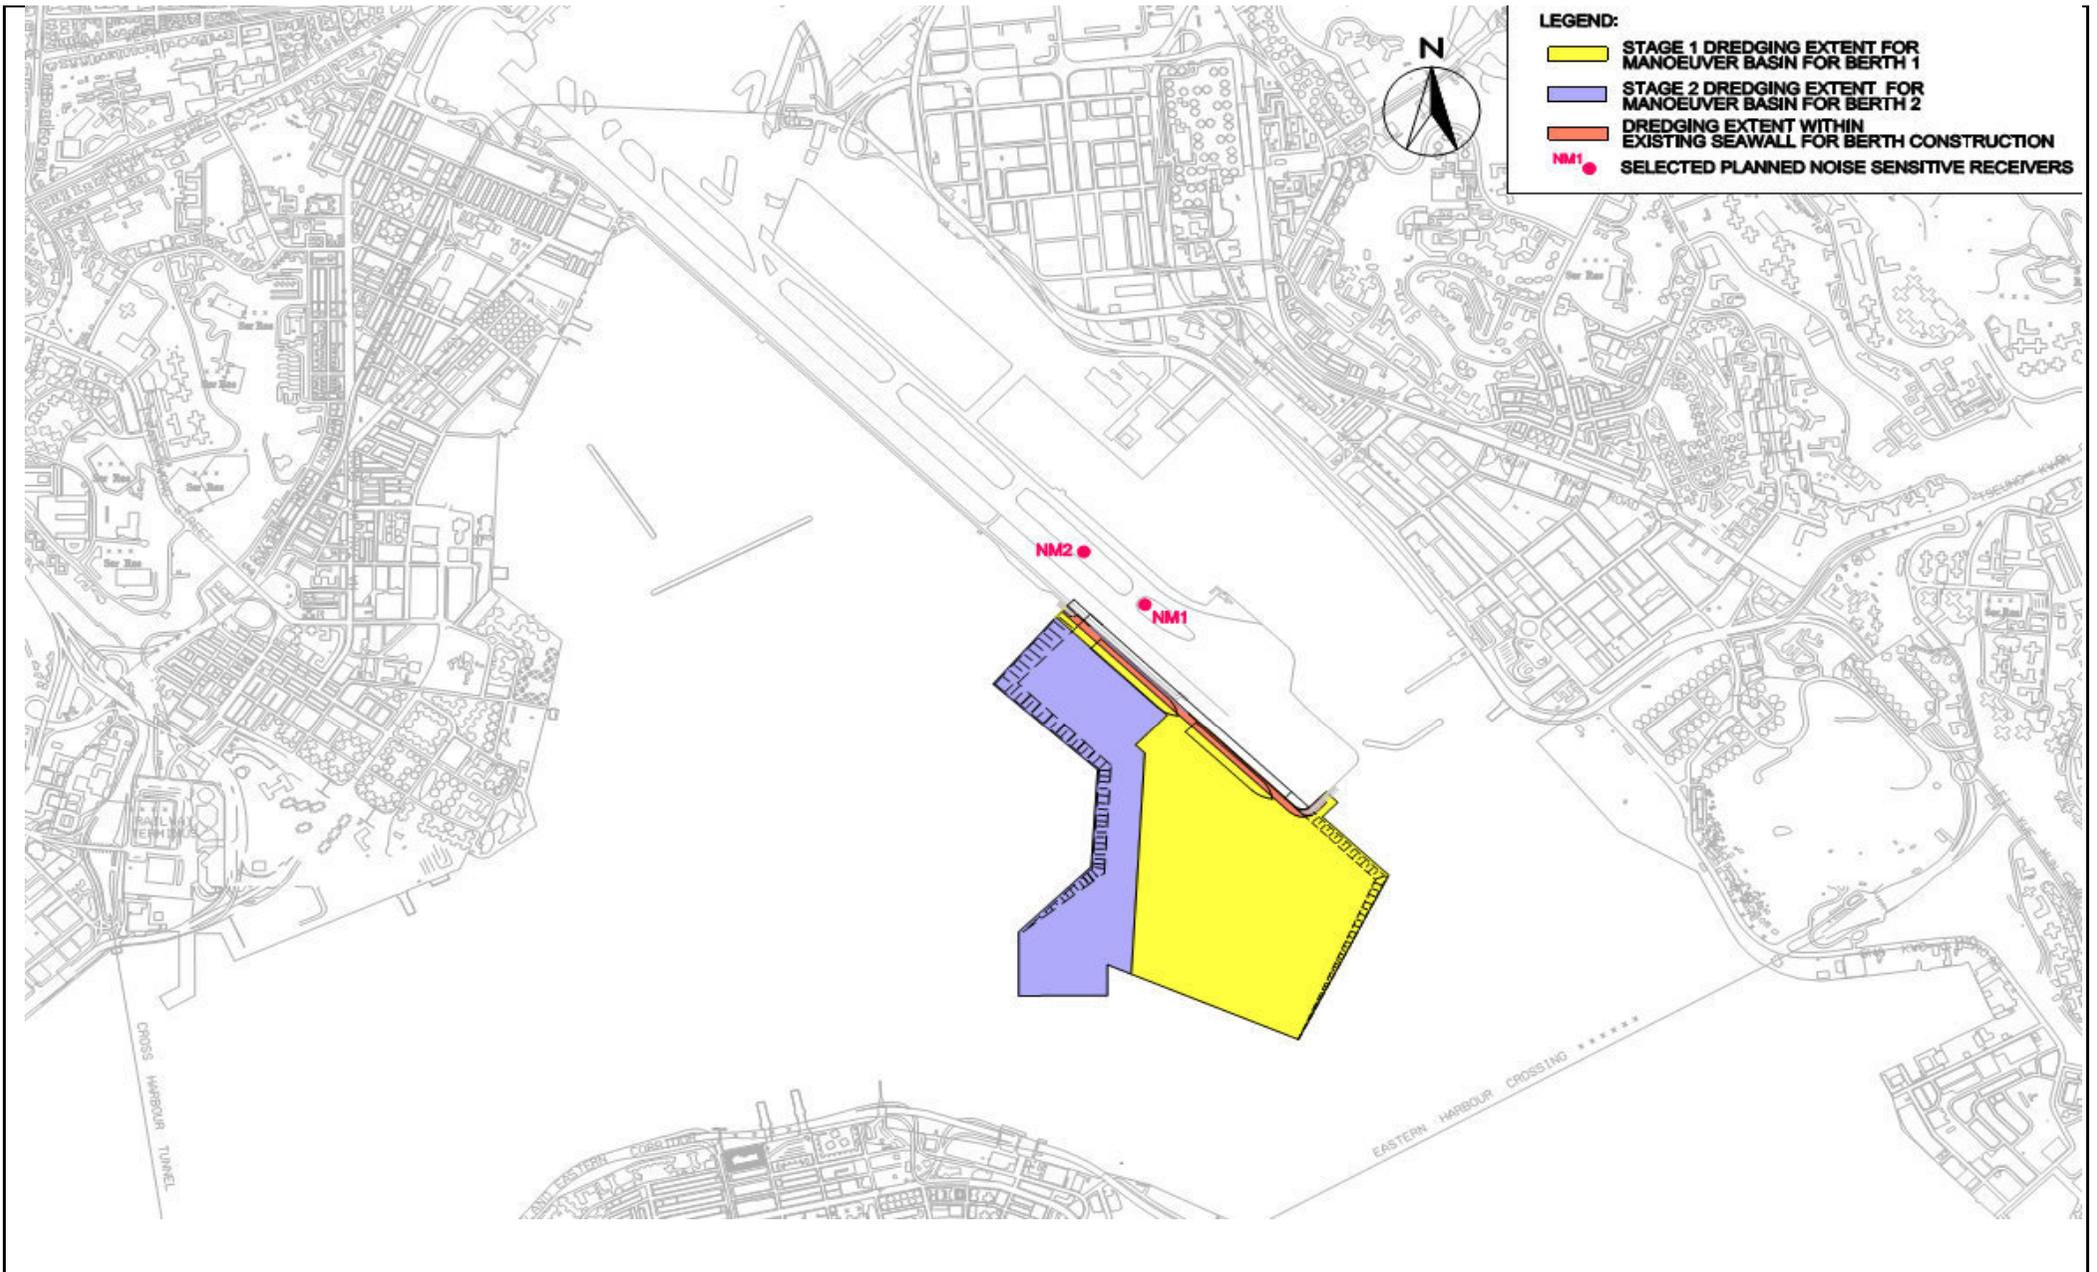
Title	Contract No. CV/2013/02	Scale	Propose	CINOTECH
	CEDD Maintenance Contract for Seawalls and Navigation Channels (2013-2016) Dredging at Cruise Terminal Stage 2	N.T.S	No. MA14015	
	Planned Noise Monitoring Stations during Construction Phase	Date	Figure	
		Apr-14	3

- 3.1 In accordance with the EIA Report and the EM&A Manual, it is anticipated that construction activities, if unmitigated, would not cause any adverse noise impact to the nearest NSRs in the vicinity of the work site. The predicted noise levels at the NSRs would comply with construction noise criteria.
- 3.2 These nearest NSRs are designated for construction noise monitoring as listed in Table 3.1 and **Figure 3**.

5. Due to the non-existence of planned NSRs during the reporting period, no noise monitoring was required to be conducted at the planned noise monitoring locations NM1 and NM2.

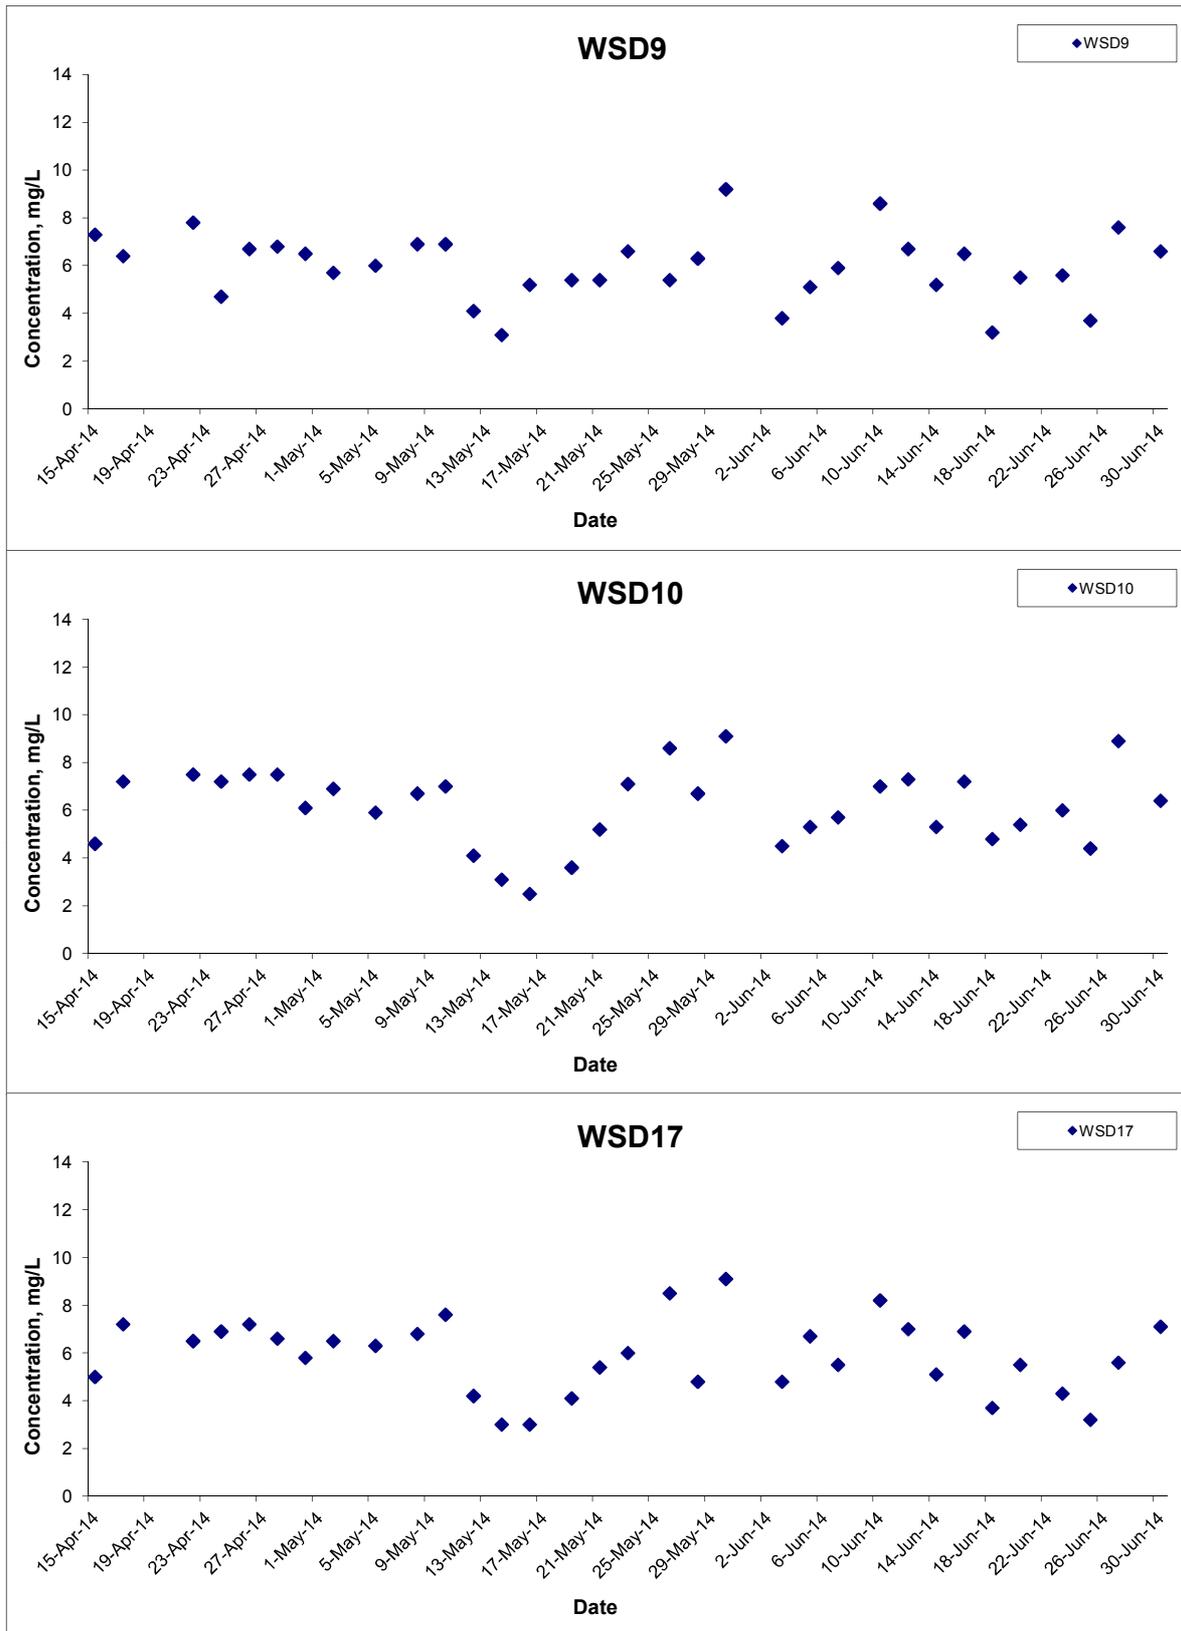
Dissolved Oxygen at Mid-Ebb Tide

Title Contract No. CV/2013/02 - CEDD Maintenance Contract for Seawalls and Navigation Channels (2013-2016) - Dredging at Cruise Terminal Stage 2
Graphical Presentation of Water Quality Monitoring Results

4. All water quality monitoring was conducted as scheduled in the reporting month. No Action/Limit Level exceedance was recorded.

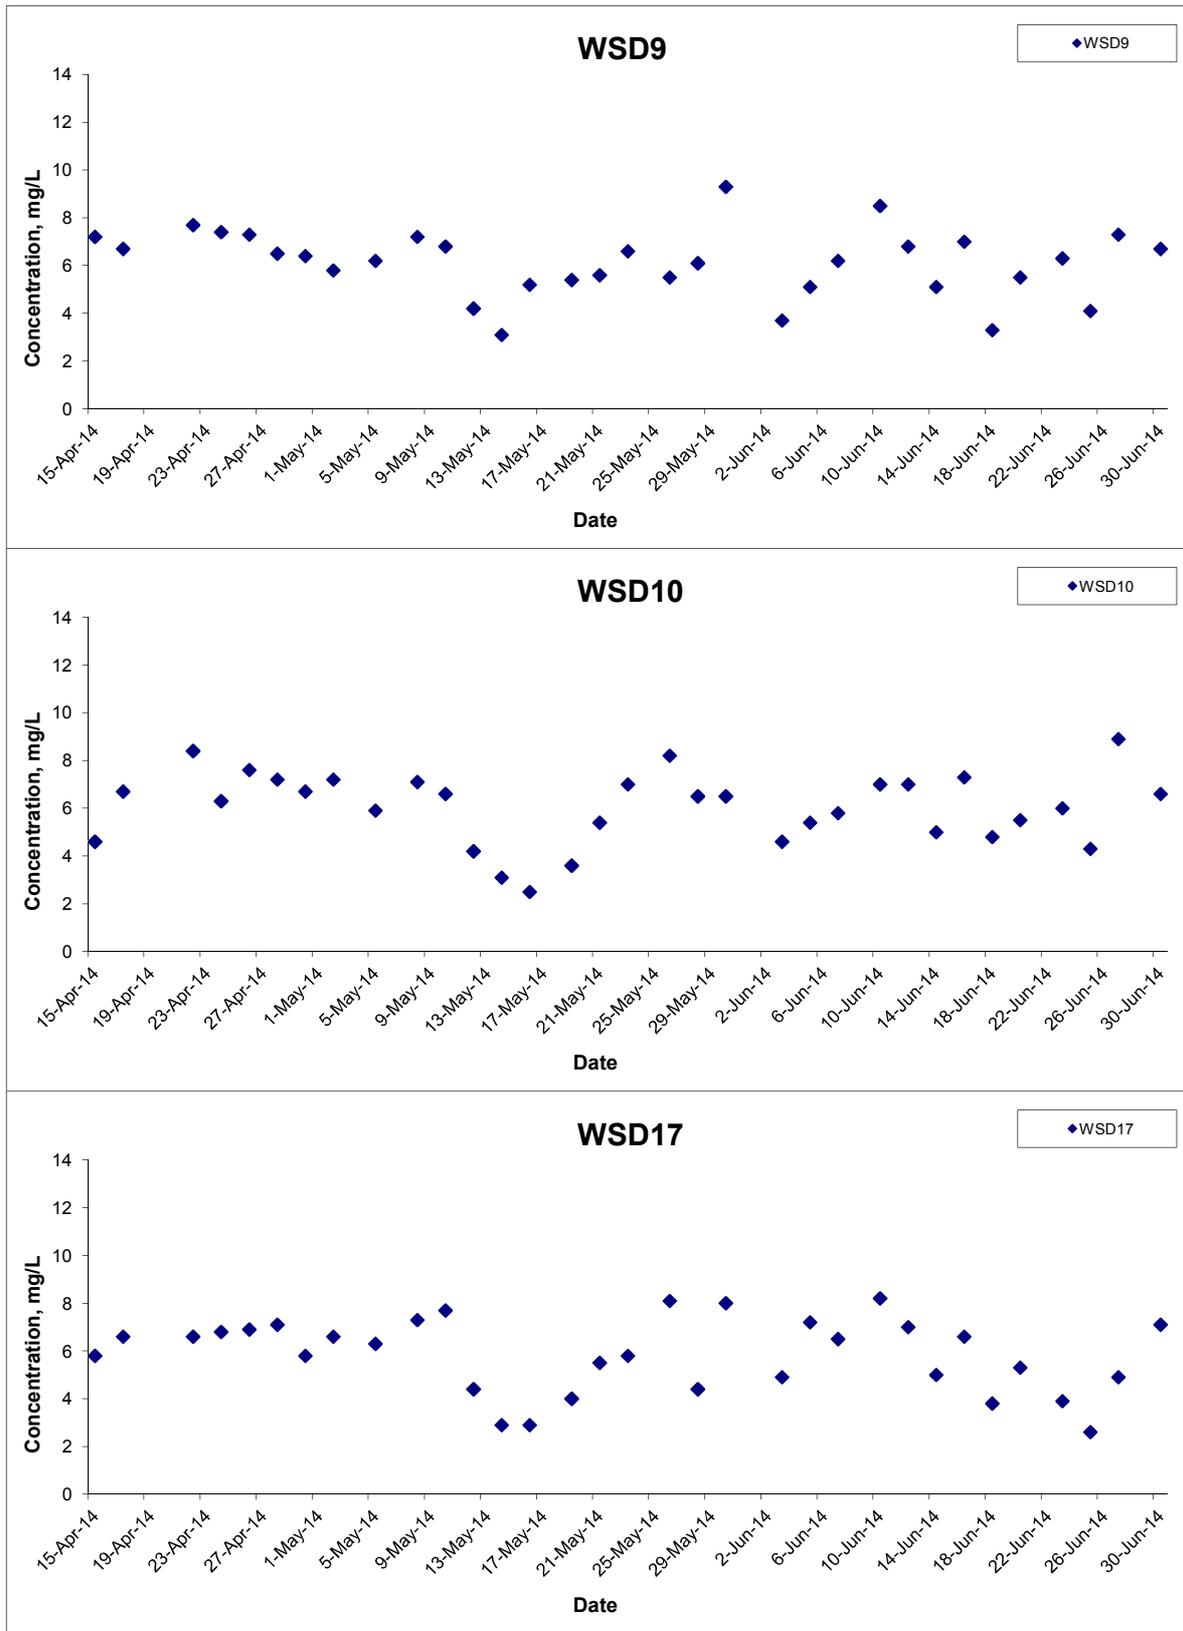
Dissolved Oxygen at Mid-Flood Tide

Graphical Presentation of Water Quality Monitoring Results

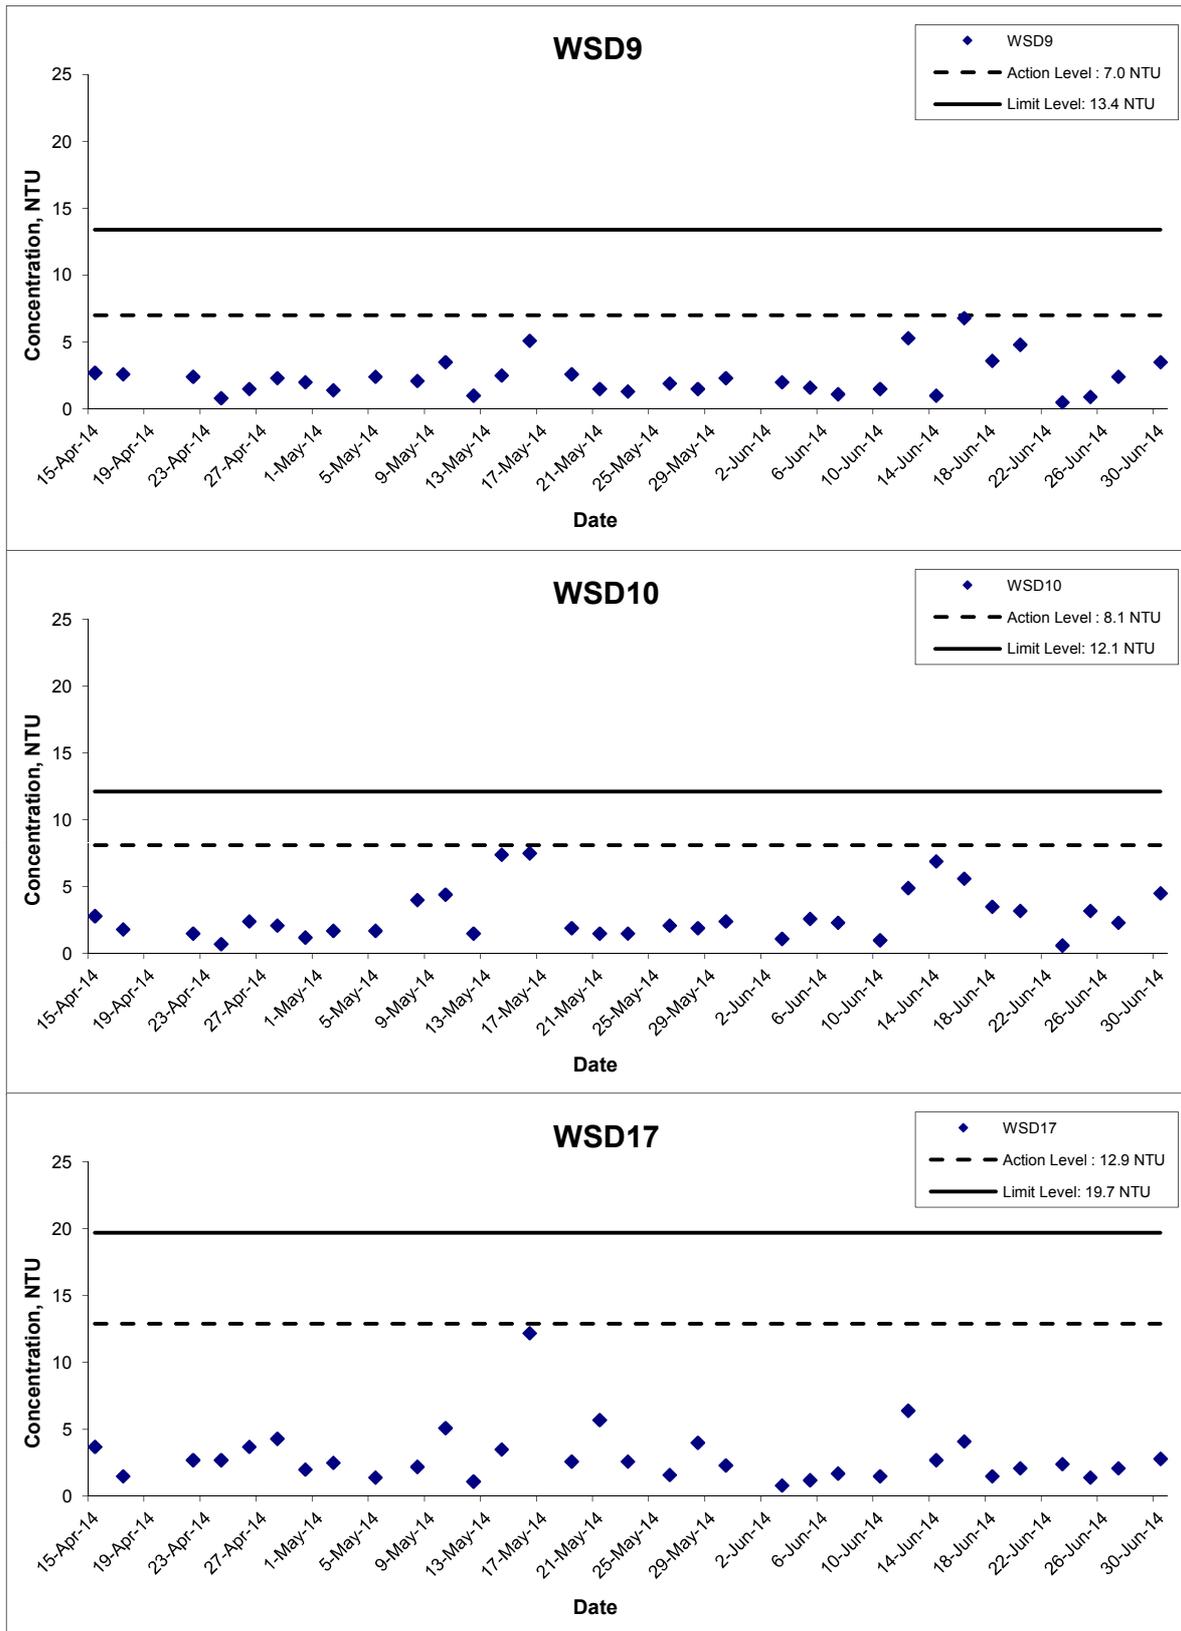
Turbidity at Mid-Ebb Tide

Title Contract No. CV/2013/02 - CEDD Maintenance Contract for Seawalls and Navigation Channels (2013-2016) - Dredging at Cruise Terminal Stage 2
Graphical Presentation of Water Quality Monitoring Results

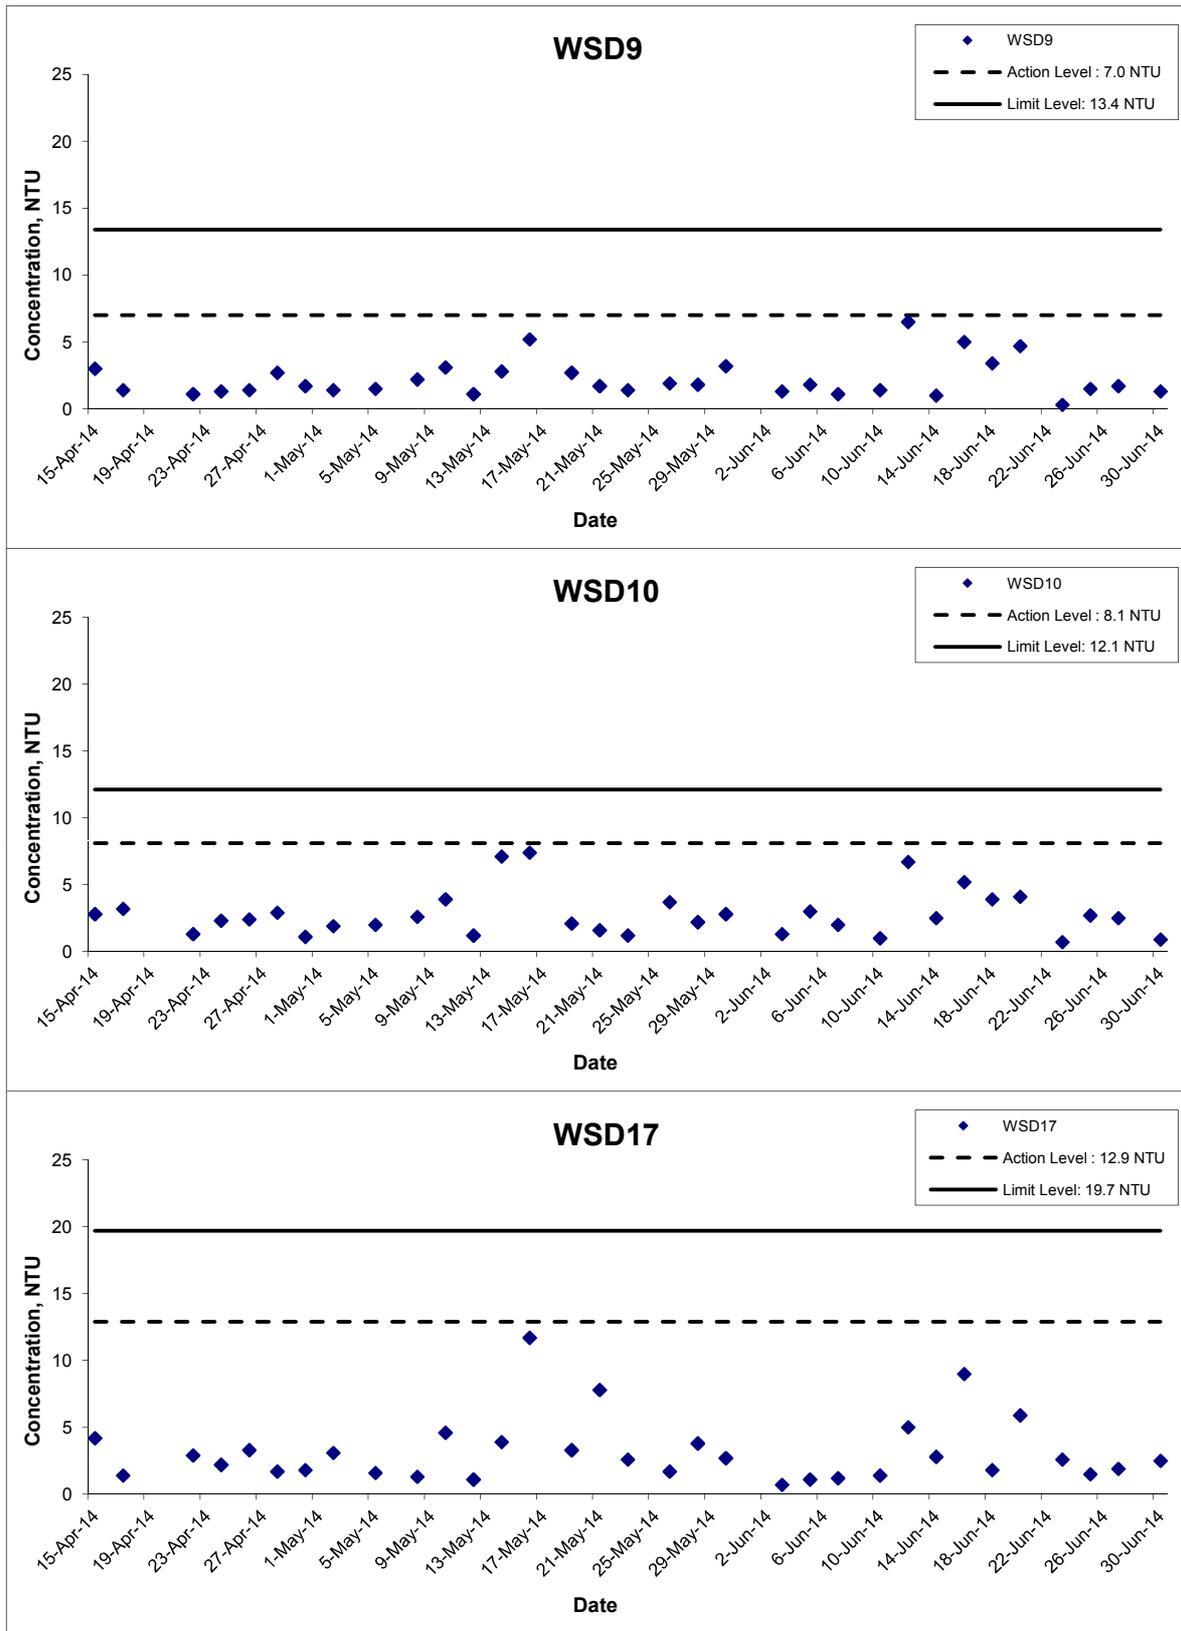
Turbidity at Mid-Flood Tide

Graphical Presentation of Water Quality Monitoring Results

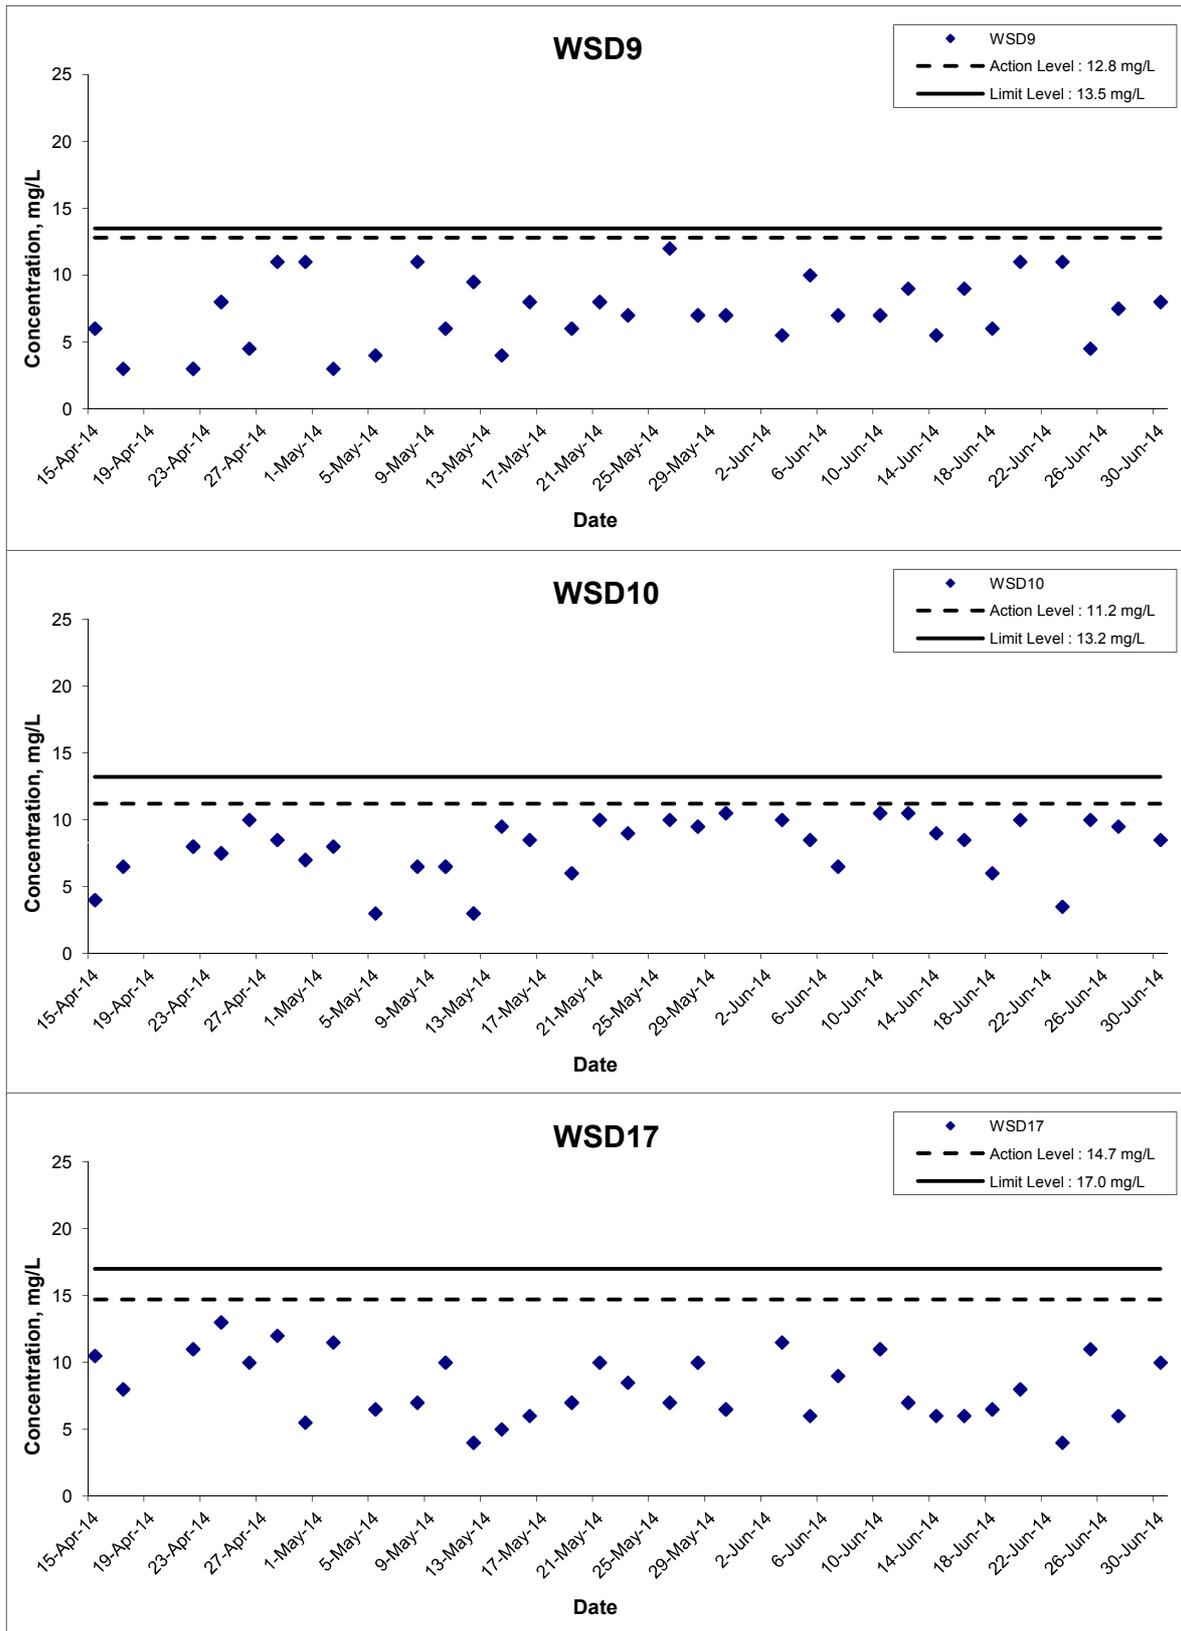
Suspended Solids at Mid-Ebb Tide

Graphical Presentation of Water Quality Monitoring Results

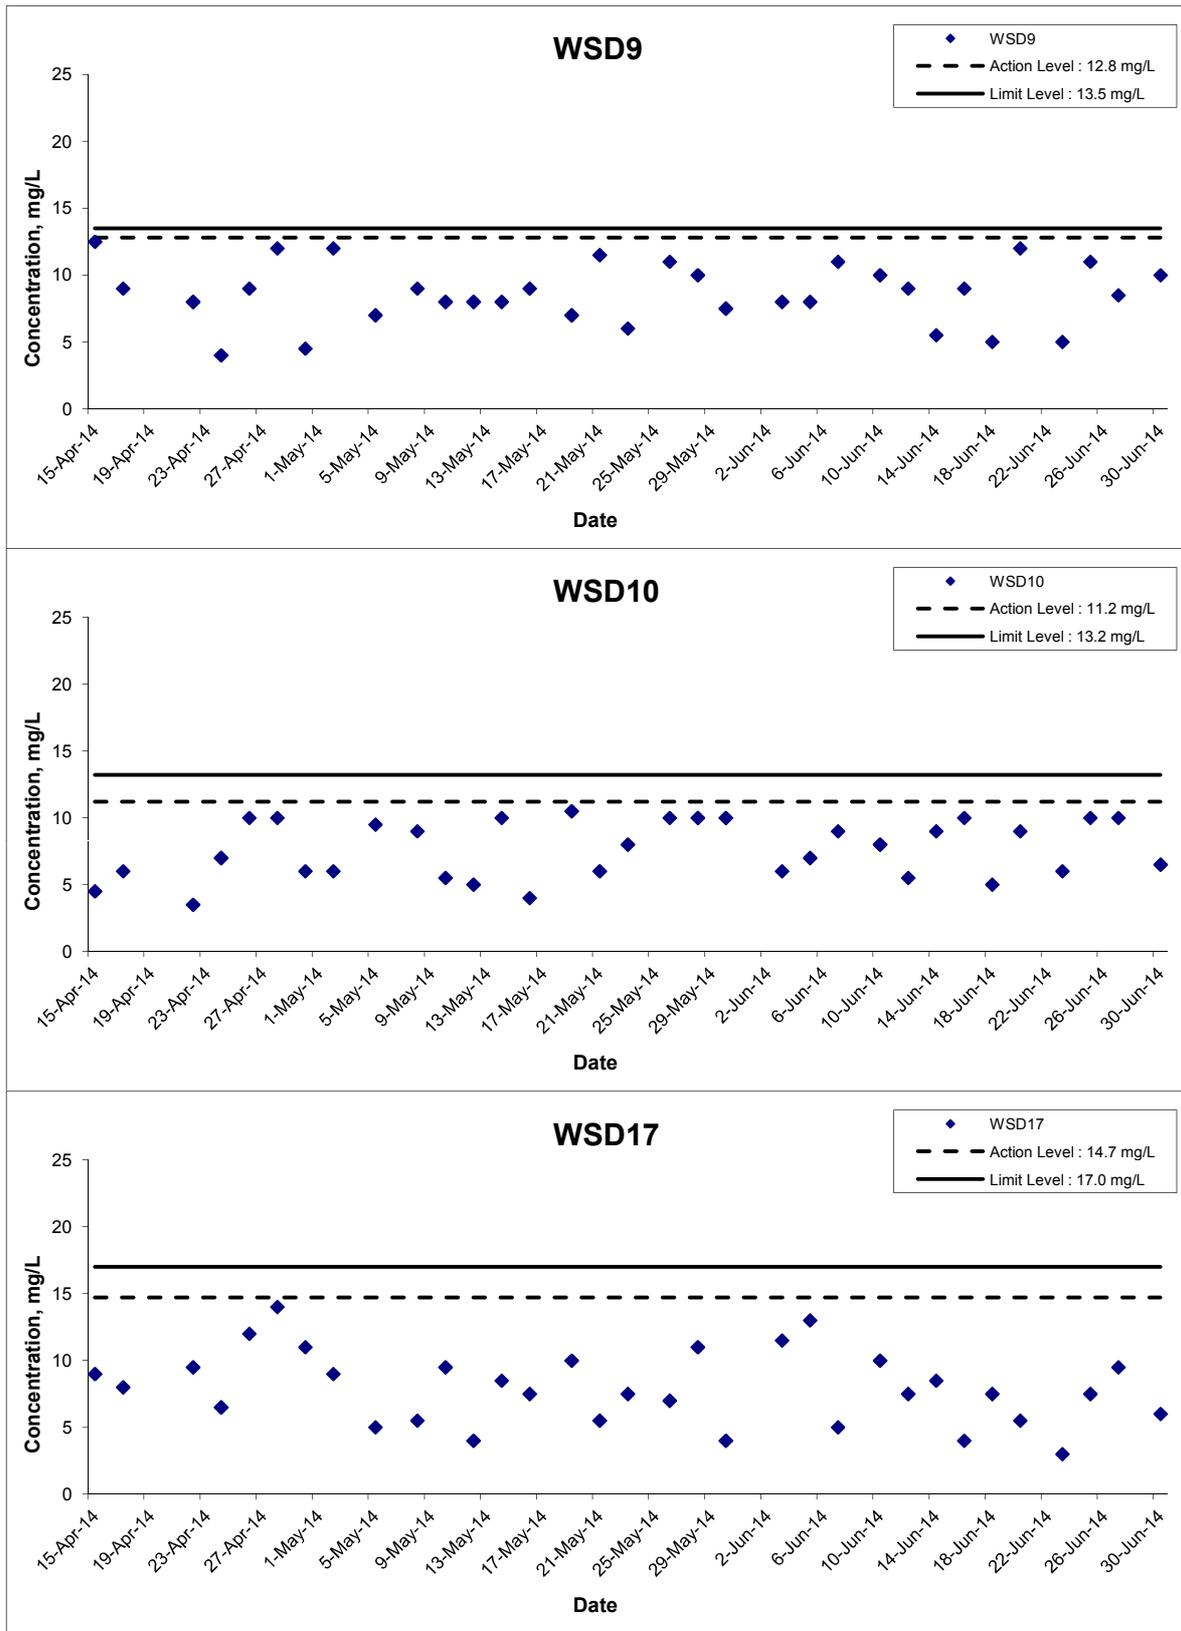
Suspended Solids at Mid-Flood Tide

Graphical Presentation of Water Quality Monitoring Results
