**CEDD Maintenance Contract for Seawalls  
and Navigation Channels (2013-2016)**

**Dredging at Cruise Terminal Stage 2**

**Monthly EM&A Report**

**July 2014  
(Version 1.0)**

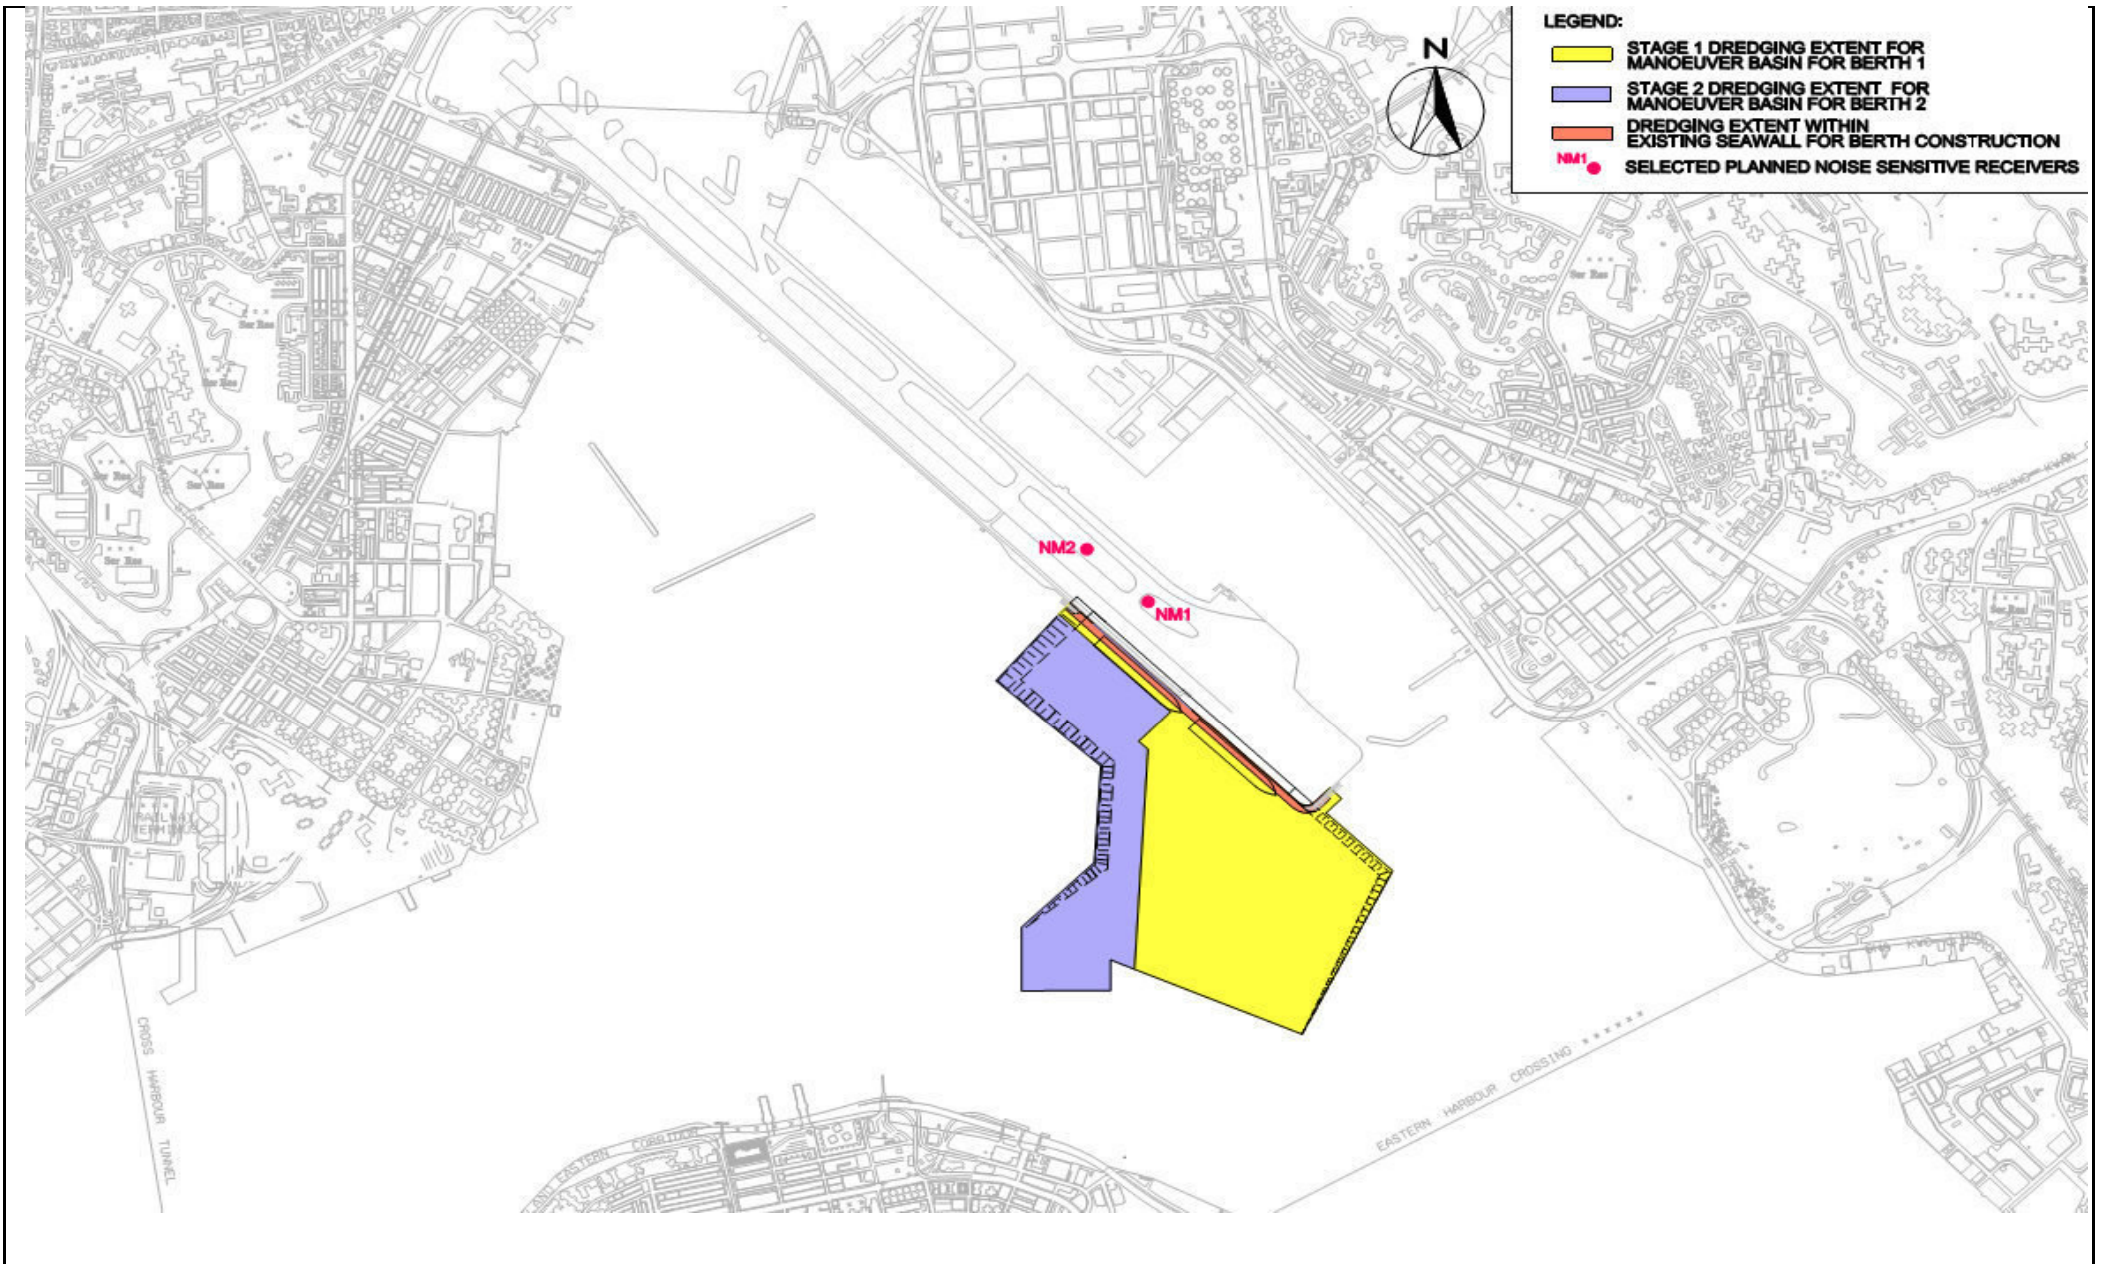
Title	Contract No. CV/2013/02		Scale	Propose No.	MA14015	CINOTECH
	CEDD Maintenance Contract for Seawalls and Navigation Channels (2013-2016)					
	Dredging at Cruise Terminal Stage 2		Date	Figure	3	
	Planned Noise Monitoring Stations during Construction Phase		Apr-14

- 3.1 In accordance with the EIA Report and the EM&A Manual, it is anticipated that construction activities, if unmitigated, would not cause any adverse noise impact to the nearest NSRs in the vicinity of the work site. The predicted noise levels at the NSRs would comply with construction noise criteria.
- 3.2 These nearest NSRs are designated for construction noise monitoring as listed in Table 3.1 and **Figure 3**.

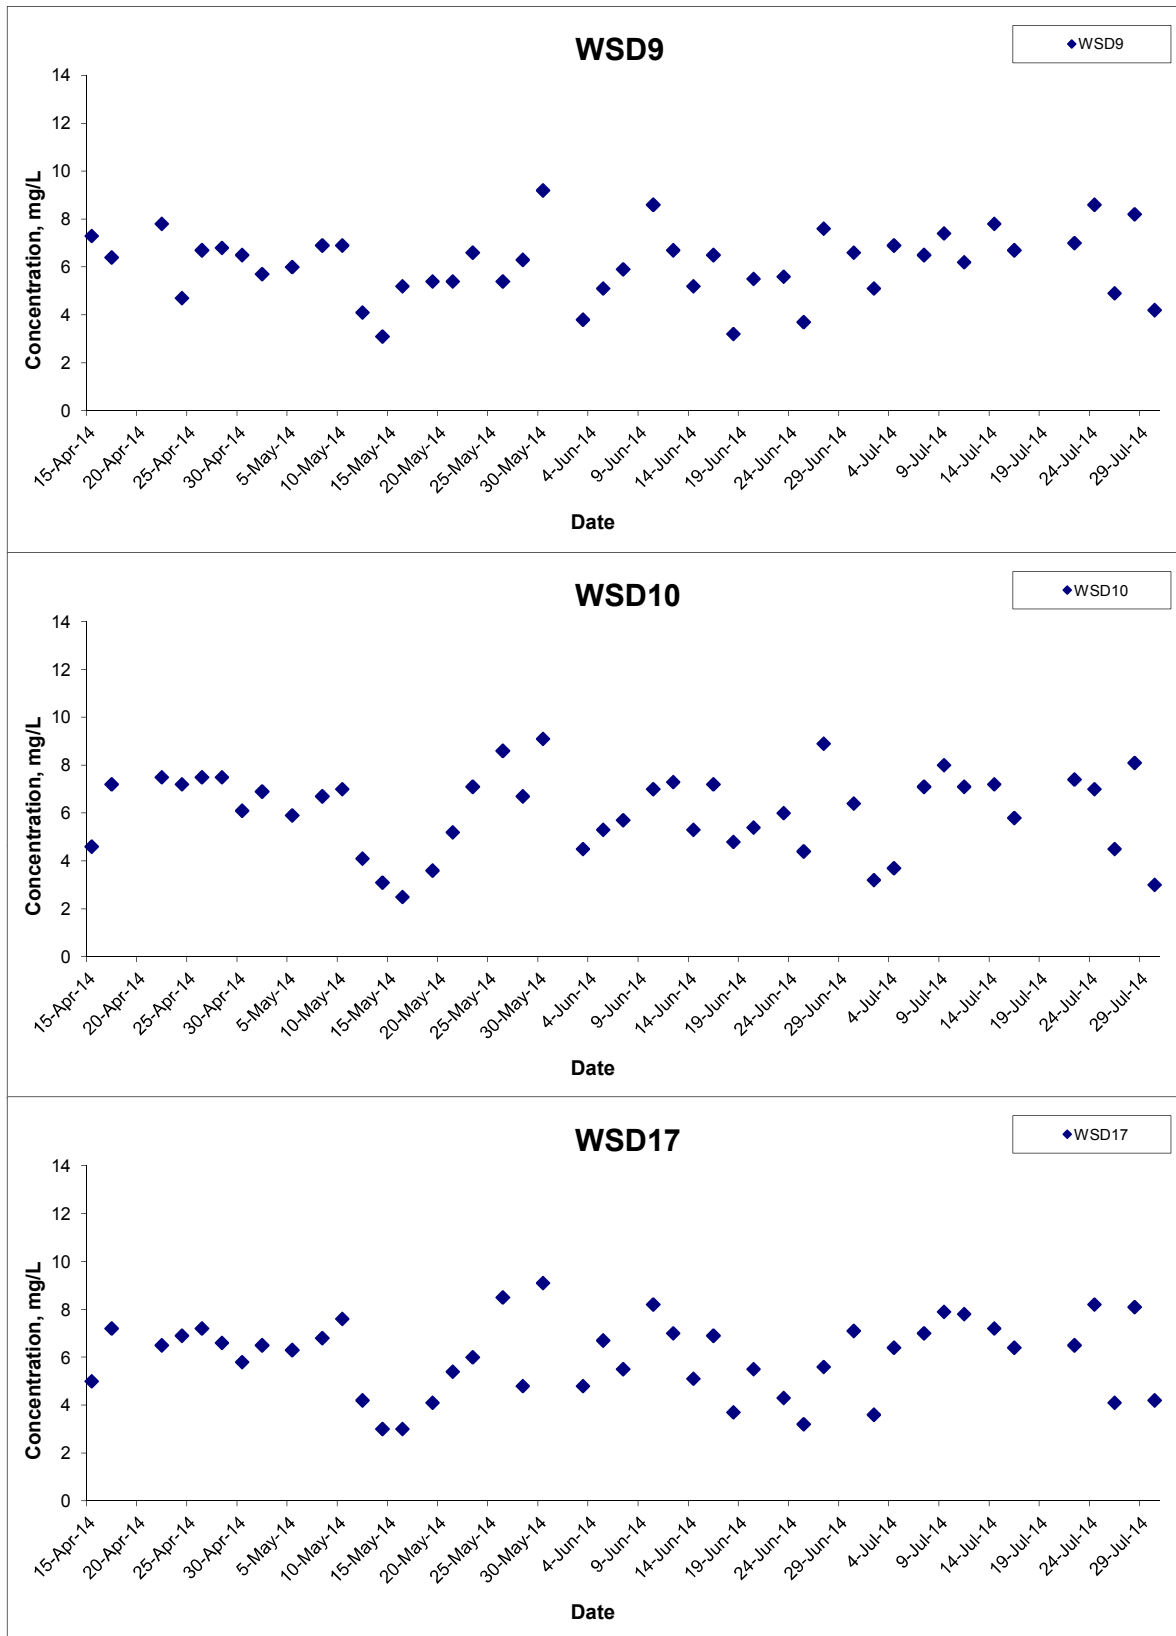
## Dissolved Oxygen at Mid-Ebb Tide

Remark: Water quality monitoring on 18 July 2014 was cancelled due to adverse weather (Typhoon Signal No. 3)

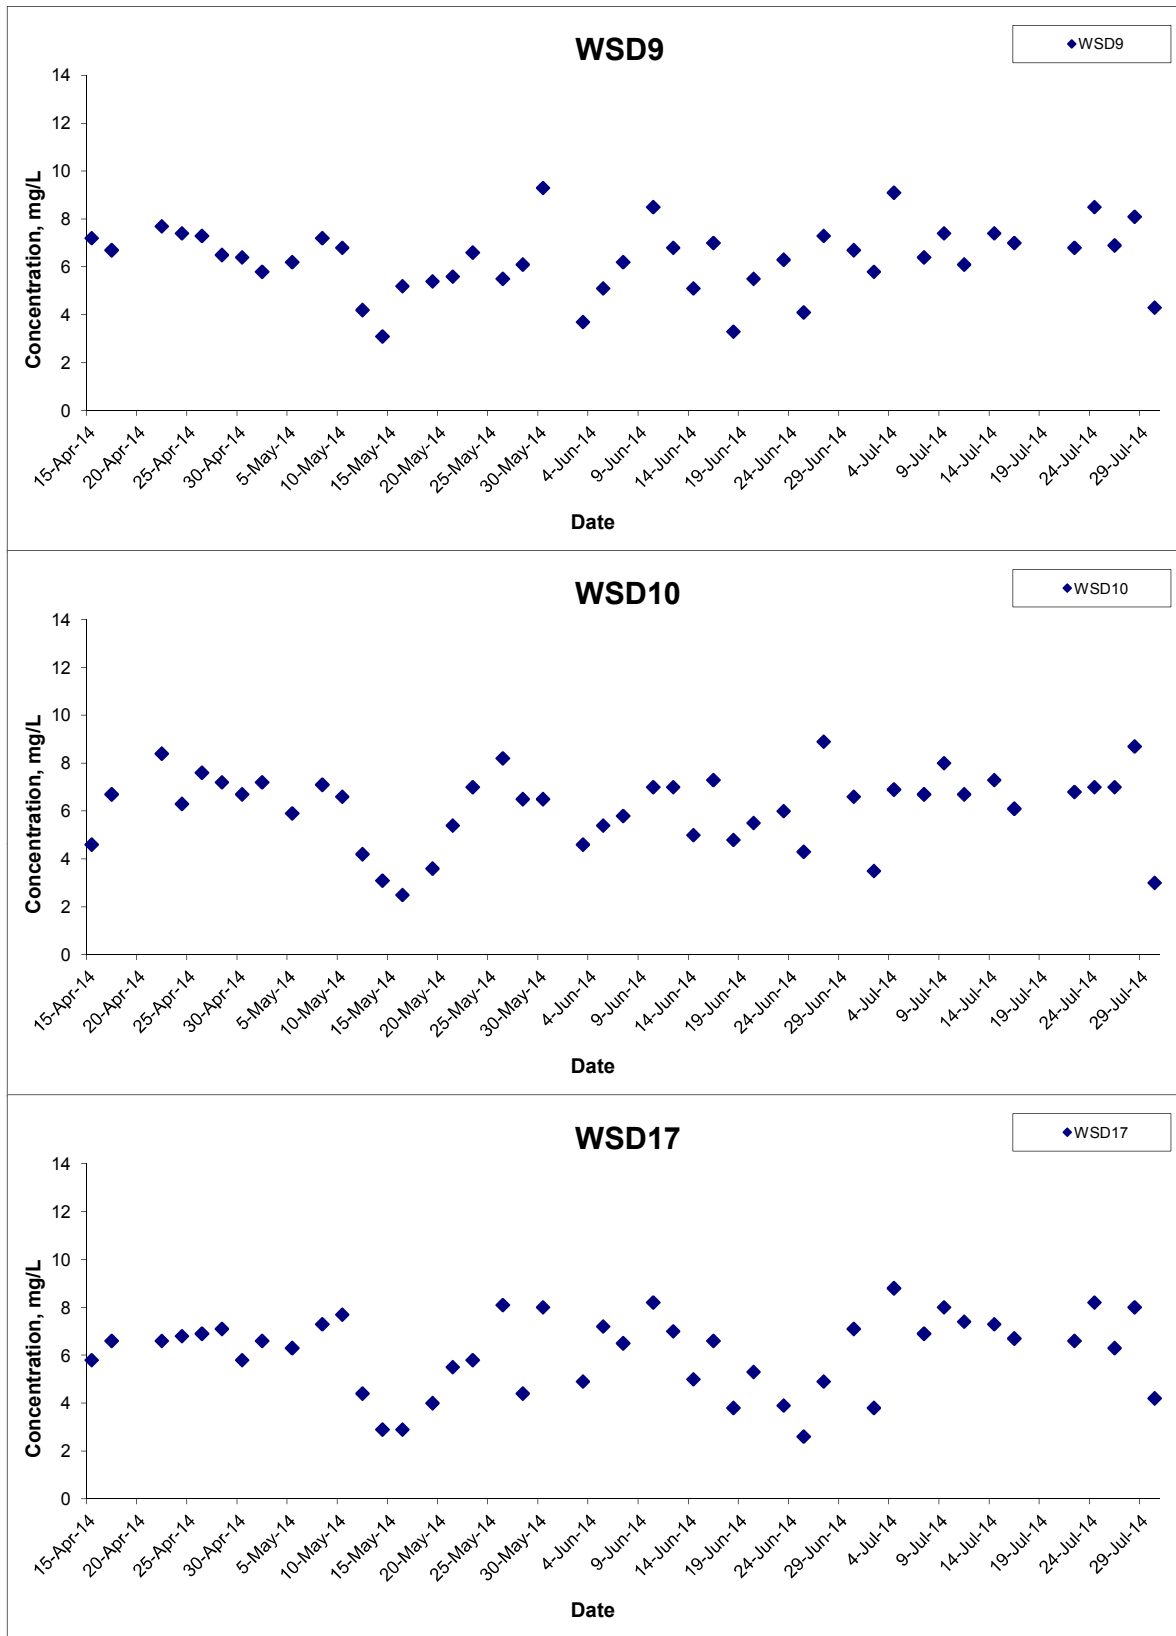
## Dissolved Oxygen at Mid-Flood Tide

Remark: Water quality monitoring on 18 July 2014 was cancelled due to adverse weather (Typhoon Signal No. 3)

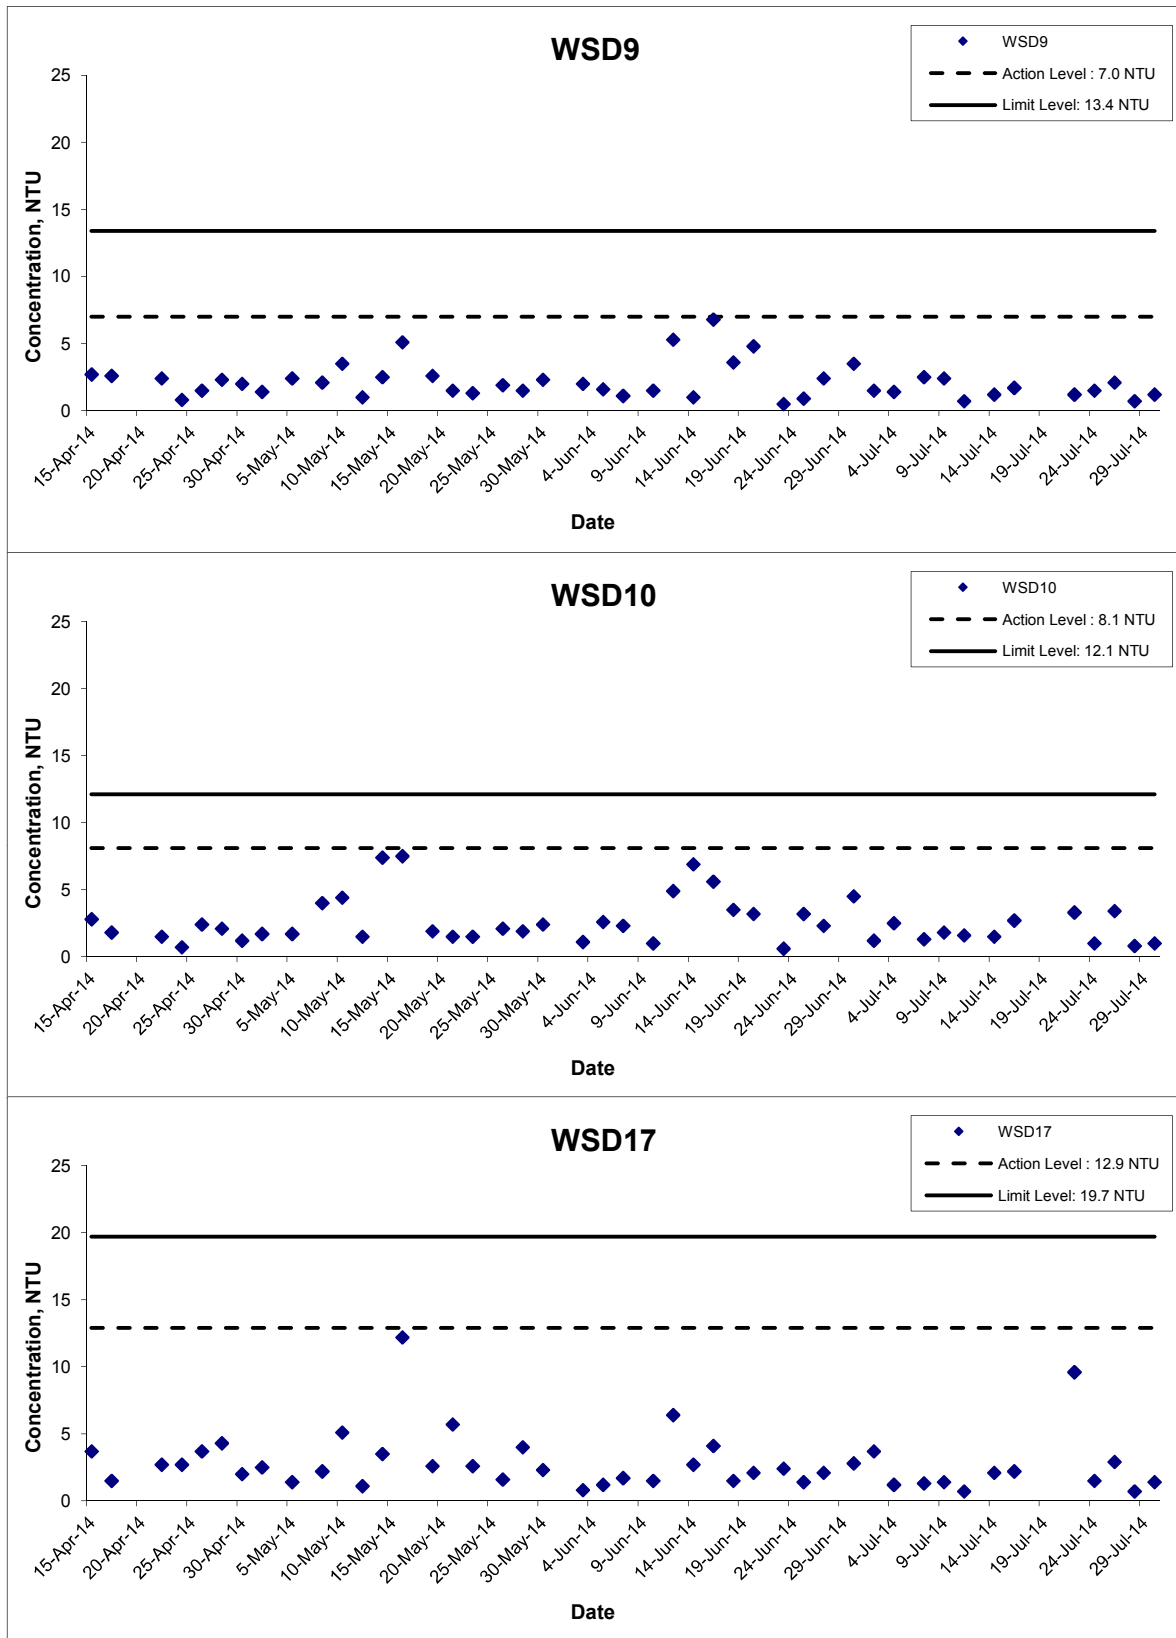
## Turbidity at Mid-Ebb Tide

Remark: Water quality monitoring on 18 July 2014 was cancelled due to adverse weather (Typhoon Signal No. 3)

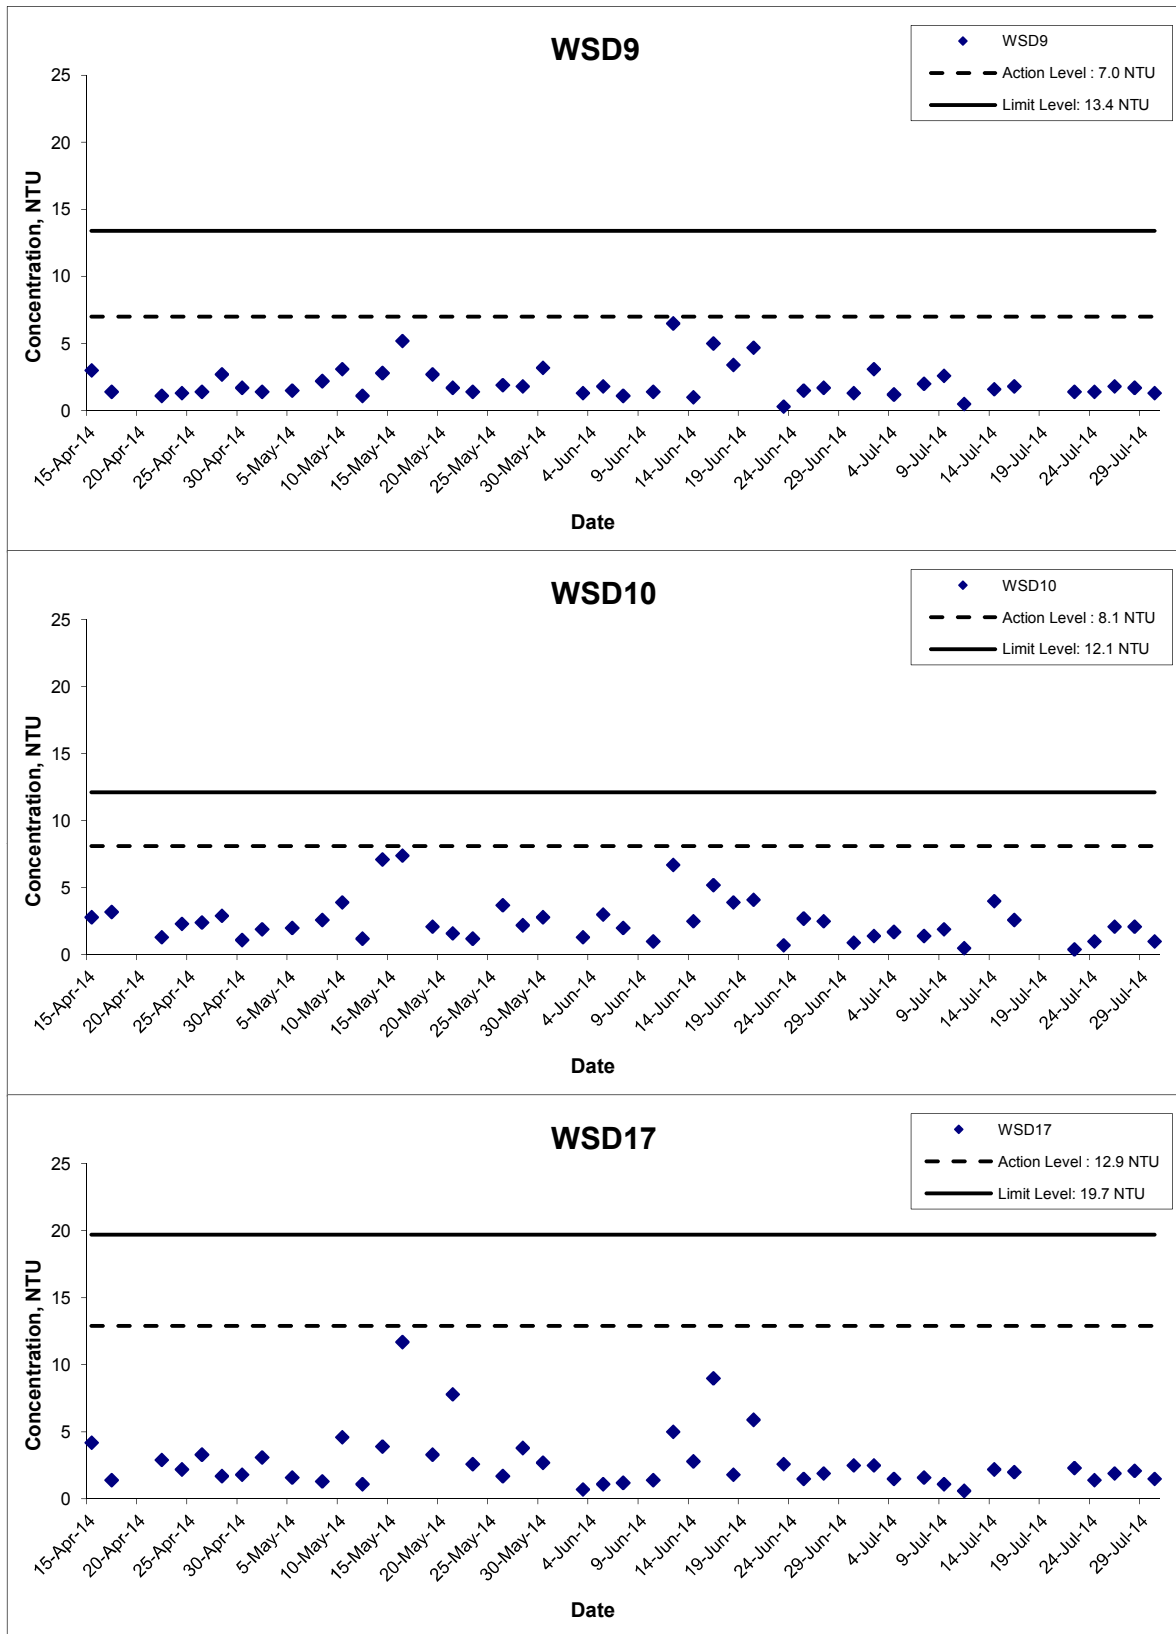
## Turbidity at Mid-Flood Tide

Remark: Water quality monitoring on 18 July 2014 was cancelled due to adverse weather (Typhoon Signal No. 3)

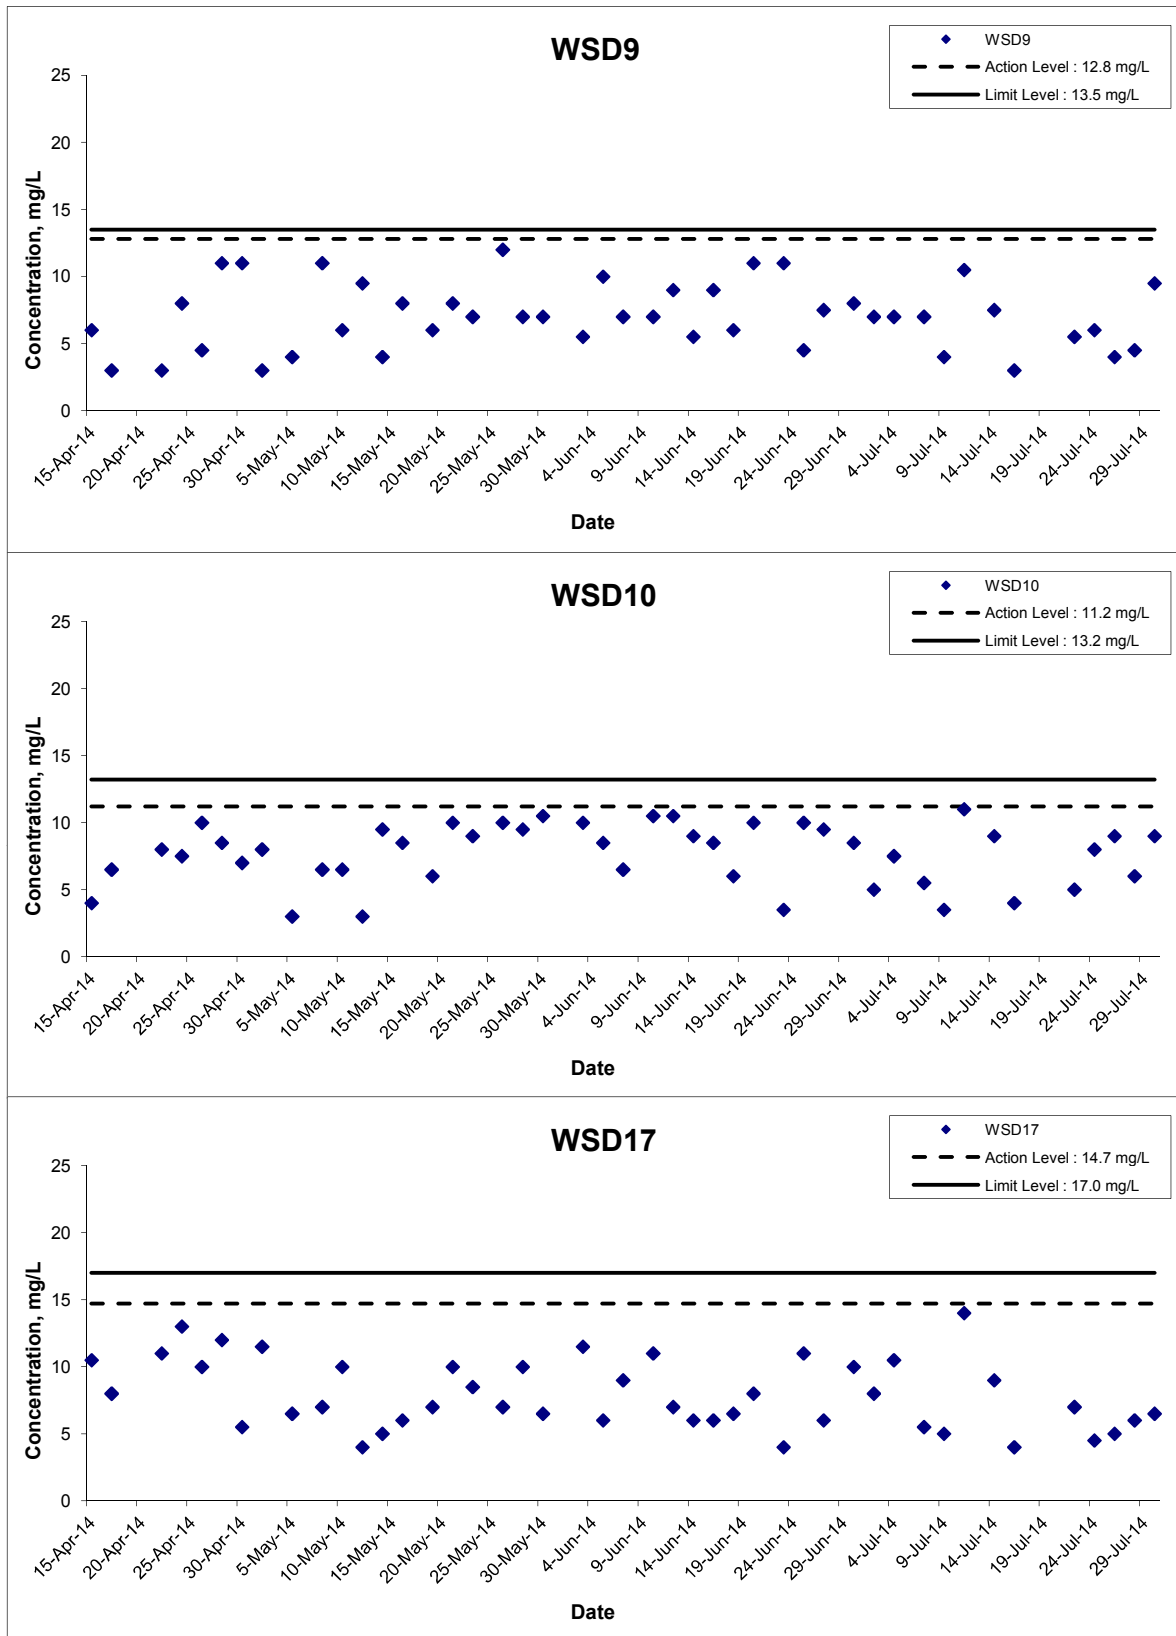
## Suspended Solids at Mid-Ebb Tide

Remark: Water quality monitoring on 18 July 2014 was cancelled due to adverse weather (Typhoon Signal No. 3)

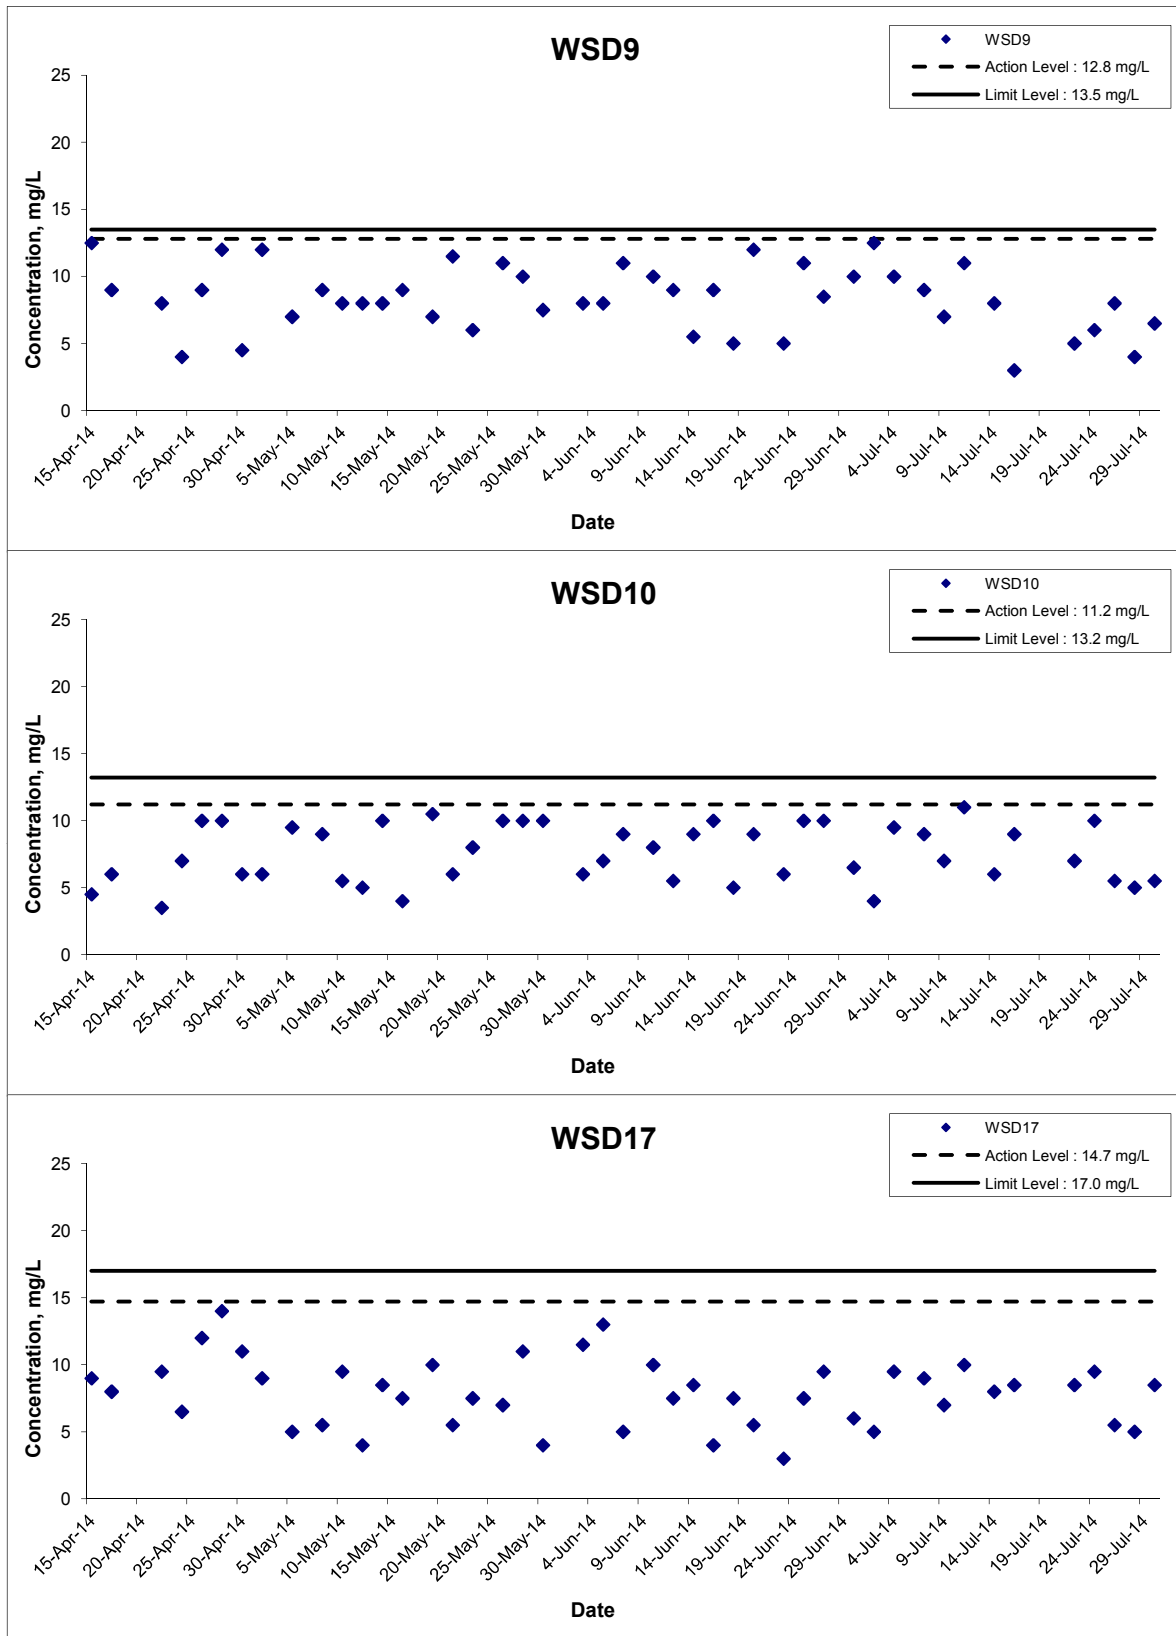
## Suspended Solids at Mid-Flood Tide

Remark: Water quality monitoring on 18 July 2014 was cancelled due to adverse weather (Typhoon Signal No. 3)
