Contract No. CV/2013/02

**CEDD Maintenance Contract for Seawalls
and Navigation Channels (2013-2016)
Dredging at Cruise Terminal Stage 2**

Monthly EM&A Report

**September 2014
(Version 1.0)**

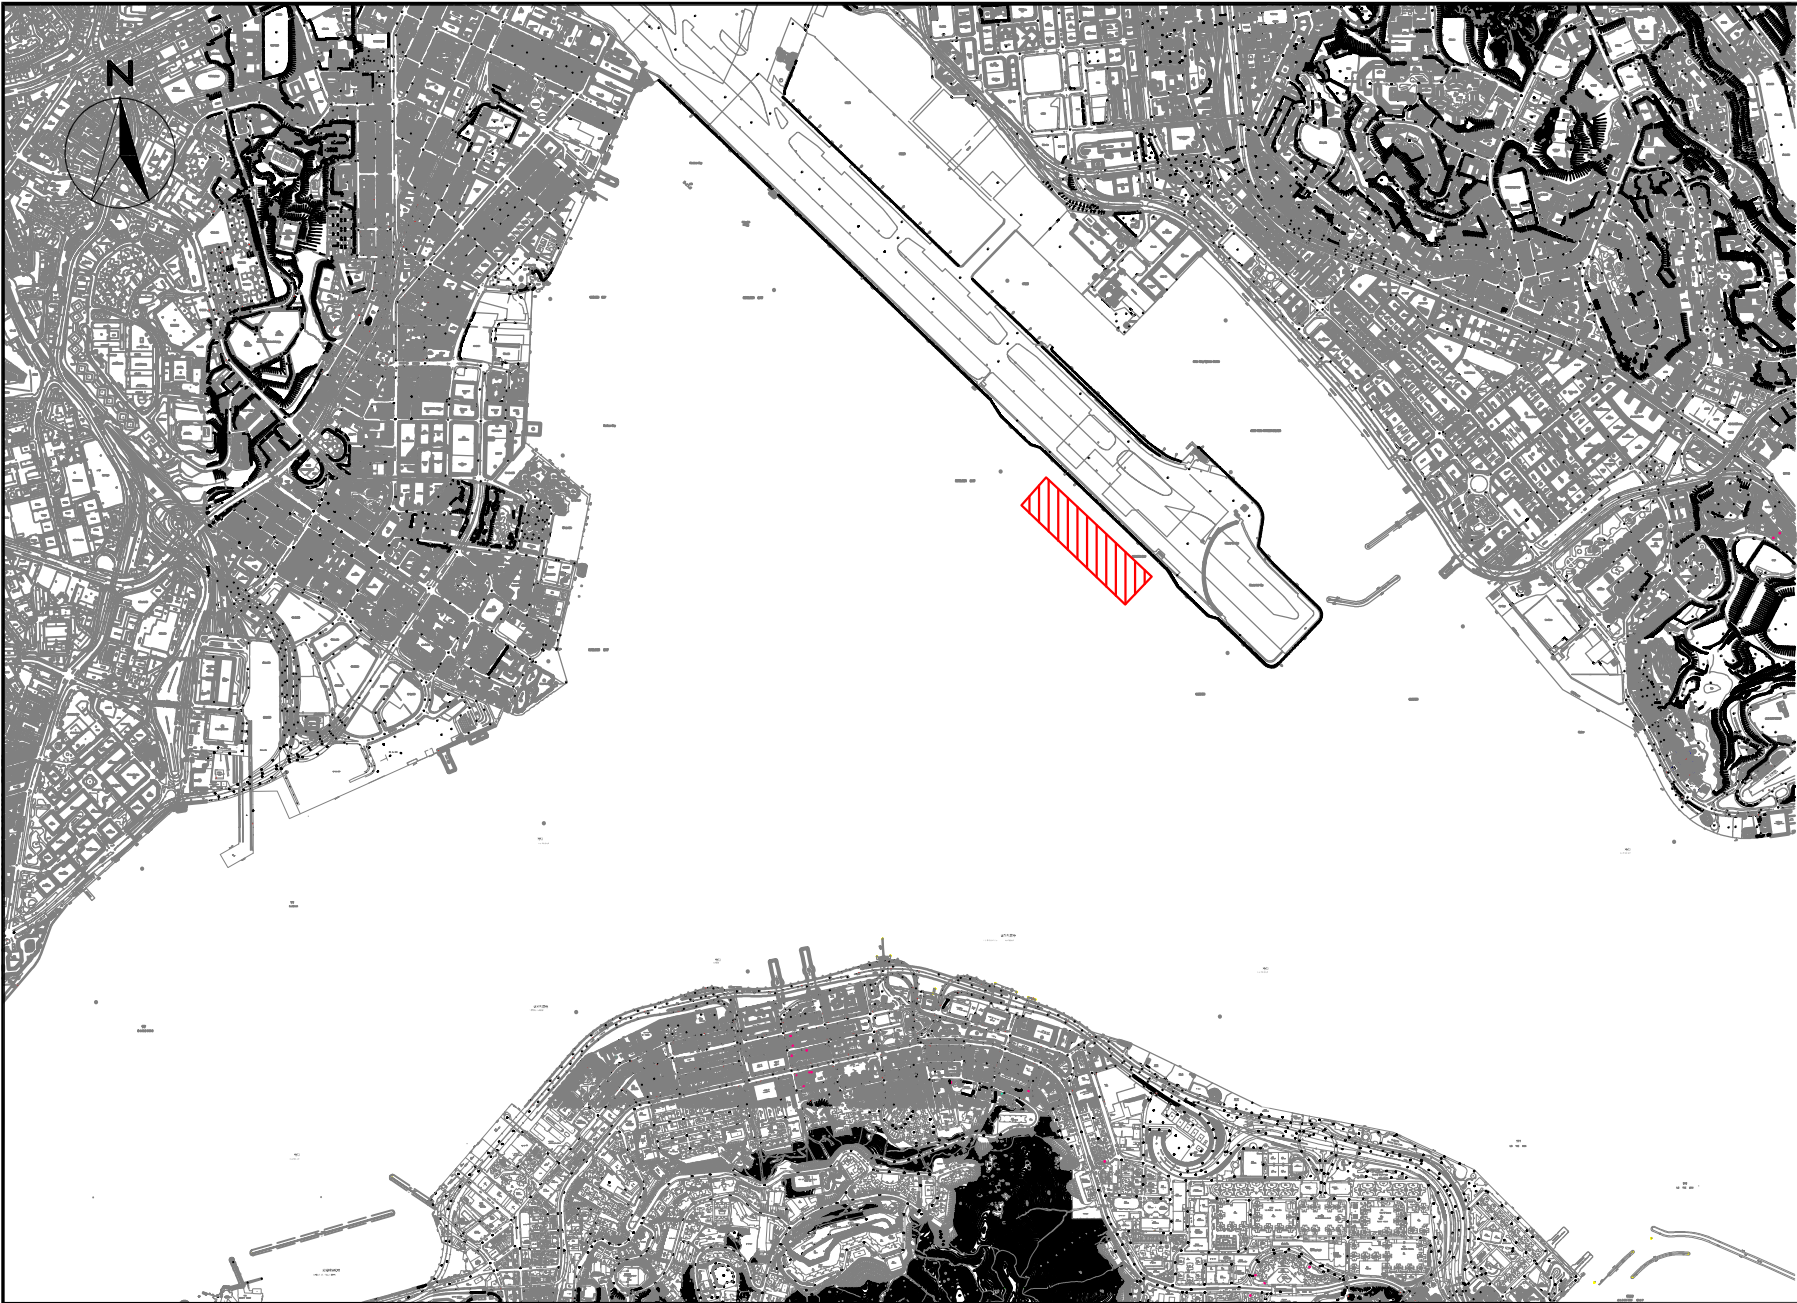
SCALE	1:25000@A4	DATE	MAR 14
CHECK	IT	DRAWN	JW
JOB No.	MA14015	FIGURE NO.	1
		REV	-

- 2.3 Development of the cruise terminal at Kai Tak would require dredging at the existing seawall at the southern tip of the former Kai Tak Airport runway for construction of a quay deck structure for two berths, and dredging the seabed fronting the new quay to provide necessary manoeuvring basin. The general layout of the proposed cruise terminal construction is shown in **Figure 1**.

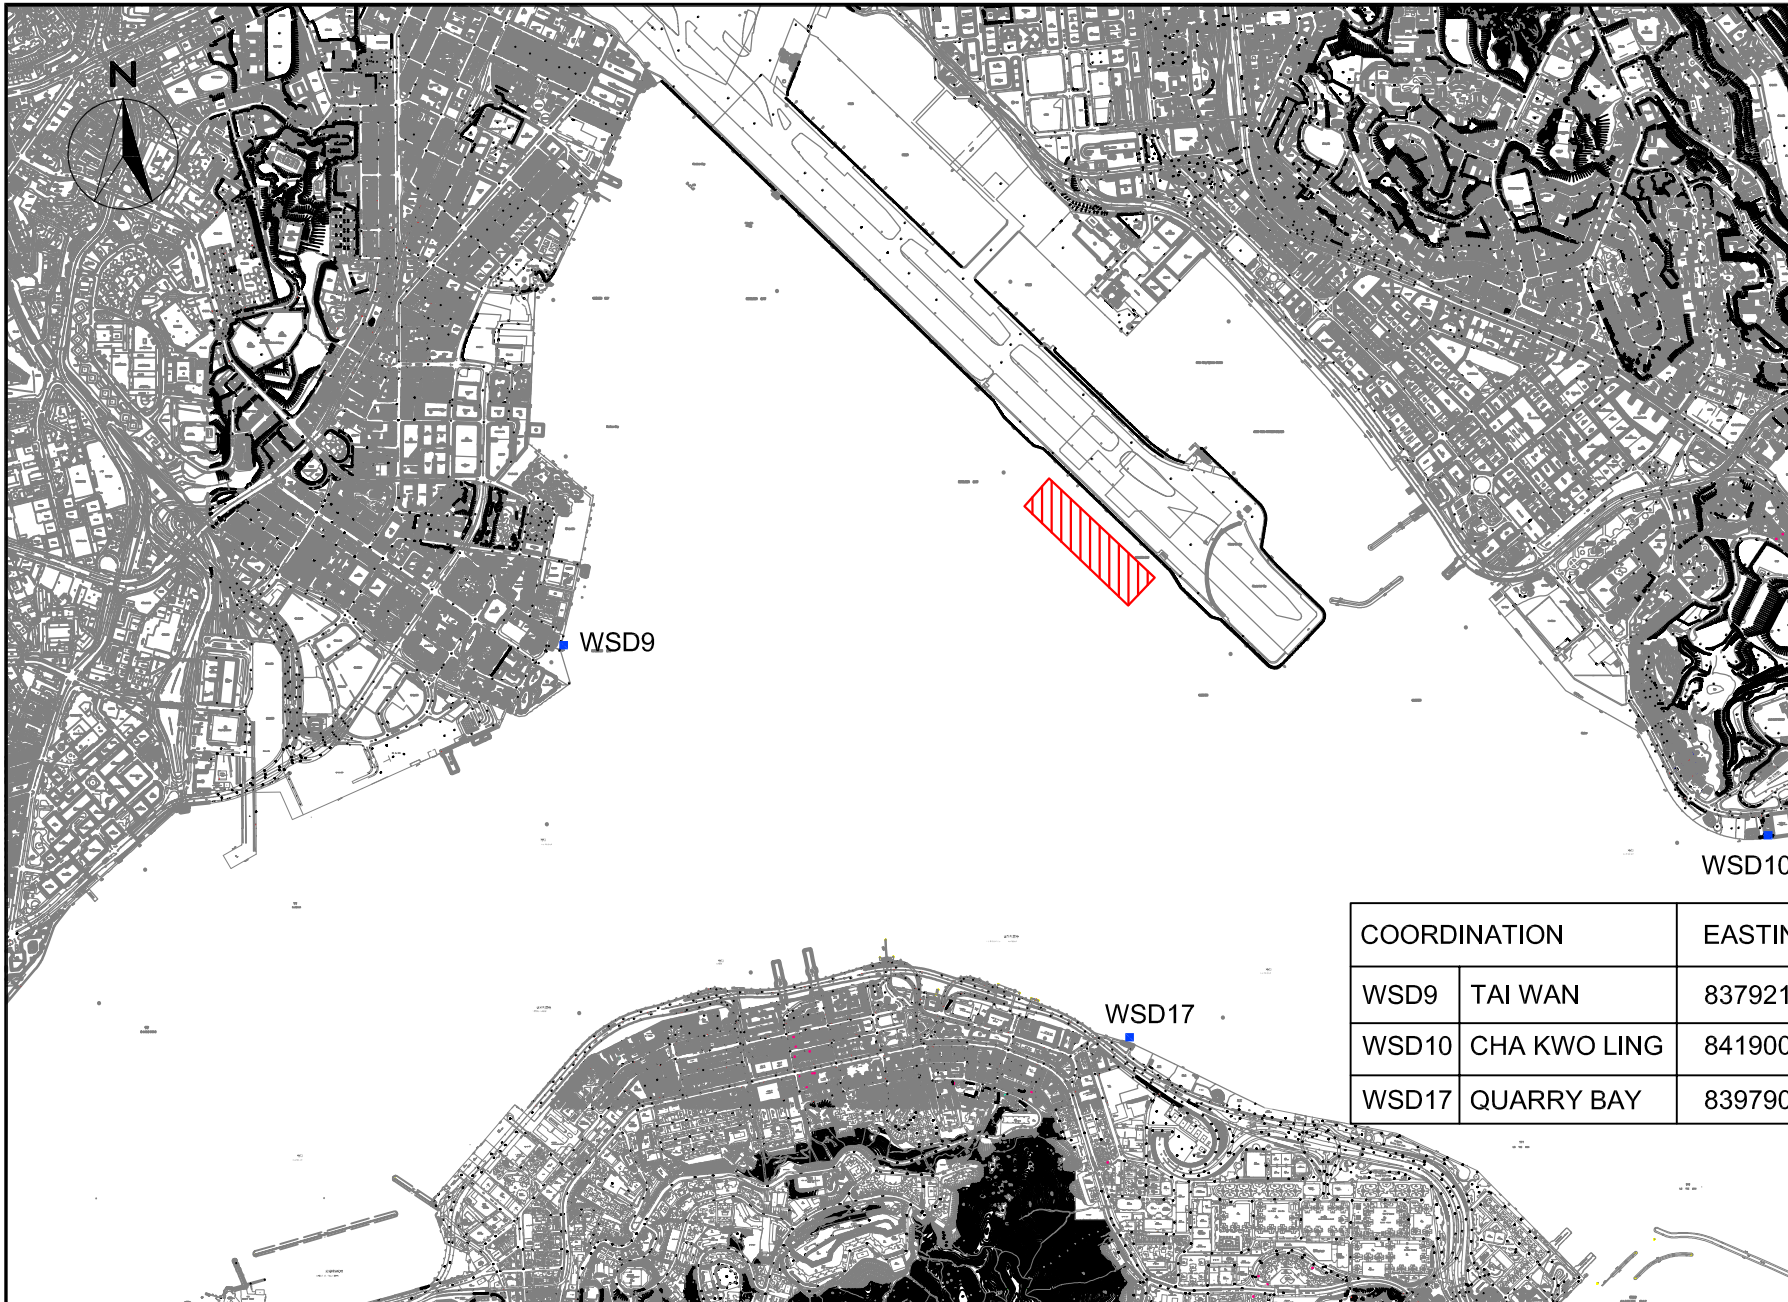
WATER QUALITY MONITORING STATION

COORDINATION		EASTING (m)	NORTHING (m)
WSD9	TAI WAN	837921.0	818330.0
WSD10	CHA KWO LING	841900.9	817700.1
WSD17	QUARRY BAY	839790.3	817032.2

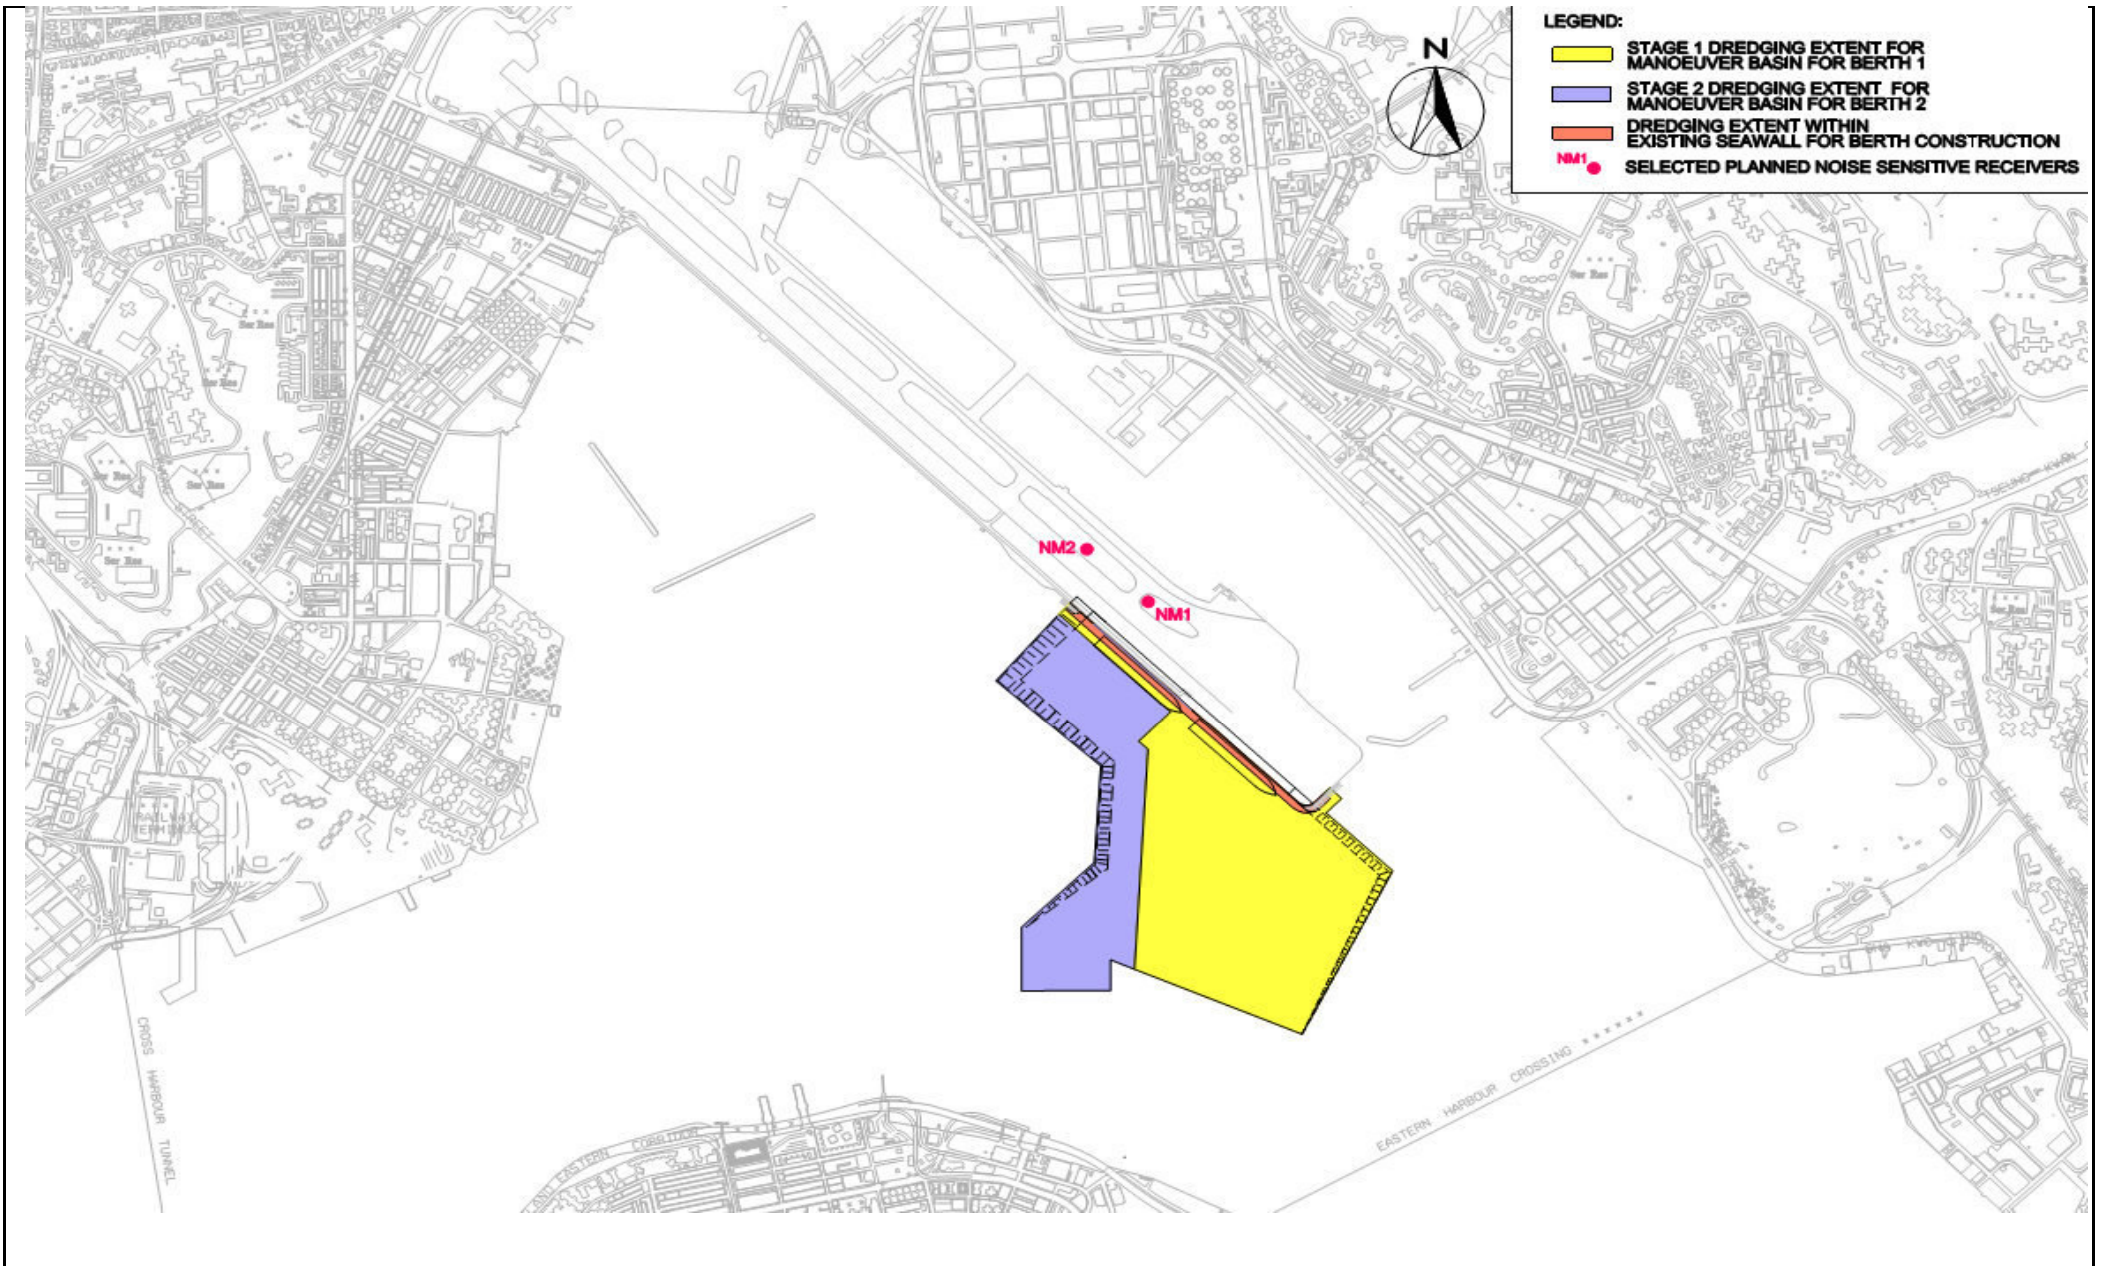
Title	Contract No. CV/2013/02		Scale	Propose No.	MA14015	CINOTECH
	CEDD Maintenance Contract for Seawalls and Navigation Channels (2013-2016)					
	Dredging at Cruise Terminal Stage 2		Date	Figure	3	
	Planned Noise Monitoring Stations during Construction Phase		Apr-14

- 3.1 In accordance with the EIA Report and the EM&A Manual, it is anticipated that construction activities, if unmitigated, would not cause any adverse noise impact to the nearest NSRs in the vicinity of the work site. The predicted noise levels at the NSRs would comply with construction noise criteria.
- 3.2 These nearest NSRs are designated for construction noise monitoring as listed in Table 3.1 and **Figure 3**.

Monitoring Stations	Description
NM1	Planned Residential Development (R3 site)
NM2	Planned Residential Development (R3 site)

5. Due to the non-existence of planned NSRs during the reporting period, no noise monitoring was required to be conducted at the planned noise monitoring locations NM1 and NM2.

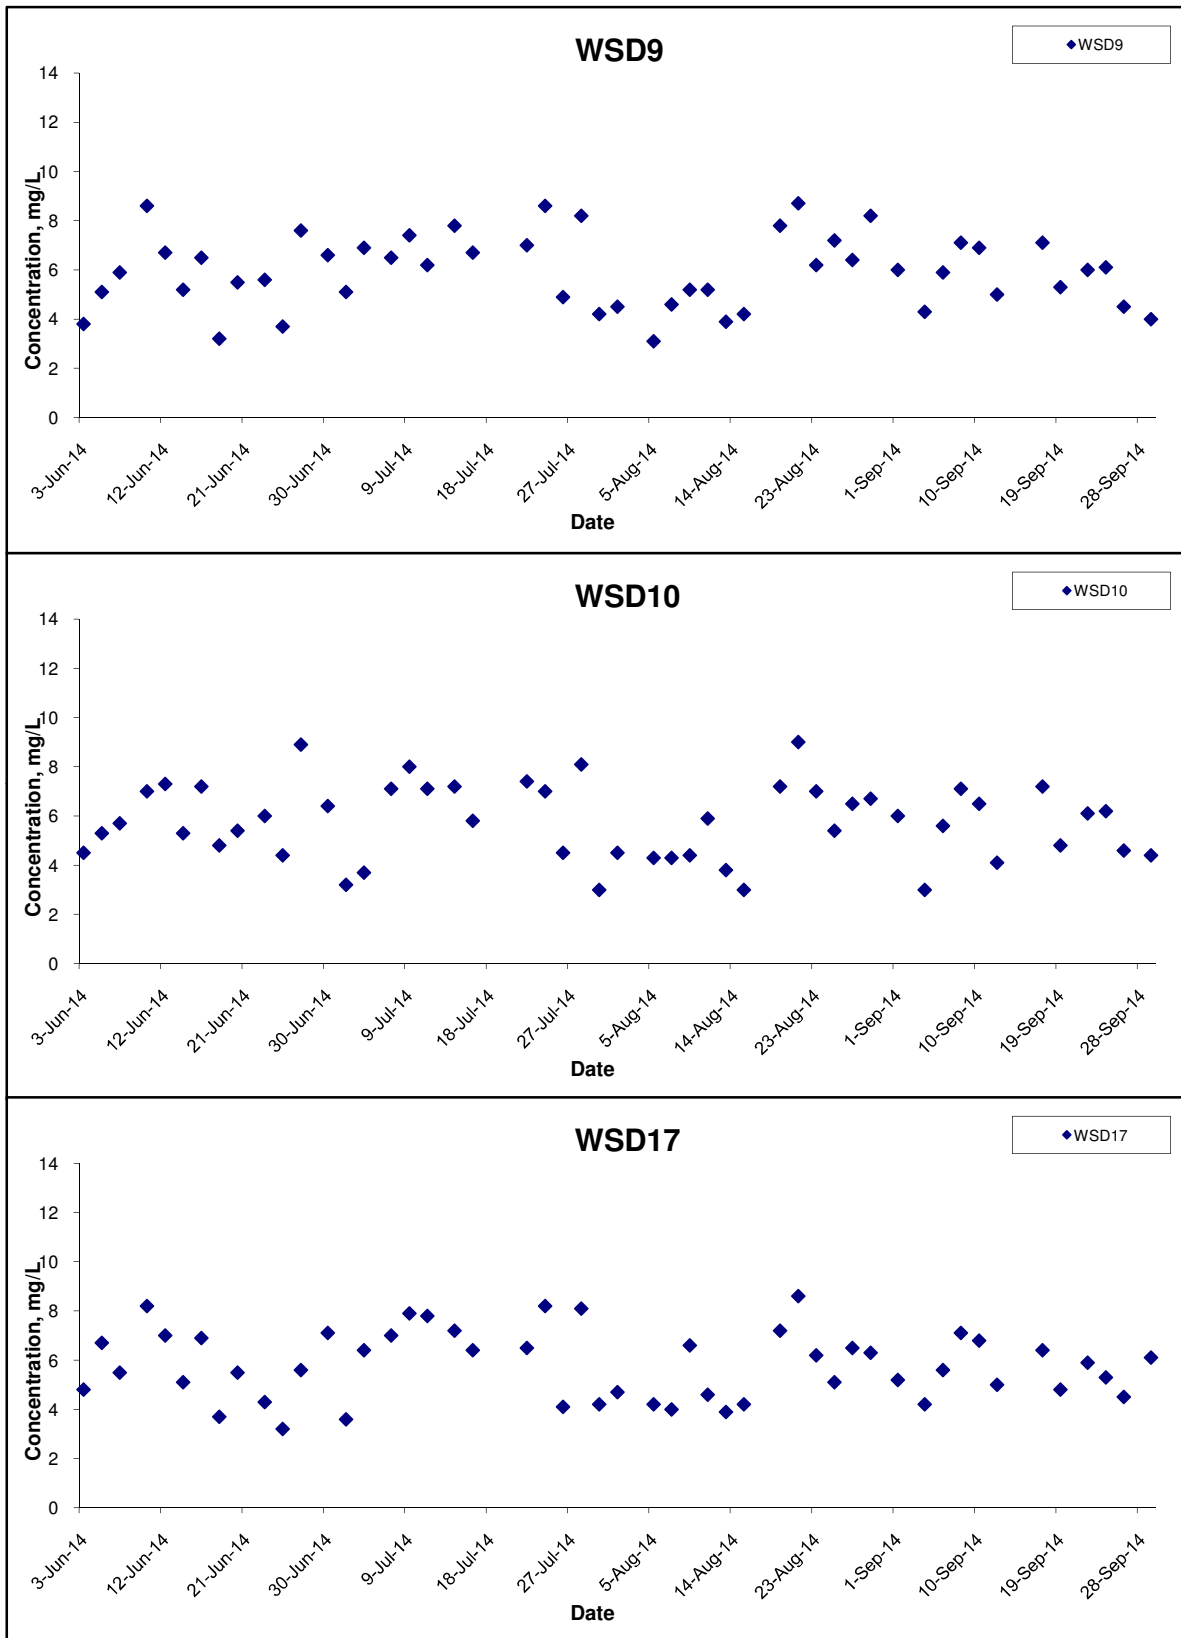
Dissolved Oxygen at Mid-Ebb Tide

Remark: Water quality monitoring on 15 September 2014 was cancelled due to adverse weather (Typhoon Signal No. 3)

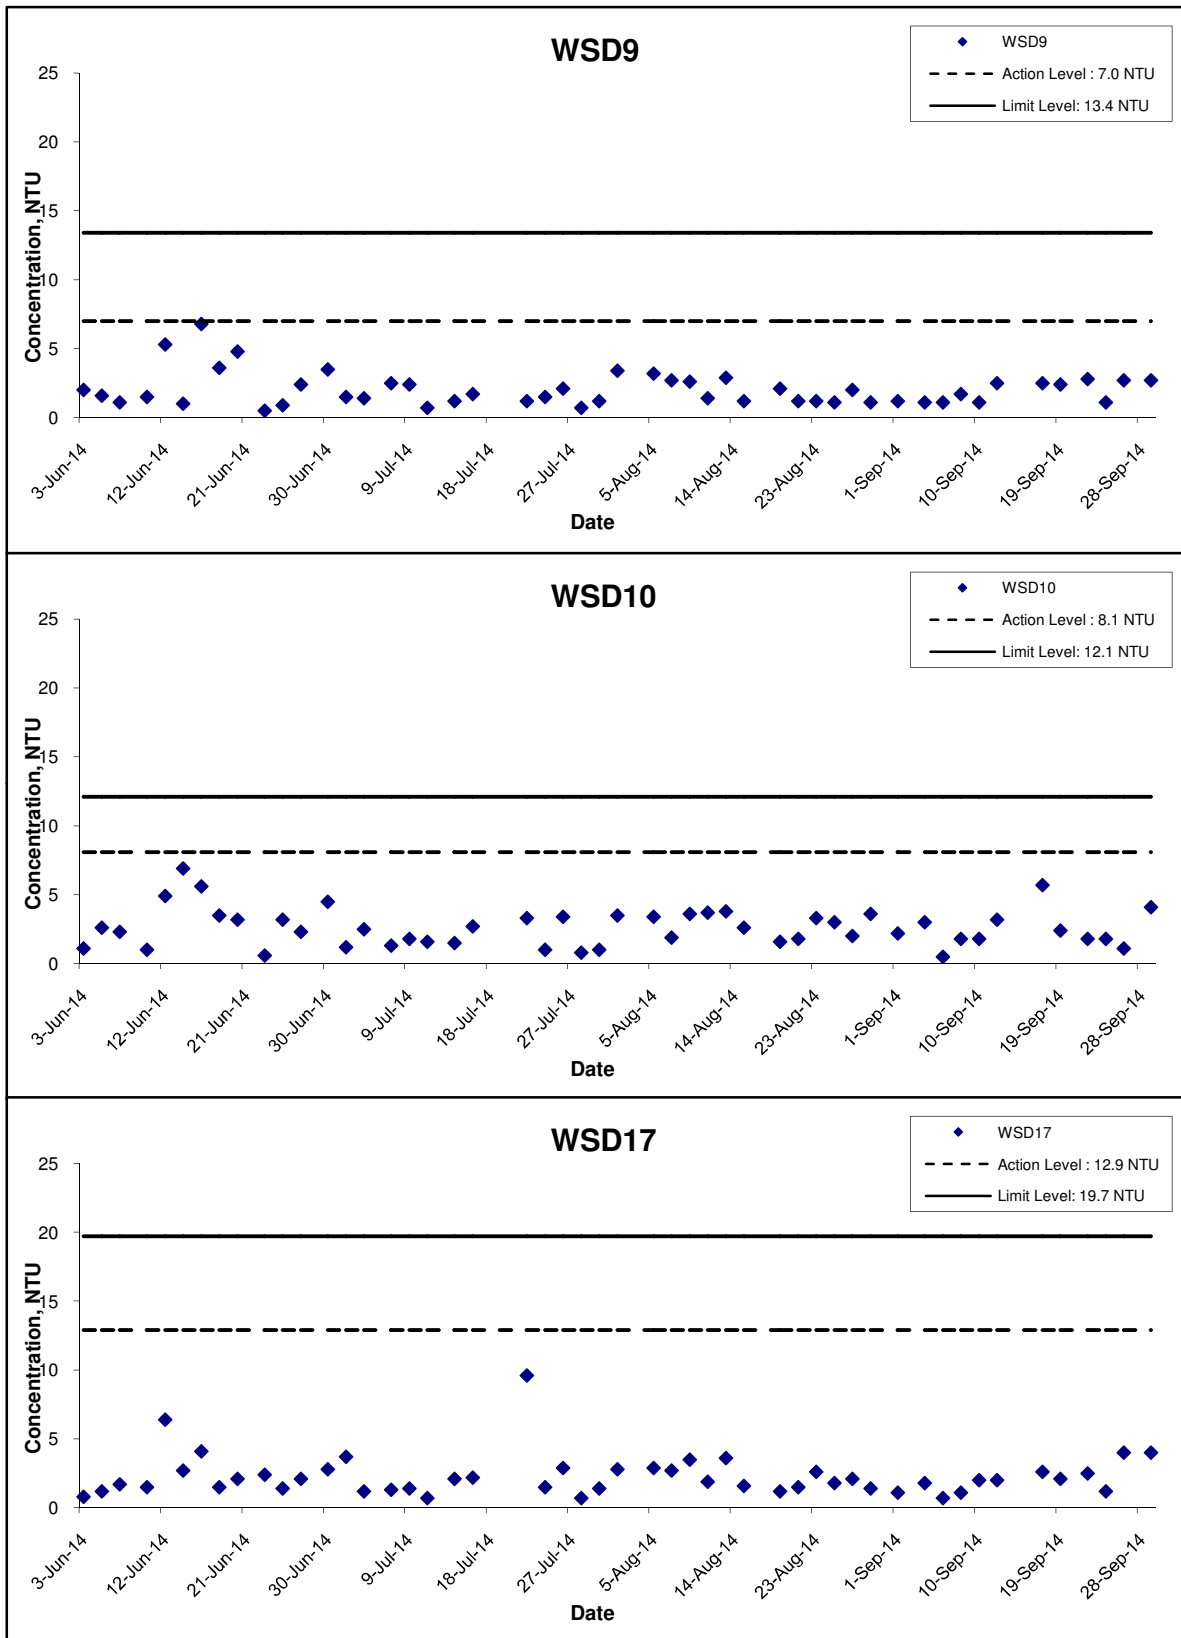
Turbidity at Mid-Ebb Tide

Remark: Water quality monitoring on 15 September 2014 was cancelled due to adverse weather (Typhoon Signal No. 3)

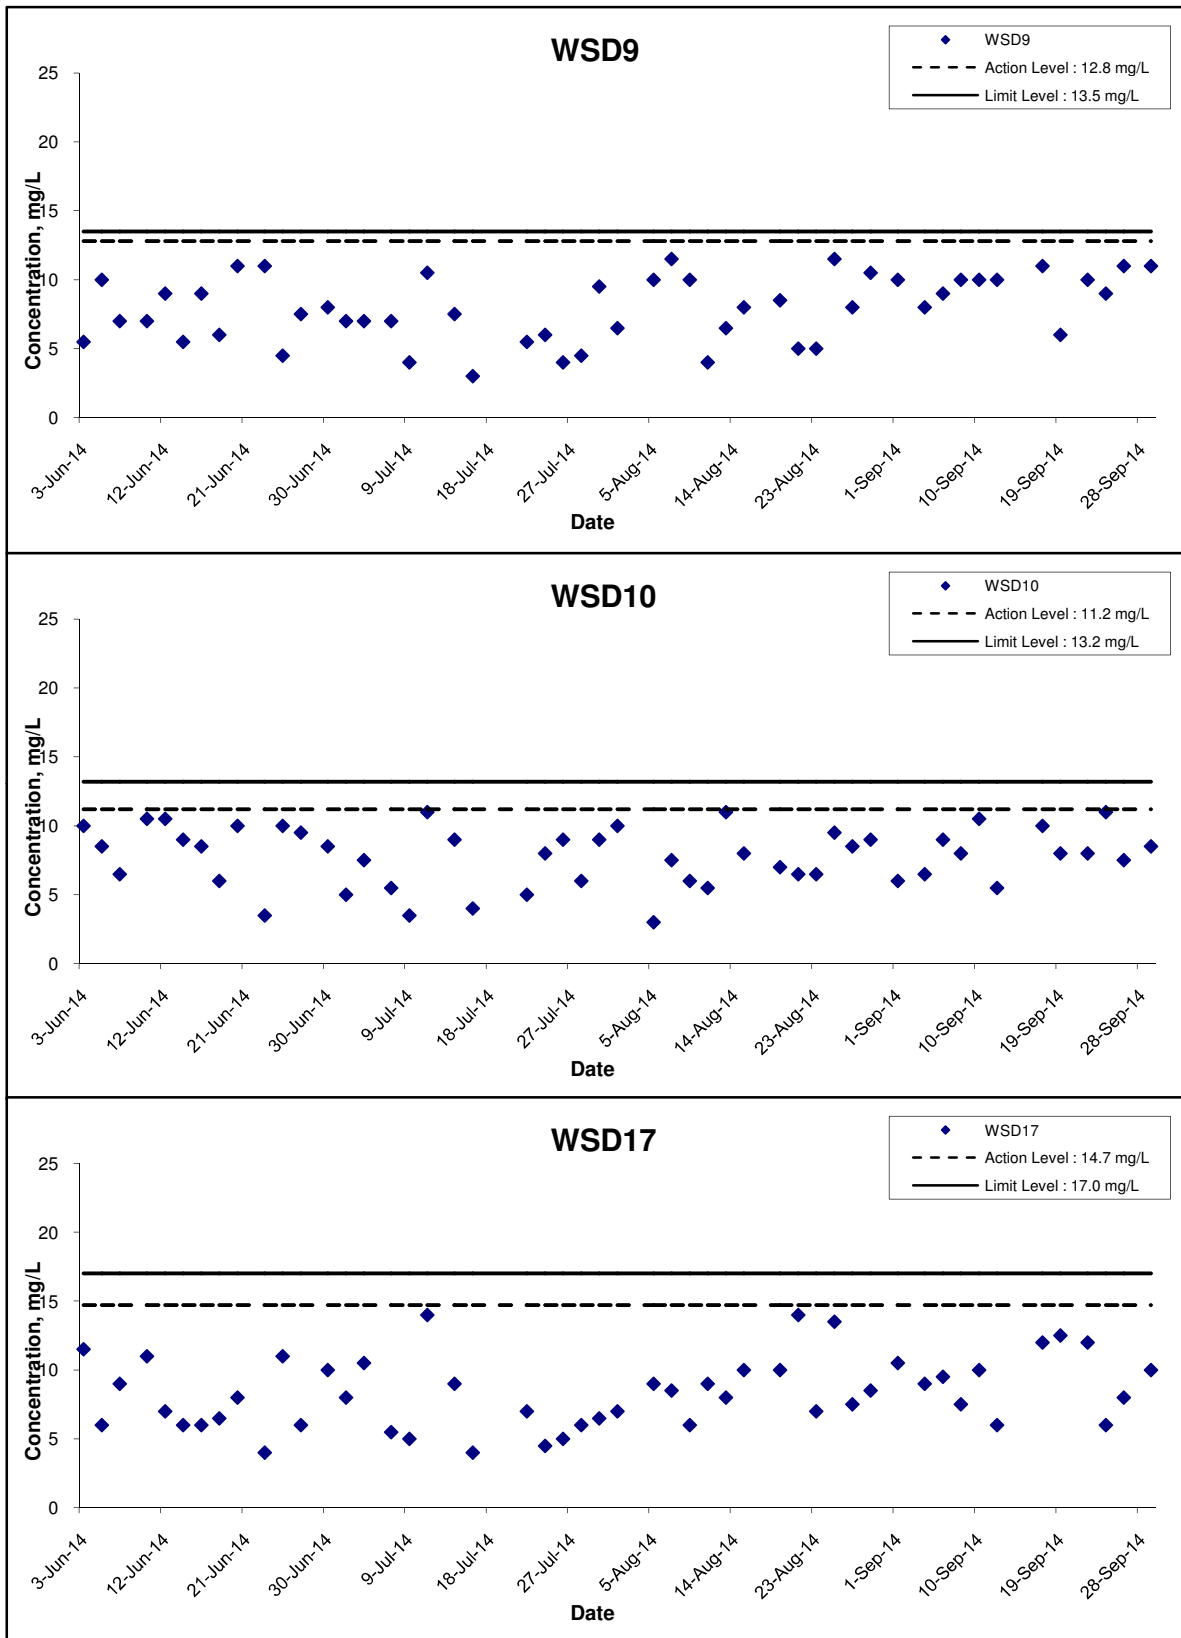
Suspended Solids at Mid-Ebb Tide

Remark: Water quality monitoring on 15 September 2014 was cancelled due to adverse weather (Typhoon Signal No. 3)
