Contract No. KL/2013/01

**Site Formation for Kai Tak Cruise Terminal
Development – Remaining Works**

**Monthly EM&A Report
June 2015
(Version 2.0)**

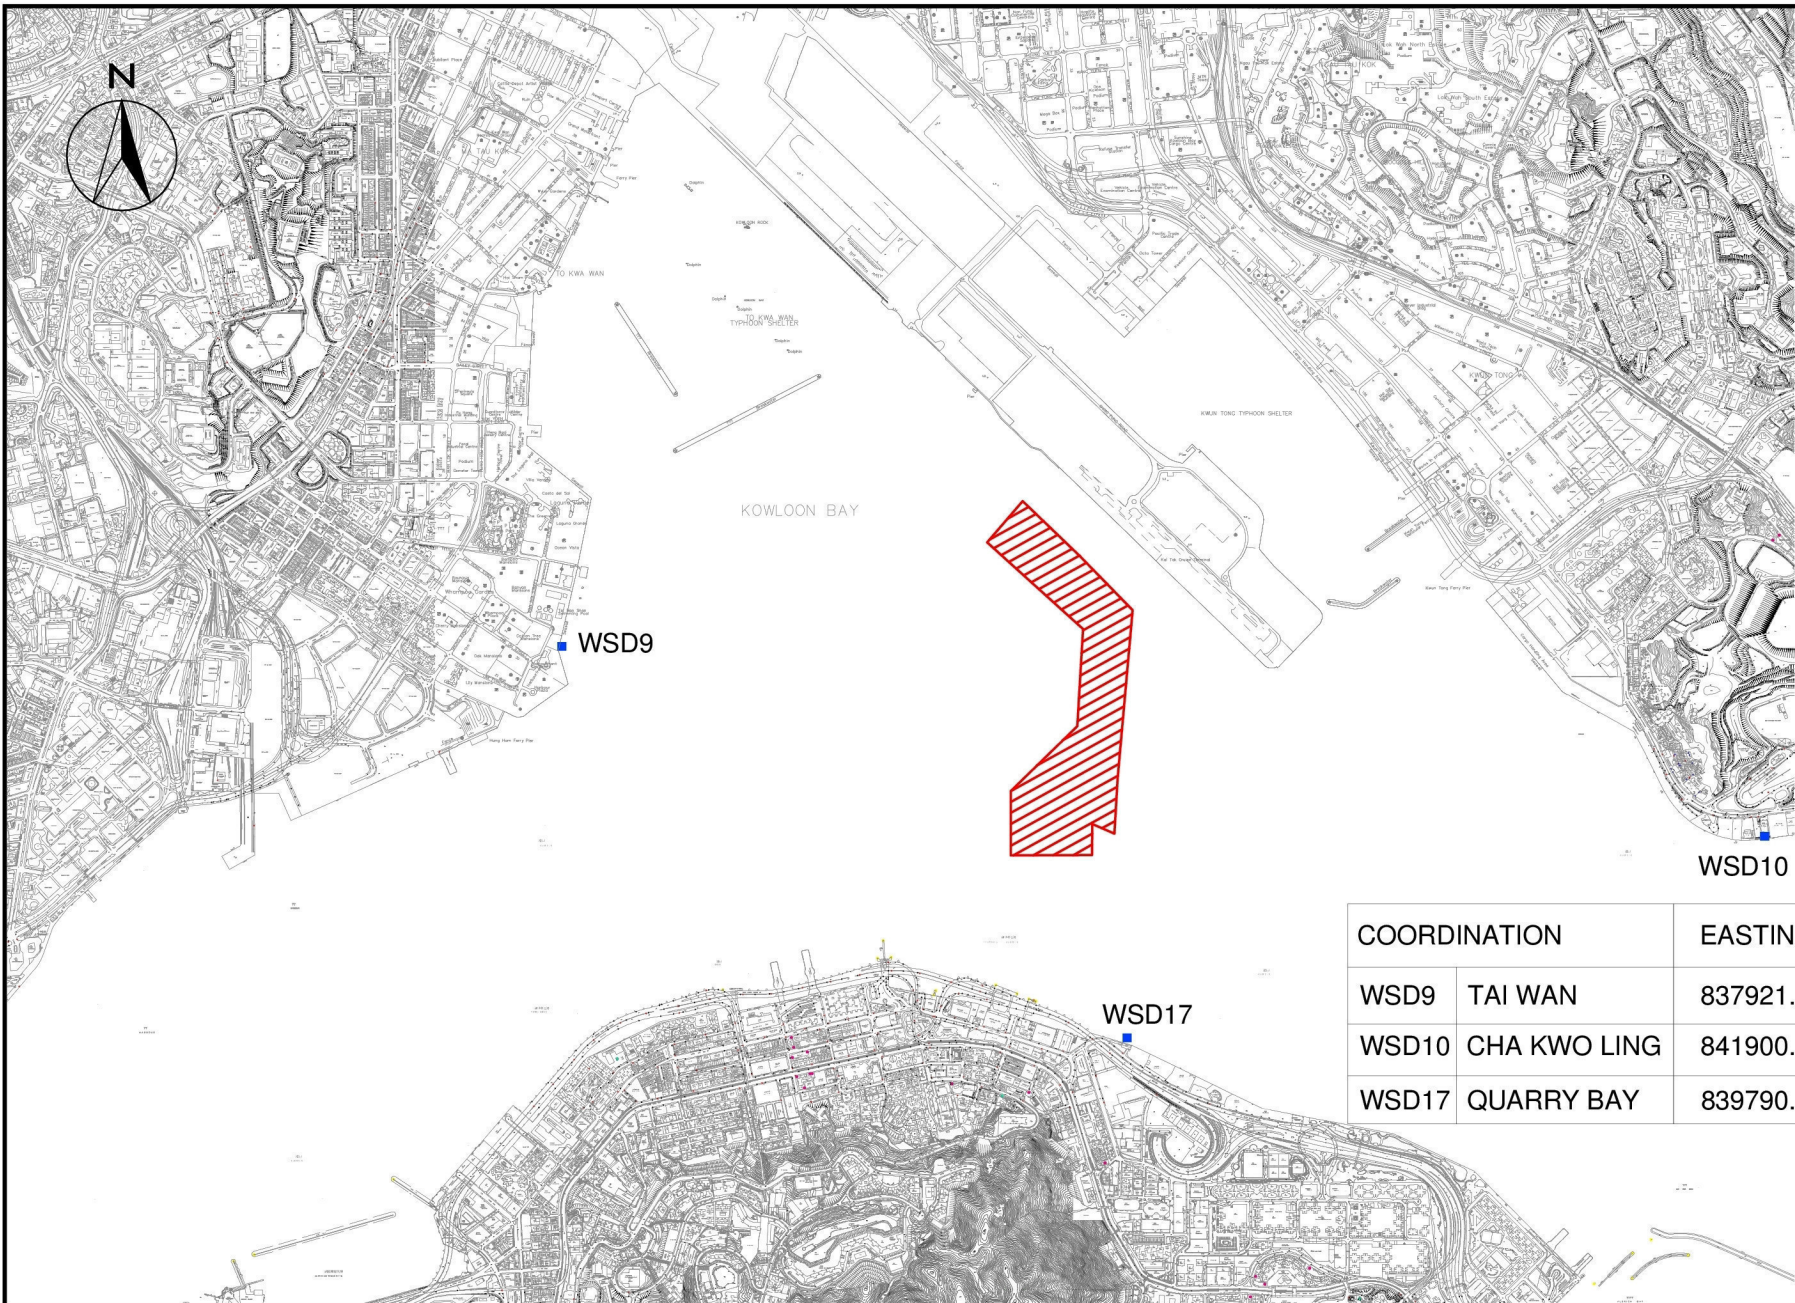
SCALE	1:25000@A4	DATE	JUN 15	
CHECK	IT	DRAWN	JW	
JOB No.	MA15011	FIGURE NO.	2	REV -

LOCATION OF WATER QUALITY MONITORING STATIONS

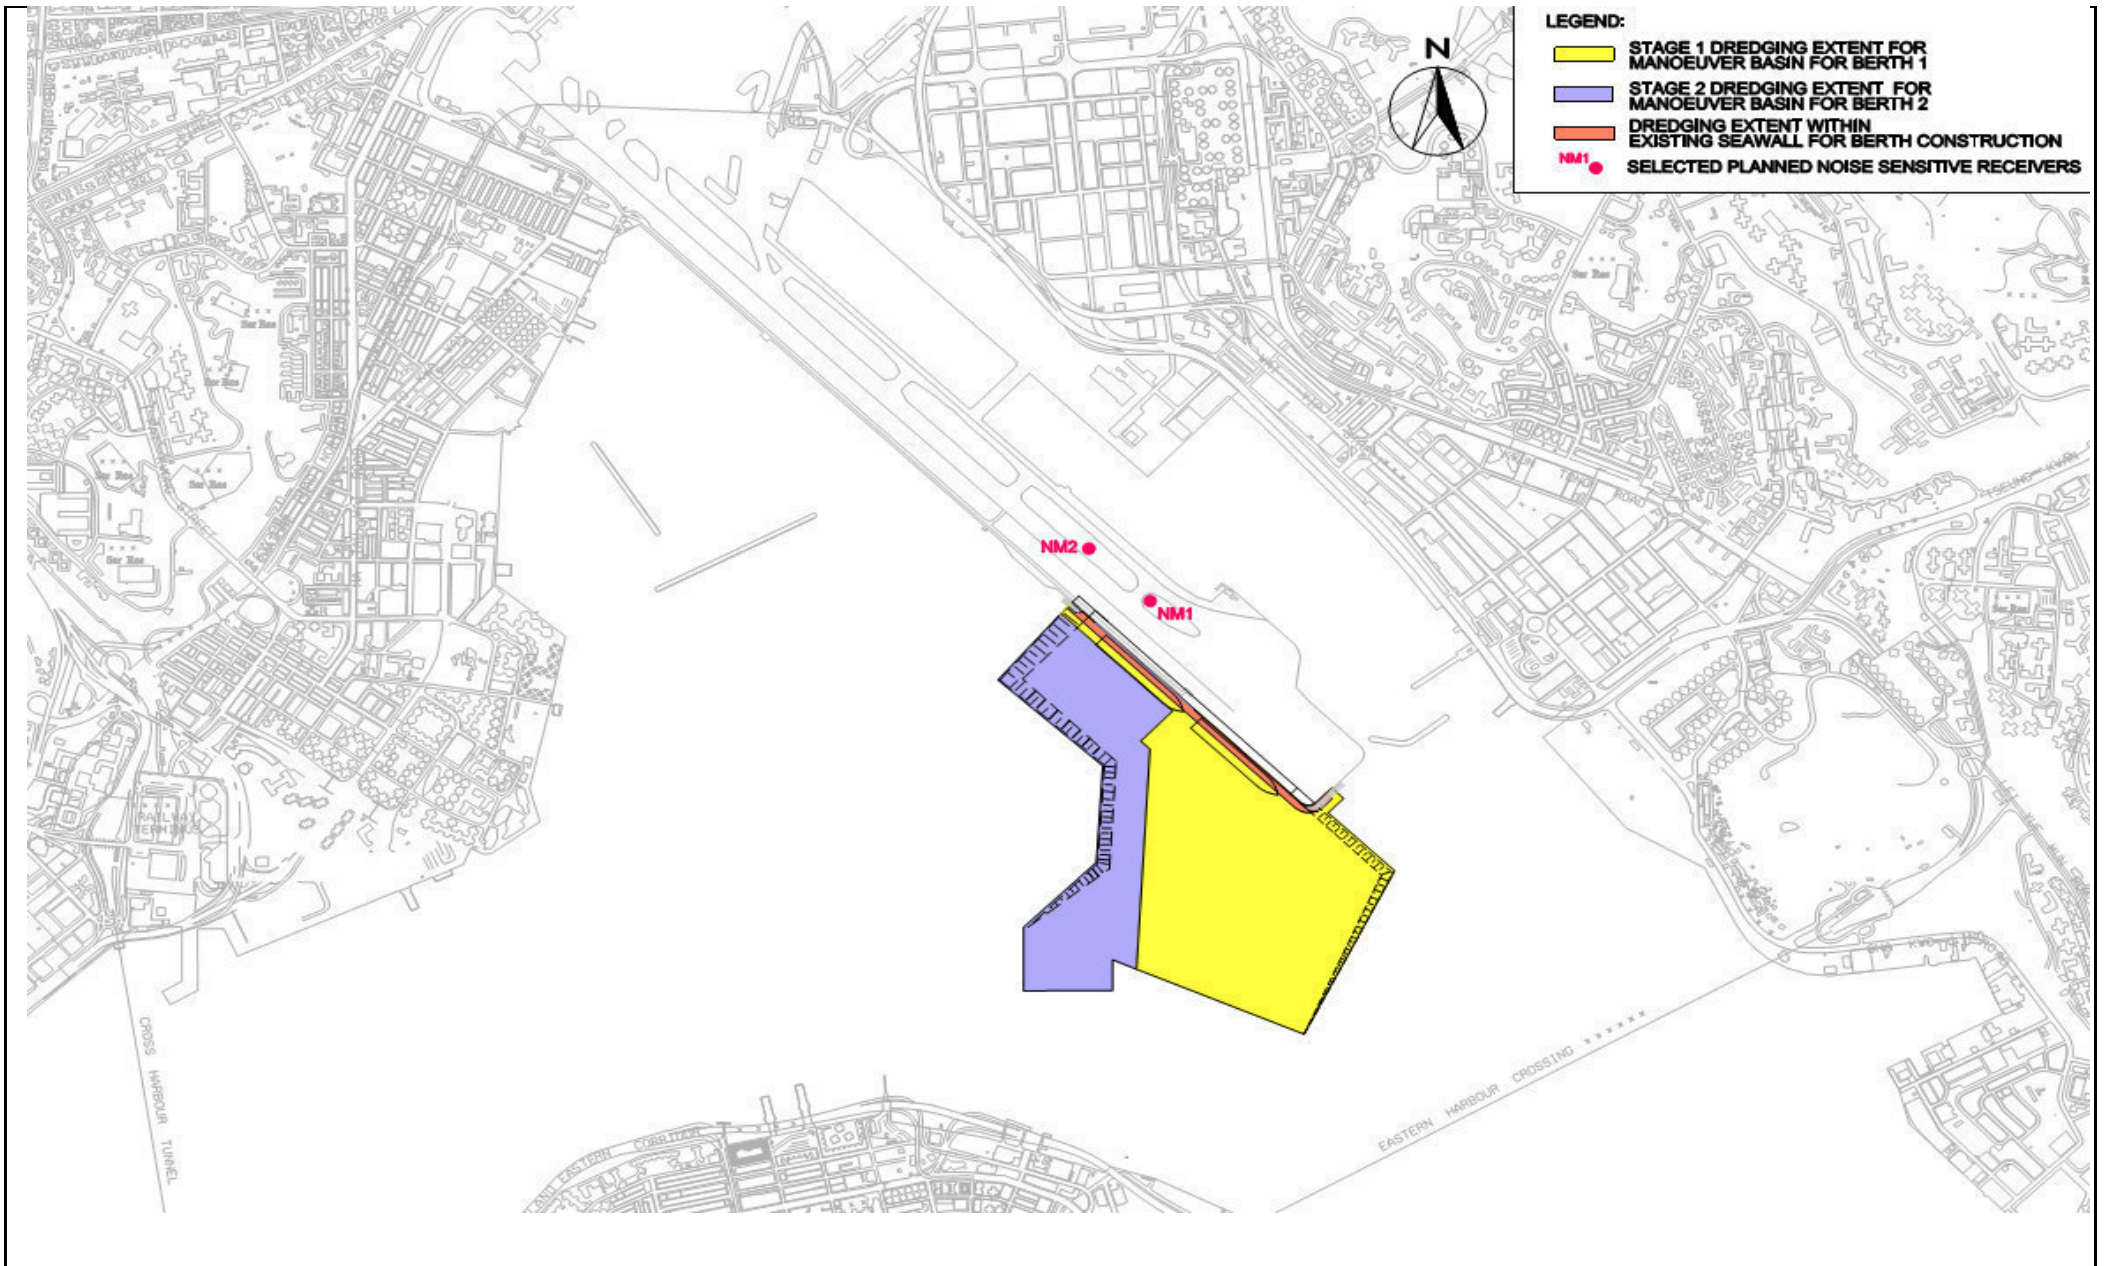
- 3.1 In accordance with the EIA Report and the EM&A Manual, it is anticipated that construction activities, if unmitigated, would not cause any adverse noise impact to the nearest NSRs in the vicinity of the work site. The predicted noise levels at the NSRs would comply with construction noise criteria.
- 3.2 These nearest NSRs are designated for construction noise monitoring as listed in Table 3.1 and **Figure 3**.

Title	Contract No. KL/2013/01		Scale	N.T.S	Propose	MA15011	CINOTECH
	Site Formation for Kai Tak Cruise Terminal Development - Remaining Works		Date	Apr-15	Figure		
Planned Noise Monitoring Stations during Construction Phase

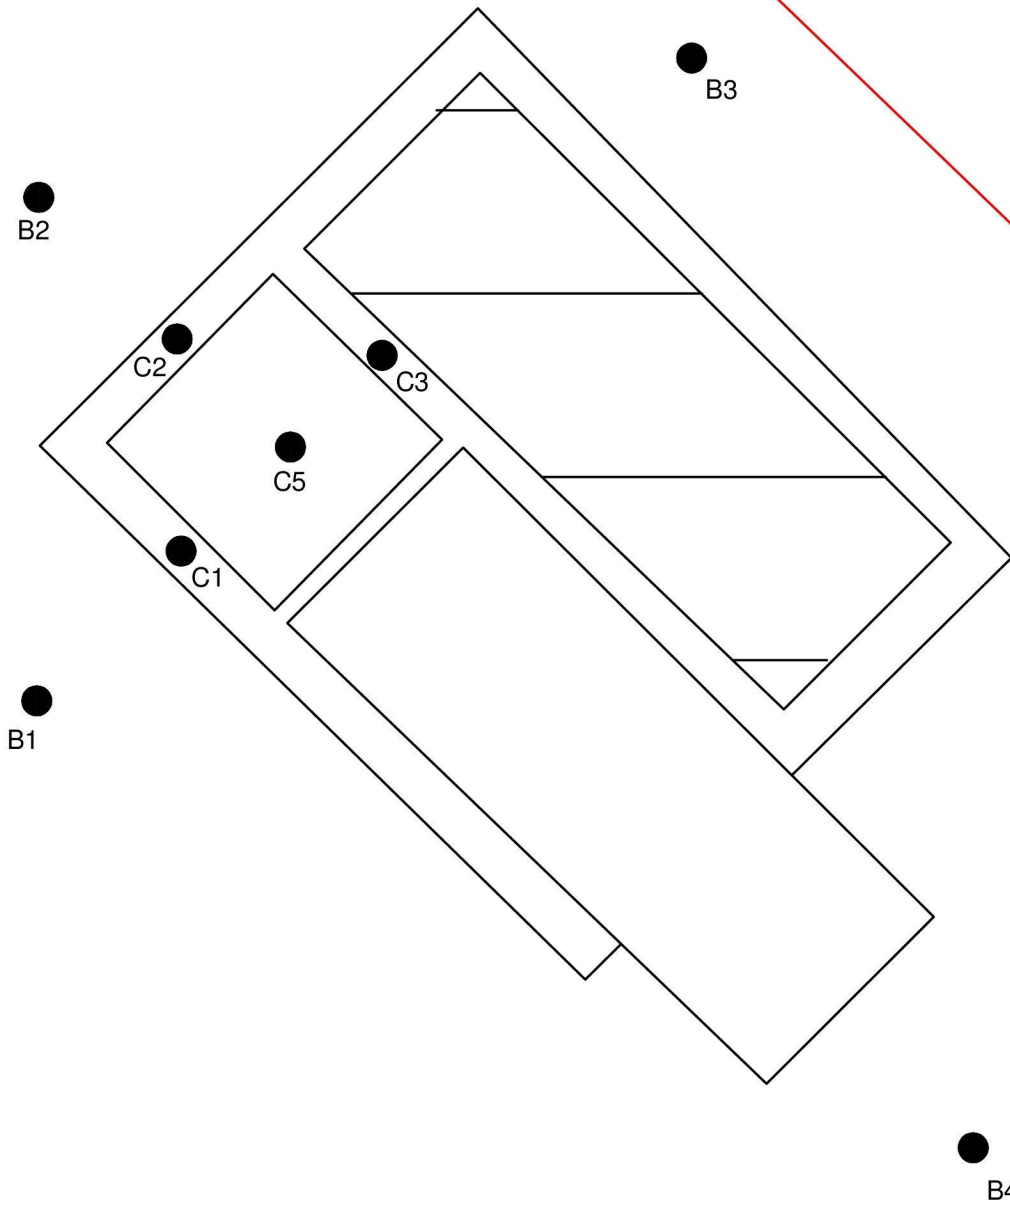
SCALE	N.T.S.		JUN 15
CHECK	IT	DRAWN	KC
JOB No.	MA15011	FIGURE	5.1
		REV	-

10 June 2015

- SILT CURTAIN(S) AT GRAB
- HOPPER BARGE
- DREDGER
- SILT CURTAIN (SURROUNDING THE DREDGER)

SET	COORDINATE	EASTING (m)	NORTHING (m)
A	A1	839733.348	818527.579
	A2	839386.623	818742.398
	A3	839524.739	818496.534
	A4	839713.112	818245.810
B	B1	POSITIONS CHANGE WITH THE LOCATION OF DREDGER AND THE SILT CURTAIN AT GRAB AND IN 4 ORTHOGONAL DIRECTIONS FROM THE SILT CURTAIN AS AGREED WITH THE ENGINEER	
	B2		
	B3		
	B4		
C	C1	POSITIONS CHANGE WITH THE LOCATION OF DREDGER AND THE SILT CURTAIN AT GRAB AND IN 4 ORTHOGONAL DIRECTIONS FROM THE SILT CURTAIN AS AGREED WITH THE ENGINEER	
	C2		
	C3		
	C5

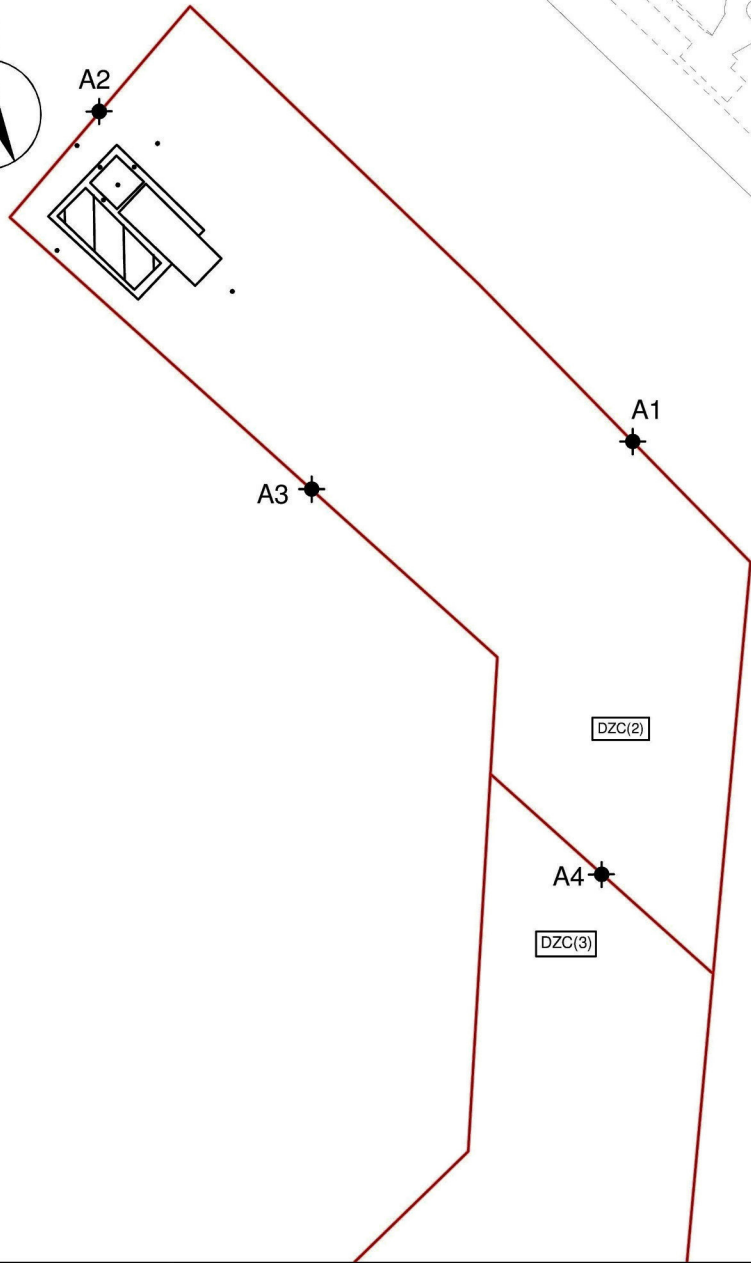
LOCATION OF WATER QUALITY MONITORING STATION FOR WATER QUALITY SURVEILLANCE SYSTEM - 10 JUNE 2015

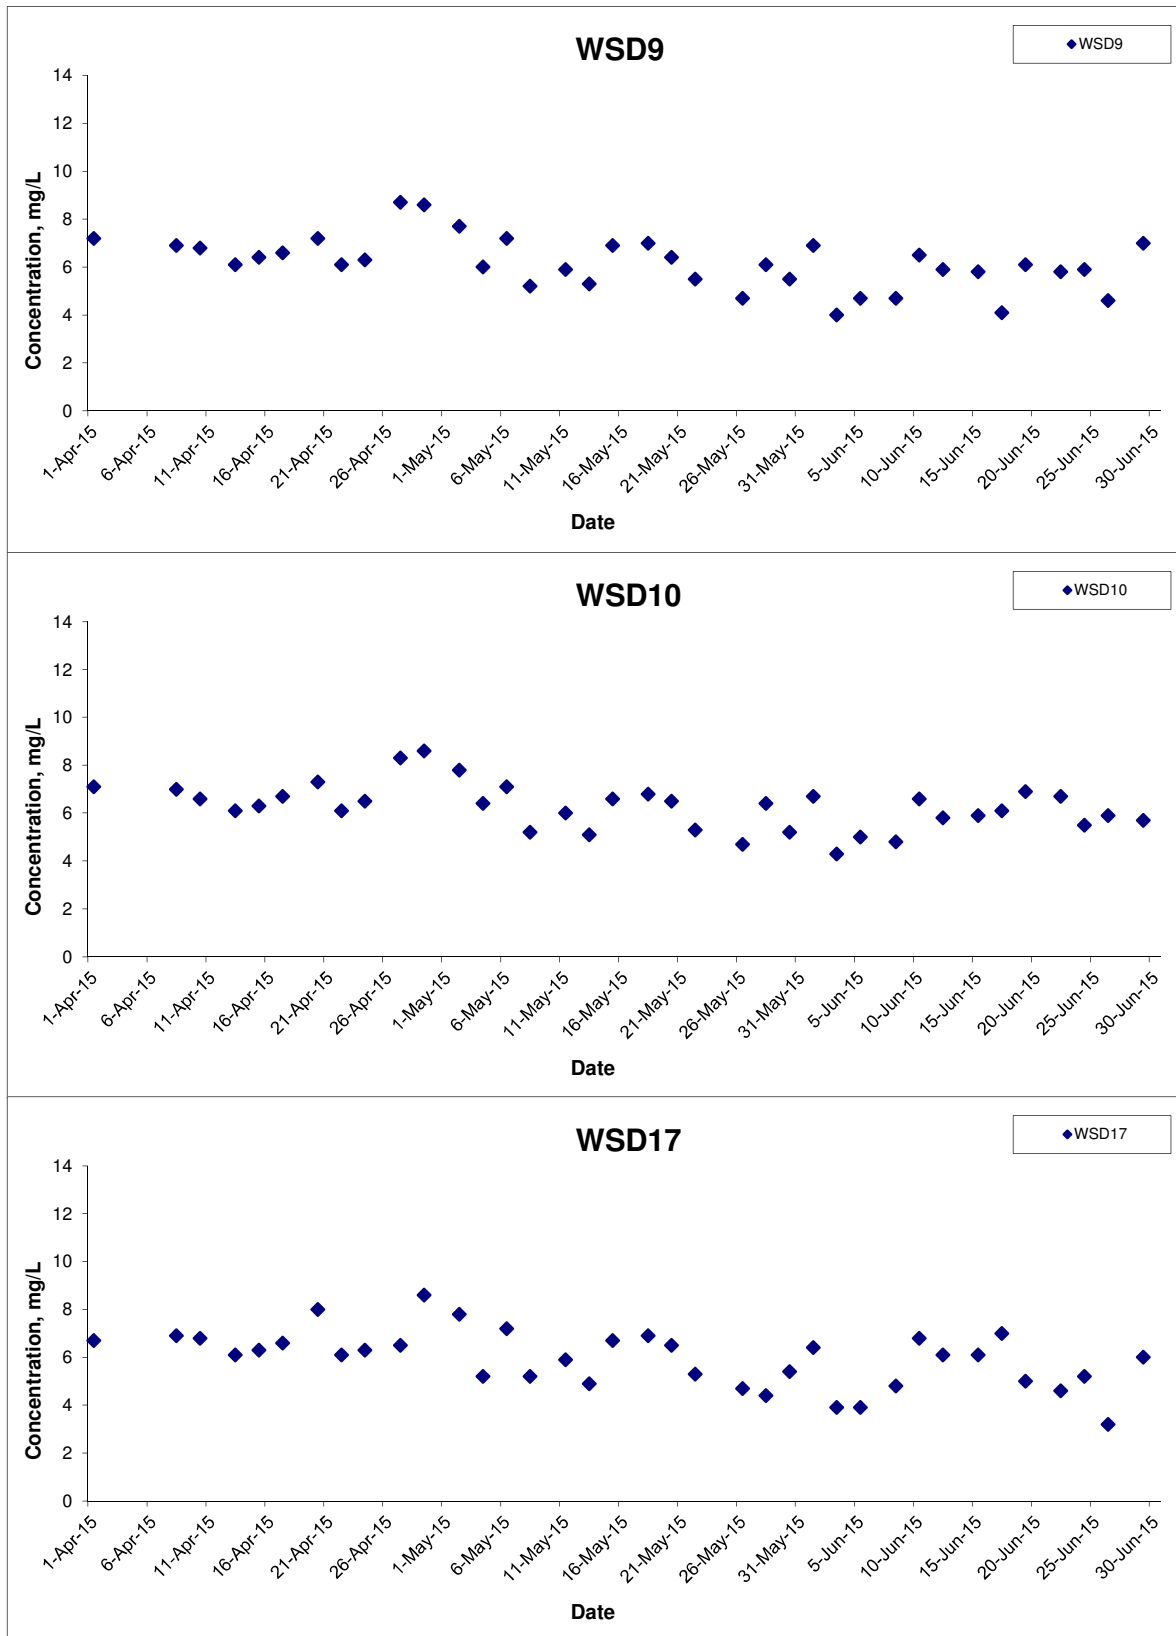
Dissolved Oxygen at Mid-Ebb Tide

Title Contract No. KL/2013/01 -
 Site Formation For Kai Tak Cruise Terminal Development -
 Remaining Works
 Graphical Presentation of Water Quality Monitoring
 Results

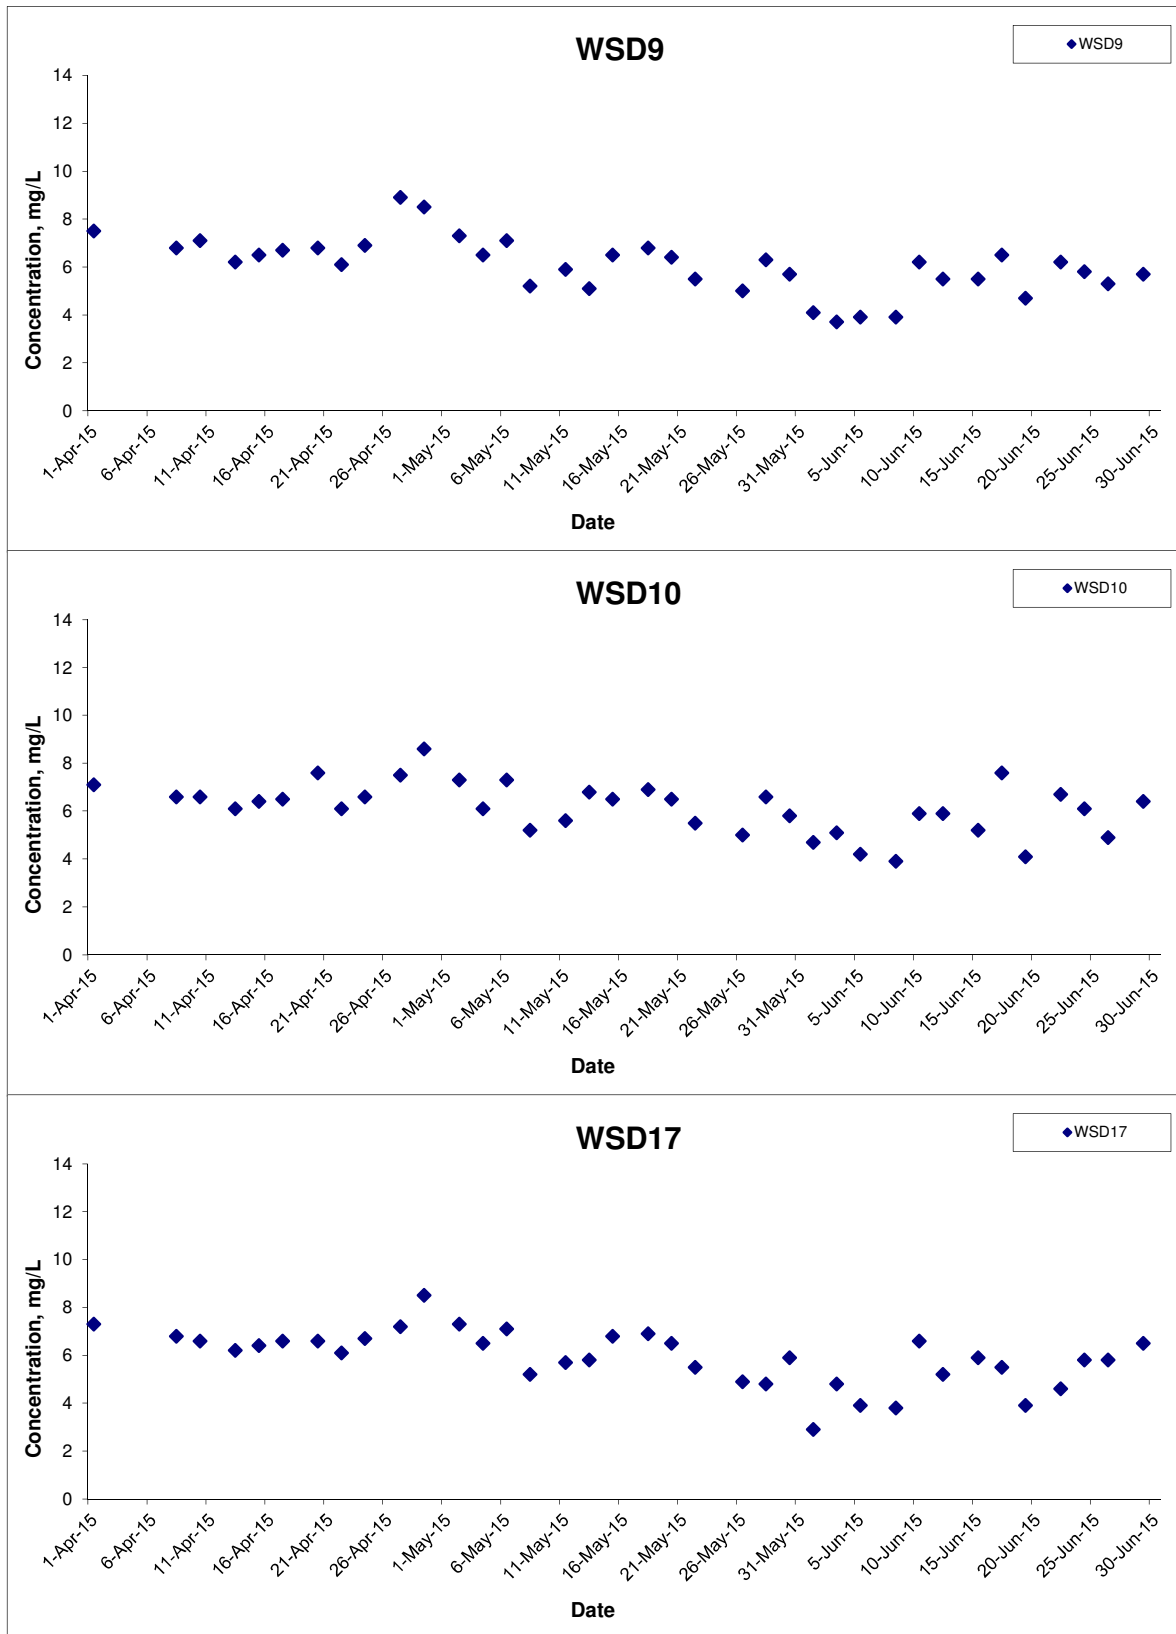
Dissolved Oxygen at Mid-Flood Tide

Title Contract No. KL/2013/01 - Site Formation For Kai Tak Cruise Terminal Development - Remaining Works Graphical Presentation of Water Quality Monitoring Results	Scale	N.T.S	Project No. MA15011	CINOTECH
	Date	Jun 15	Appendix E

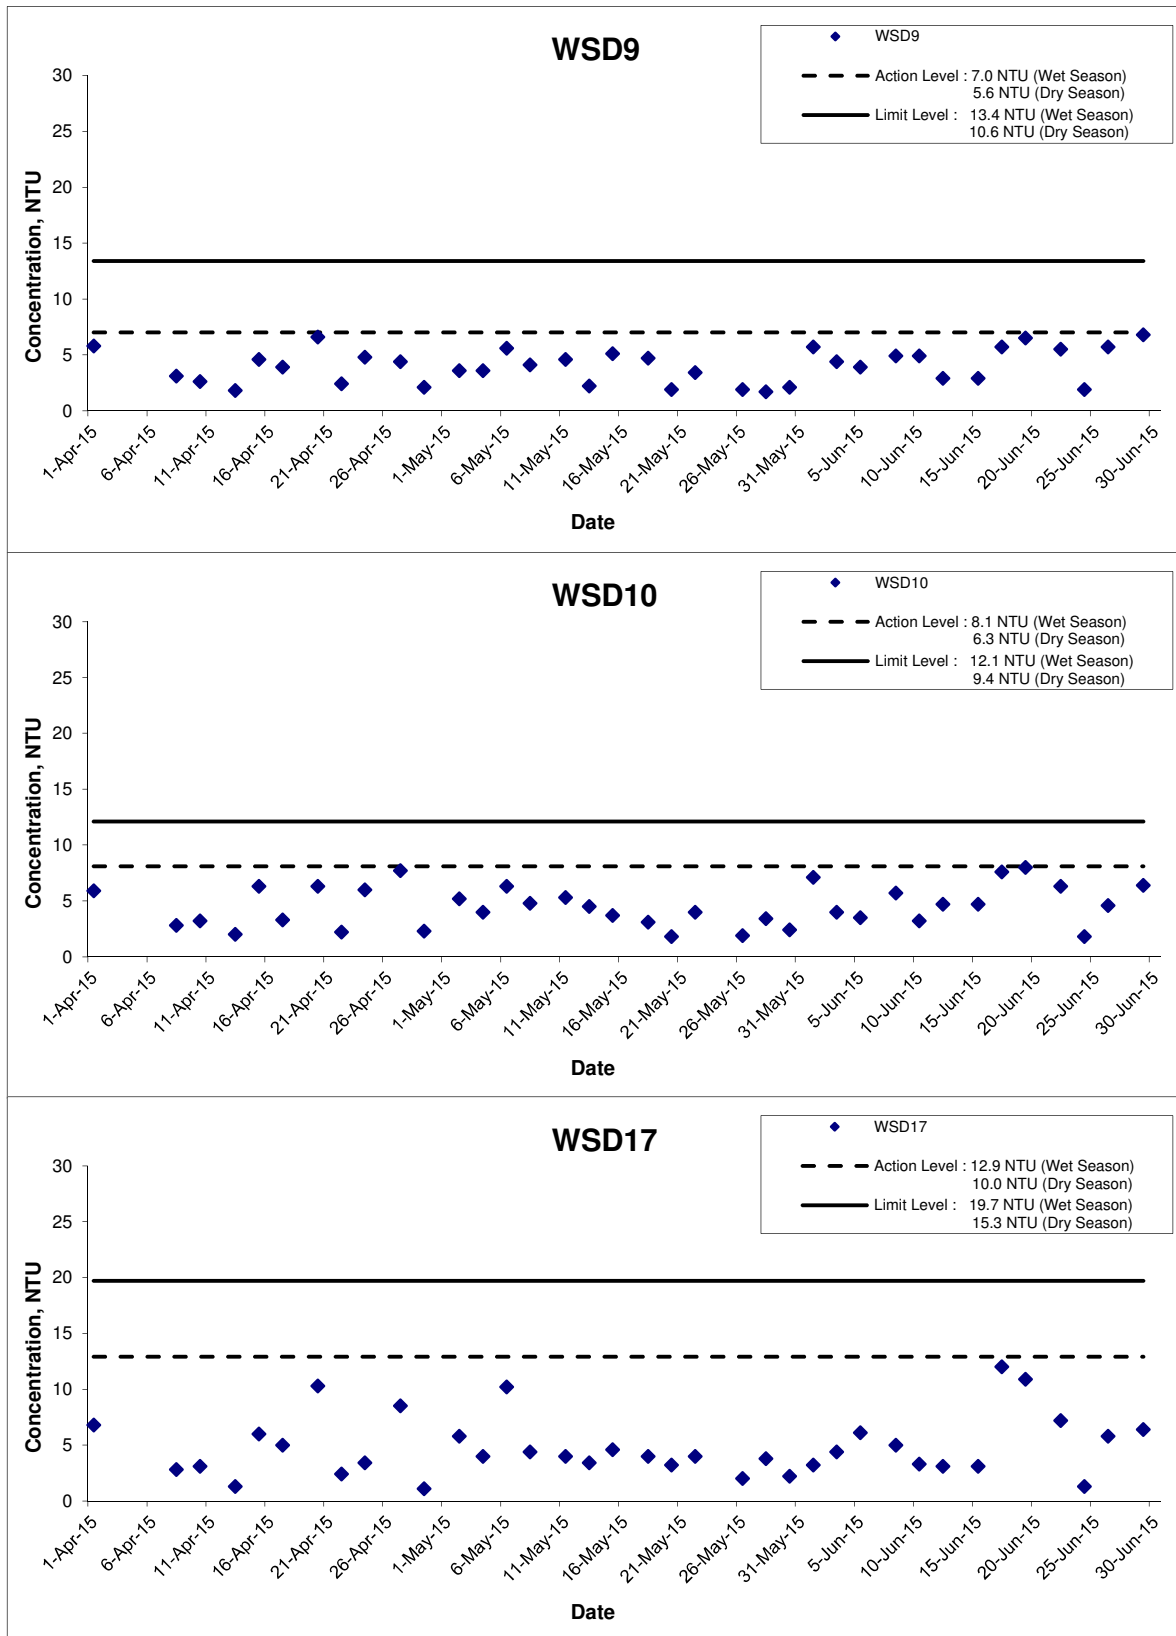
Turbidity at Mid-Ebb Tide

Title
 Contract No. KL/2013/01 -
 Site Formation For Kai Tak Cruise Terminal Development -
 Remaining Works
 Graphical Presentation of Water Quality Monitoring
 Results

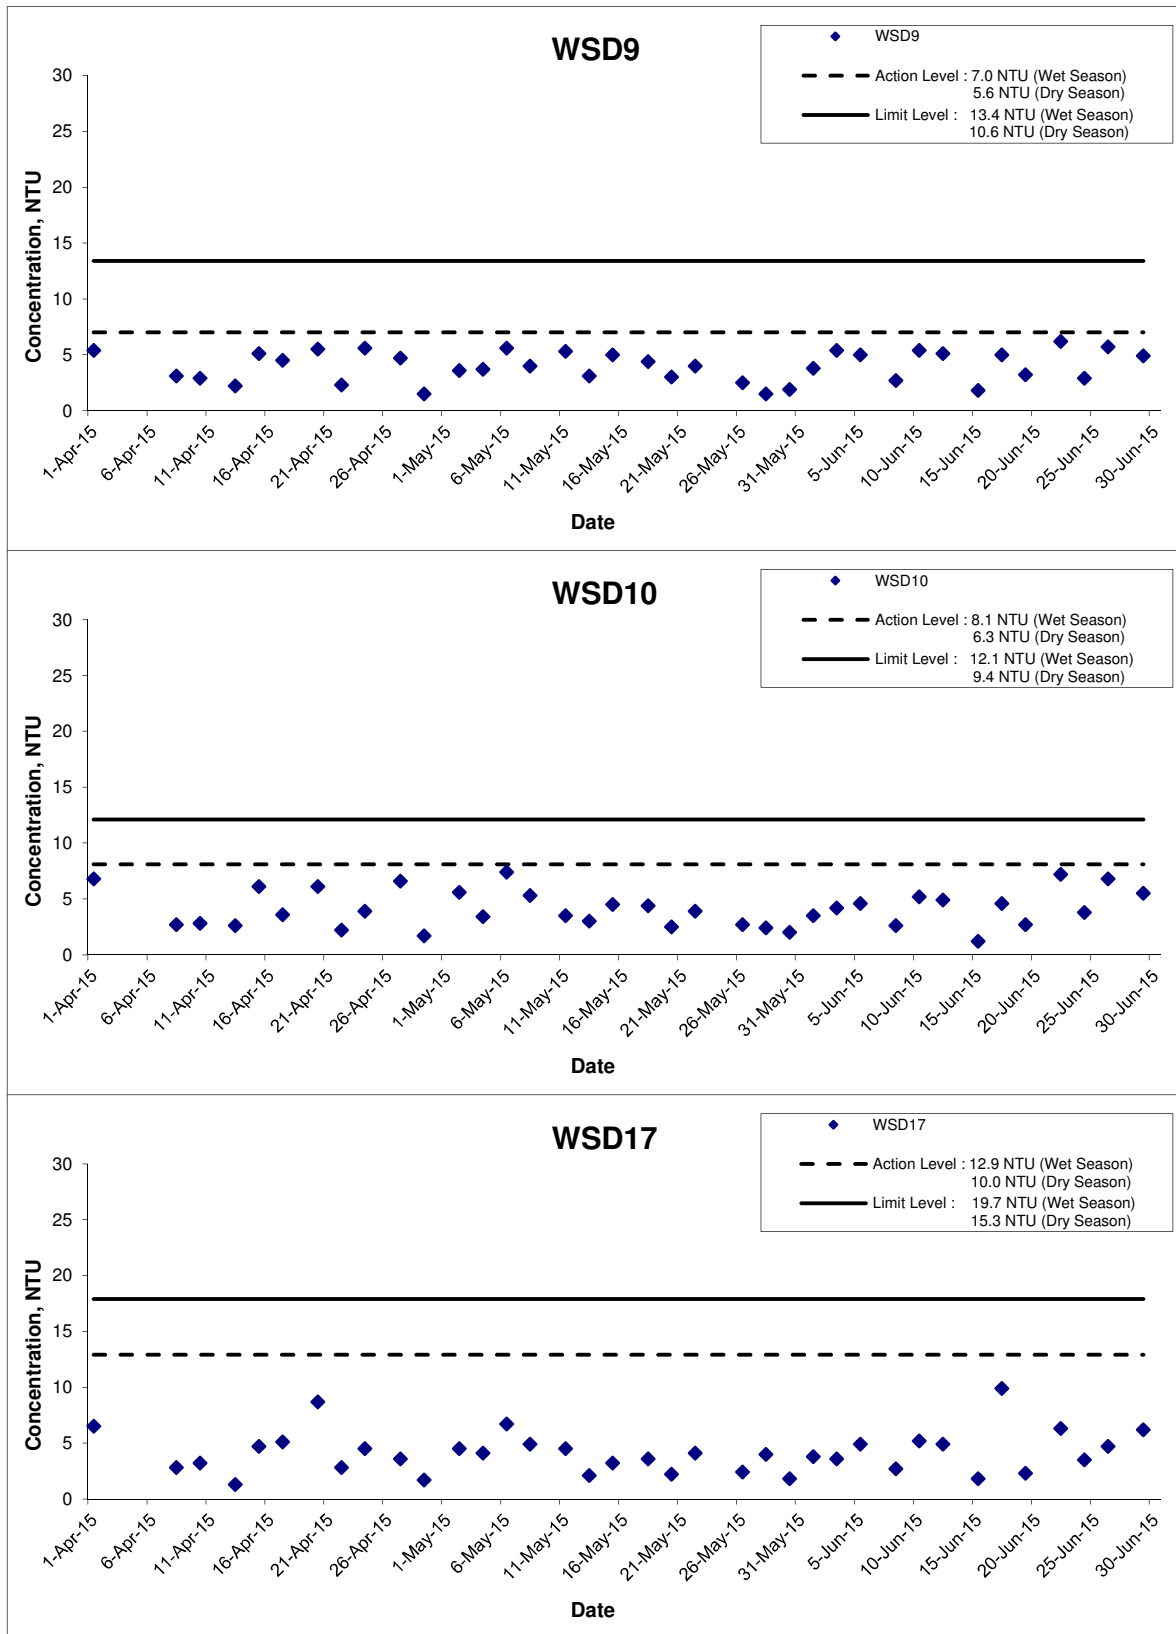
Turbidity at Mid-Flood Tide

Title Contract No. KL/2013/01 -
 Site Formation For Kai Tak Cruise Terminal Development -
 Remaining Works
 Graphical Presentation of Water Quality Monitoring
 Results

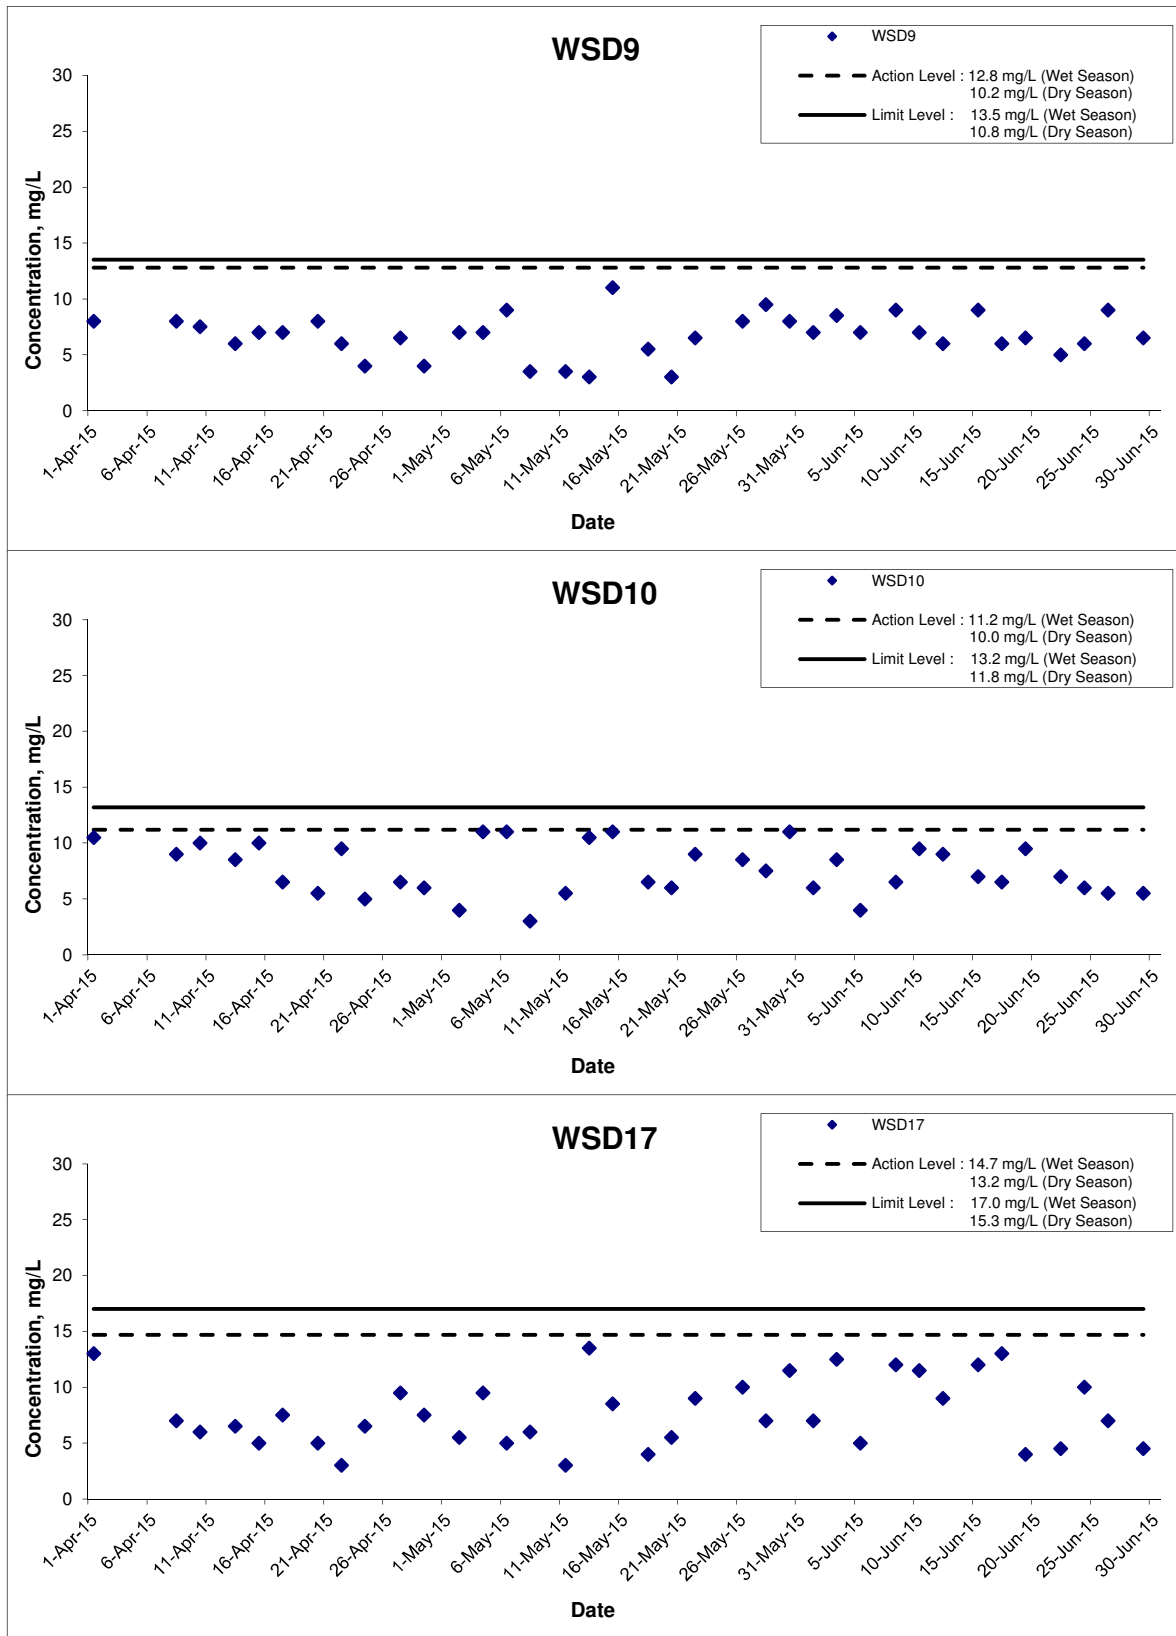
Suspended Solids at Mid-Ebb Tide

Title Contract No. KL/2013/01 -
 Site Formation For Kai Tak Cruise Terminal Development -
 Remaining Works
 Graphical Presentation of Water Quality Monitoring
 Results

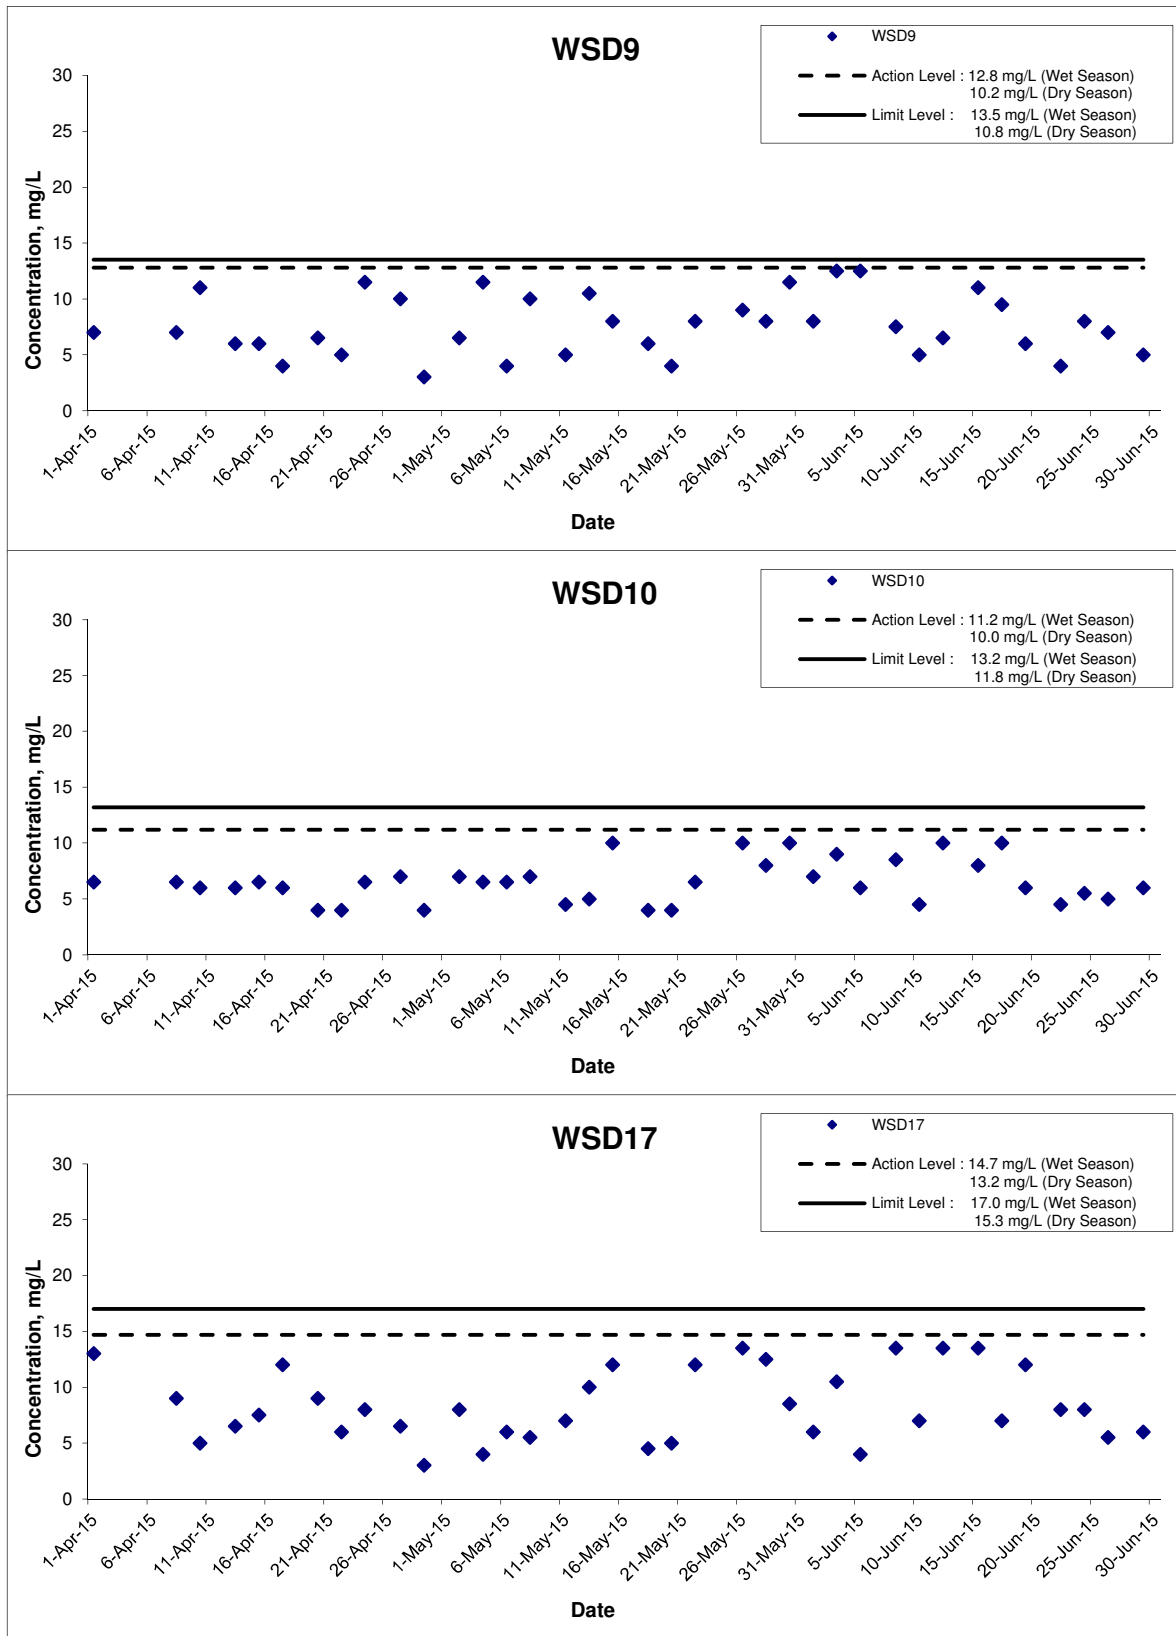
Suspended Solids at Mid-Flood Tide

Title Contract No. KL/2013/01 -
 Site Formation For Kai Tak Cruise Terminal Development -
 Remaining Works
 Graphical Presentation of Water Quality Monitoring
 Results

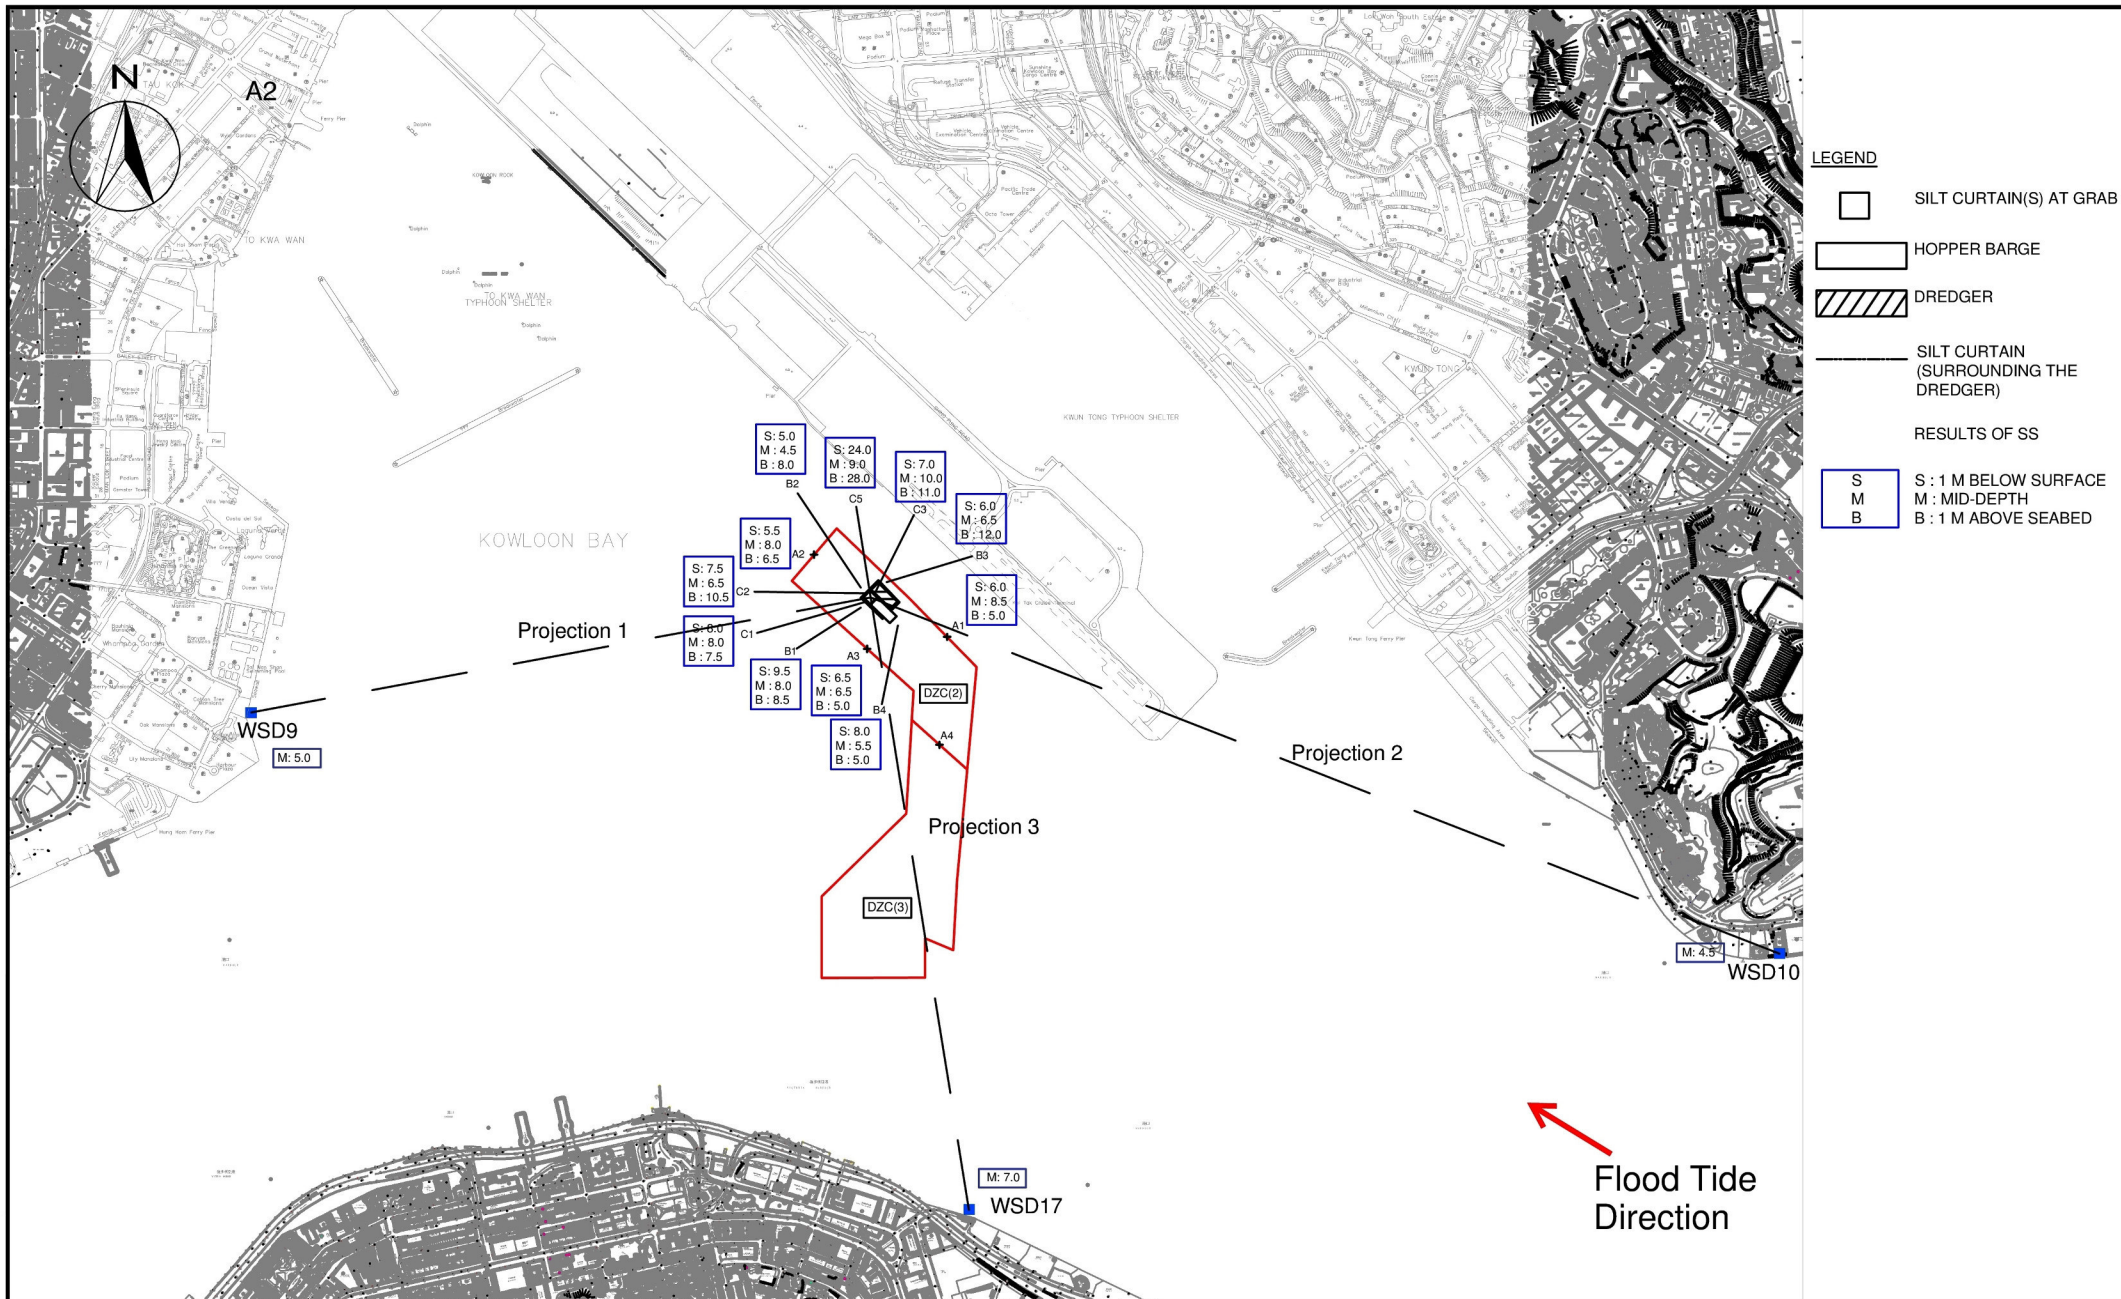
WATER QUALITY SURVEILLANCE SYSTEM - 10 June 2015 (Flood Tide)
