Contract No. KL/2013/01

**Site Formation for Kai Tak Cruise Terminal
Development – Remaining Works**

**Monthly EM&A Report
June 2015
(Version 2.0)**

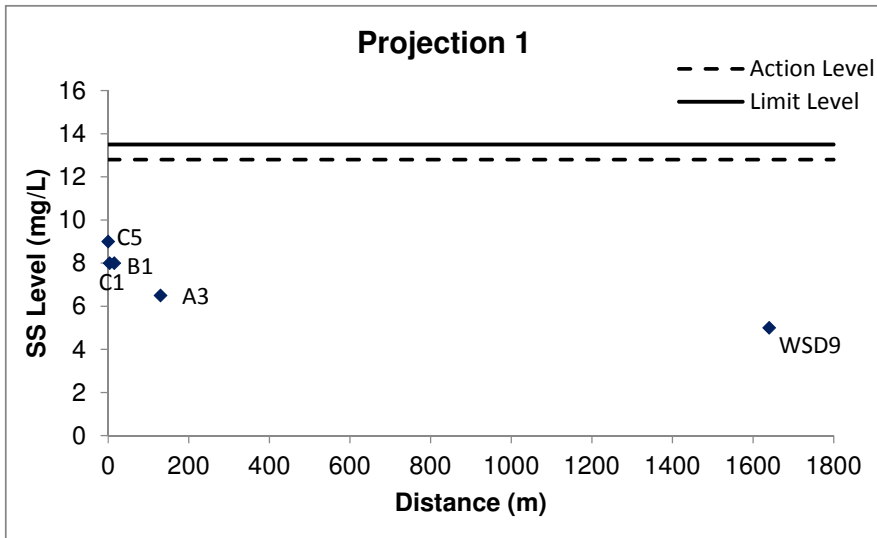
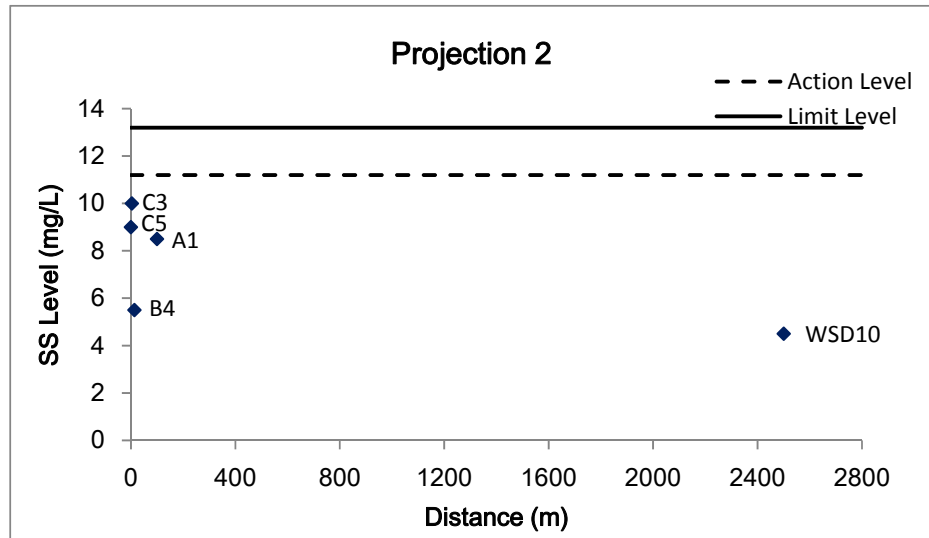
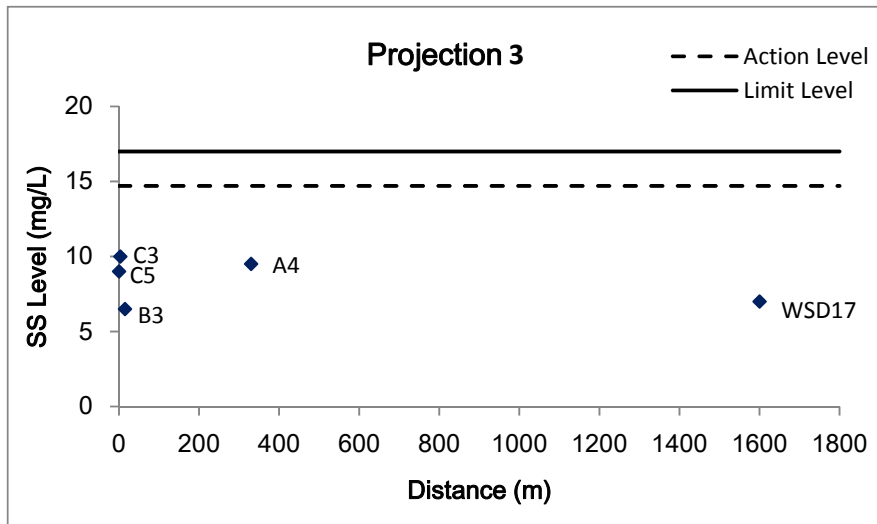
SCALE	N.T.S.		JUN 15
CHECK	IT	DRAWN	KC
JOB No.	MA15011	APPENDIX	REV
		F	-

WATER QUALITY SURVEILLANCE SYSTEM - 10 June 2015 (Flood Tide)

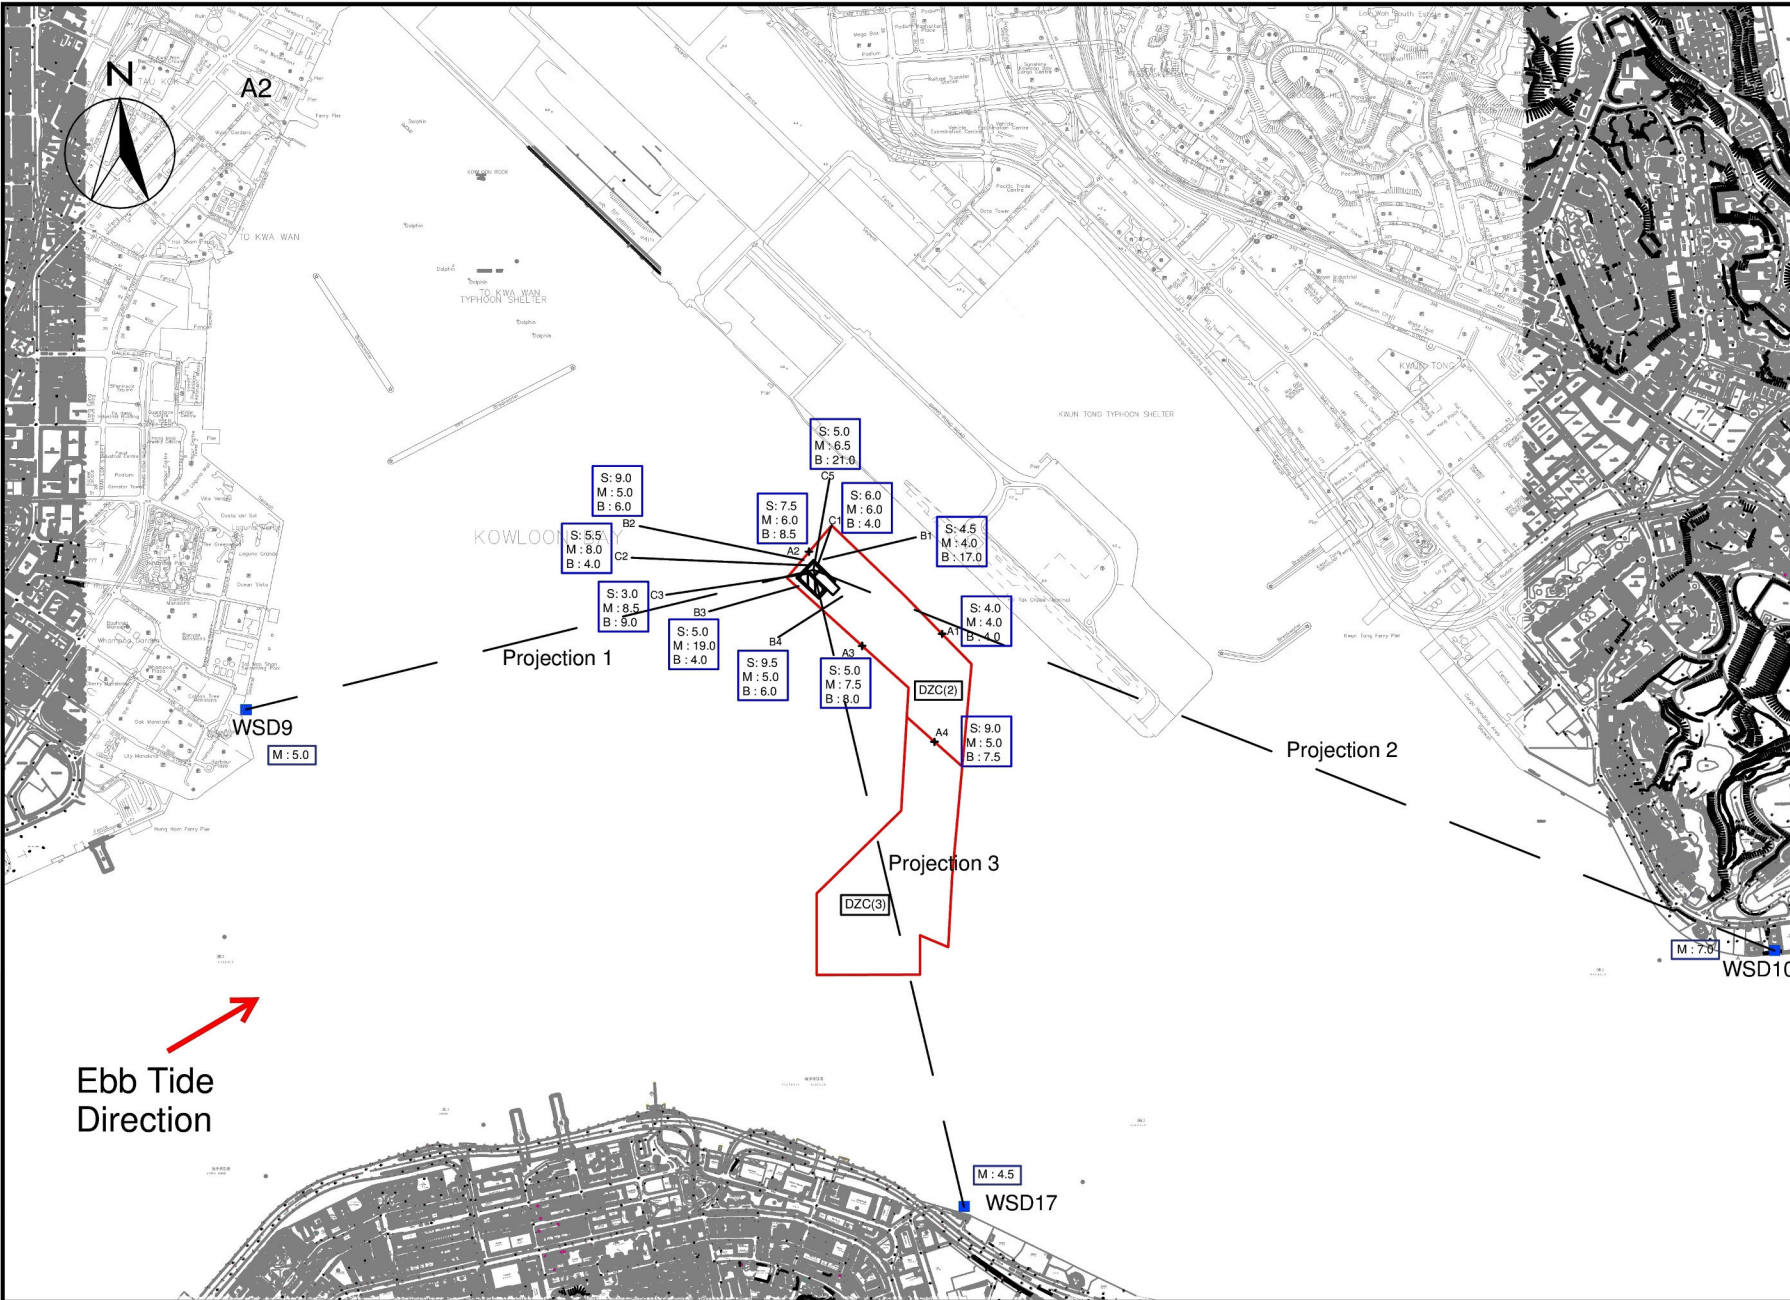
- SILT CURTAIN(S) AT GRAB
- HOPPER BARGE
- DREDGER
- SILT CURTAIN (SURROUNDING THE DREDGER)

WATER QUALITY SURVEILLANCE SYSTEM - 22 June 2015 (Ebb Tide)

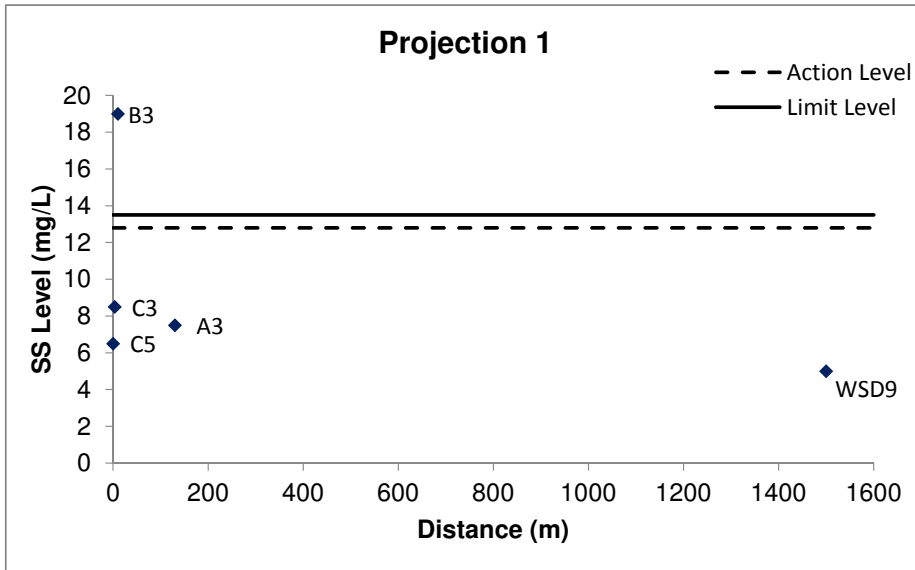
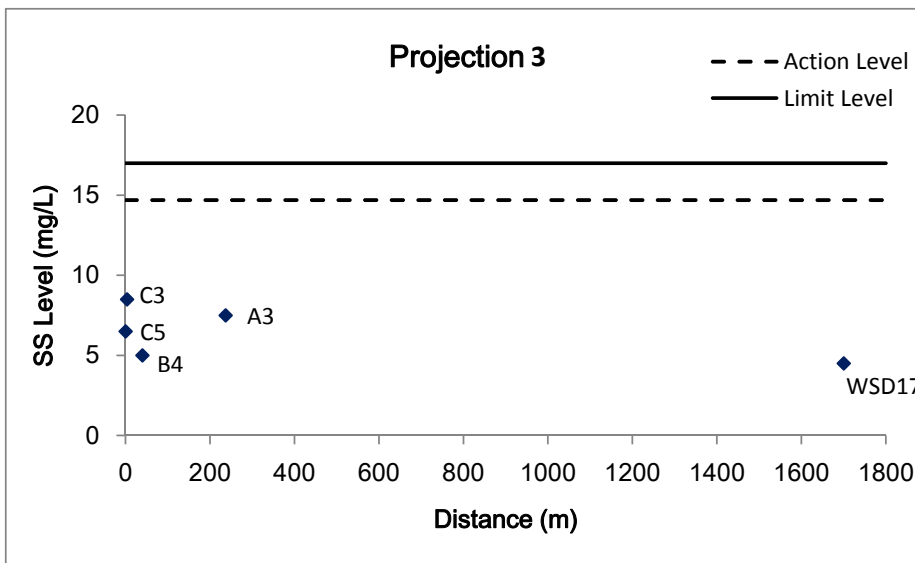
Title Contract No. KL/2013/01 -
 Site Formation for Kai Tak Cruise Terminal Development - Remaining Works
 Graphical Presentation of Wate Quality Surveilance System Results
 (22 June 2015 - Ebb Tide)
