Contract No. KL/2013/01

**Site Formation for Kai Tak Cruise Terminal
Development – Remaining Works**

**Monthly EM&A Report
September 2015
(Version 1.0)**

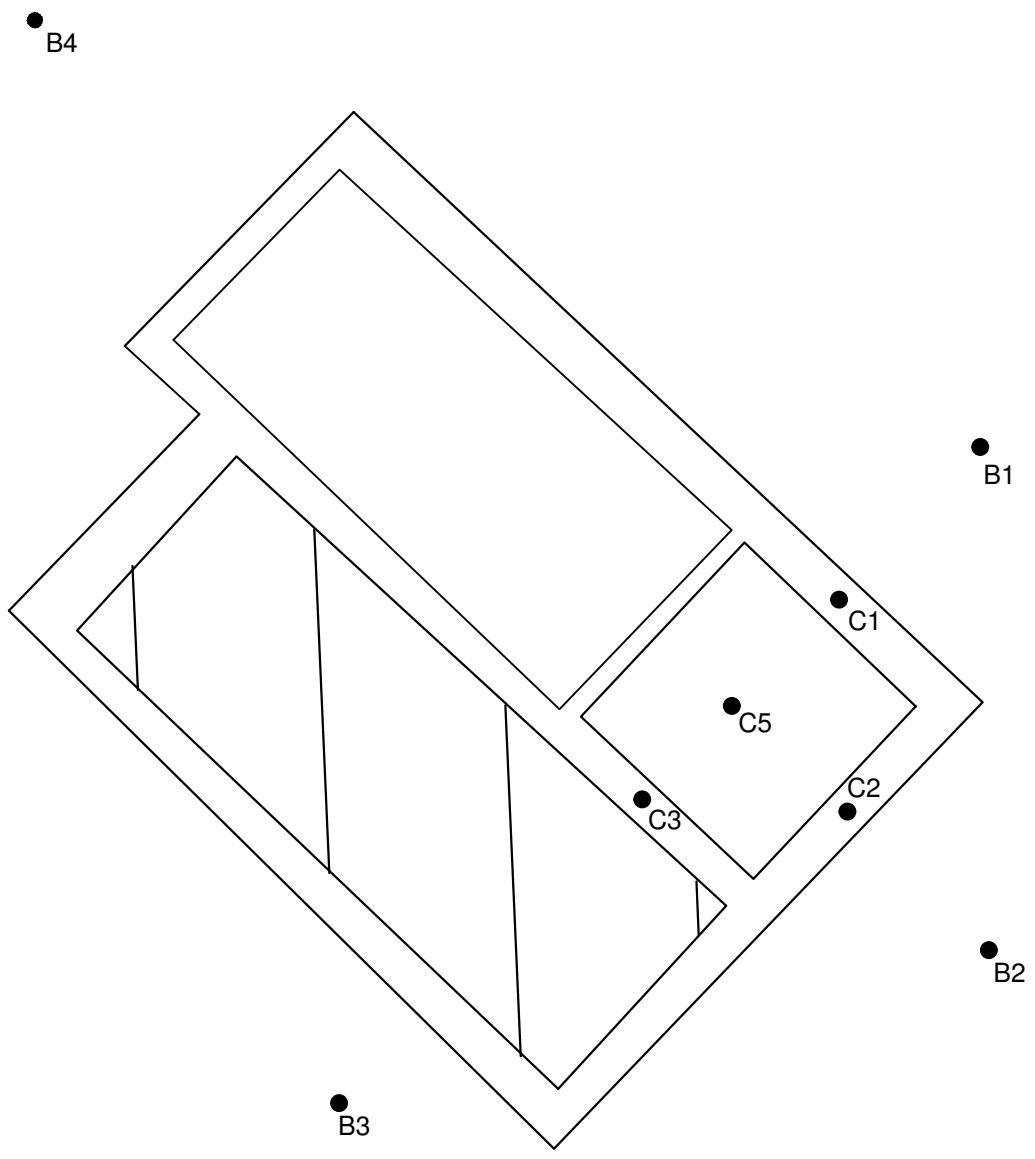
N.T.S.		SEP 15
CHECK	IT	DRAWN	KC
JOB No.	MA15011	FIGURE	5.2
		REV	-

- SILT CURTAIN(S) AT GRAB
- HOPPER BARGE
- DREDGER
- SILT CURTAIN (SURROUNDING THE DREDGER)

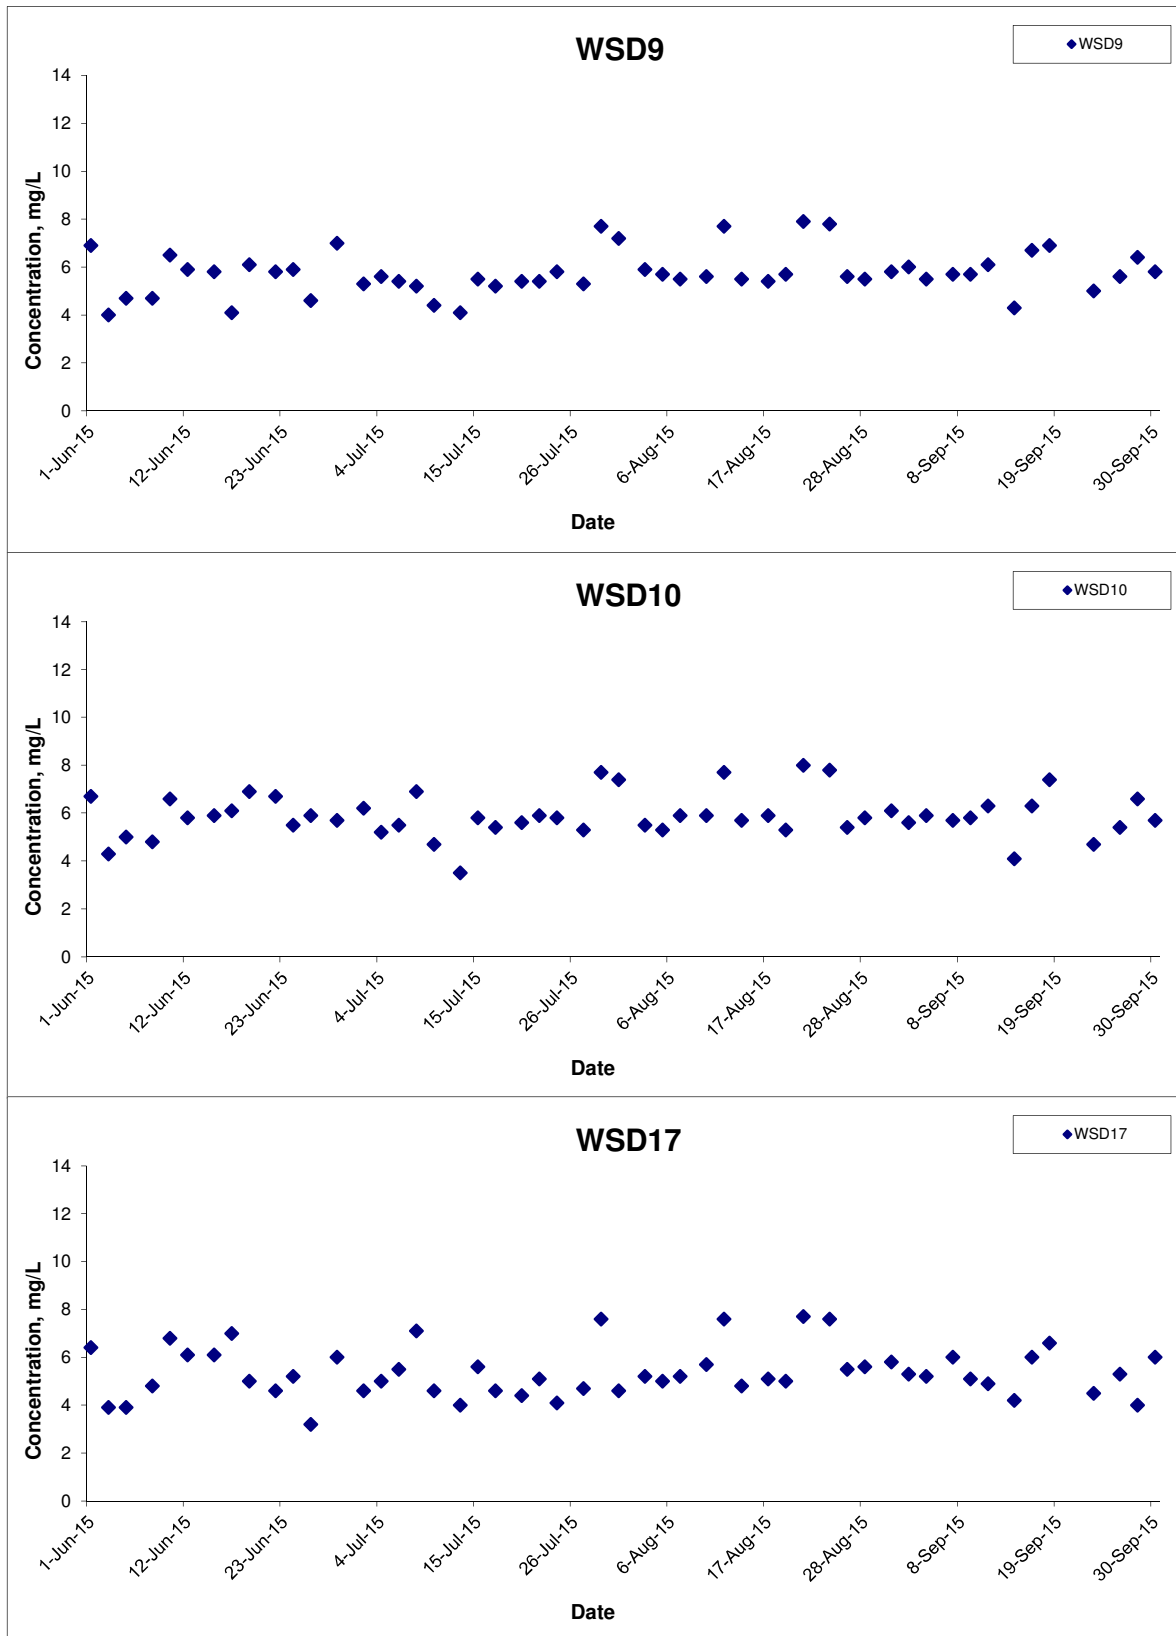
Dissolved Oxygen at Mid-Ebb Tide

Title Contract No. KL/2013/01 -
 Site Formation For Kai Tak Cruise Terminal Development -
 Remaining Works
 Graphical Presentation of Water Quality Monitoring
 Results

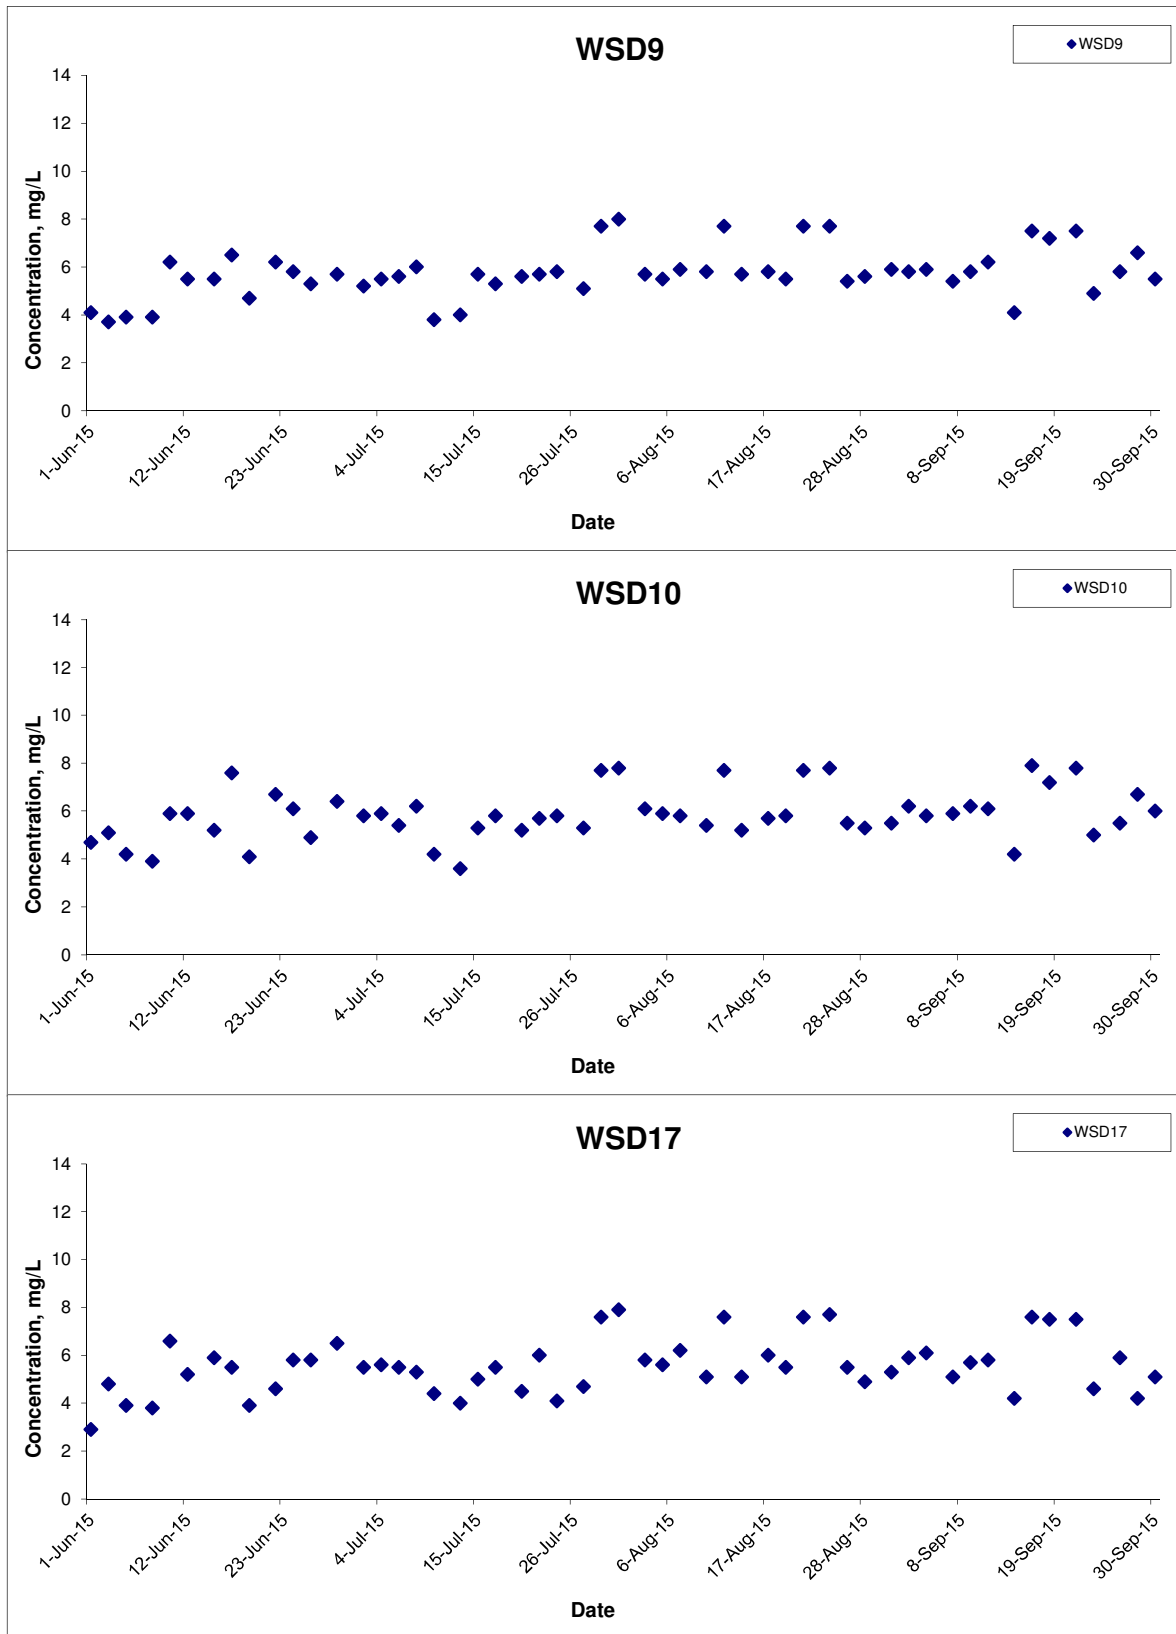
Dissolved Oxygen at Mid-Flood Tide

Title Contract No. KL/2013/01 -
 Site Formation For Kai Tak Cruise Terminal Development -
 Remaining Works
 Graphical Presentation of Water Quality Monitoring
 Results

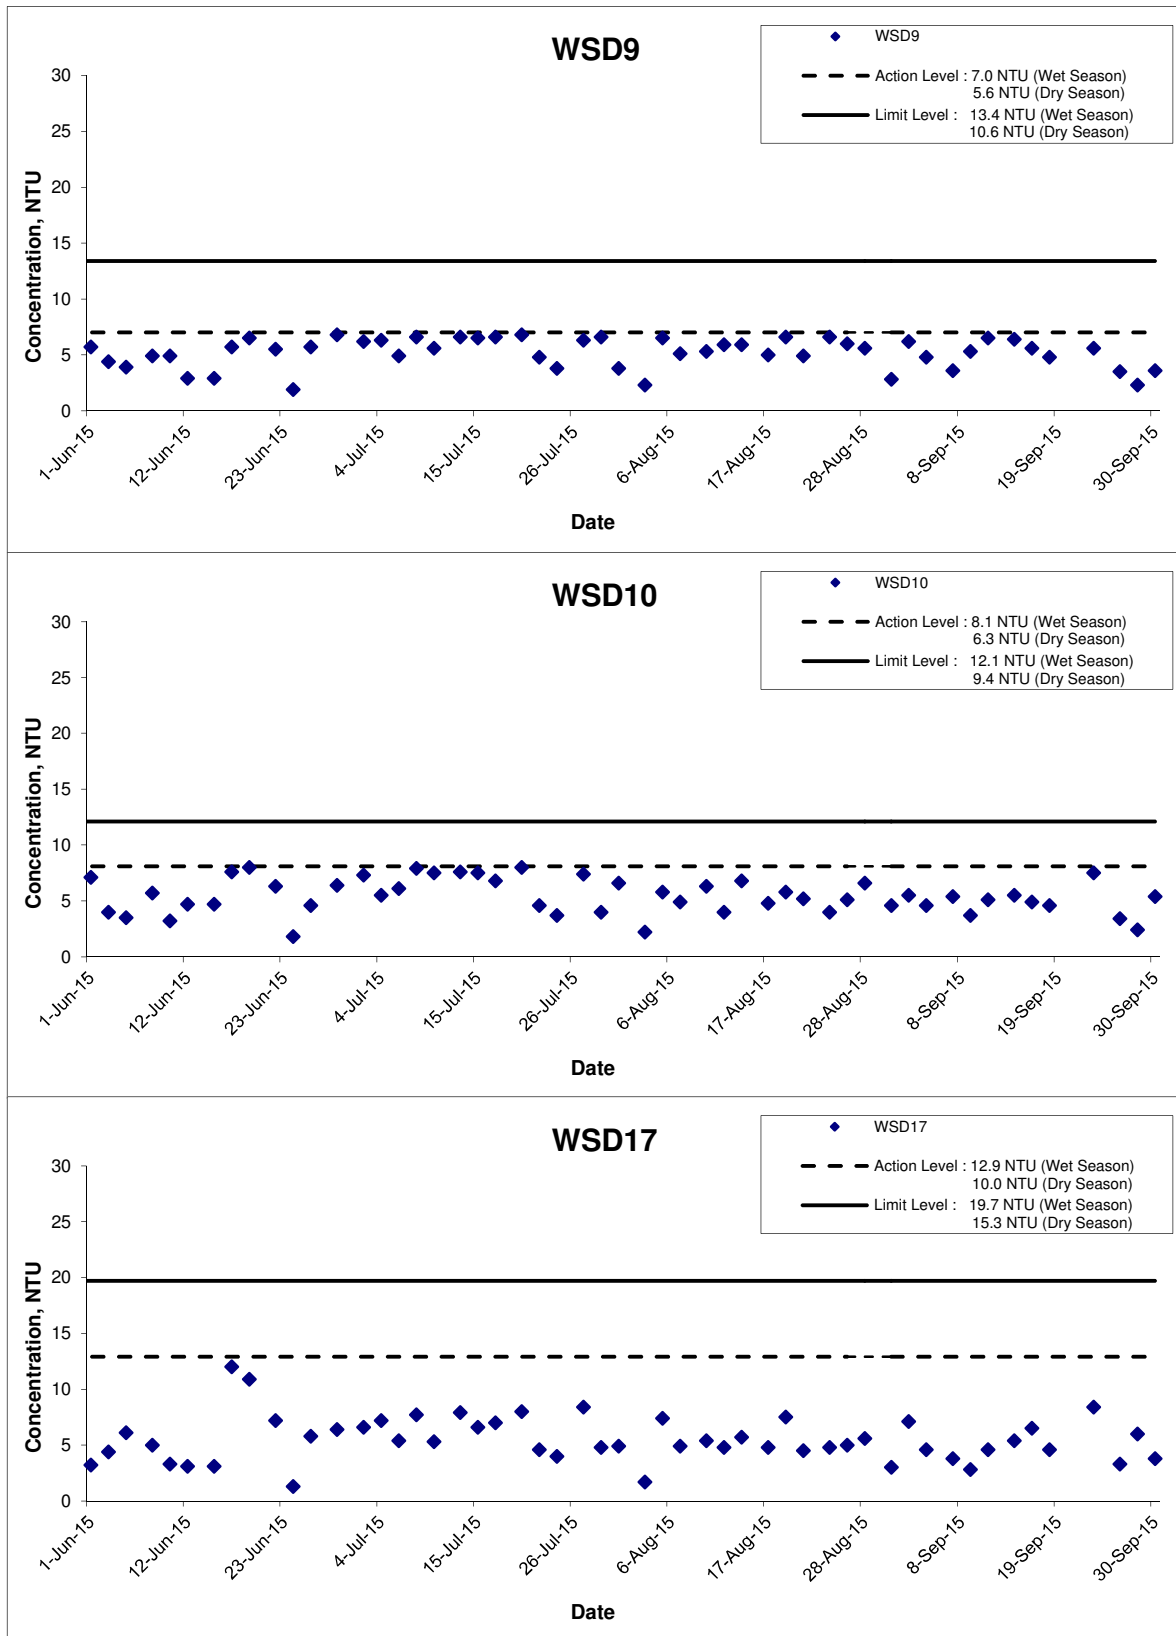
Turbidity at Mid-Ebb Tide

Title Contract No. KL/2013/01 -
 Site Formation For Kai Tak Cruise Terminal Development -
 Remaining Works
 Graphical Presentation of Water Quality Monitoring
 Results

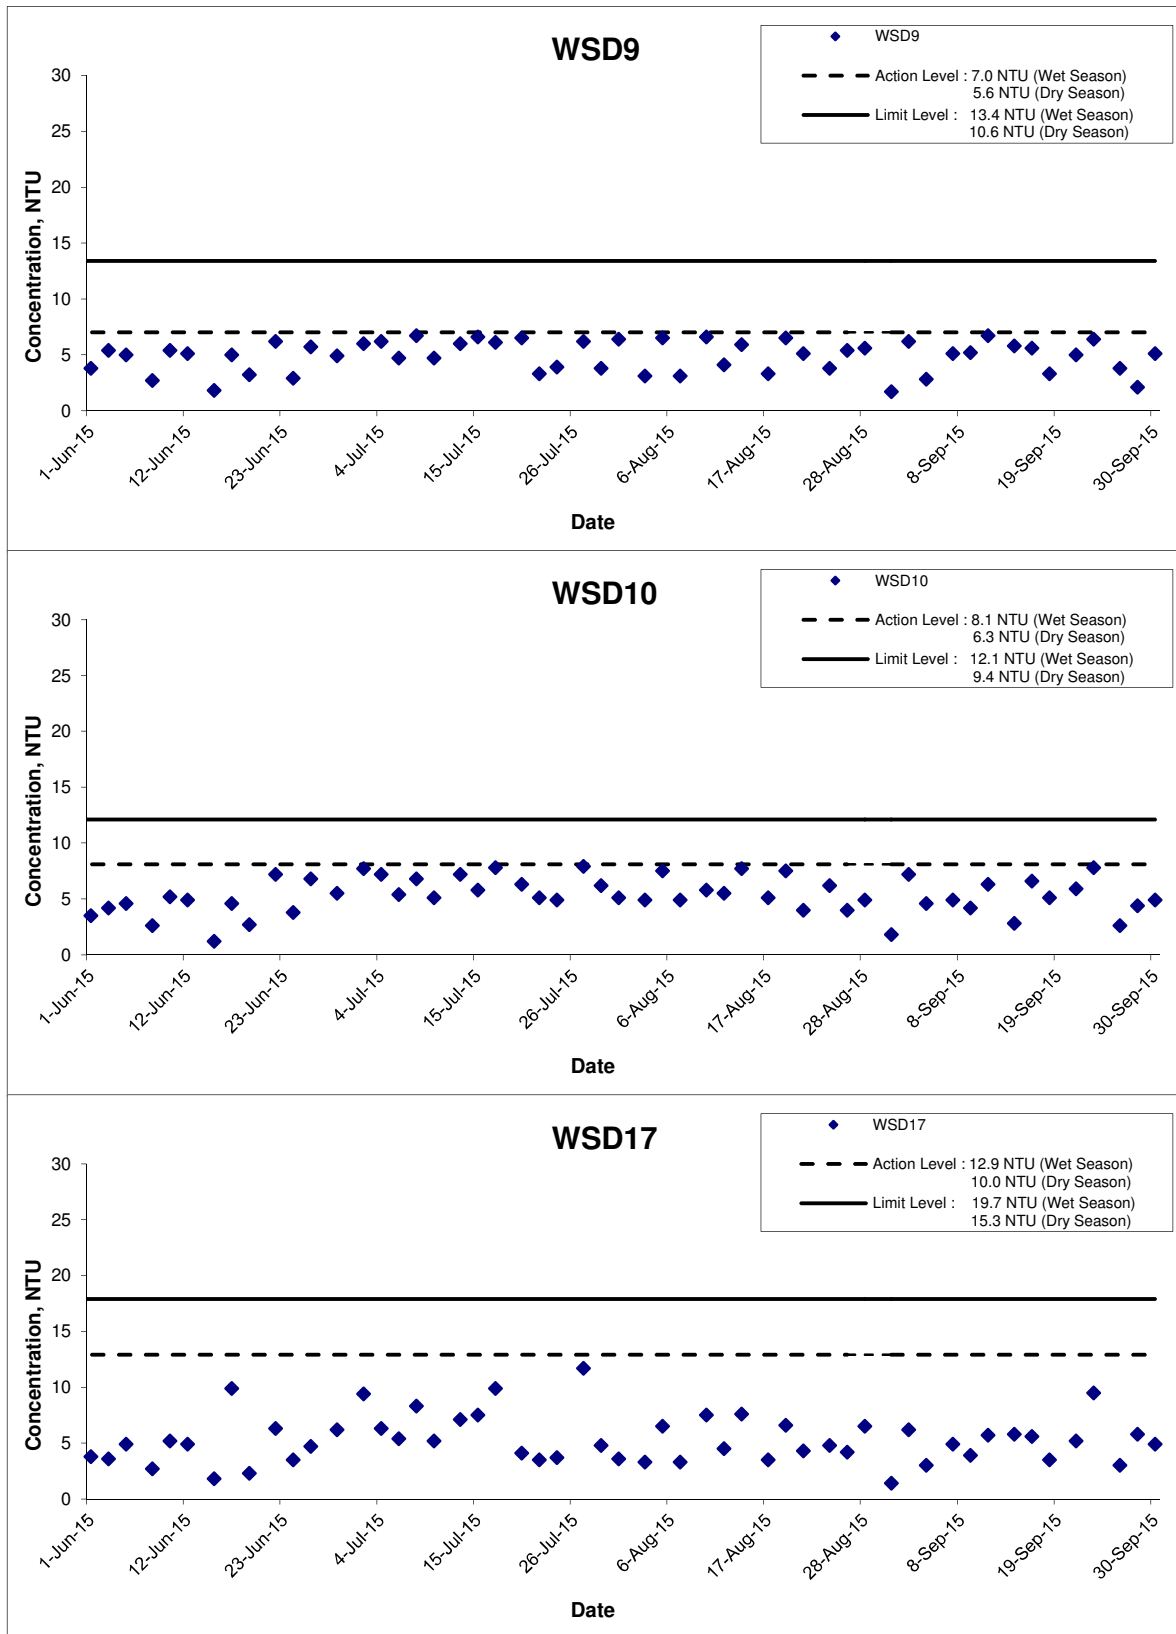
Turbidity at Mid-Flood Tide

Title Contract No. KL/2013/01 -
 Site Formation For Kai Tak Cruise Terminal Development -
 Remaining Works
 Graphical Presentation of Water Quality Monitoring
 Results

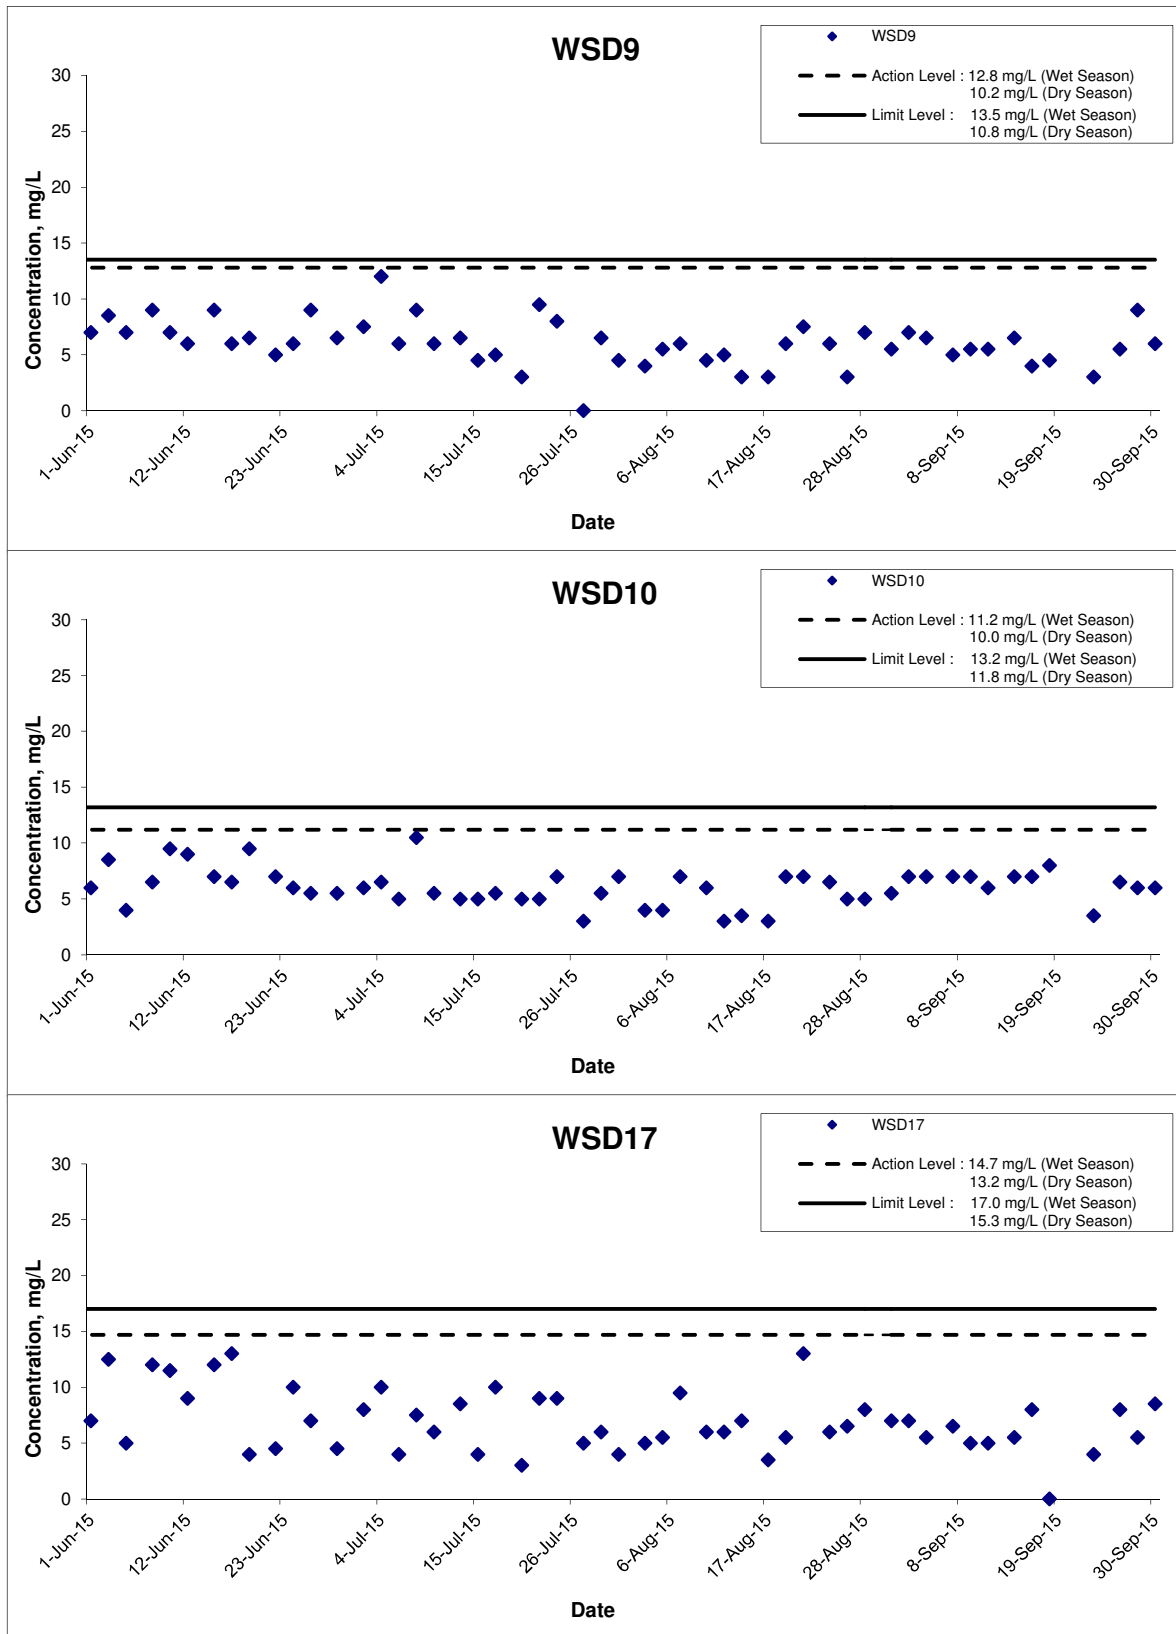
Suspended Solids at Mid-Ebb Tide

The graphical point at zero concentration is presented as <2.5 mg/L

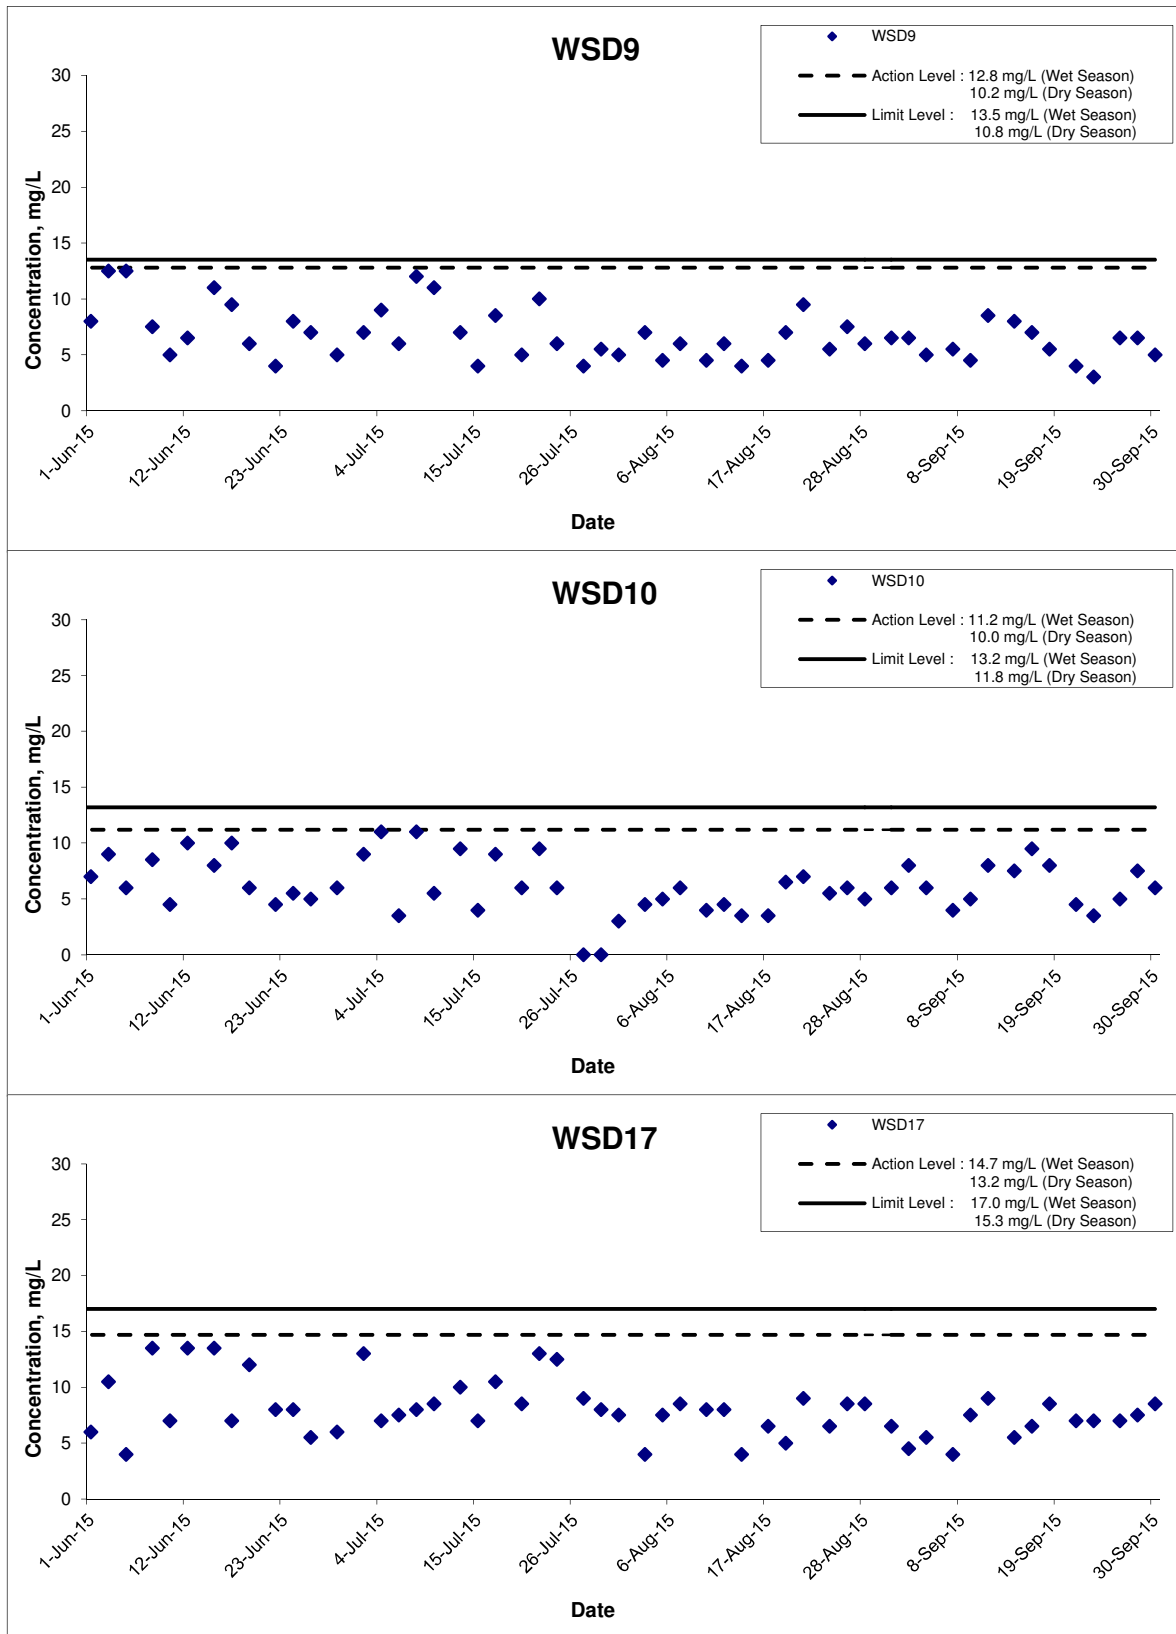
Suspended Solids at Mid-Flood Tide

The graphical point at zero concentration is presented as <2.5 mg/L

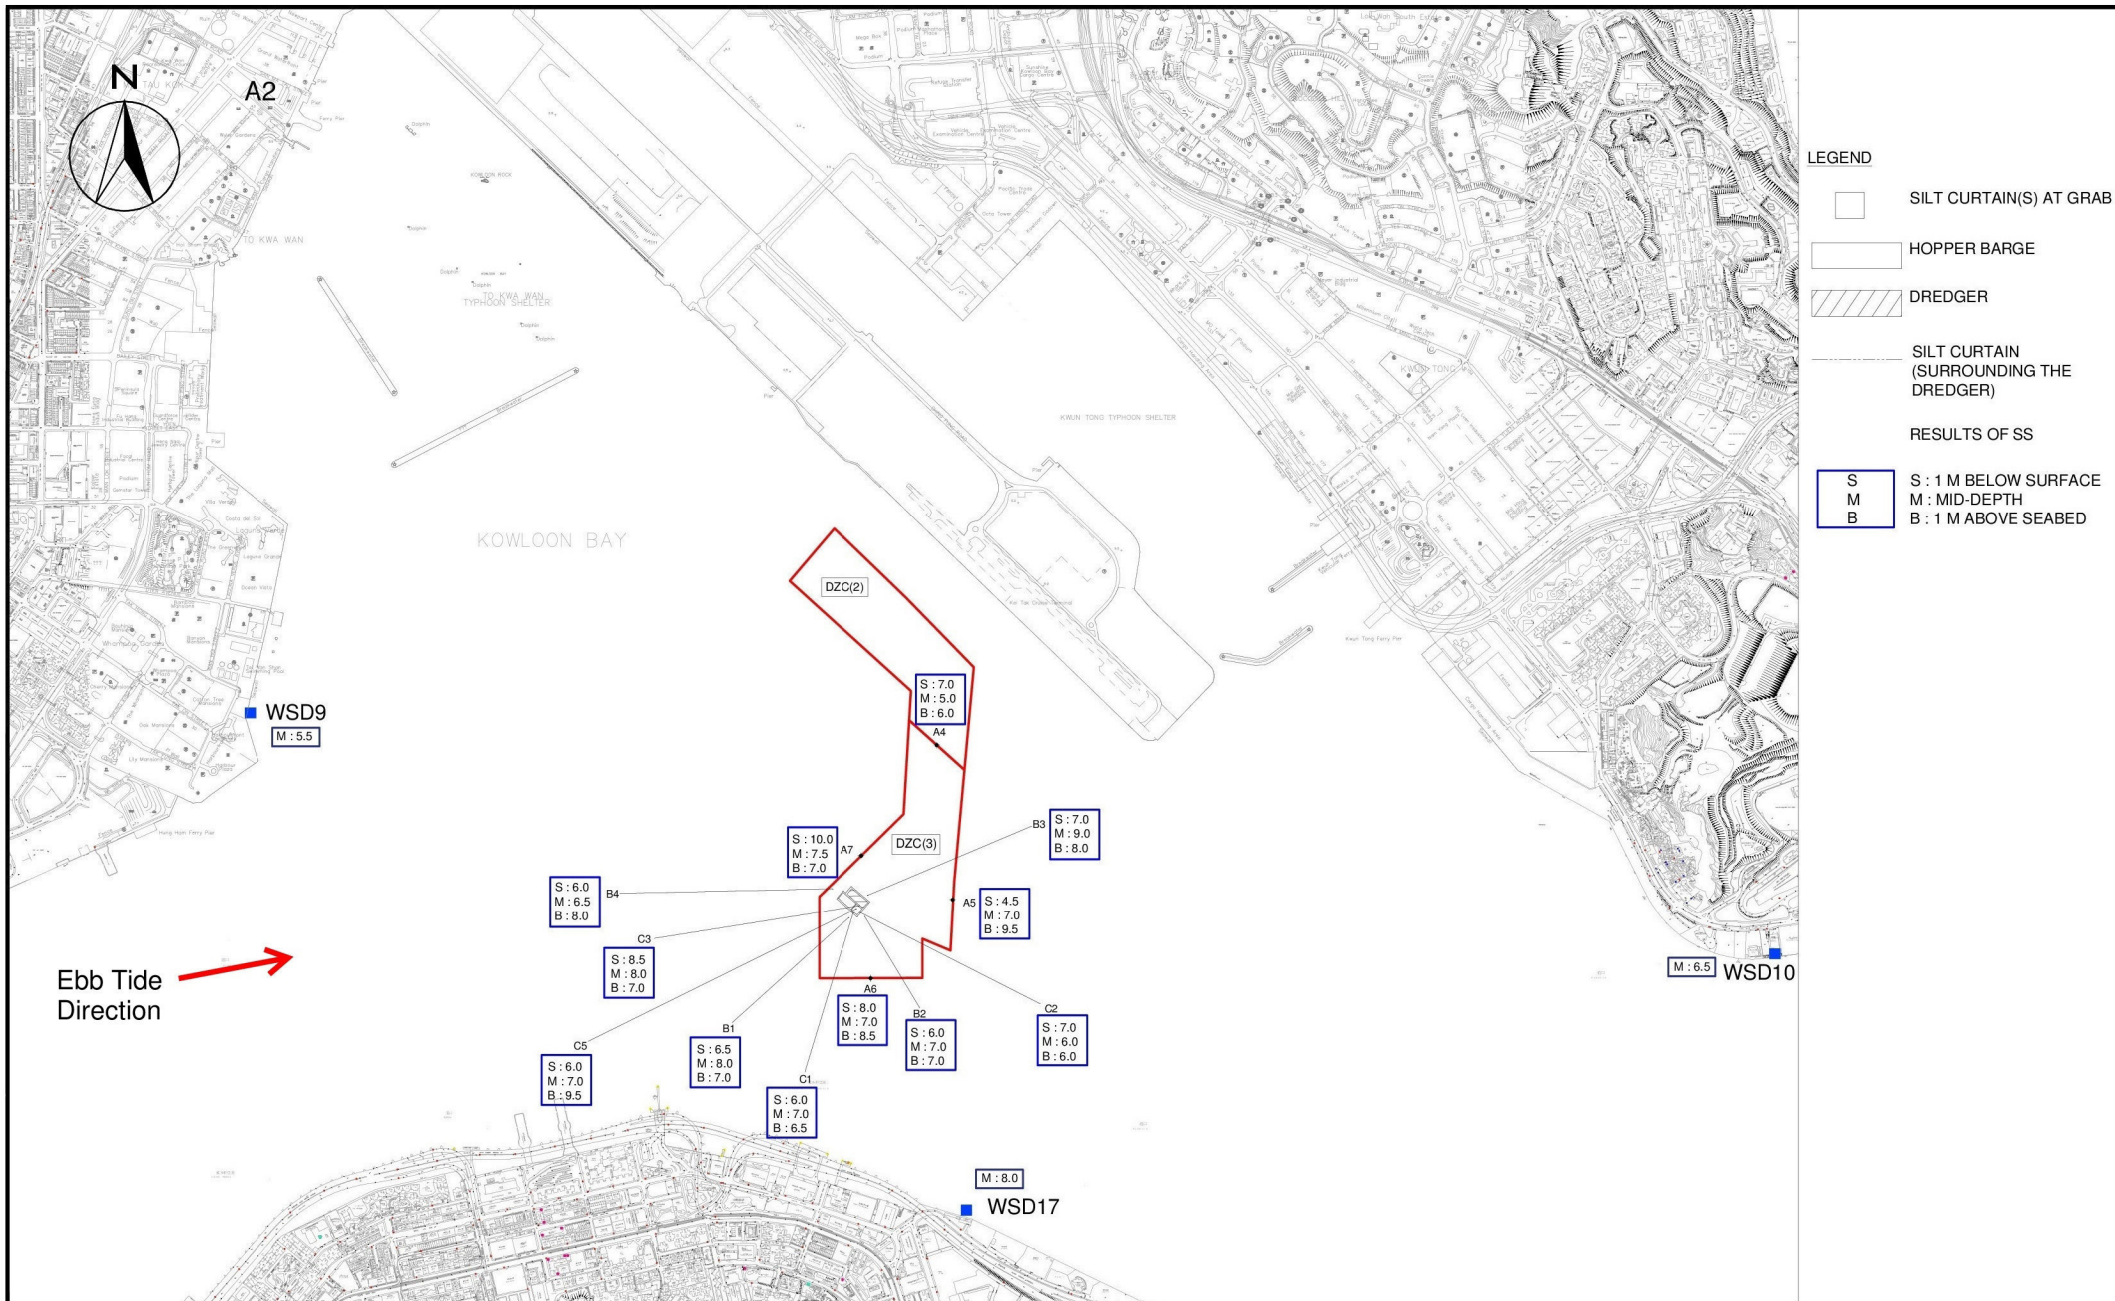
WATER QUALITY SURVEILLANCE SYSTEM - 26 September 2015 (Ebb Tide)

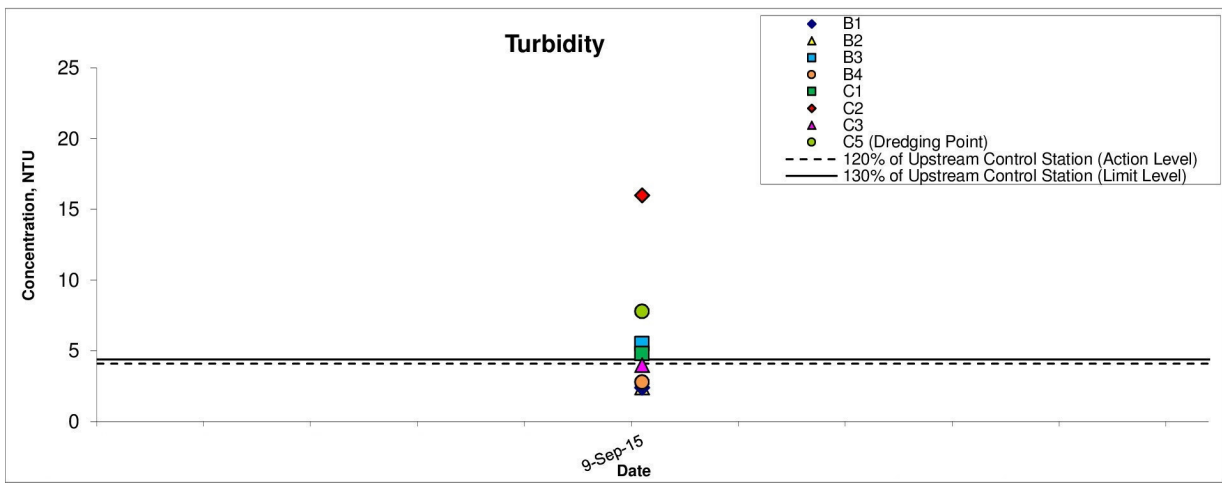
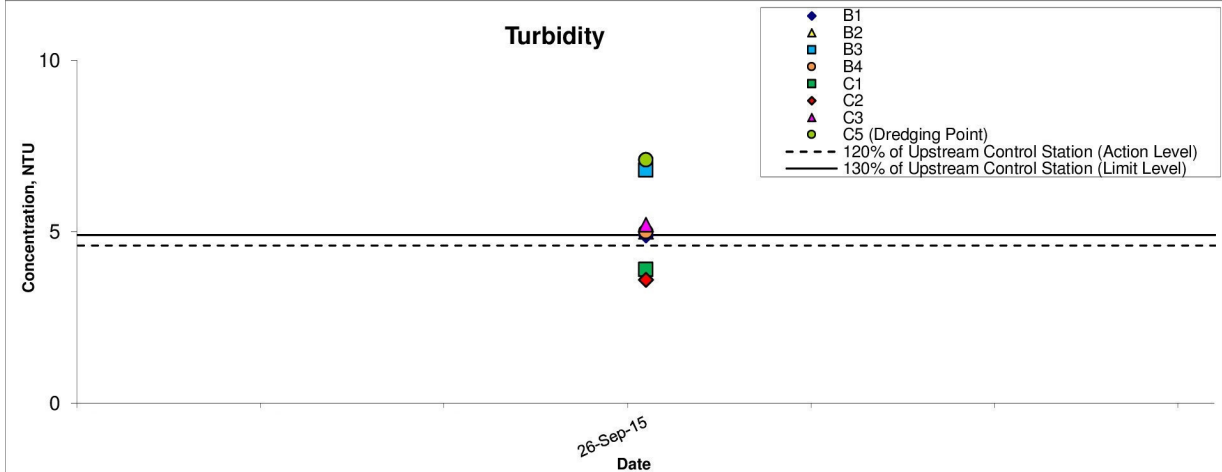
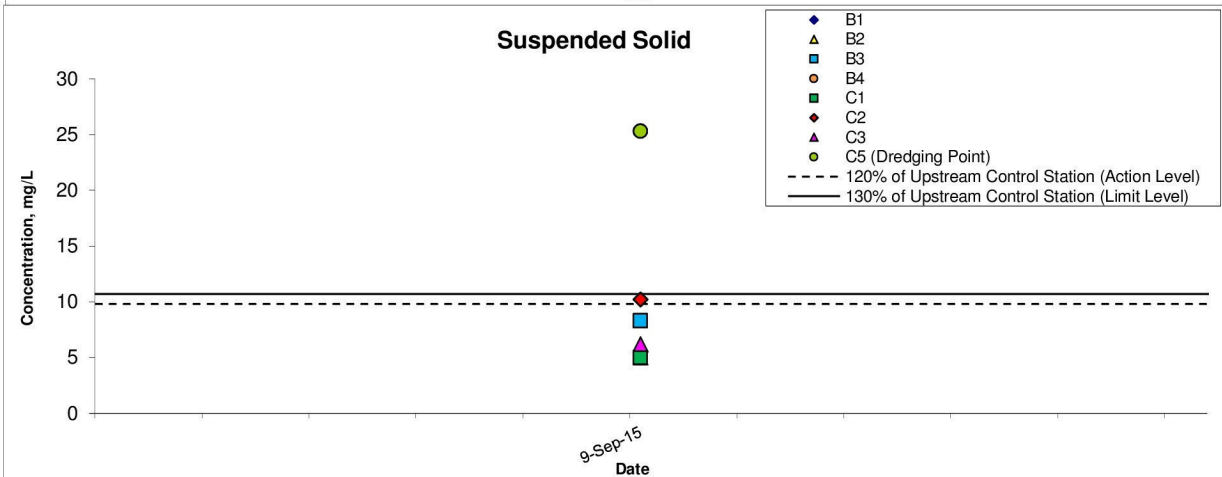
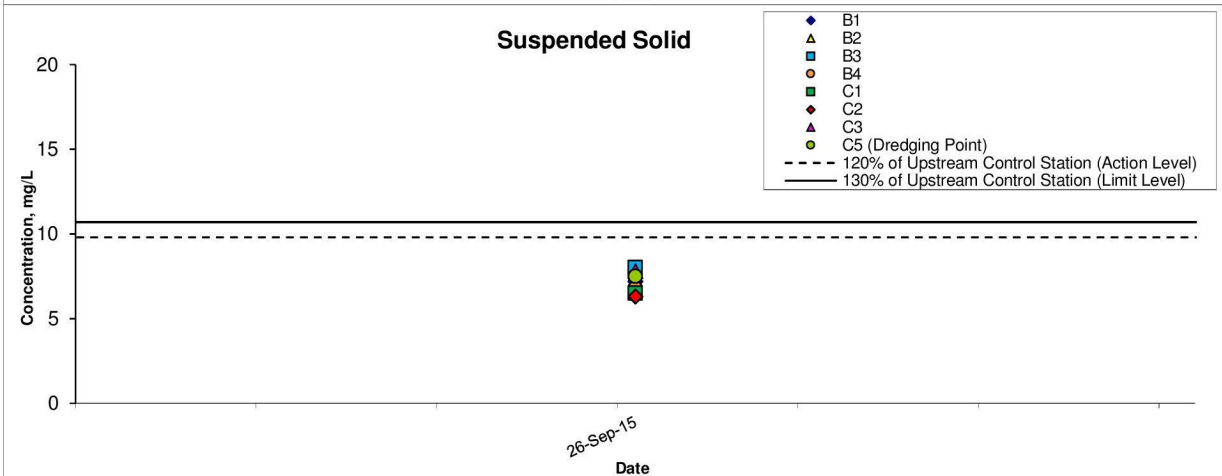
Remarks: A5 and A6 were taken as upstream control station on 9 September 2015, and A7 was taken as upstream control station 26 September 2015 respectively. The Action and Limit Levels for water quality surveillance system were derived from 120% of 130% of upstream control stations's SS/turbidity in depth average at the same tide of the same day.

Title Contract No. KL/2013/01 - Site Formation For Kai Tak Cruise Terminal Development - Remaining Works Graphical Presentation of Water Quality Surveillance System Results	Scale	N.T.S	Project No.	MA15011	CINOTECH
	Date	Sep-15	Appendix	F
