**Contract No. KL/2013/01**

**Site Formation for Kai Tak Cruise Terminal  
Development – Remaining Works**

**Monthly EM&A Report  
December 2015  
(Version 1.0)**

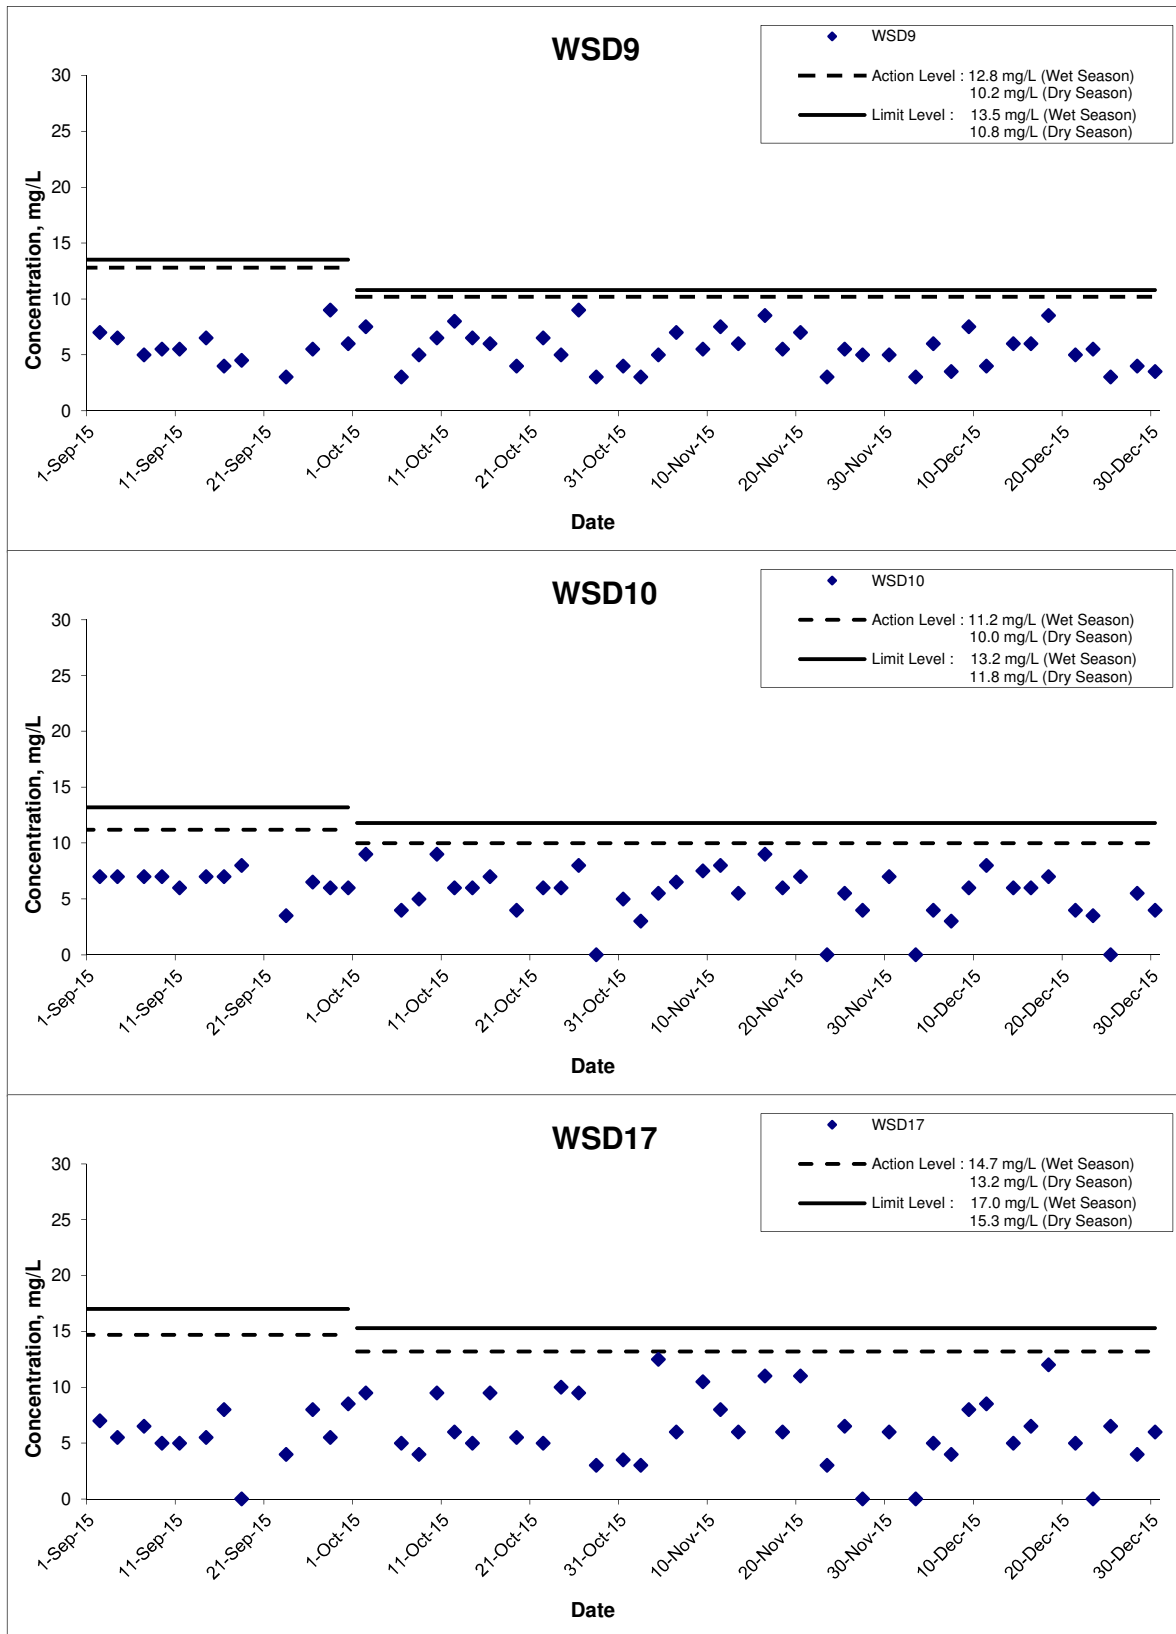
## Suspended Solids at Mid-Ebb Tide

The graphical point at zero concentration is presented as <2.5 mg/L

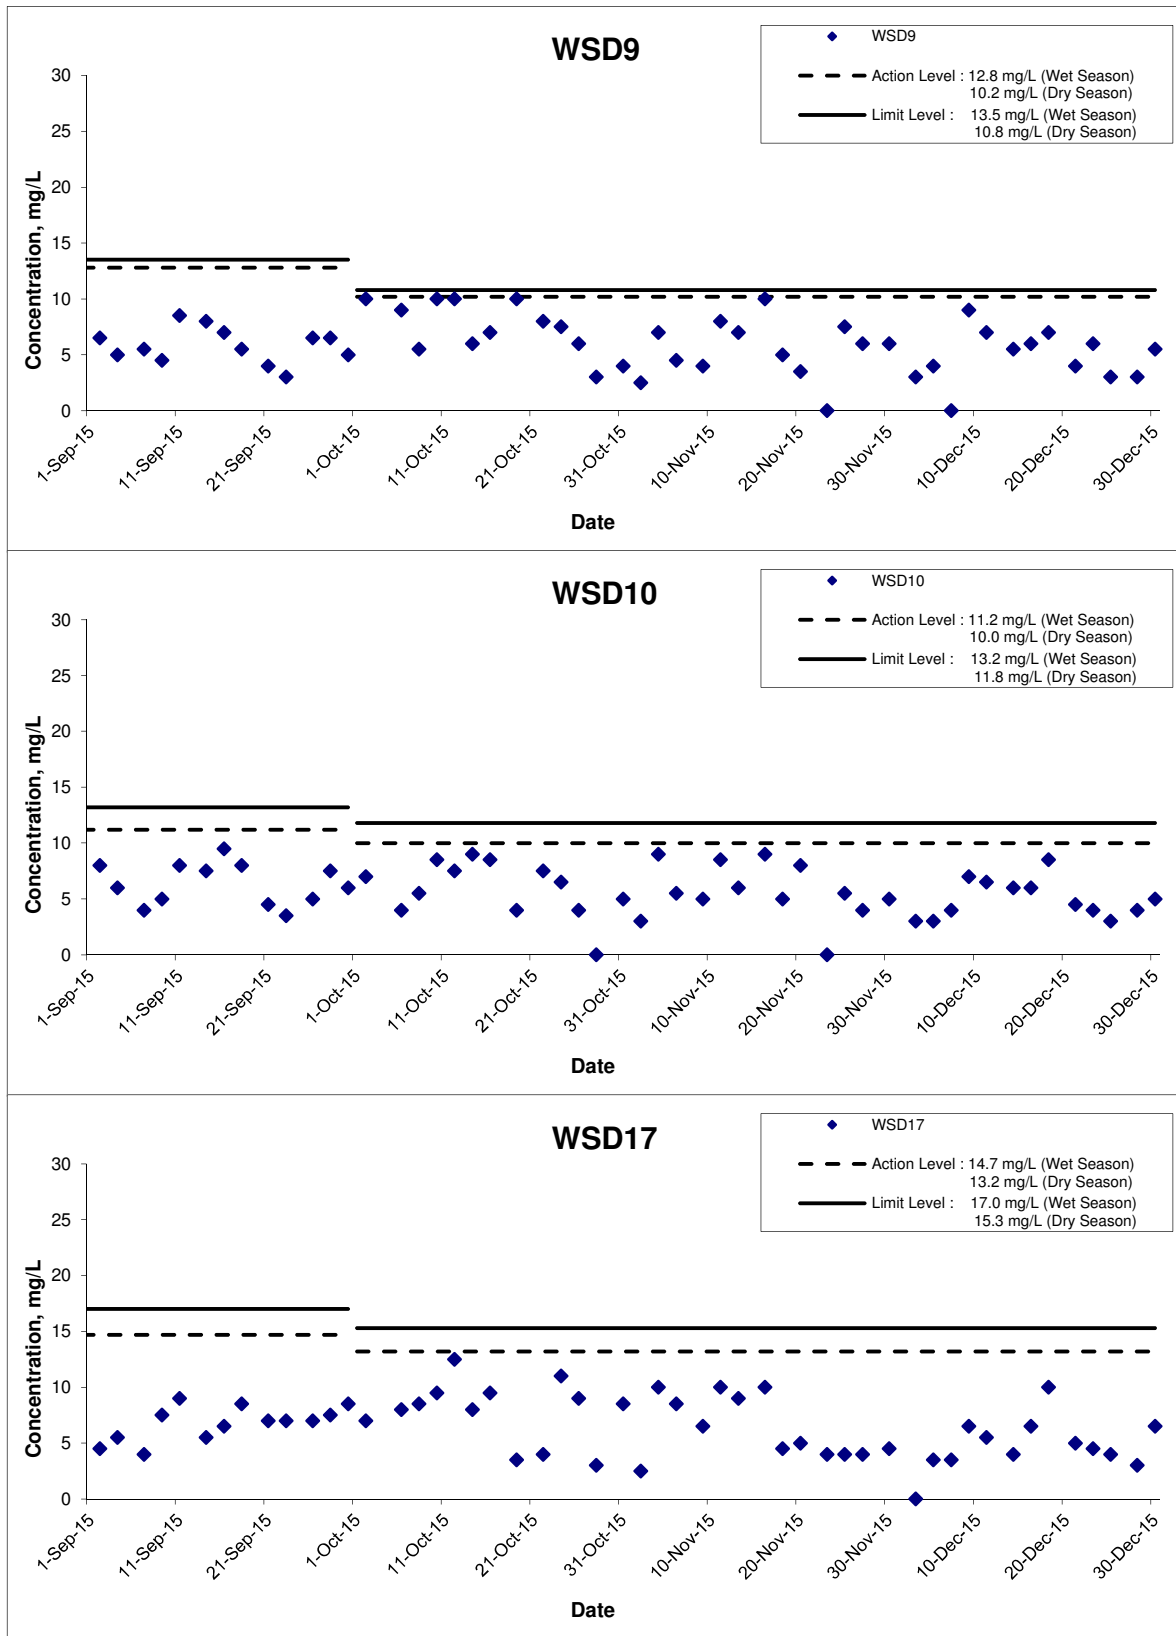
## Suspended Solids at Mid-Flood Tide

The graphical point at zero concentration is presented as <2.5 mg/L
