Contract No. KL/2013/01

**Site Formation for Kai Tak Cruise Terminal
Development – Remaining Works**

**Monthly EM&A Report
March 2016
(Version 1.0)**

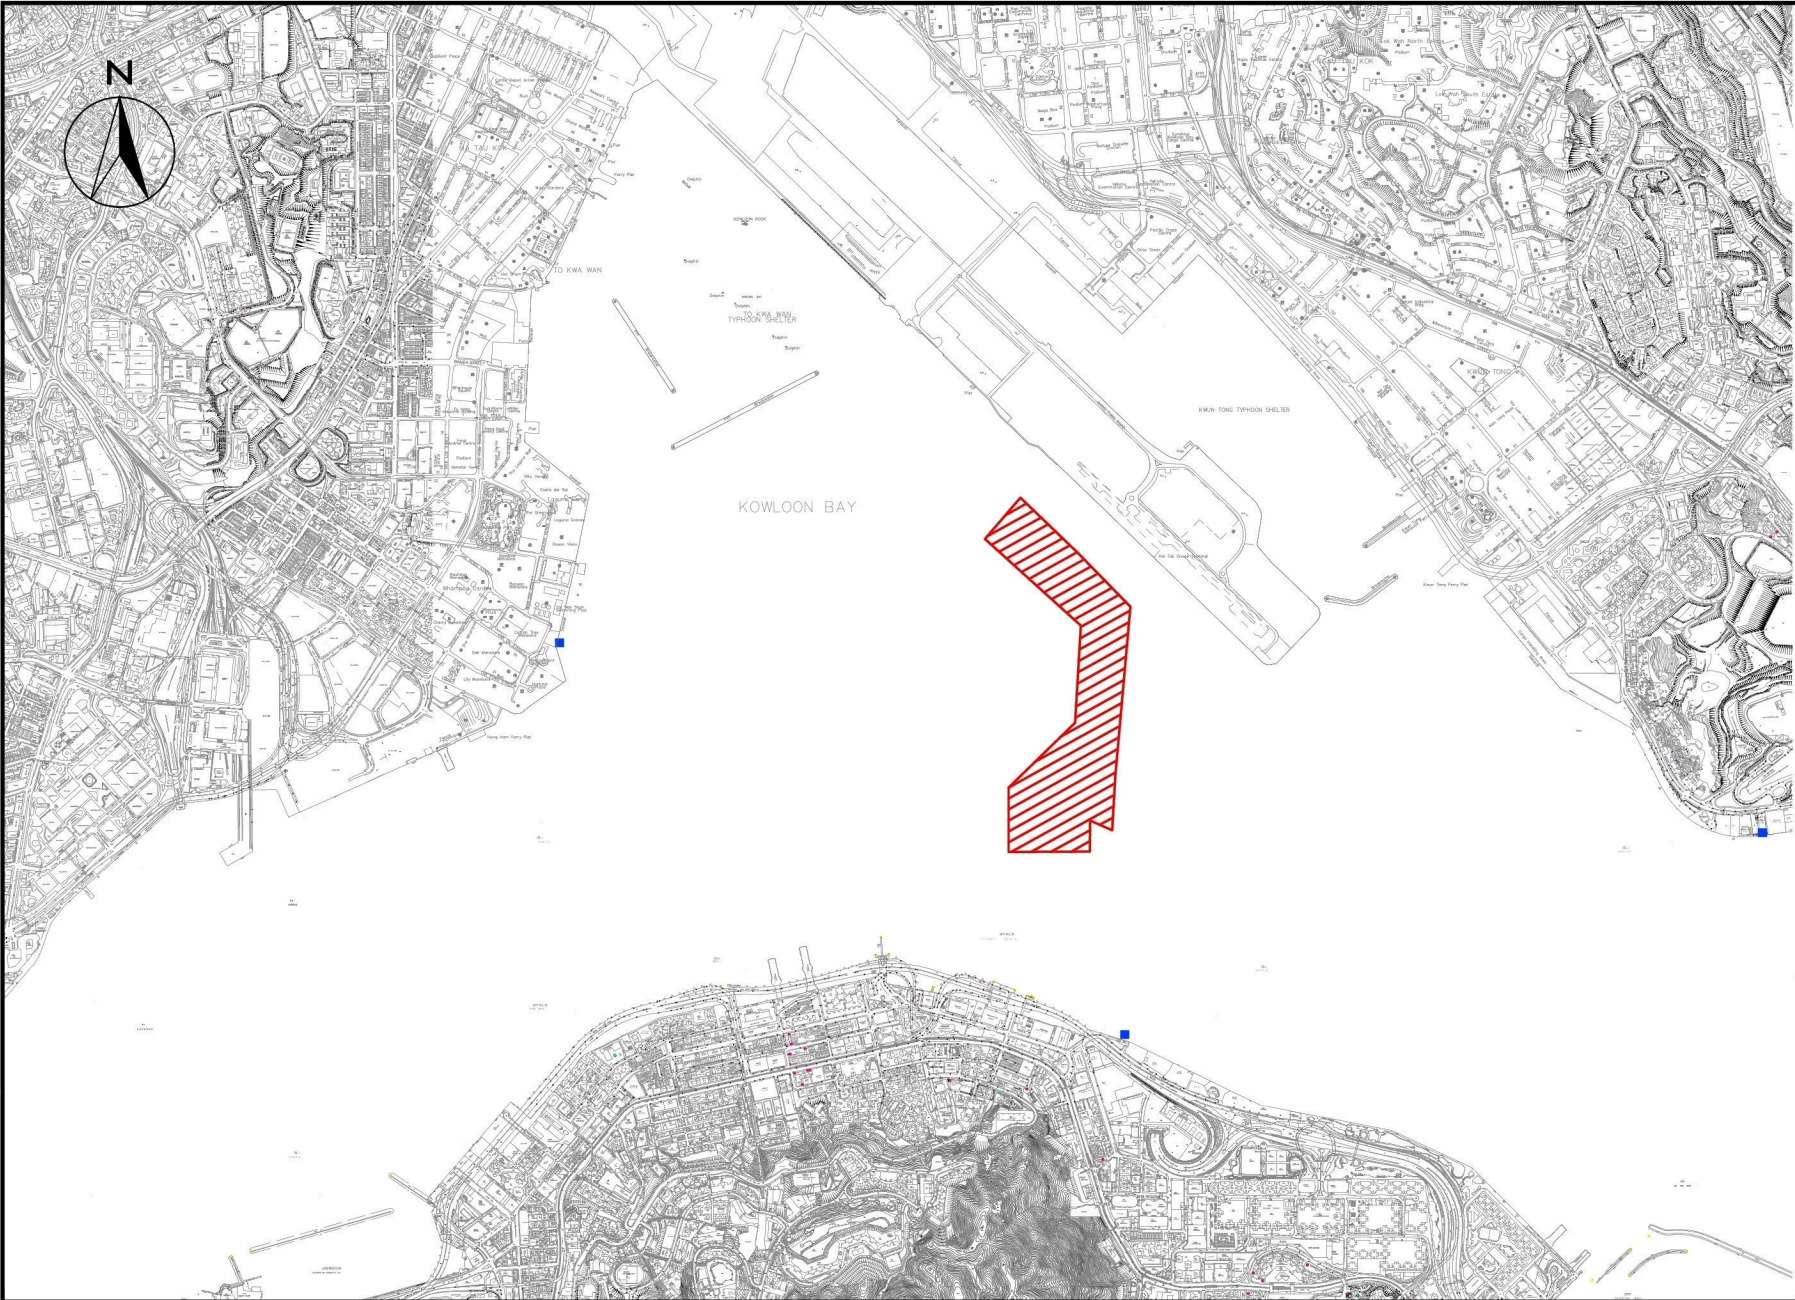
SCALE	1:25000@A4	DATE	JUN 15
CHECK	IT	DRAWN	JW
JOB No.	MA15011	FIGURE NO.	1
		REV	-

**DREDGING
AREA**

- 2.3 Development of the cruise terminal at Kai Tak would require dredging at the existing seawall at the southern tip of the former Kai Tak Airport runway for construction of a quay deck structure for two berths, and dredging the seabed fronting the new quay to provide necessary manoeuvring basin. The general layout of the proposed cruise terminal construction is shown in **Figure 1**.

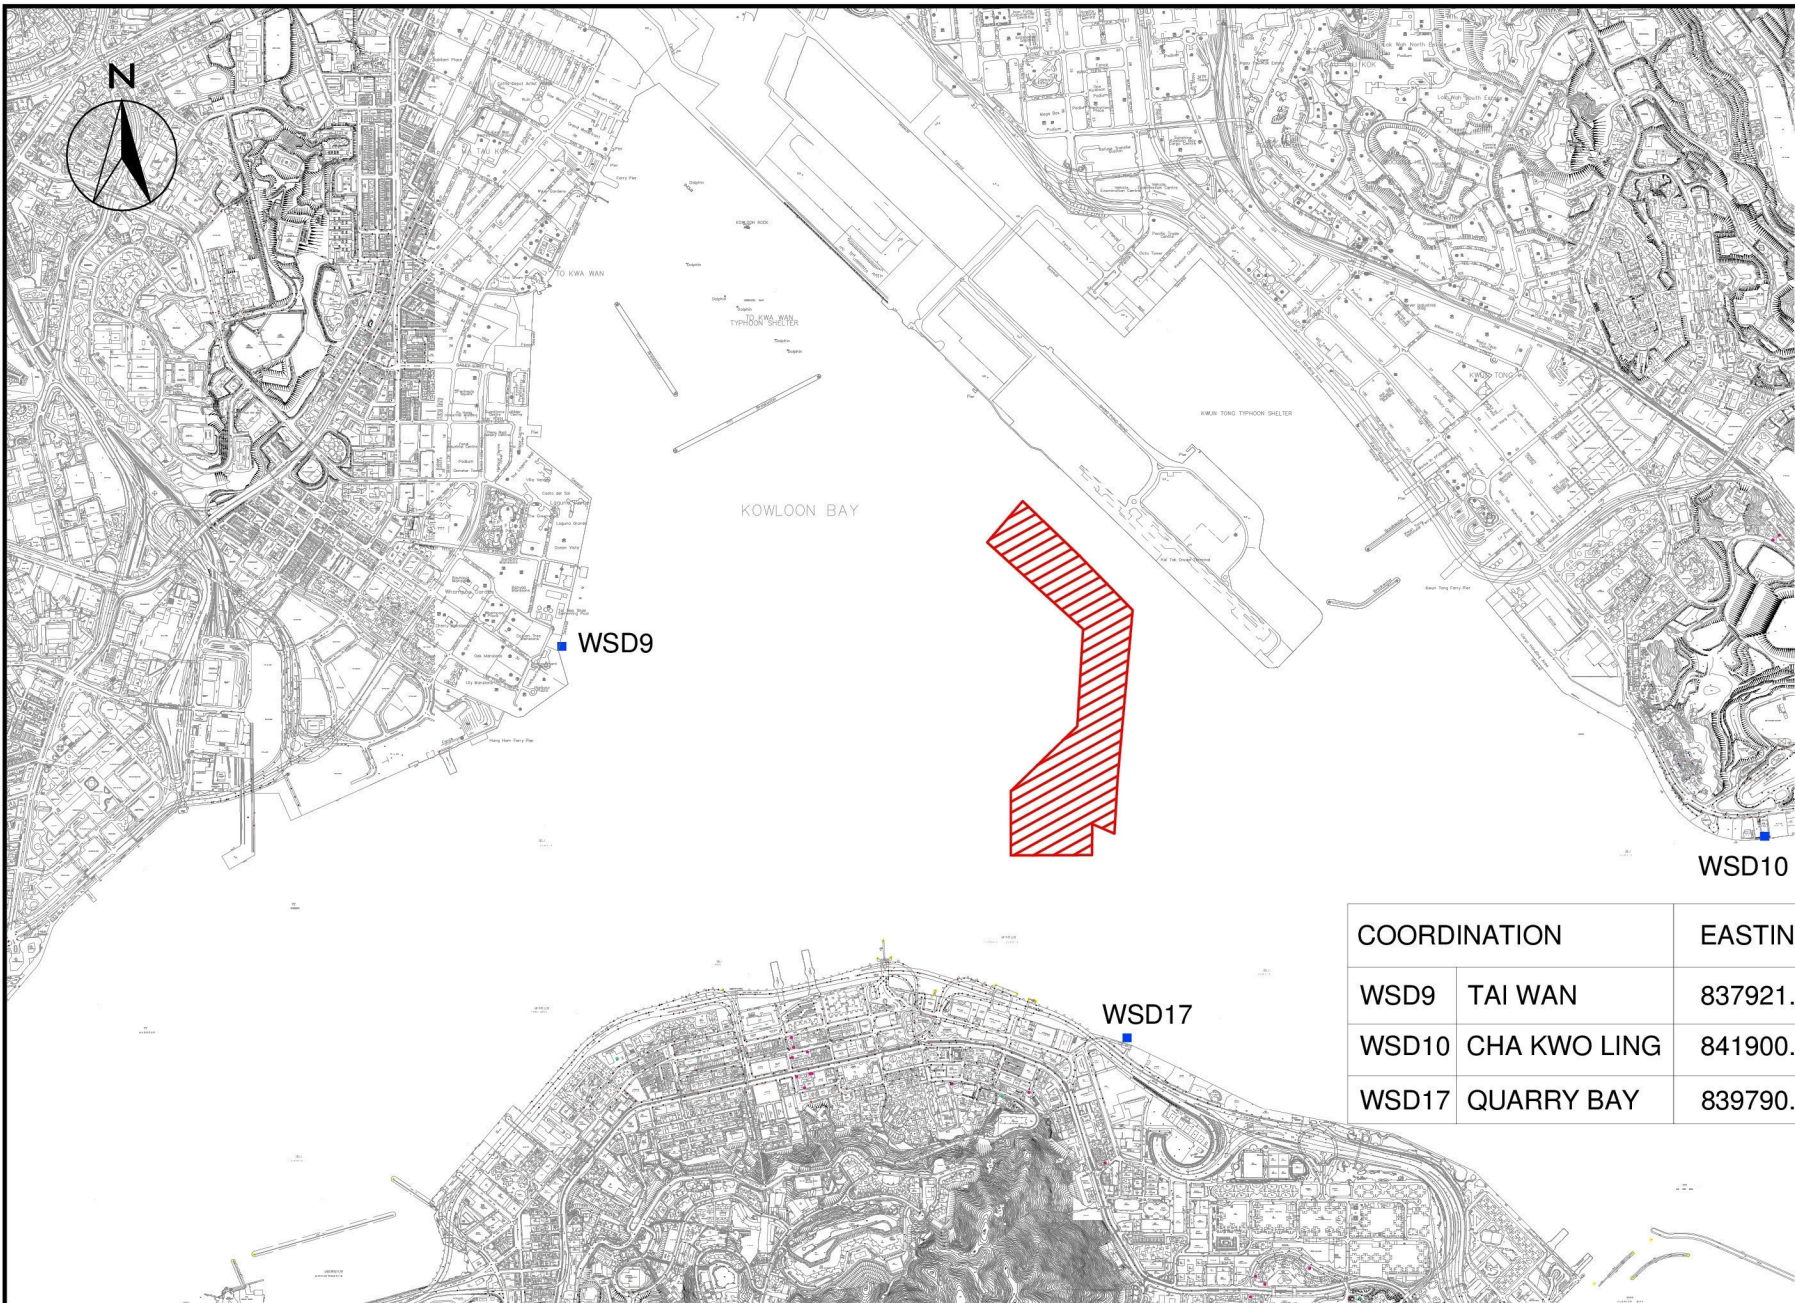
SCALE	1:25000@A4	DATE	JUN 15	
CHECK	IT	DRAWN	JW	
JOB No.	MA15011	FIGURE NO.	2	REV -

LOCATION OF WATER QUALITY MONITORING STATIONS

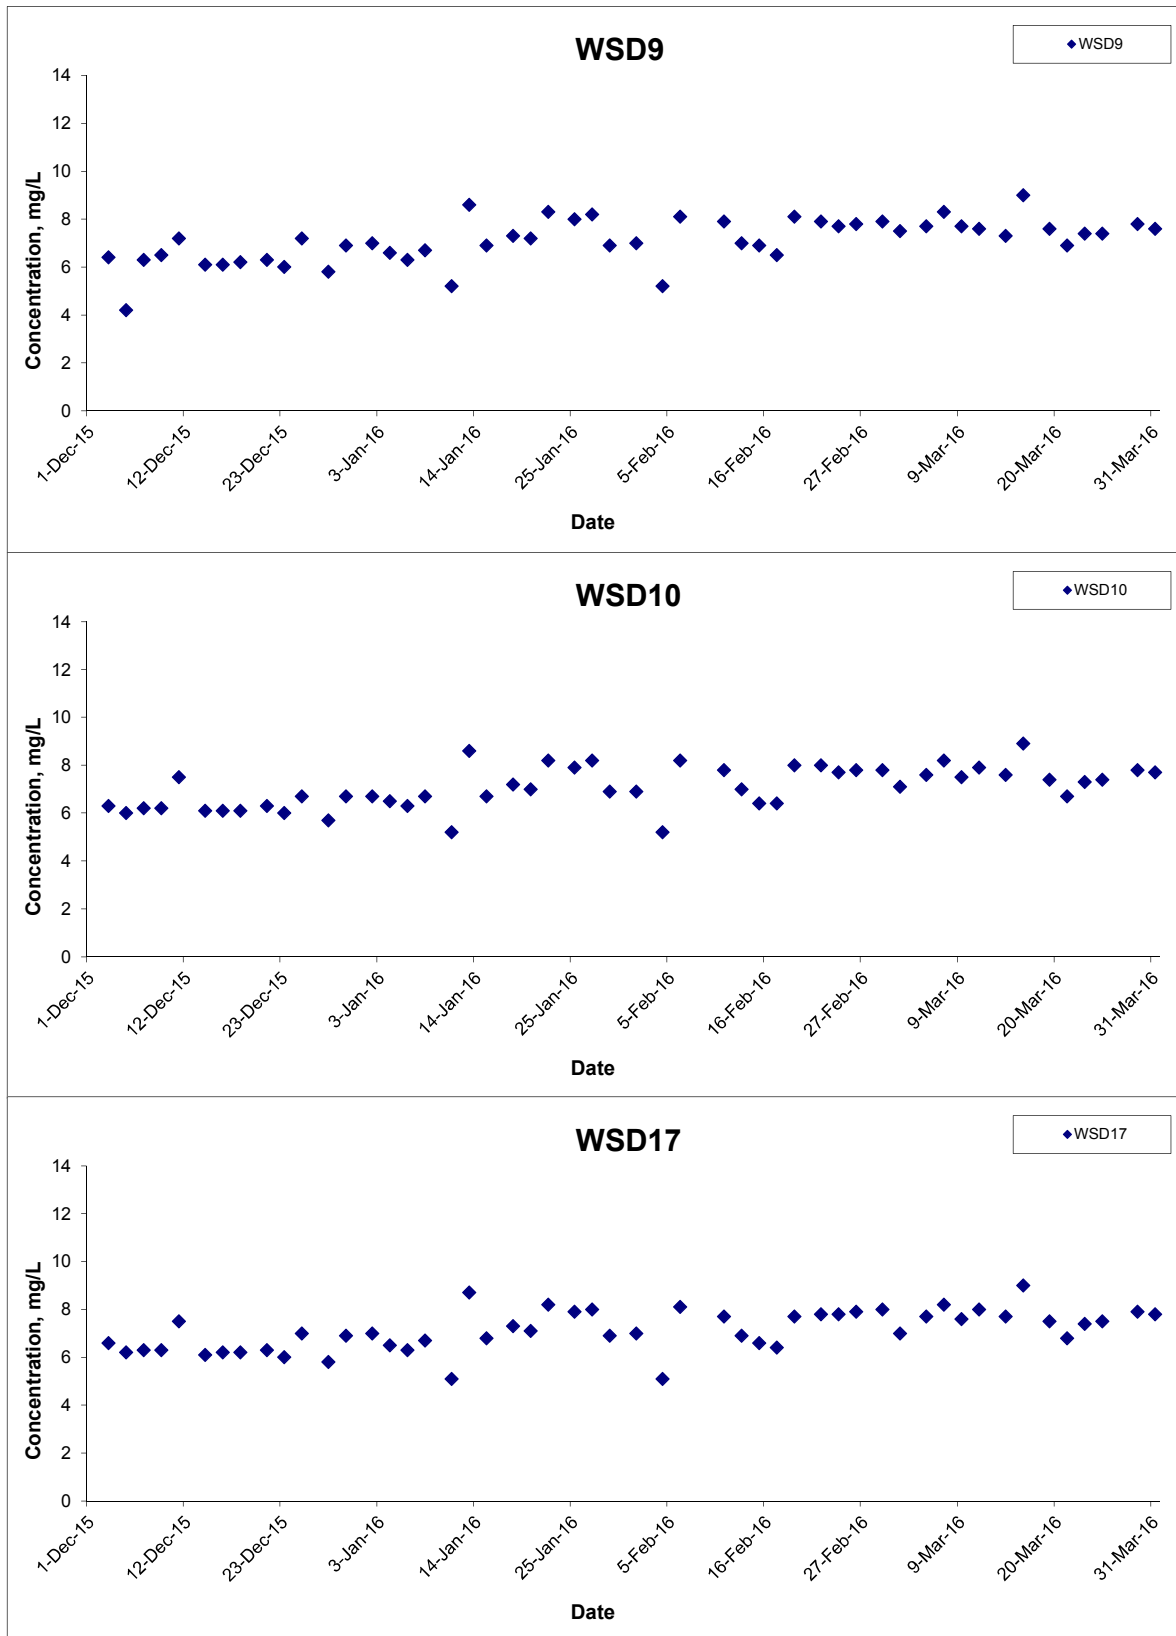
Title Contract No. KL/2013/01 - Site Formation For Kai Tak Cruise Terminal Development - Remaining Works Graphical Presentation of Water Quality Monitoring Results	Scale	N.T.S	Project No. MA15011	CINOTECH
	Date	Mar 16	Appendix E

Dissolved Oxygen at Mid-Ebb Tide

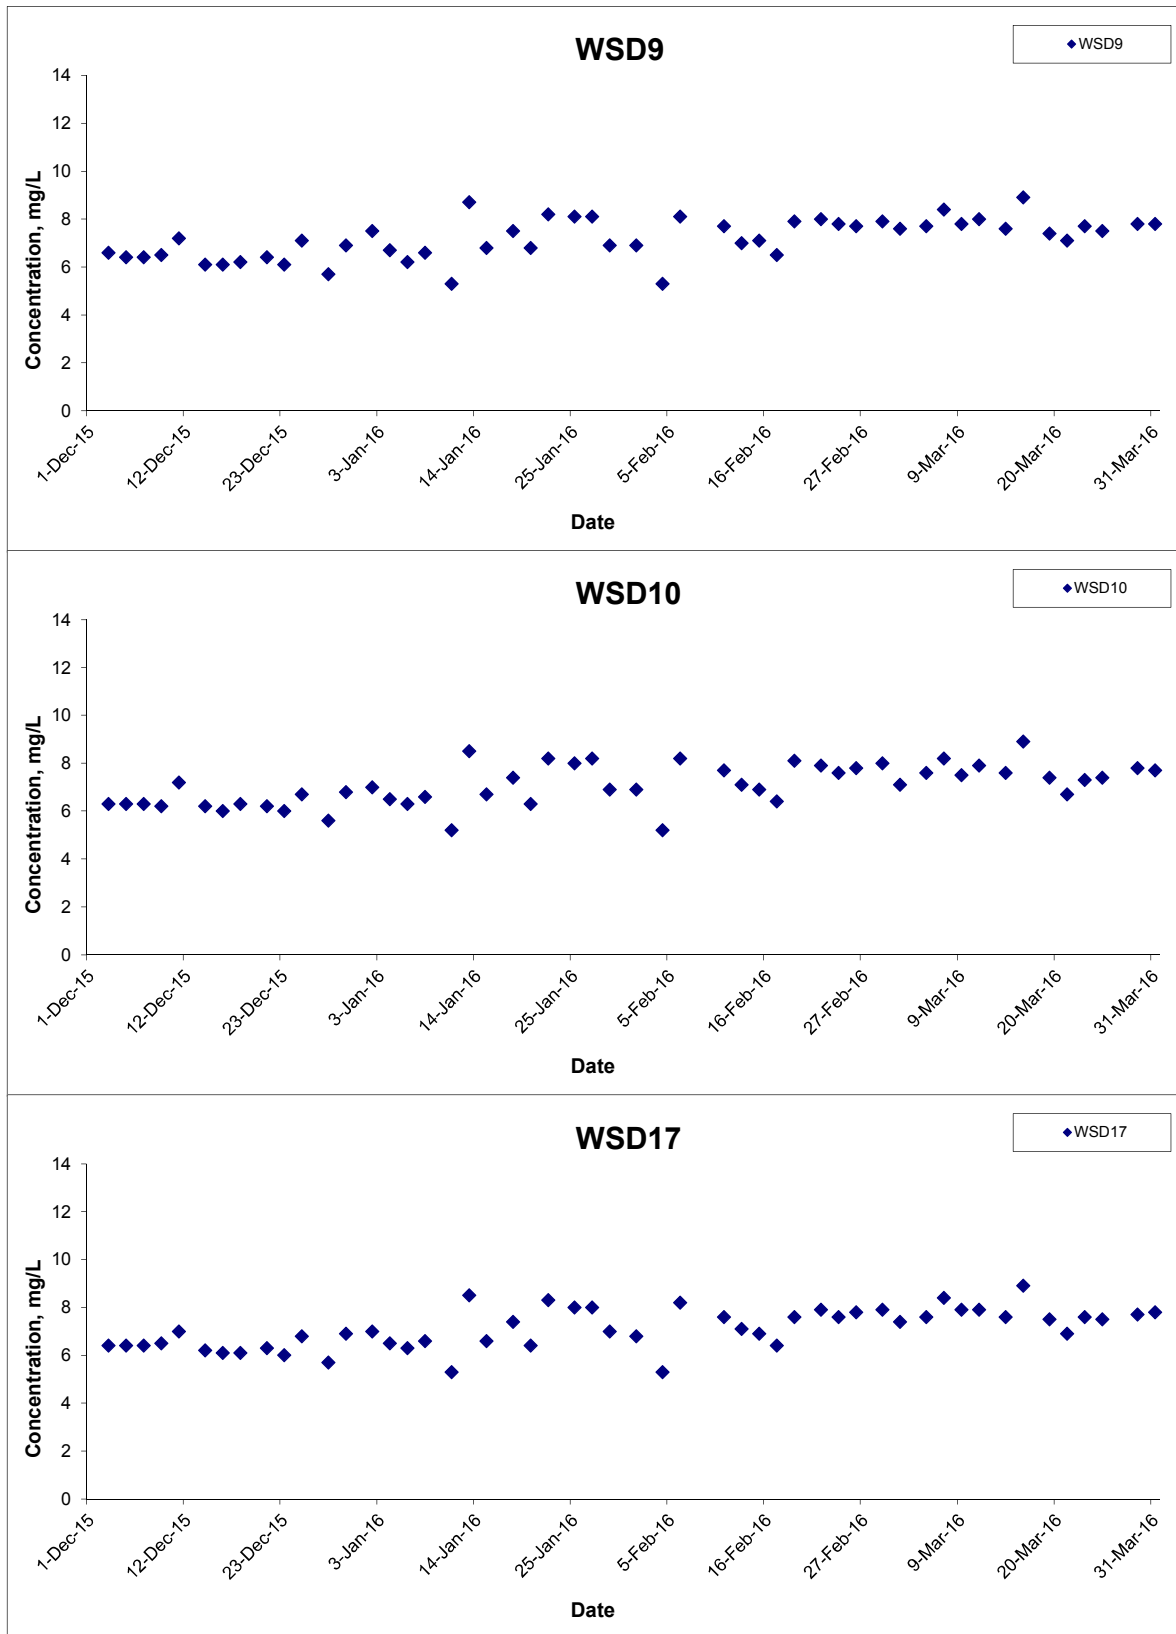
Title Contract No. KL/2013/01 -
 Site Formation For Kai Tak Cruise Terminal Development -
 Remaining Works
 Graphical Presentation of Water Quality Monitoring
 Results

Dissolved Oxygen at Mid-Flood Tide

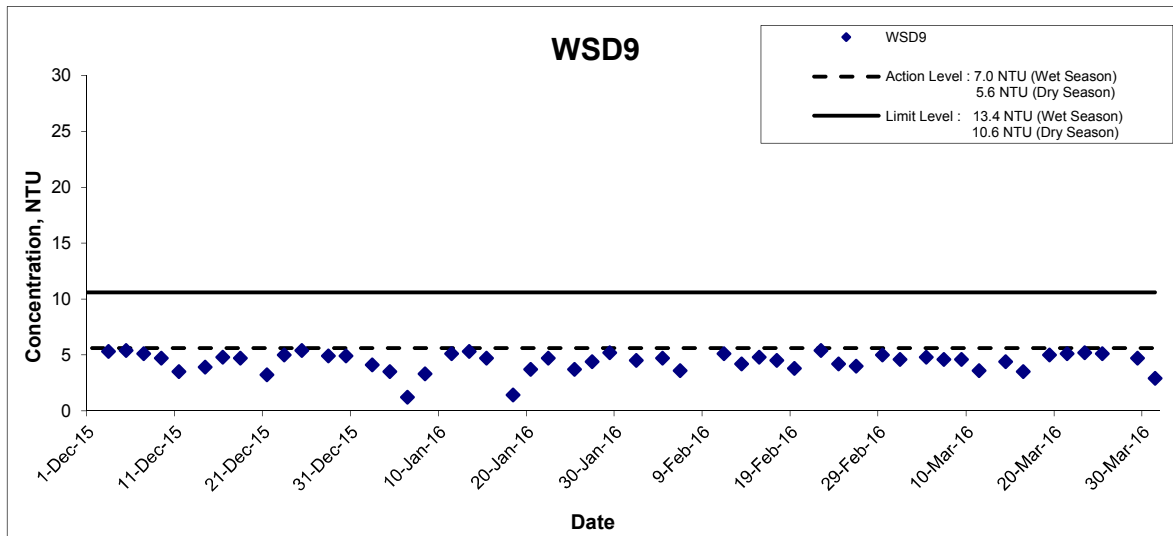
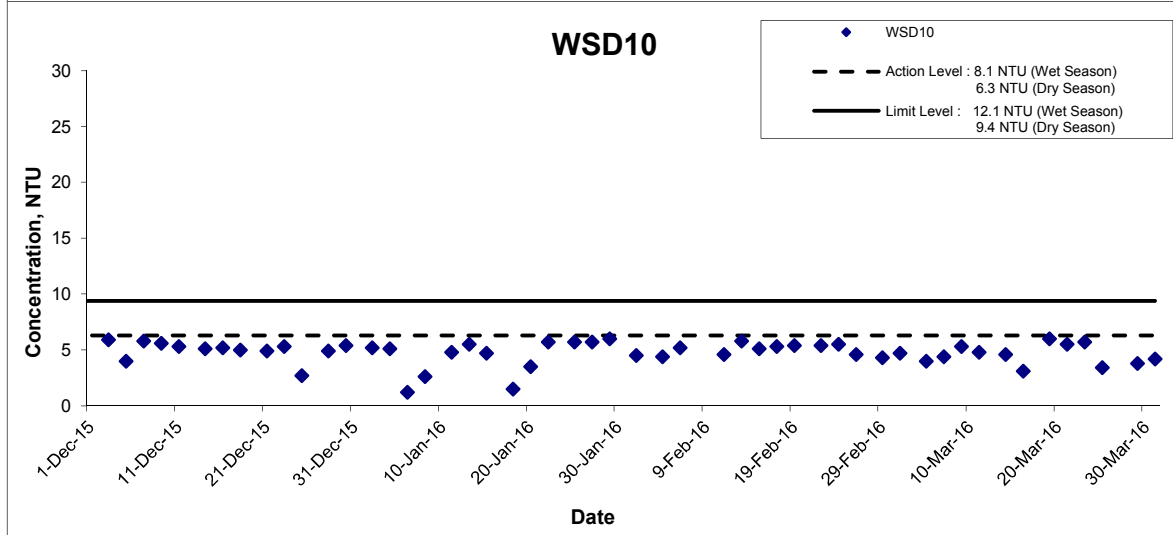
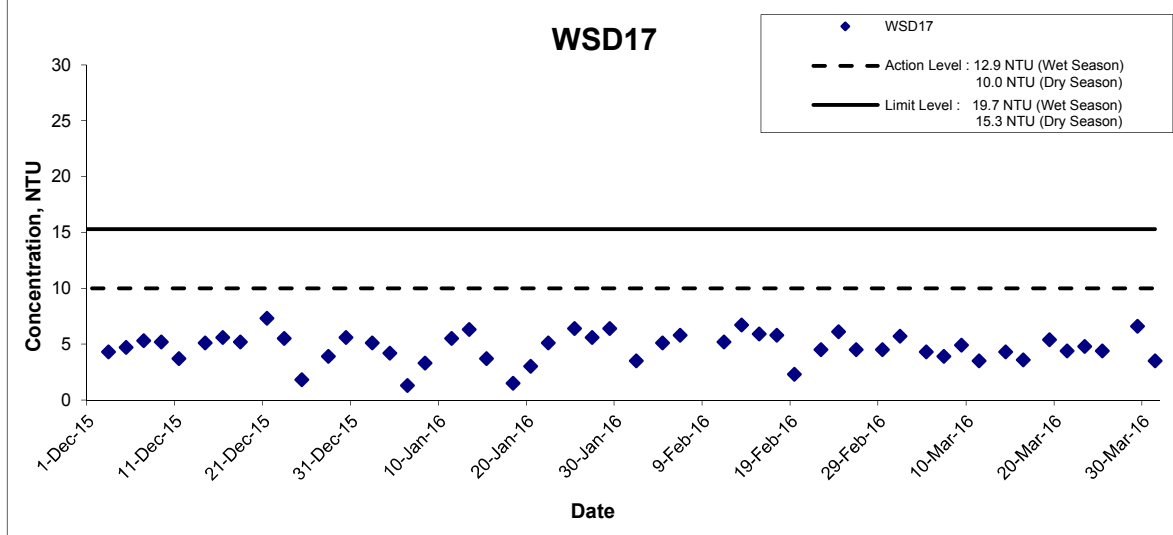
Title Contract No. KL/2013/01 -
Site Formation For Kai Tak Cruise Terminal Development -
Remaining Works
Graphical Presentation of Water Quality Monitoring
Results

Turbidity at Mid-Ebb Tide

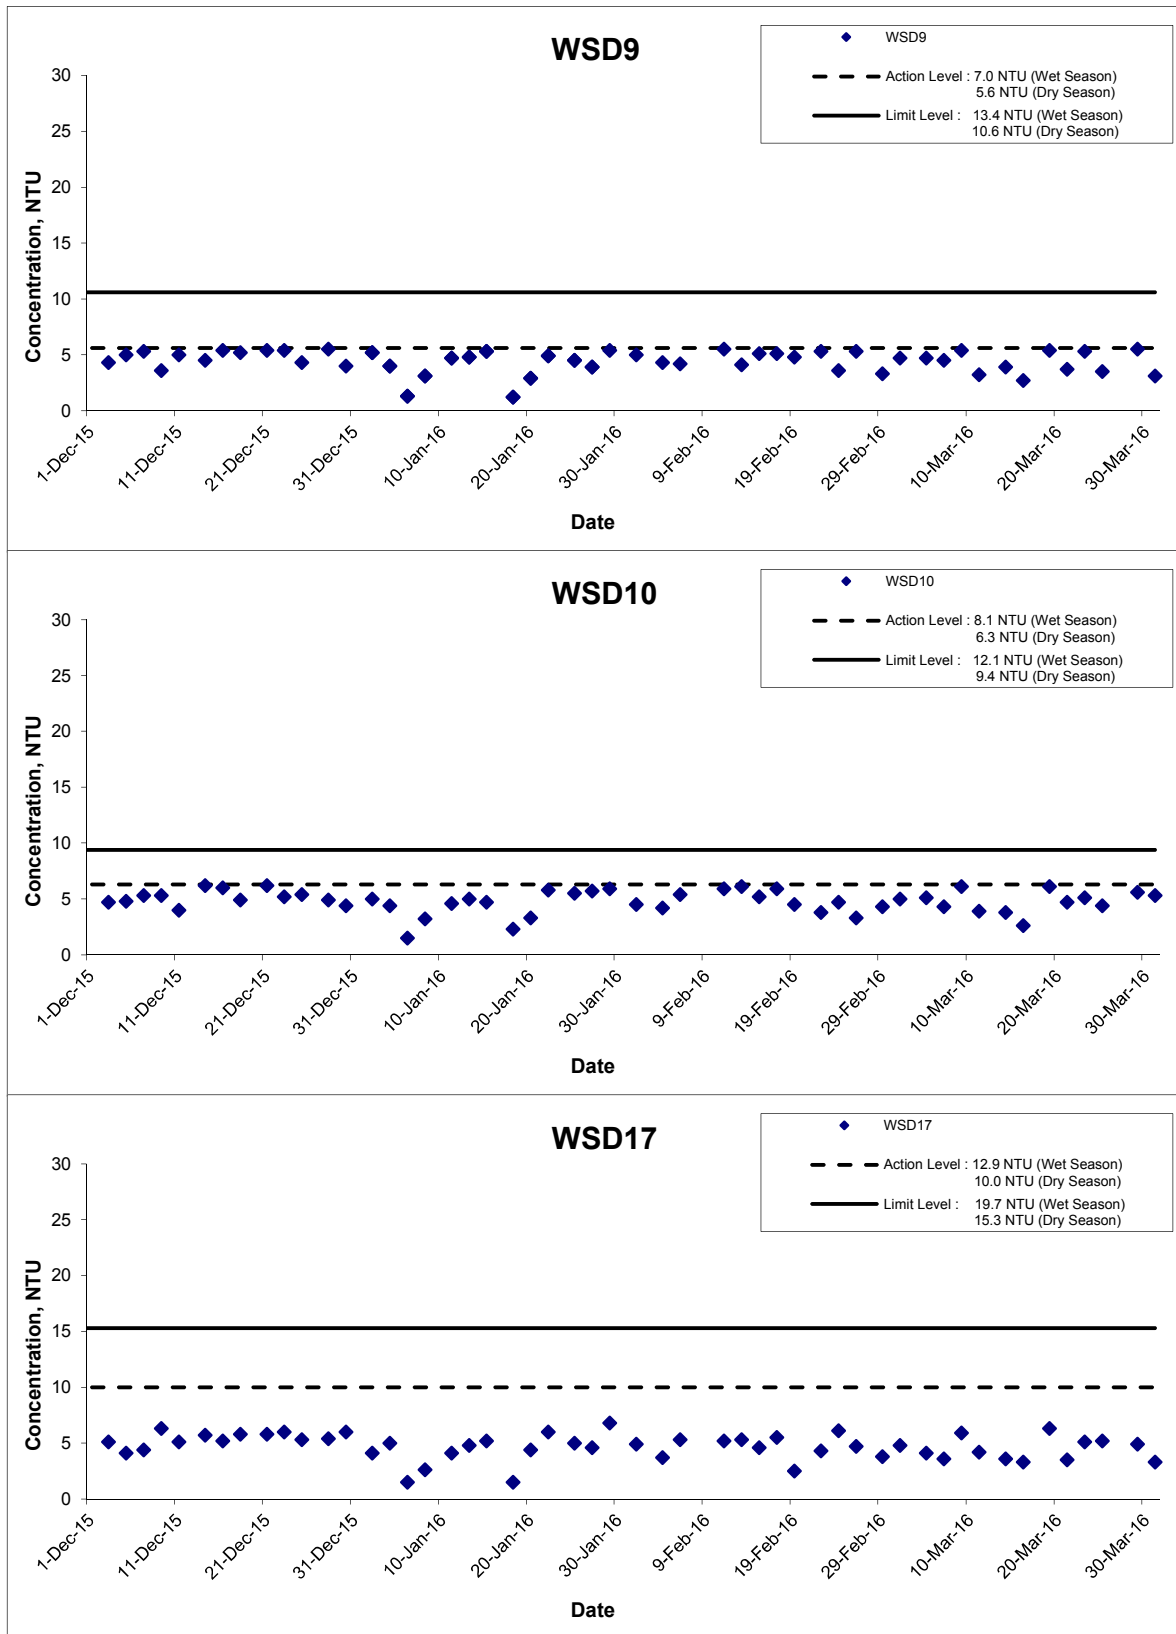
Title Contract No. KL/2013/01 -
 Site Formation For Kai Tak Cruise Terminal Development -
 Remaining Works
 Graphical Presentation of Water Quality Monitoring
 Results

Turbidity at Mid-Flood Tide

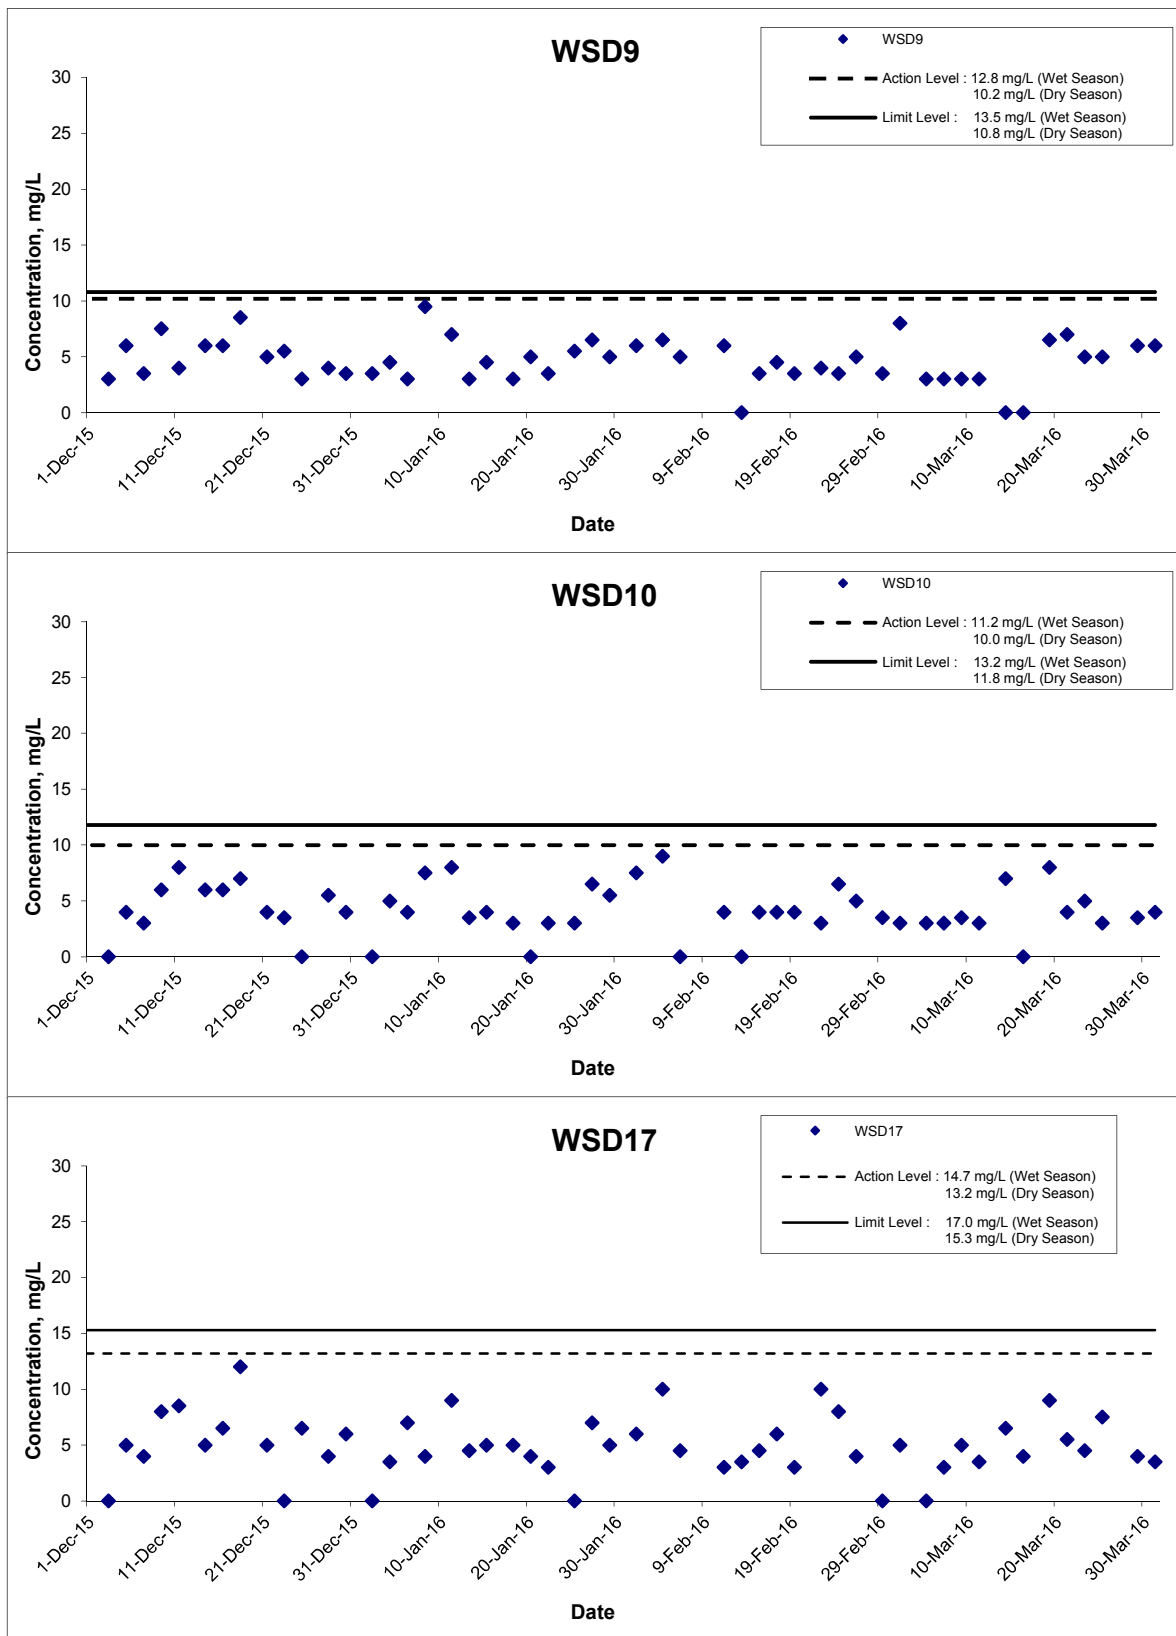
Title Contract No. KL/2013/01 - Site Formation For Kai Tak Cruise Terminal Development - Remaining Works Graphical Presentation of Water Quality Monitoring Results	Scale	N.T.S	Project No. MA15011	
	Date	Mar 16	Appendix

Suspended Solids at Mid-Ebb Tide

The graphical point at zero concentration is presented as <2.5 mg/L

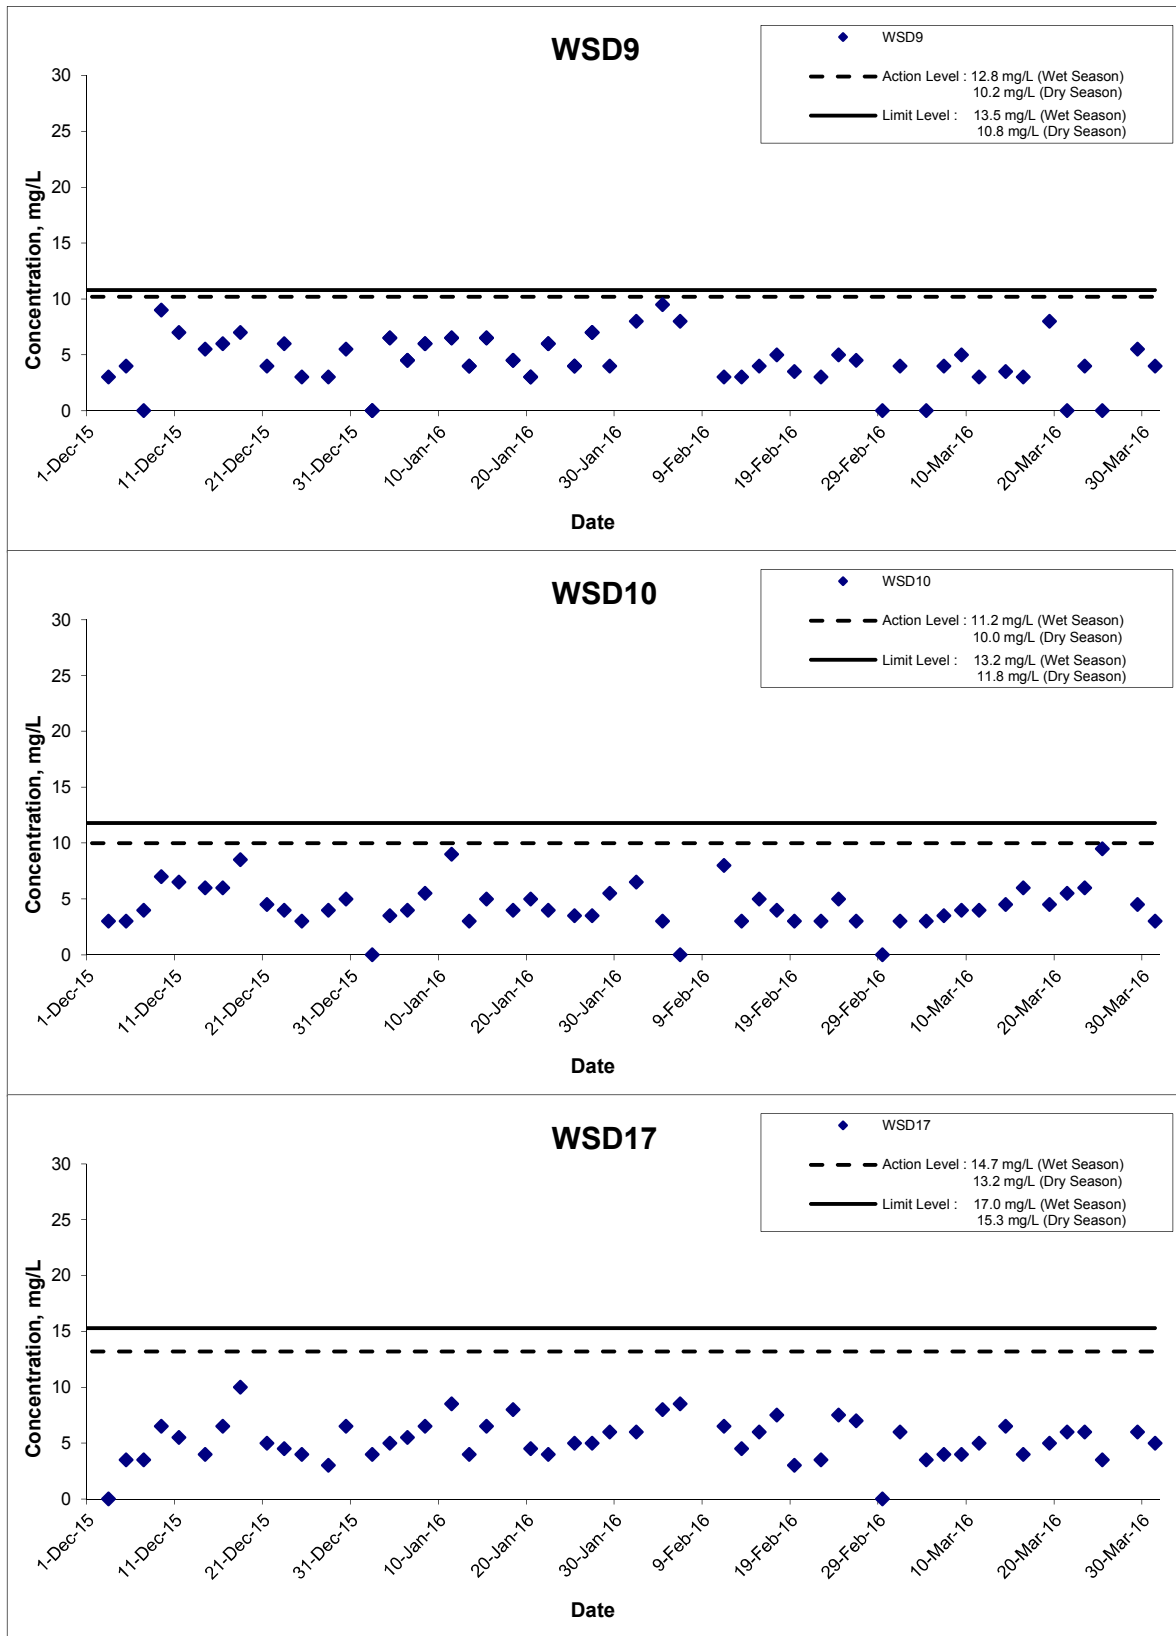
Title Contract No. KL/2013/01 - Site Formation For Kai Tak Cruise Terminal Development - Remaining Works Graphical Presentation of Water Quality Monitoring Results	Scale	N.T.S	Project No. MA15011	
	Date	Mar 16	Appendix E

Suspended Solids at Mid-Flood Tide

The graphical point at zero concentration is presented as <2.5 mg/L
