**Contract No. KL/2013/01**

**Site Formation for Kai Tak Cruise Terminal  
Development – Remaining Works**

**Monthly EM&A Report  
May 2016  
(Version 1.0)**

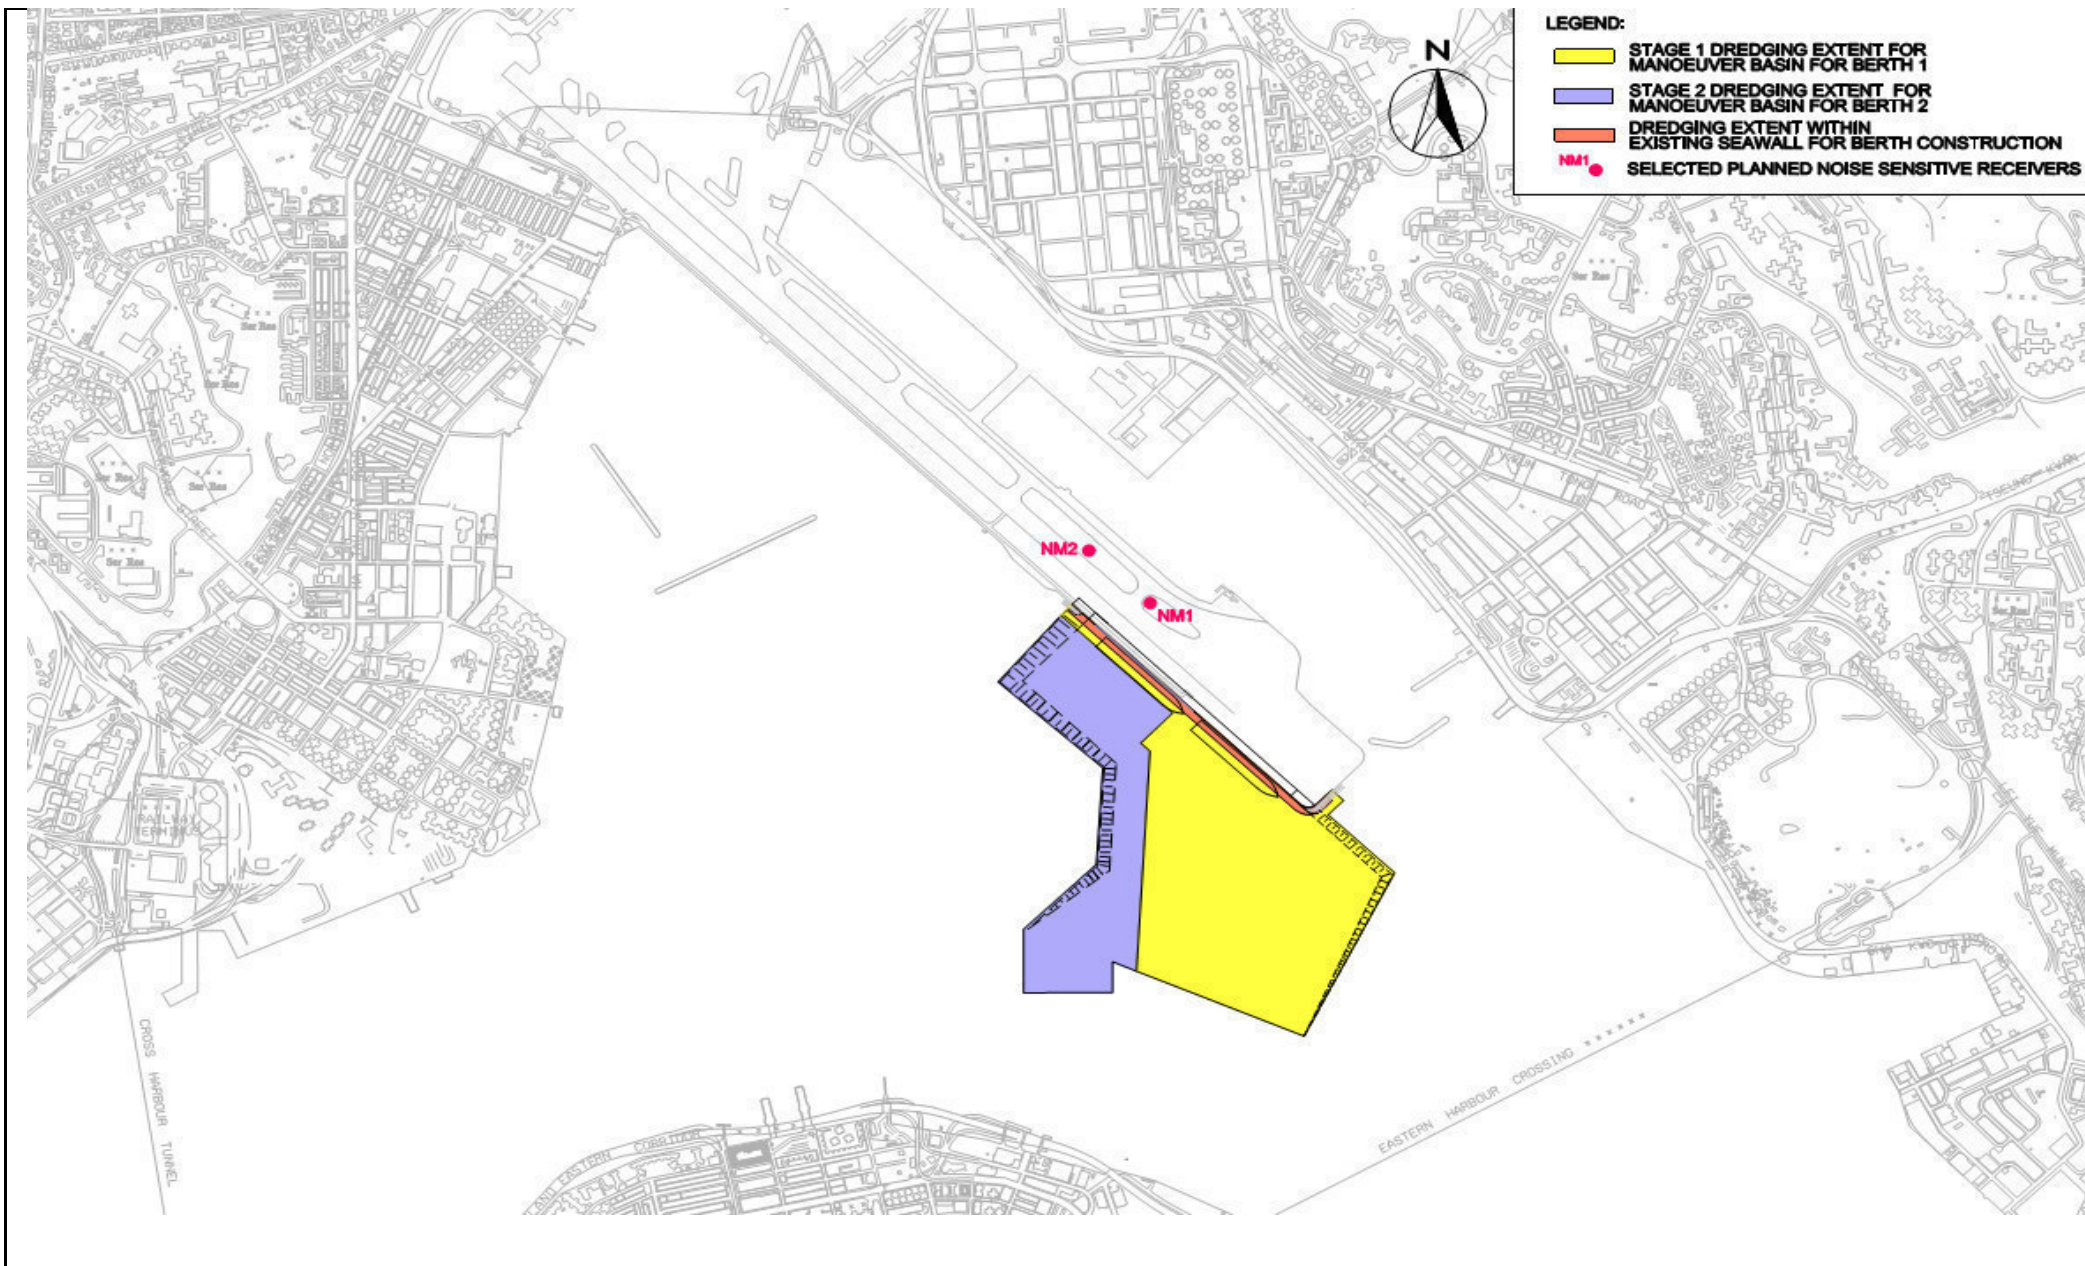
Title	Contract No. KL/2013/01		Scale	N.T.S	Propose	MA15011	CINOTECH
	Site Formation for Kai Tak Cruise Terminal Development - Remaining Works		Date	Apr-15	Figure		
Planned Noise Monitoring Stations during Construction Phase

6. Due to the non-existence of planned NSRs during the reporting period, no noise monitoring was required to be conducted at the planned noise monitoring locations NM1 and NM2.

- 3.1 In accordance with the EIA Report and the EM&A Manual, it is anticipated that construction activities, if unmitigated, would not cause any adverse noise impact to the nearest NSRs in the vicinity of the work site. The predicted noise levels at the NSRs would comply with construction noise criteria.
- 3.2 These nearest NSRs are designated for construction noise monitoring as listed in Table 3.1 and **Figure 3**.

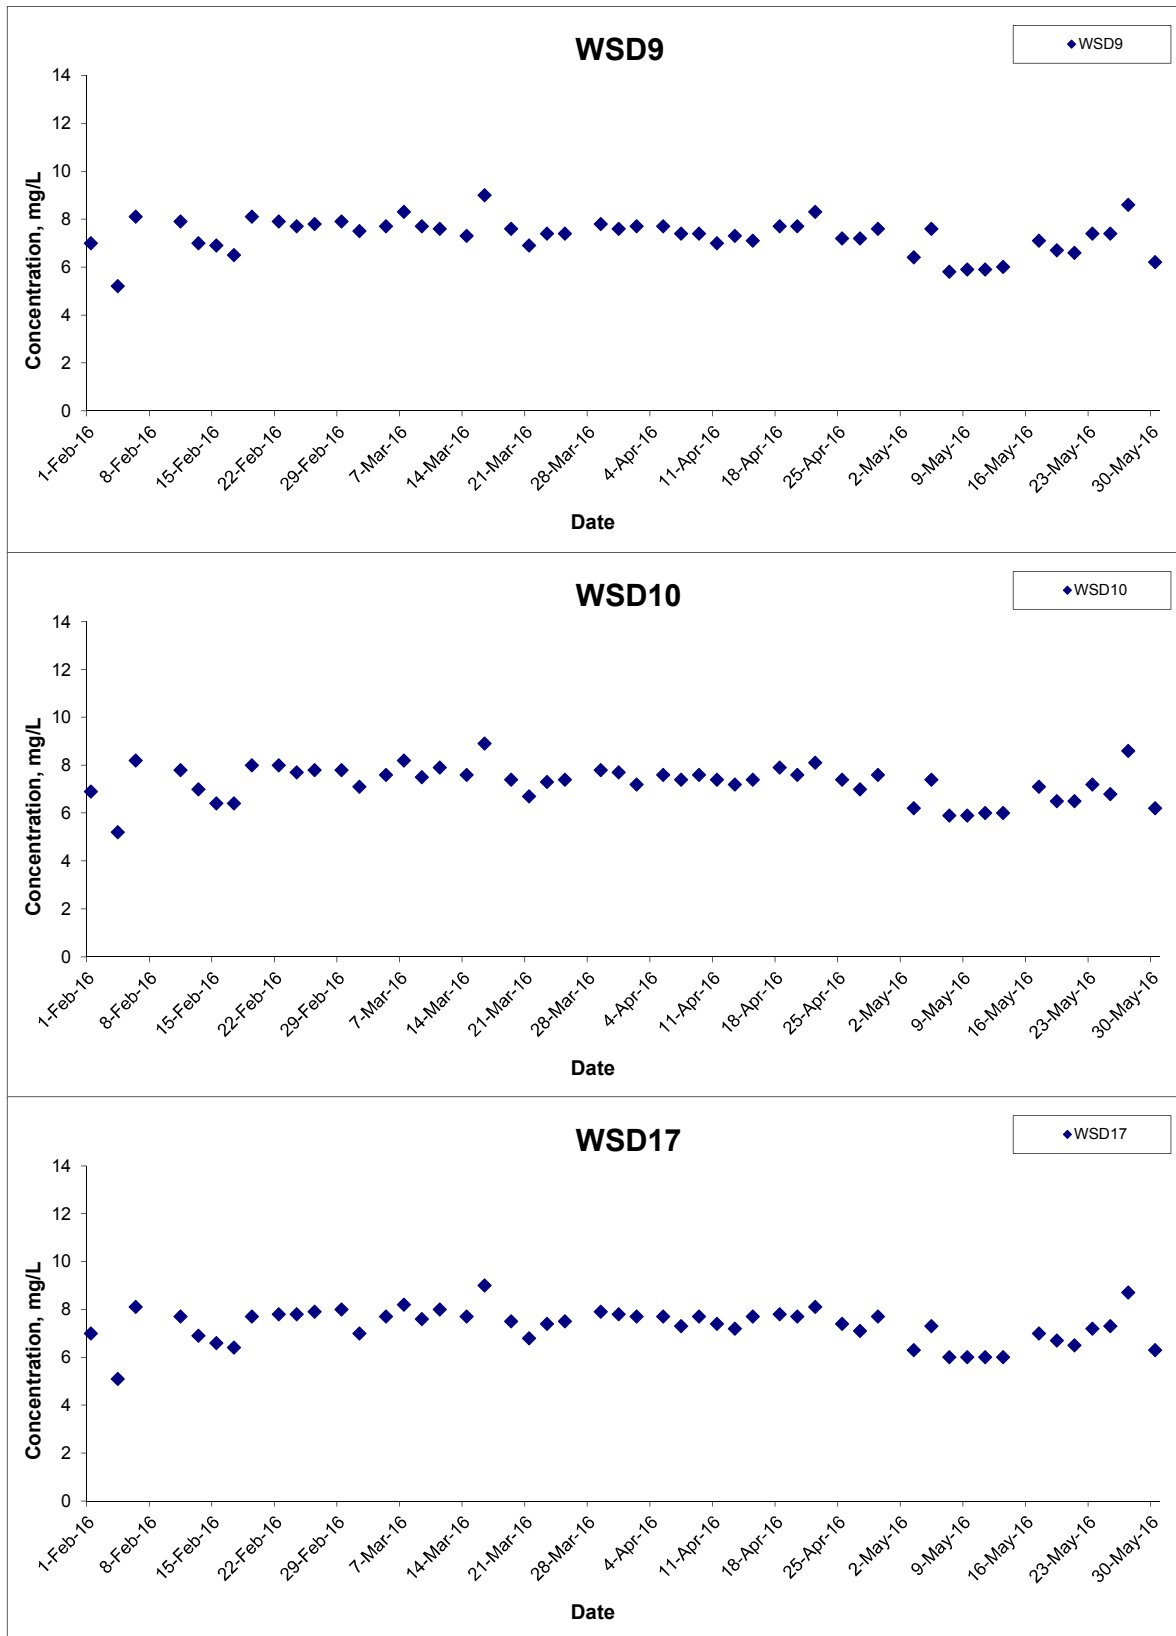
Title Contract No. KL/2013/01 -  
 Site Formation For Kai Tak Cruise Terminal Development -  
 Remaining Works  
 Graphical Presentation of Water Quality Monitoring  
 Results

## Dissolved Oxygen at Mid-Ebb Tide

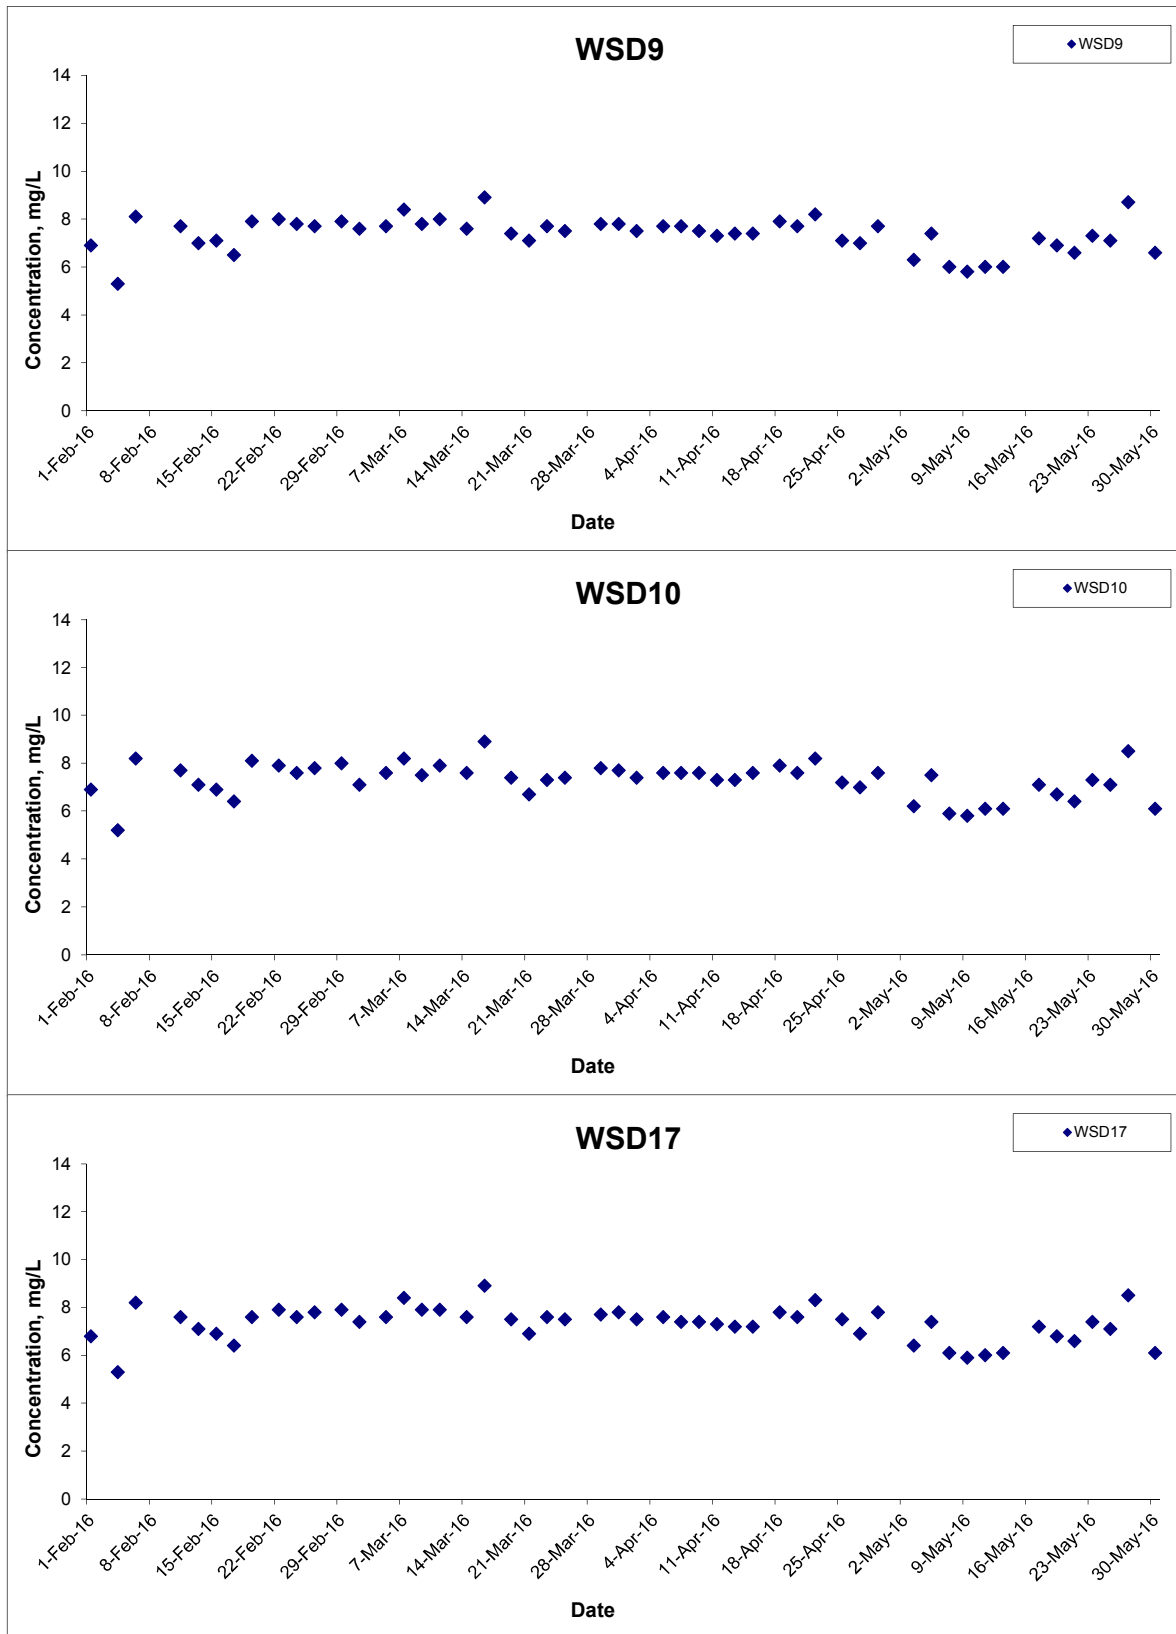
Title Contract No. KL/2013/01 -  
 Site Formation For Kai Tak Cruise Terminal Development -  
 Remaining Works  
 Graphical Presentation of Water Quality Monitoring  
 Results

## Dissolved Oxygen at Mid-Flood Tide

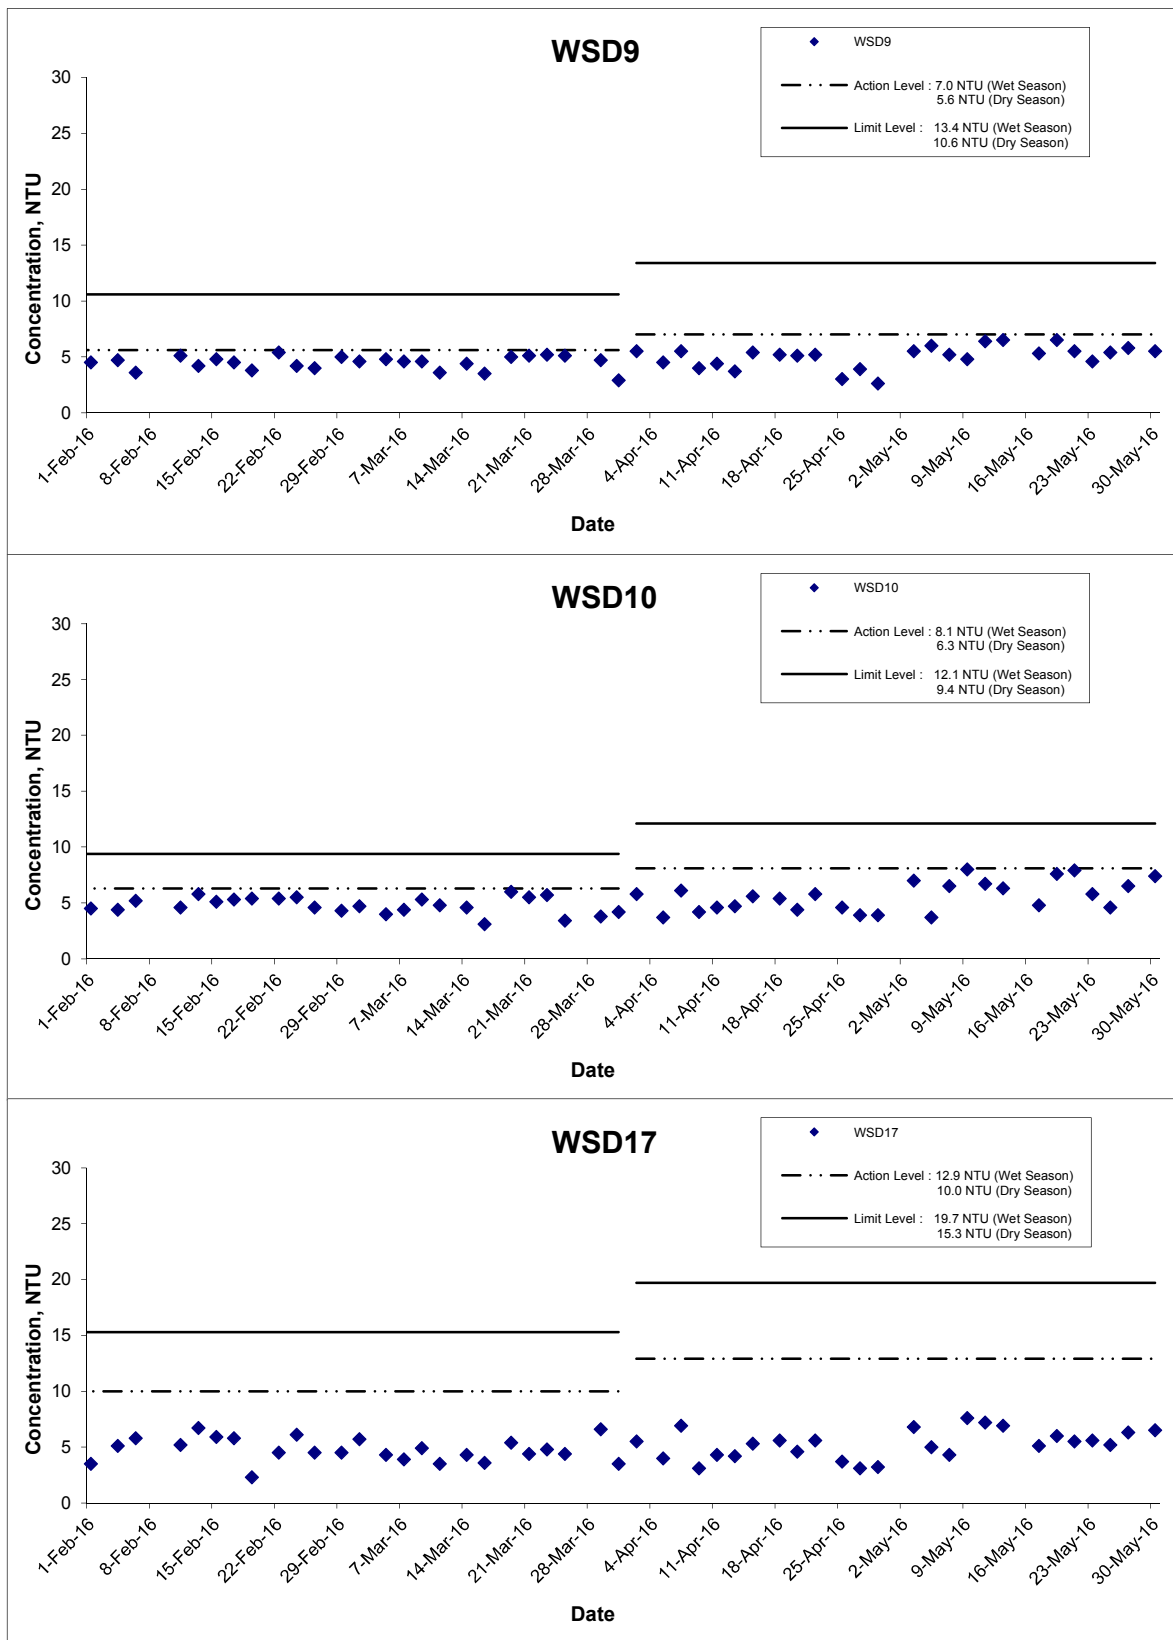
Title Contract No. KL/2013/01 -  
 Site Formation For Kai Tak Cruise Terminal Development -  
 Remaining Works  
 Graphical Presentation of Water Quality Monitoring  
 Results

### Turbidity at Mid-Ebb Tide

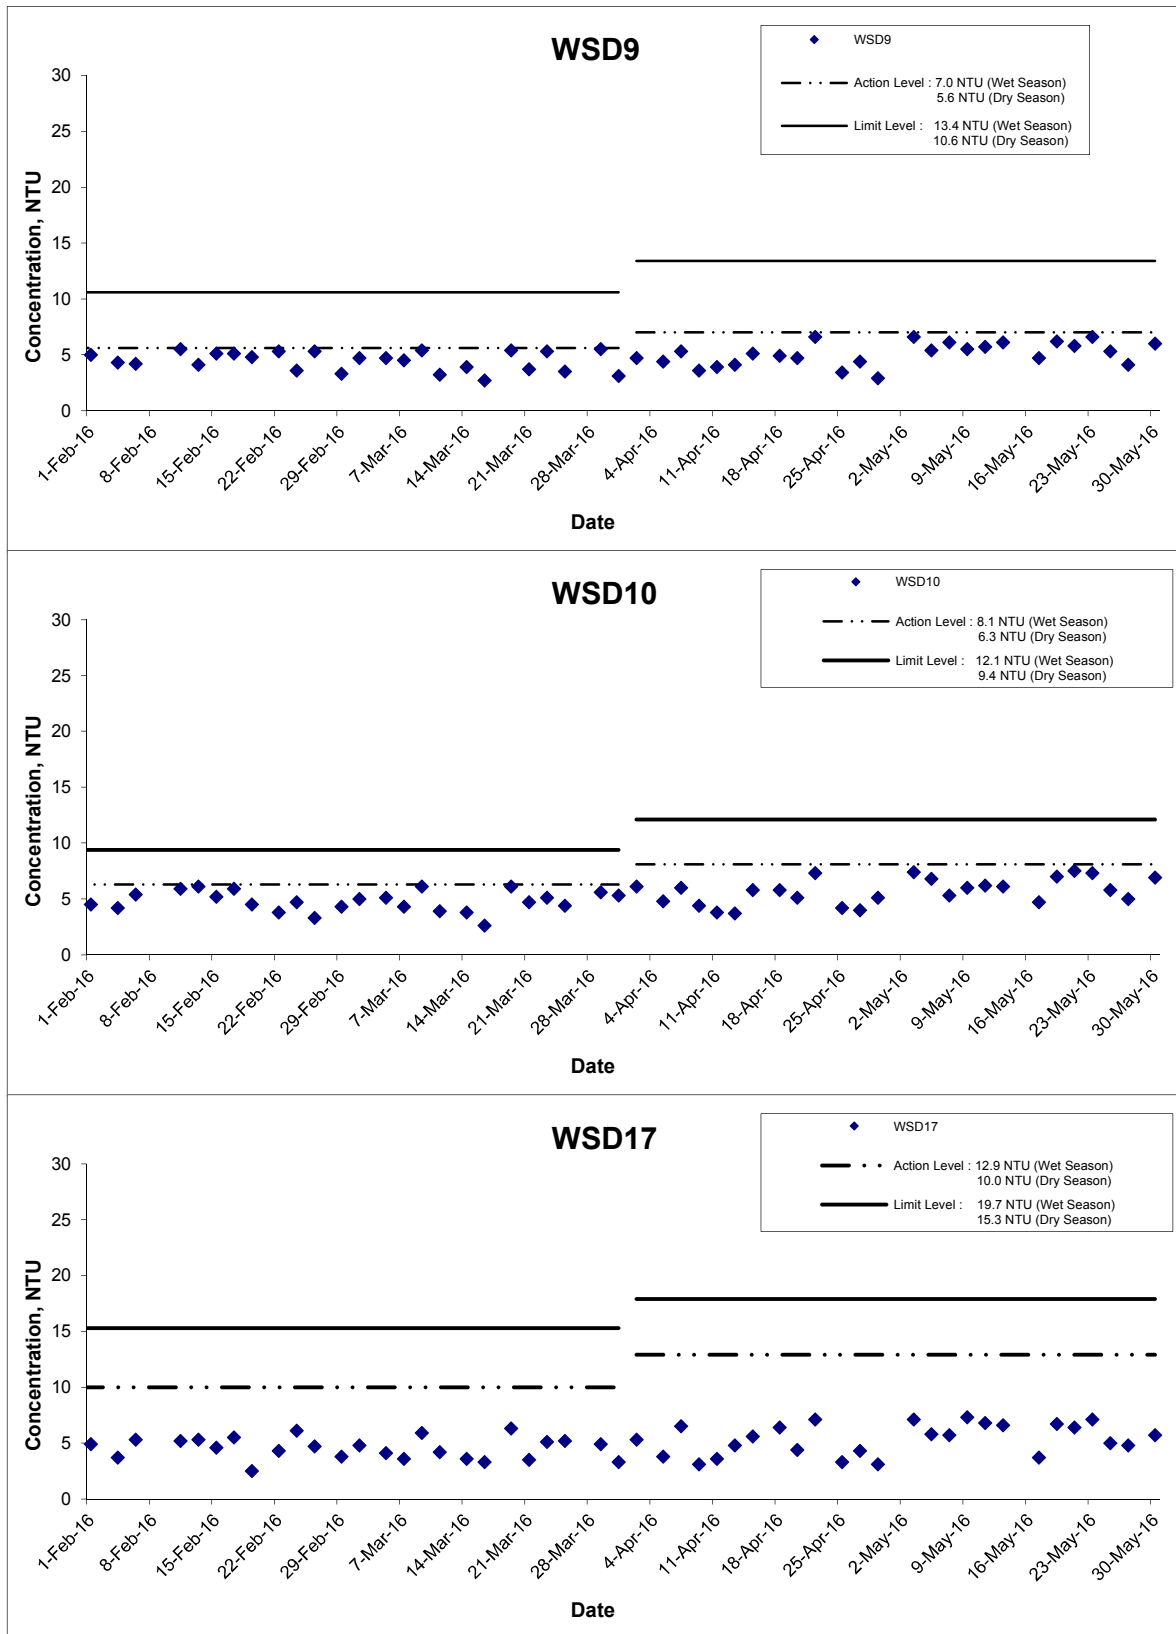
Title Contract No. KL/2013/01 -  
 Site Formation For Kai Tak Cruise Terminal Development -  
 Remaining Works  
 Graphical Presentation of Water Quality Monitoring  
 Results

## Turbidity at Mid-Flood Tide

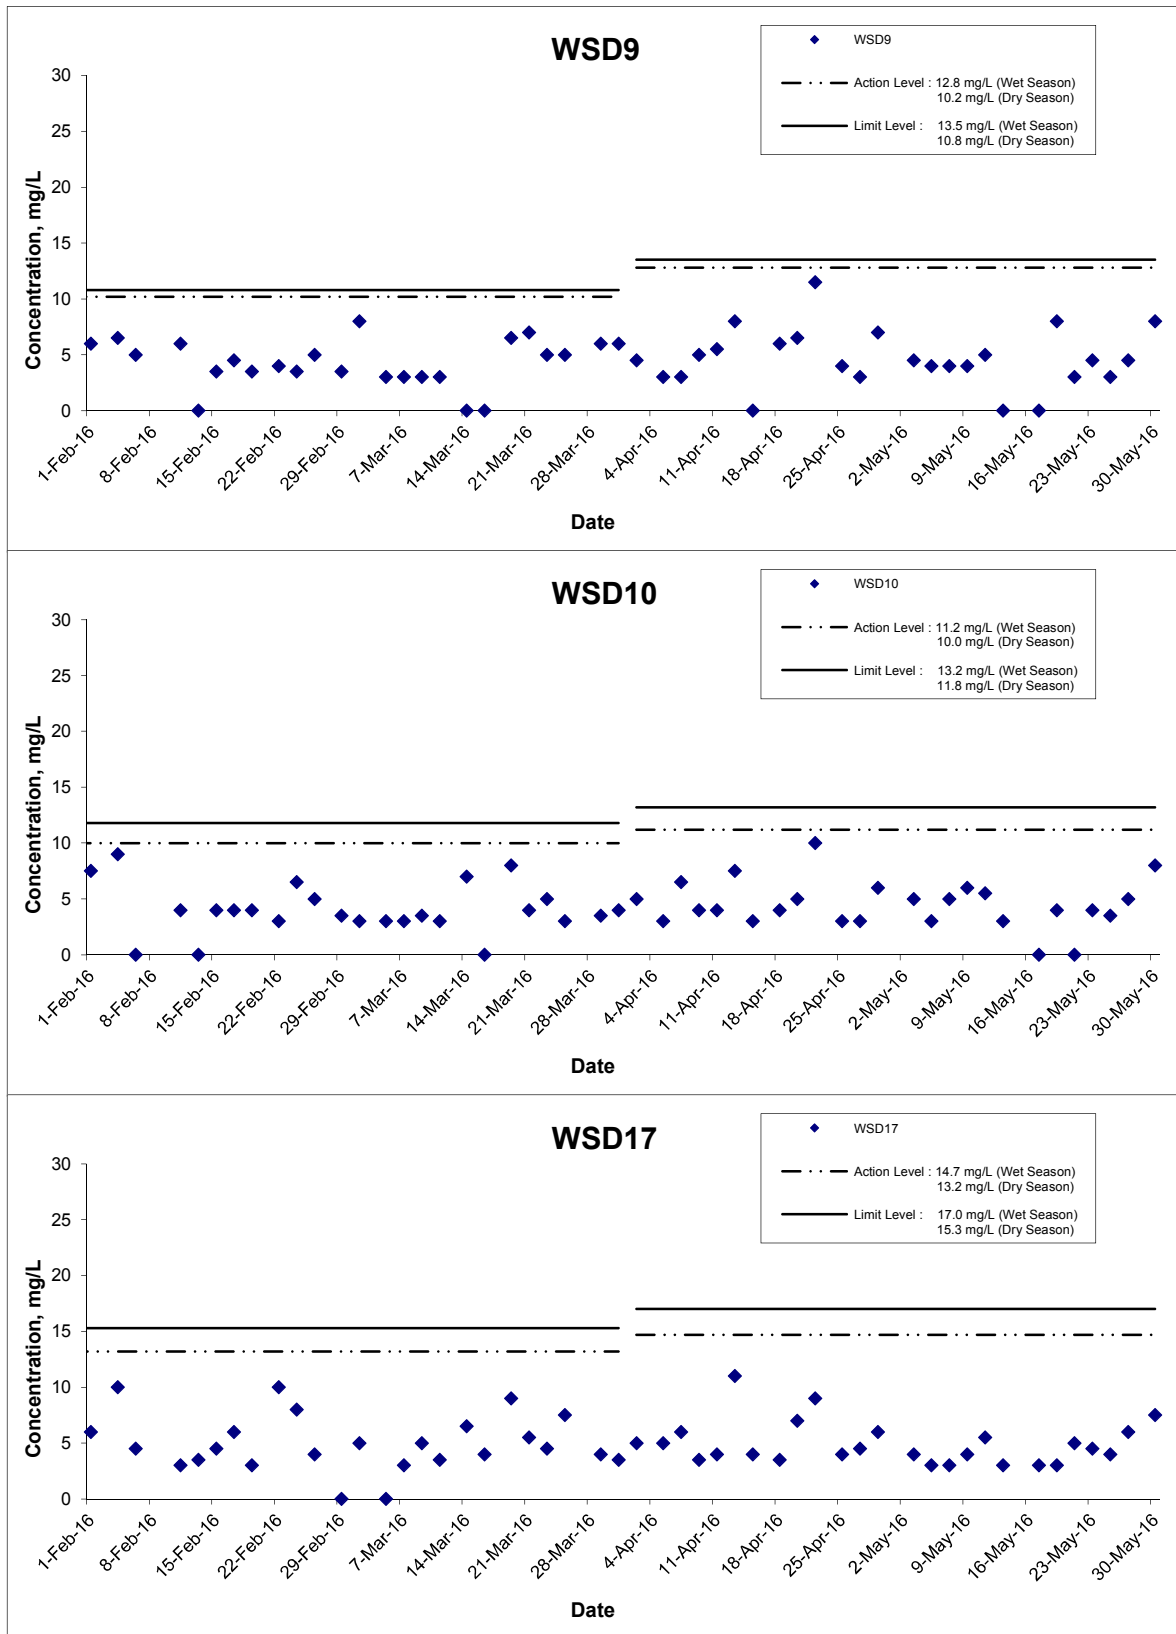
Title Contract No. KL/2013/01 - Site Formation For Kai Tak Cruise Terminal Development - Remaining Works  Graphical Presentation of Water Quality Monitoring Results	Scale	N.T.S	Project No. MA15011	CINOTECH
	Date	May 16	Appendix

## Suspended Solids at Mid-Ebb Tide

Remarks: The graphical point at zero concentration is presented as <2.5 mg/L

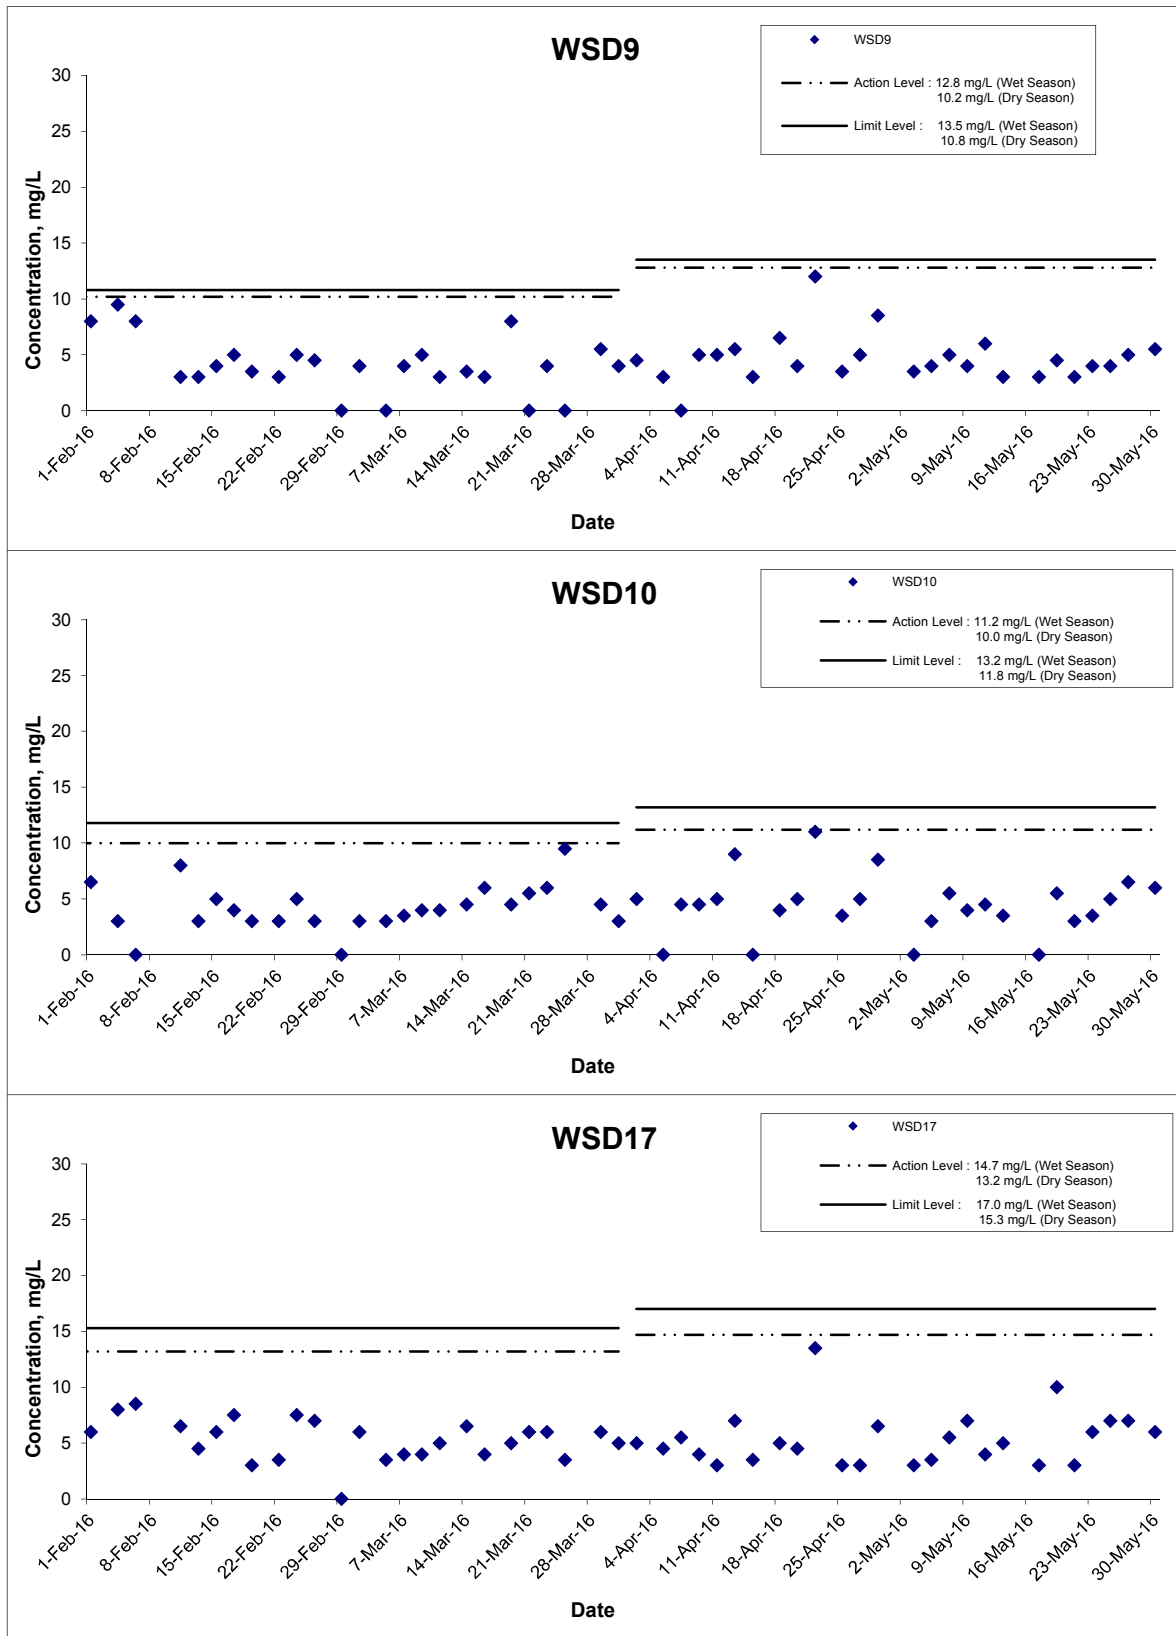
Title Contract No. KL/2013/01 - Site Formation For Kai Tak Cruise Terminal Development - Remaining Works  Graphical Presentation of Water Quality Monitoring Results	Scale	N.T.S	Project No. MA15011	
	Date	May 16	Appendix

## Suspended Solids at Mid-Flood Tide

Remarks: The graphical point at zero concentration is presented as <2.5 mg/L
