Site Formation for Kai Tak Cruise Terminal Development - Design and Construction

First Post-Translocation Coral Monitoring Report

Deliverable ID: D28

November 2009

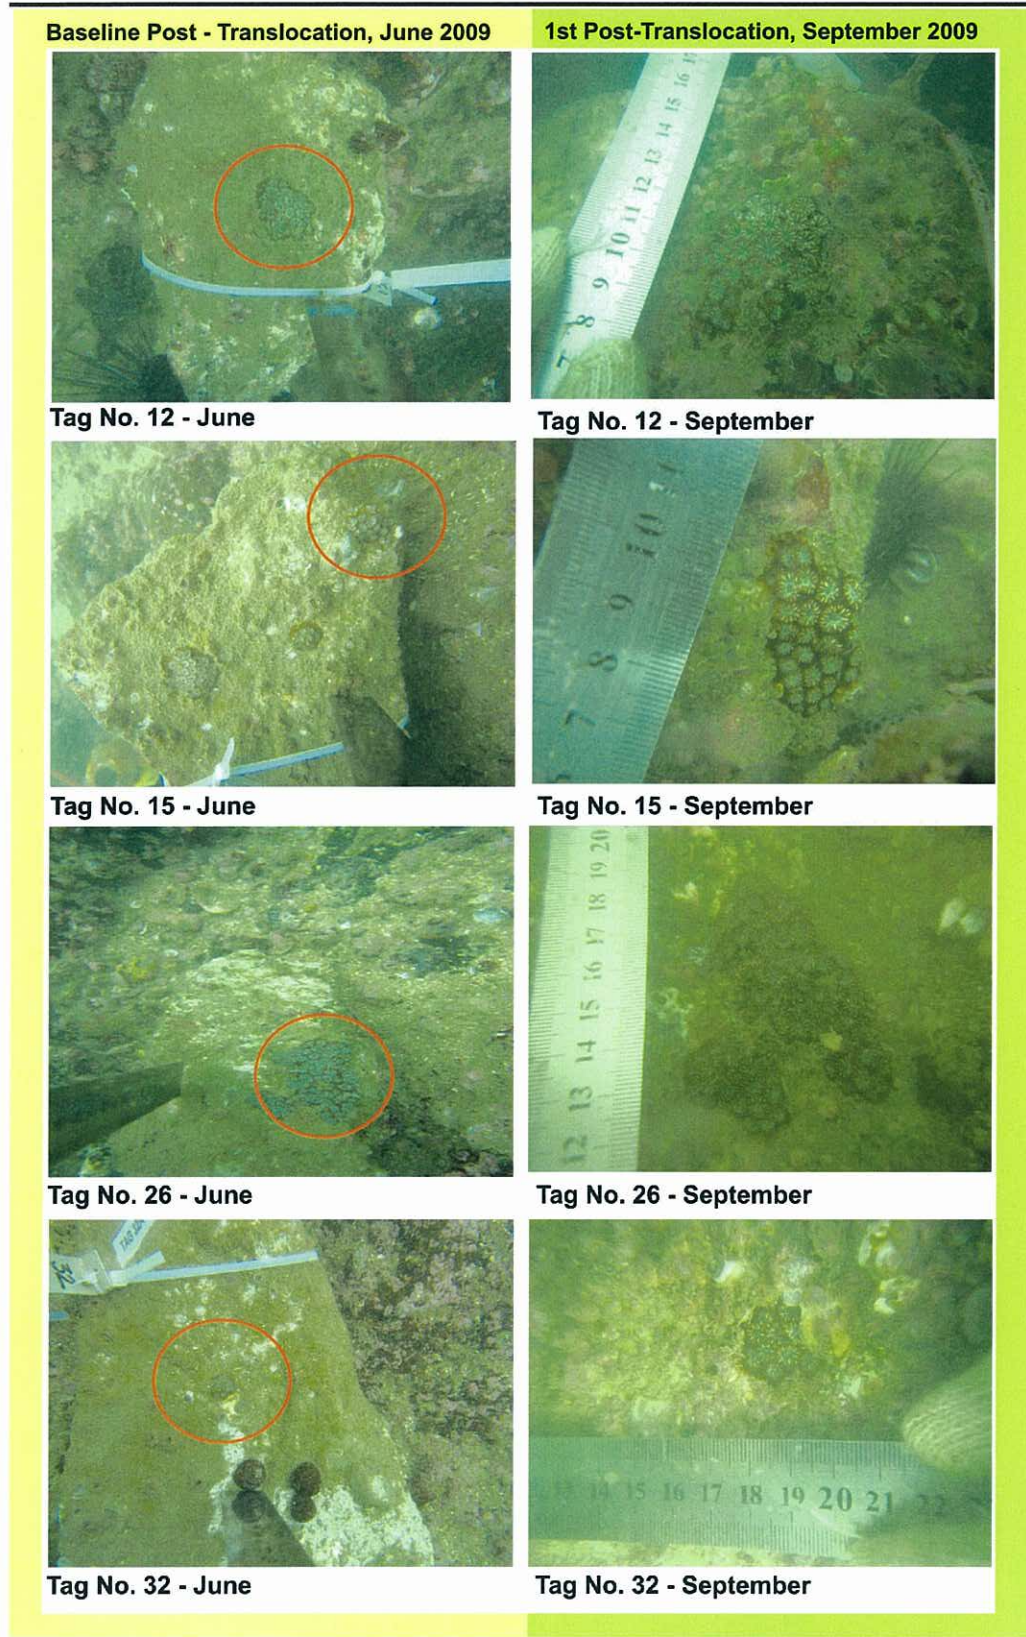
Figure 3.3 Representative Photographs of Selected *Oulastrea crispata* Colonies immediately following the move from Kai Tak (June, 2009) and three months later (September, 2009)
